Durability of reinforced PVC-P geomembranes installed in reservoirs in eastern Spain

M. Blanco¹, N. Touze-Foltz², M. Pérez Sánchez³, M. Redon-Santafe⁴, F. J. Sánchez Romero⁵, J. B. Torregrosa Soler⁶ and F. A. Zapata Raboso⁷

KEYWORDS: Geosynthetics, Geomembrane, PVC-P, Waterproofing, Water reservoir, Durability

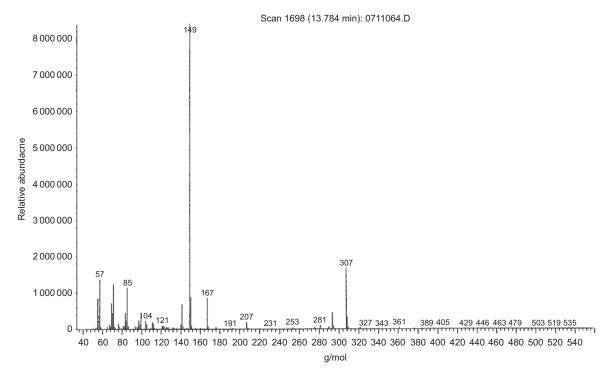
Figure 1 shows the MS spectrum of the plasticiser. The following fragmentations were observed: MS, m/z (relative intensity): 390 (M^+), 279 ($C_{16}H_{23}$ O_4^+ , 12), 167 ($C_8H_7O_4^+$, 39), 149 ($C_8H_5O_3^+$, 100), 113 ($C_8H_{17}^+$, 9), and 57 ($C_4H_9^+$, 18). This was identified as the bis(2-ethylhexyl) phthalate. Its molecular weight is 390,

Figure 1. Mass spectrum of the plasticiser extracted from the geomembrane

which is lower than the current recommended value of 400 for high-durability PVC-P geomembranes (PGI 2004; MARM 2010).

The low molecular weight of this additive justifies its tendency to fundamentally migrate to the air (Stark *et al.* 2005). Additionally, this behaviour is consistent with the high losses of plasticisers found in all the geomembranes. GC showed a chromatogram with a single peak at a 82.93 min retention time.

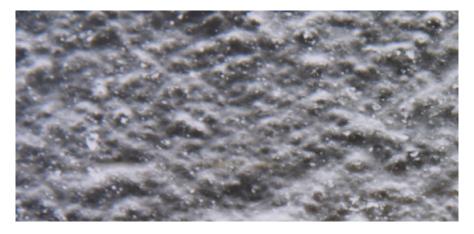
The original samples observed using SEM at ×90 and ×900 magnifications are shown in Figures 2 and 3, respectively. In the first image (×90), the presence of micropores can be observed, and they are clearly evident in the second microphotograph taken at a higher magnification (×900).

Figure 2. SEM microphotograph of the original geomembrane at $\times 90$ magnification

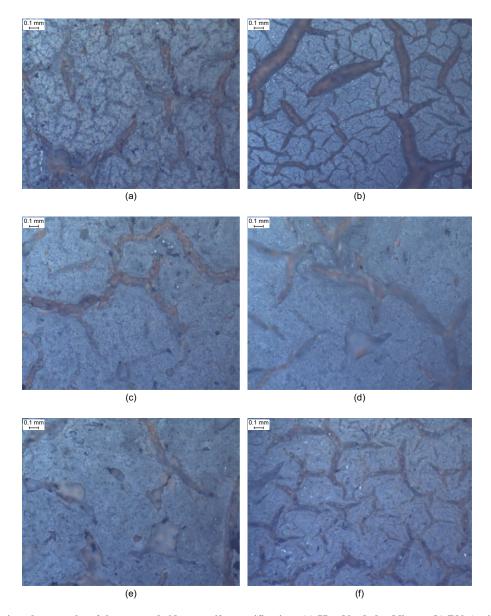
For all the 2015 samples, Figure 4 depicts the ROM images for the external side at ×60 magnification. Likewise, Figure 5 shows the appearance of the external side of the materials by SEM at ×90 magnification. Both the ROM and SEM images reveal a significant deterioration in the external side of the geomembranes, with visual evidence of surface cracking.

Figure 4. ROM microphotographs of the external sides at ×60 magnification. (a) Hondón de las Nieves; (b) Plá Aceituna; (c) El Rollo; (d) Caseta de Mira; (e) El Cid-III; (f) El Rabosero

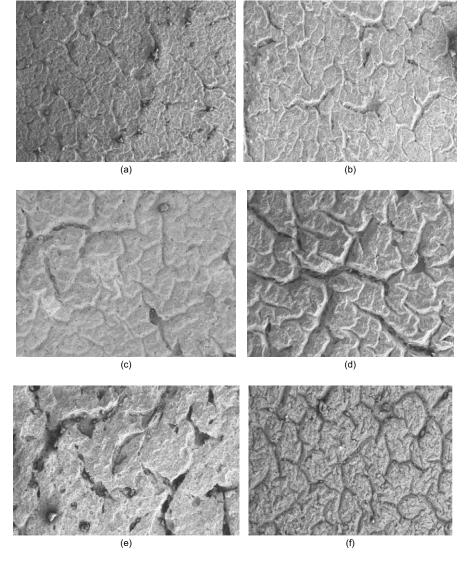
Figure 5. SEM microphotographs of the external side of the geomembranes at ×90 magnification. (a) Hondón de las Nieves; (b) Plá Aceituna; (c) El Rollo; (d) Caseta de Mira; (e) El Cid-III; (f) El Rabosero

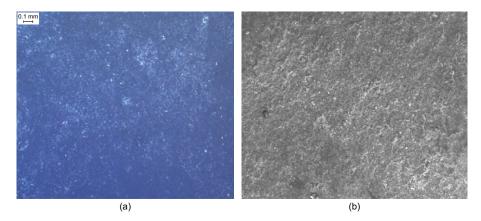
For the samples exhumed from the El Cid-III reservoir 31 years after installation, the microscopy images of the internal side show good material conditions (Figure 6). The comparison between the two sides of the test specimens illustrates the effect of UV radiation on the deterioration of the organic material.

Figure 6. (a) ROM and (b) SEM microphotographs of the internal side of samples from the El Cid III reservoir at $\times 60$ and $\times 90$ magnification, respectively

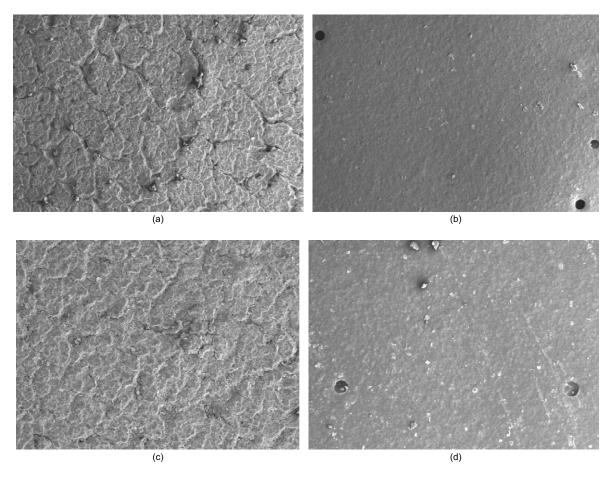
The external side shows notable cracking, which was slightly greater in the crest sample, and for the internal side, some craters can be observed. Possibly, these craters are related to the micropores that were initially observed in the geomembrane and are a consequence of the impregnation process used in the manufacturing. The coalescence of these pores and material ageing cause the formation of craters and cracking over time.

Figure 7. SEM microphotographs of the geomembrane from Hondón de las Nieves reservoir at ×90 magnification. (a) External side at crest, (b) internal side at crest, (c) external side in the intermediate area, (d) internal side in the intermediate area
