**QUANTITATIVE ANALYSIS PROCEDURE FOR BUILDING MATERIALS IN
HISTORIC BUILDINGS BY APPLYING INFRARED THERMOGRAPHY**

We have applied this methodology to a unique historic building in Valencia (Spain): the Seminary-School of Corpus Christi. This religious institution was built between 1586 and 1610, with the intention of training priests, which still remains as its main function nowadays. Surprisingly, the façades of this building have never been restored or rehabilitated. Its current state has an enormous interest from an architectural, structural or building process point of view. The exterior walls of the building are supported on a perimeter plinth of stone. These walls are made of rammed earth with solid brick inside, according to the practice in Valencia at that time. The building façades are finished with seen brick in some representative points as the bell tower or the upper arches located in the gallery.

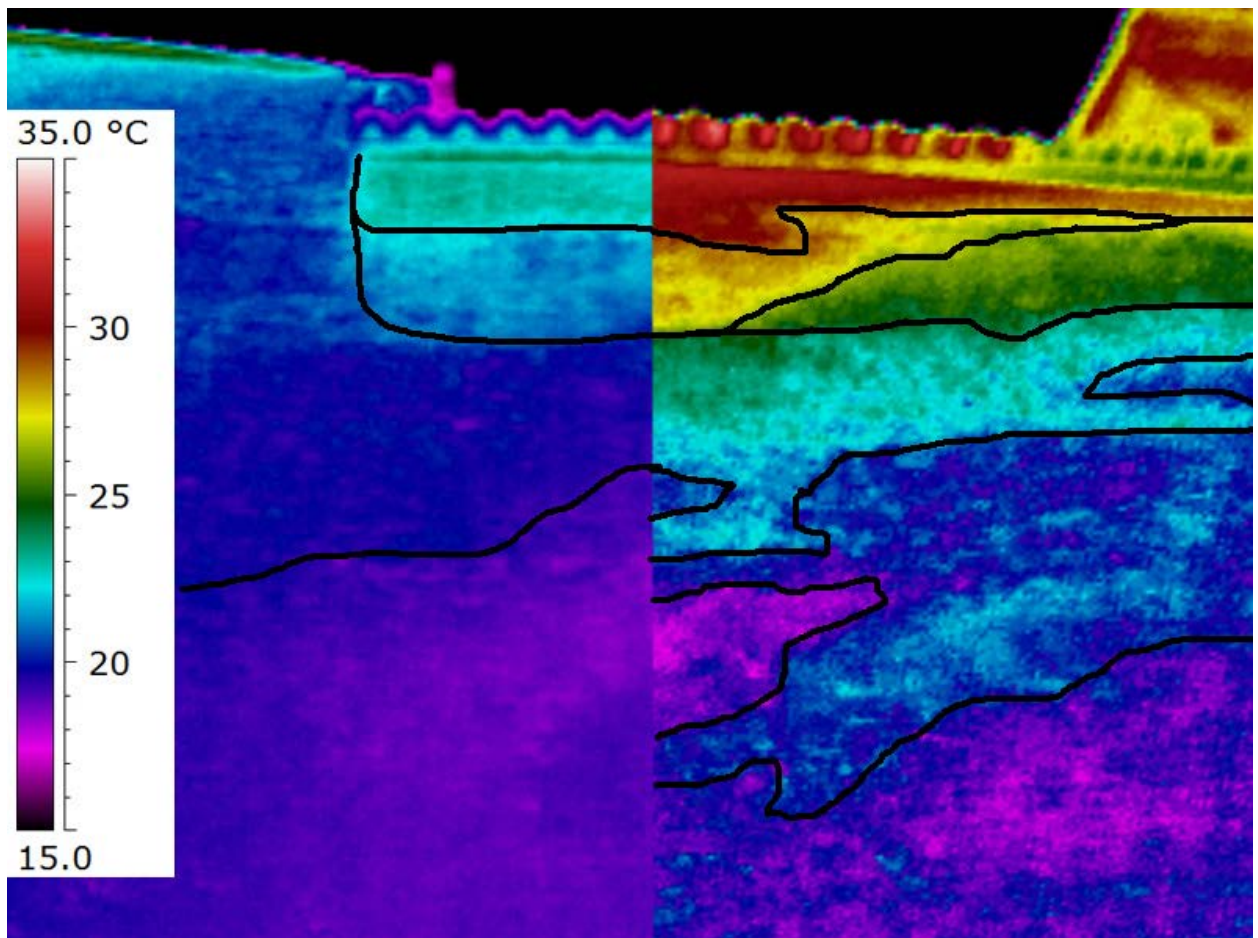
Figure 1. Day (right) and night (left) thermography of the west façade.

There is a clearly different area near the roof where the temperature is higher during day and night in Fig. 1. It is possible that the material of the façade can influence its temperature during the day, but these differences are minimal at night (Barreira, 2007).

After all night, building materials of a façade should have cooled homogeneously because the temperature is the same everywhere, either in the base or near the roof of the building. Some defects can be observed depending on several factors like its geometry (diameter and thickness), its depth or thermal characteristics of the material (thermal conductivity, effusivity). It is interesting to compare the zone with a defect with the surrounding material (Carlomagno, 2011). A warmer area was found where temperature changes are slower. This indicates that the warmer area is located in a wet area with a significant water content (Lerma, 2014b) because it offers an important resistance to heat flow that goes through the wall (Cerqueira, 2011). The energy required to raise the temperature on this wet area is greater than in other zones where there is no water and depends directly on the specific heat capacity of the material (Avdelidis, 2003). Evaporation and drying occurs at the edges of the above area leaving a visible mark on the wall (Válek, 2010).

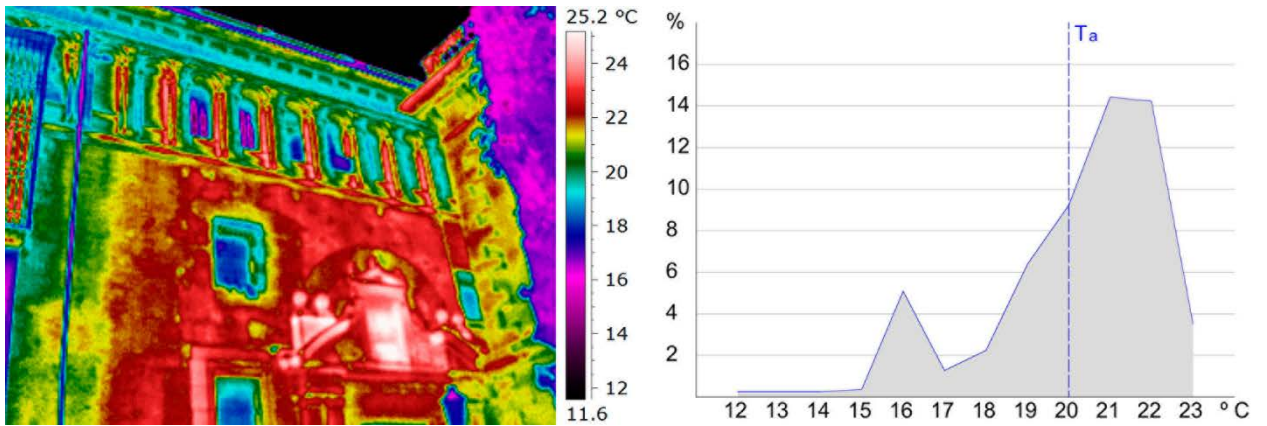
There is a wide range of temperatures on the surface of the main façade of the Seminary-School, as can be seen in Fig. 2. The average temperature and the temperature distribution of the image is obtained by analyzing each pixel, in this case is the average is 20.19 °C.

Figure 2. Thermal image evaluation with its temperature distribution.

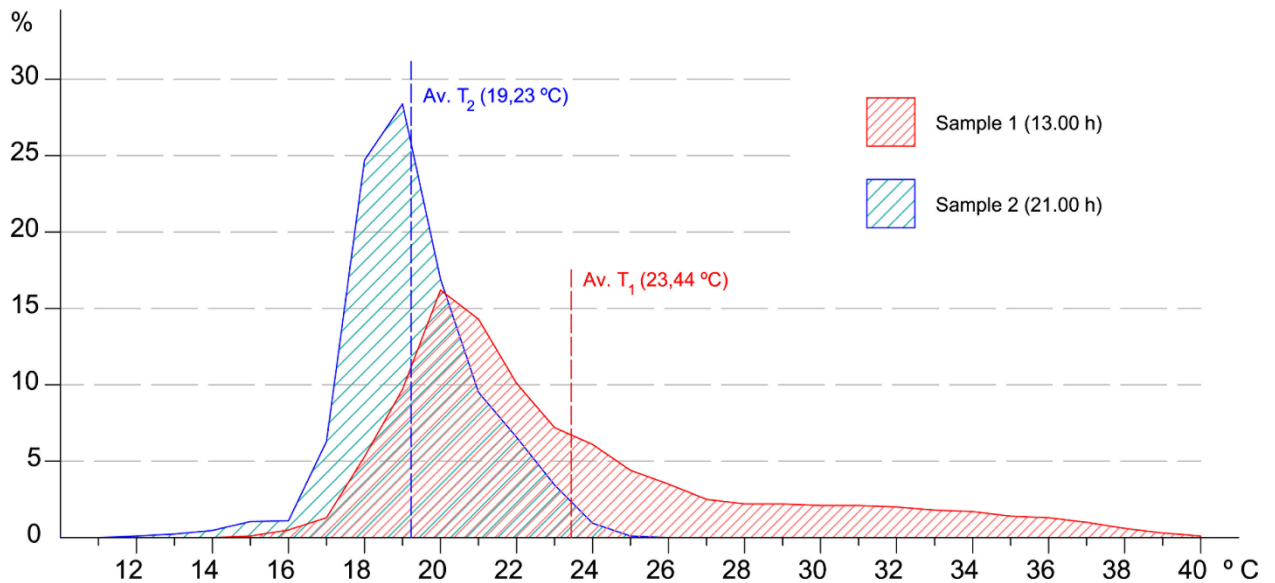
Sixty-nine images have been analyzed, 30 of them in phase 1 (at 13:00 h) and 39 of them in phase 2 (at 21:00 h). The pixels of the images are grouped based on their associated temperature (Fig. 3). The temperature distribution and the contrasts in this façade of the Seminary-School are higher in phase 1 than in phase 2, because the temperature of materials is located around its average temperature (19.23 °C).

Figure 3. Temperature distribution on the façade of the building.

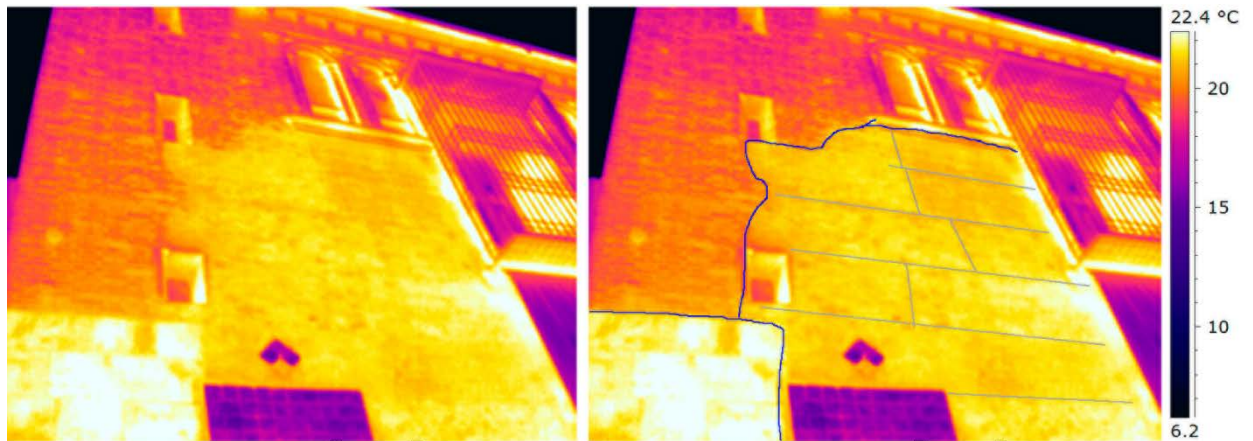
Different materials can be observed in Fig. 4: stone, brick and rammed earth wall. At first glance, it is easy to identify the joints of bricks and workstones, which are very marked. However, the position of the joints is more difficult to find out in rammed earth walls because the entire enclosure is coated with a lime mortar. The construction building technique of rammed earth wall was identical to the walls made of lime and mud in Valencia. Bricks are embedded in lime paste in each layer of well compacted earth (Galarza, 1996). Tonality and temperature changes are seen in the thermal image every certain distance, either horizontally or vertically distributed, which allows to identify the joints position. Horizontal timbers were placed in created holes to sustain the formwork. Infrared analysis makes possible to measure the height of different rammed earth courses. Specifically, one rammed earth course is five Valencian spans (1.1138 meters). Fig. 5 shows the position of the rammed earth walls of this zone of the façade.

Figure 4. Identification of the façade materials.

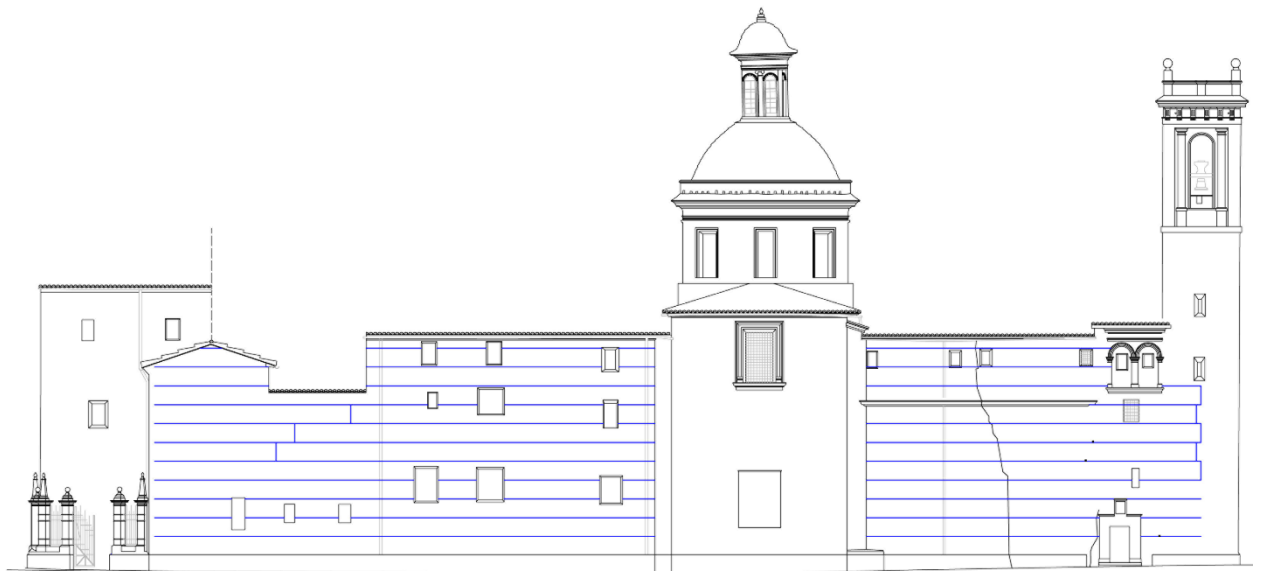
Figure 5. Courses of rammed earth wall in the west façade.

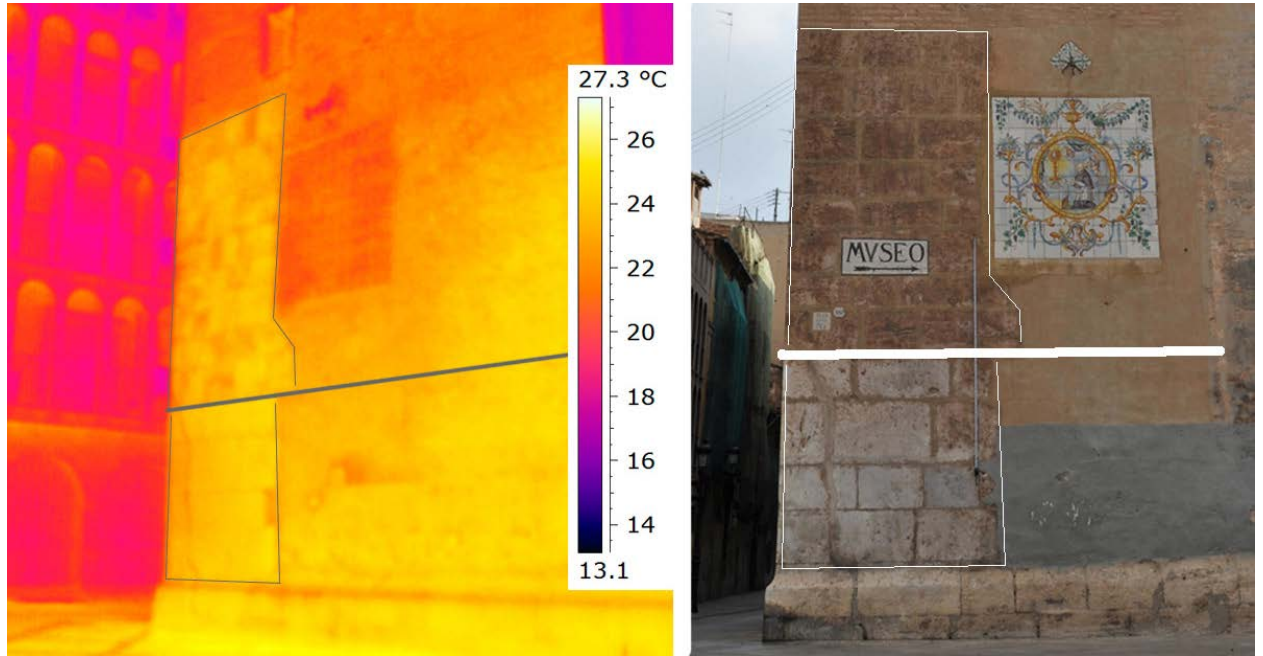
Figure 6. Stones up to 2.85 m height show a different color surface with a uniform thermal response. But the workstones between 2.85 m up to 7.65 m show a darker and reddish tonality on their surface. They have a heterogeneous thermal behavior.

Figure 6. Different thermal behavior of the stone in the southwest corner of the building.

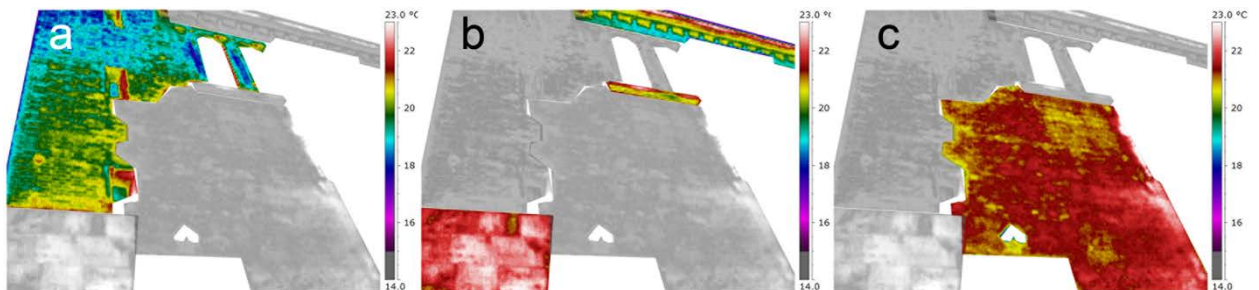
Thermography has been used to analyze the temperature of several materials and their average temperature have been calculated. Specifically, the paper is focused on stonework, seen brick and rammed earth wall. Figure 7 shows the materials that compose this zone of the façade (brick, stone and rammed earth wall, from left to right). It can be shown in Fig. 8.

Figure 7. Materials analysis of the façade (a: brick, b: stone and c: rammed earth wall).

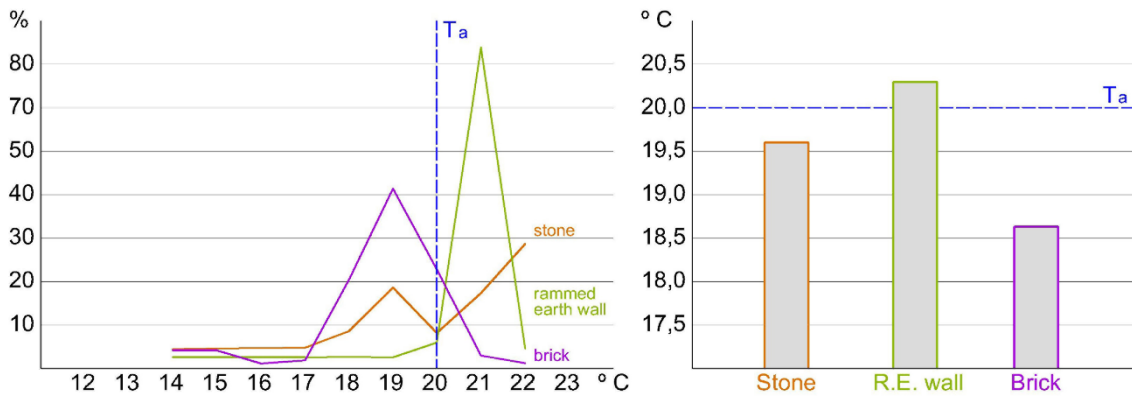
Fig. 8 compares the temperature distribution on the same façade on the left graph. The graph on the right shows the average temperature of the previous figures: 19.56 °C for stone, 20.29 °C for rammed earth wall and 18.68 °C for brick. Therefore, in April at 20:30 h, the material that retains a higher temperature after sunset is rammed earth wall, then stone and finally brick.

Figure 8. Temperature distribution and average temperature of the façade differentiating between brick, stone and rammed earth.

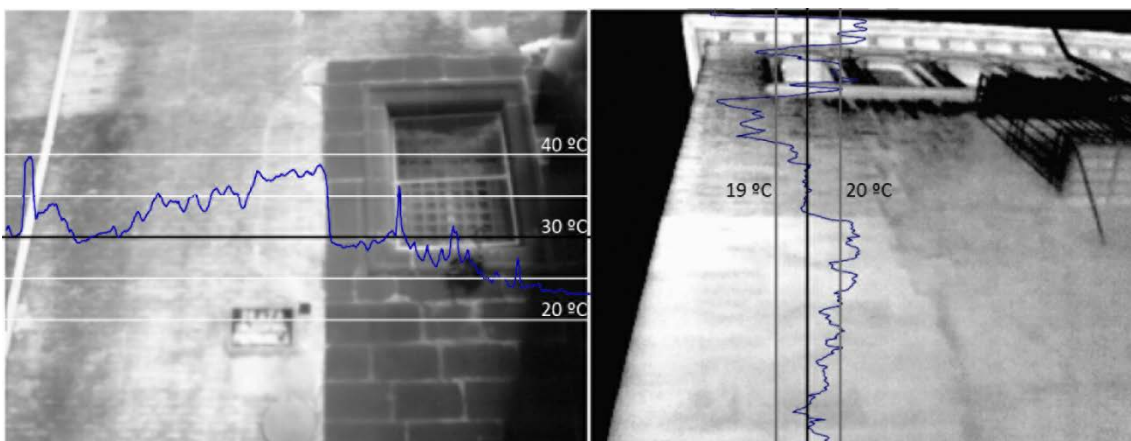
Fig. 9 show the horizontal and vertical temperature profiles of two specific area of the façade. The graph depicted over the image represents the temperature of each point. Different materials are identified due to the sudden changes in temperature.

Figure 9. Infrared images and temperature profiles on building façade.

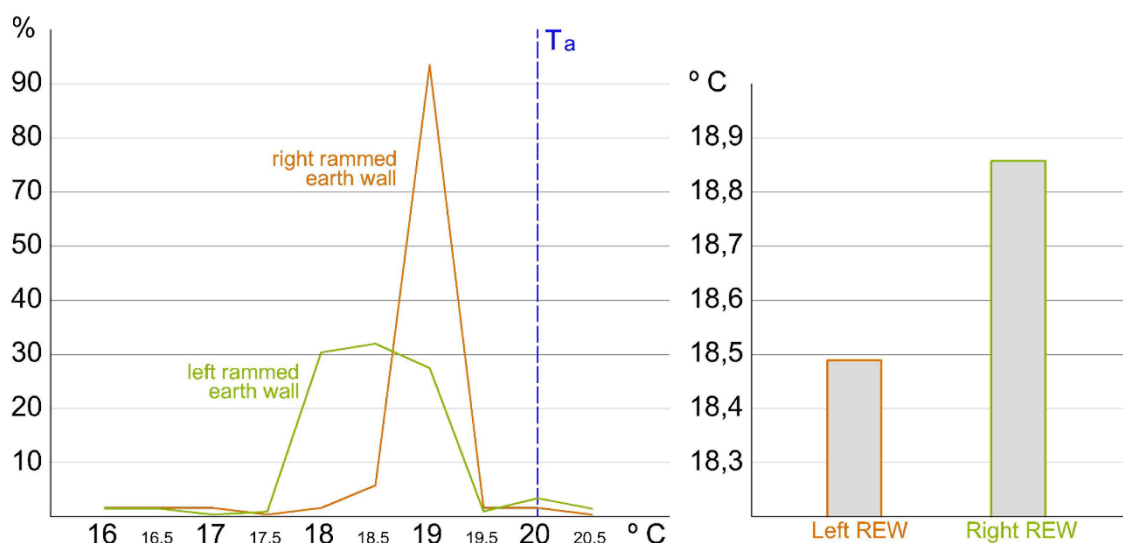
In this case, the studied wall is part of the building west façade. Two thermal images are taken at the same time of the day (20:46 h) under the same temperature (20 °C) and humidity conditions (40.3%). Each point of the figure is quantified as it is explained above. The graphs in Fig. 10 show the temperature distribution and the average temperatures of both sections of the wall. Obviously, the thermal behavior of these two parts of the same façade is different, although theoretically they are built with the same material. This result supports the hypothesis that the crossing wall of the church is built in another phase of the building construction process.

Figure 10: Temperature distribution and average temperatures of the west façade.
