Restoration project of vernacular architecture affected for ground subsidence: A case study in Juslibol Church (Zaragoza, Spain)

Topic: T4.1. Conservation and restoration projects of vernacular architecture.

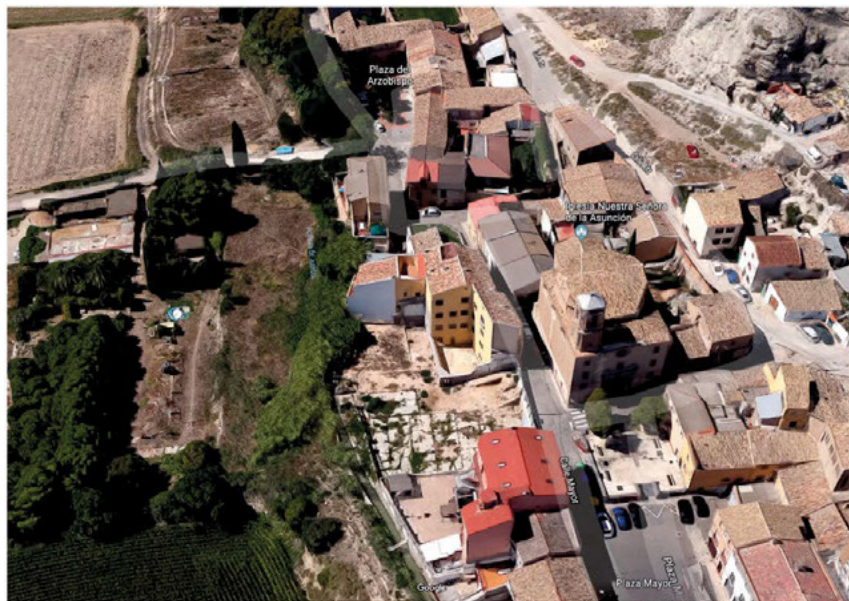
The first discharge arch (1) is obtained by correlating the cracks observed in the pavement of the street, just at the corner of the church, in front of the tower. These seem to be directly linked to the emptying of the lot on the other side of the street.

Fig. 1. Location plan. Situation and morphological analysis of the cracks on aerial photography (Source: ©2018 Google).

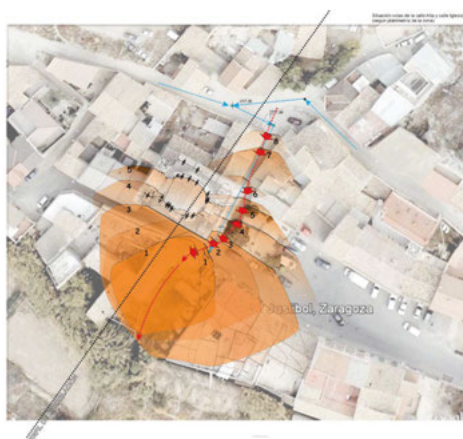
Fig. 2. Location plan. Situation and morphological analysis of the cracks on aerial photography (Source: *Investigation report for the assessment of problems in the subsoil of the justibol church (Zaragoza)*, 2014).

Arches 2 and 3 are obtained by correlating the open cracks in the sidewalk (now repaired), which continue to cross the church's street and apparently continue along the low wall of the square, towards a more open area.

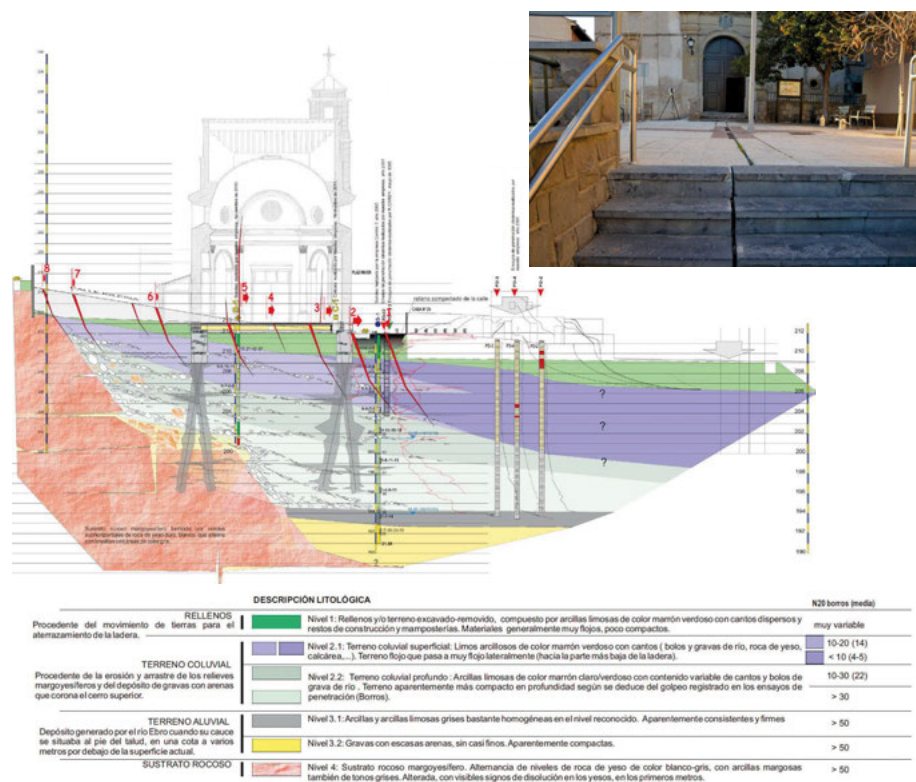
Arches 4 and 5 are the ones that project towards the interior of the church. From the square they are easily recognizable. One of the cracks crosses it in the middle and goes through the centre of the front door. The other (5) can be seen from the square, on the corner next to the house, breaking the low wall on the church's street in 2-3 places, and projecting towards its façade where it is very evident on the wall and especially in the stone oculus. Both cracks project through the interior of the church itself, exiting through the main altar. In his case, number 3 affects the sacristy and the adjoining house (currently being demolished).

Fig. 3. Geotechnical correlation profile of all available information. (Source: *Investigation report for the assessment of problems in the subsoil of the Juslibol church (Zaragoza)*, 2014). In the photograph it can be seen the crack number 4 recognisable in the square that is in front of the main door.

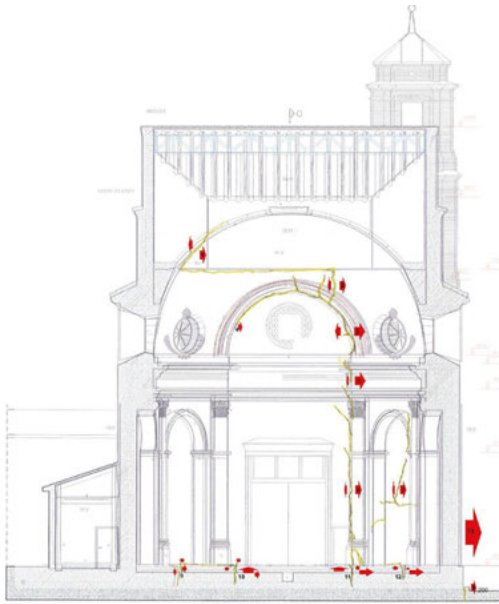
Fig. 5. Schematic profile of the main cracks and fissures that can be seen inside the church. The position and magnitude of the arrows express the apparent movement that the recognized deformation has developed. In the photograph, you can recognize some of the cracks in the part of the altar-presbytery.

1) The cracks and fissures have a typology compatible with fundamentally horizontal relative displacements between the lateral walls (longitudinal) in an apparent direction towards the lower part of the slope. They do not indicate movements due to differential seating in the vertical.

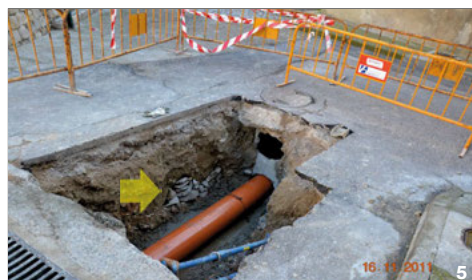
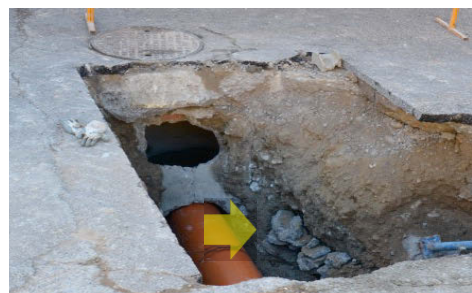
The sanitation network around the church is made up of asbestos-cement pipes that in recent years it has been replaced by more resistant plastic-PVC pipes. However, if we look at the previous photographs, it is very clear that the very ditches that were used to lay the sanitation pipes are visibly undermined and through them, and down the slope, there is a circulation of underground water contributions with drag of materials.

Fig. 6. Supporting the previous argument, it is especially relevant to observe in the two photographs 5 and 6, the holes or highly washed areas that appeared next to the manhole and collector (indicated with an arrow). These have been filled with rubble from the excavation itself, to later proceed to pour the sealing concrete of the connection socket of the new collector with the manhole. These two points would be connected and present a clear continuity parallel to the collector and apparently towards the lower part of the church's street.

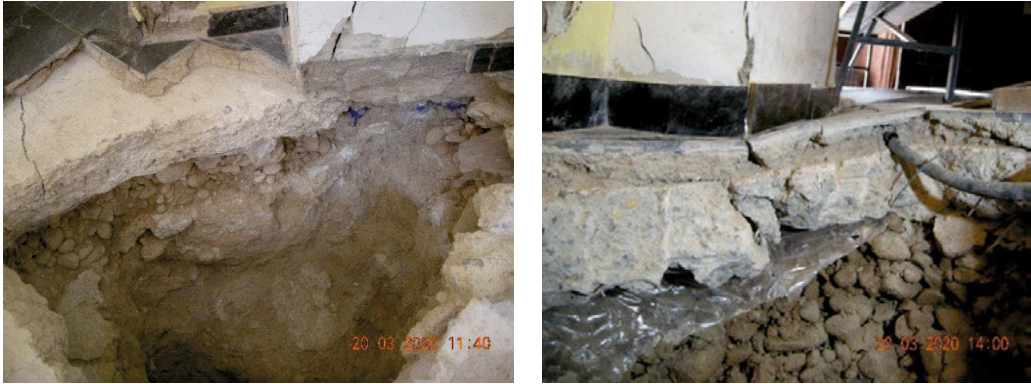
Drillings and reconnaissance test pits have been carried out inside and outside the church. In them, along with the remains of the cement grout injections, massive-looking materials with saline efflorescence and a gray-white colour have been recognized. Apparently "growing" from the cement inclusions themselves.

Fig. 7. Pit n°2, (interior). Next to the foundation wall of the Church. The fractured concrete floor and the foundation are recognizable. In the second photograph, detail of the deformations of the floor. Cracks are recognized in the base of the wall due to fundamentally vertical component thrusts.

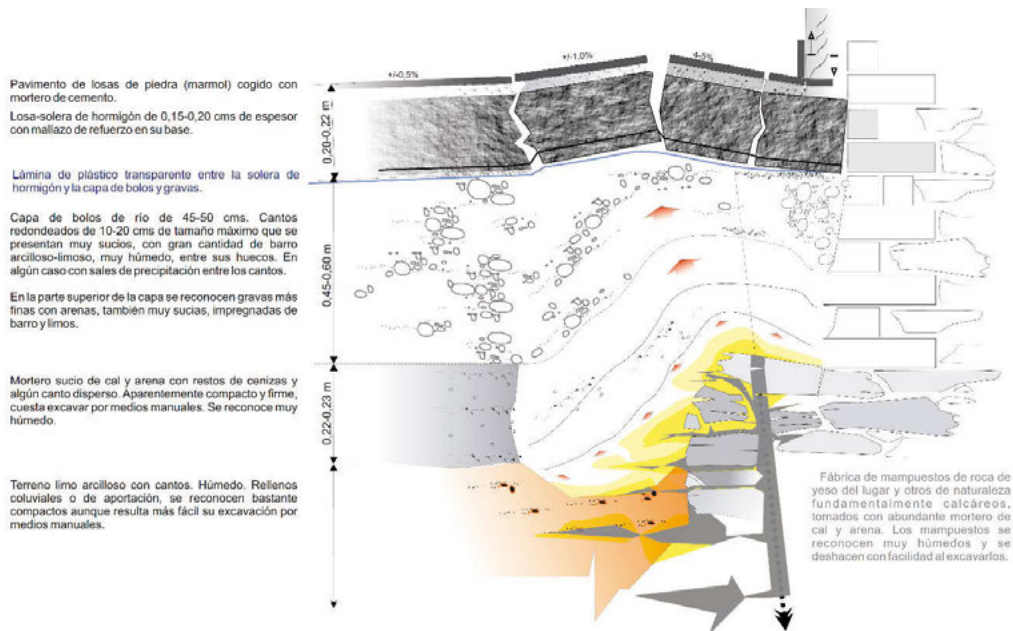
Analyses have been carried out in a specialized laboratory (Laboratory for Building Quality of the Government of Aragon) and the majority contents, within the two samples tested, of Ettringite and Thaumasite have been identified by means of X-ray refraction.

In the pit, it can be seen how these massive-looking materials, in their apparent growth, come to "force" the upper levels, generating pressures that deform the layer of gravel and pebbles and contribute to raising the floor, cracking it (Figure 8). The entire floor of the church presents deformations, with up to 15 cm of relative elevation, in an annular environment parallel to the interior perimeter of the sill.

Fig. 8. Outlined explanatory diagram of the situation observed during the excavation of pit 2. The figure includes the cement grout injections, which were injected-infiltrated between the gypsum rock masonry of the very foundation of the Church walls. These gypsum rock fragments are sometimes recognized as broken and displaced; enclosed within a grey-whitish mass (in yellow).

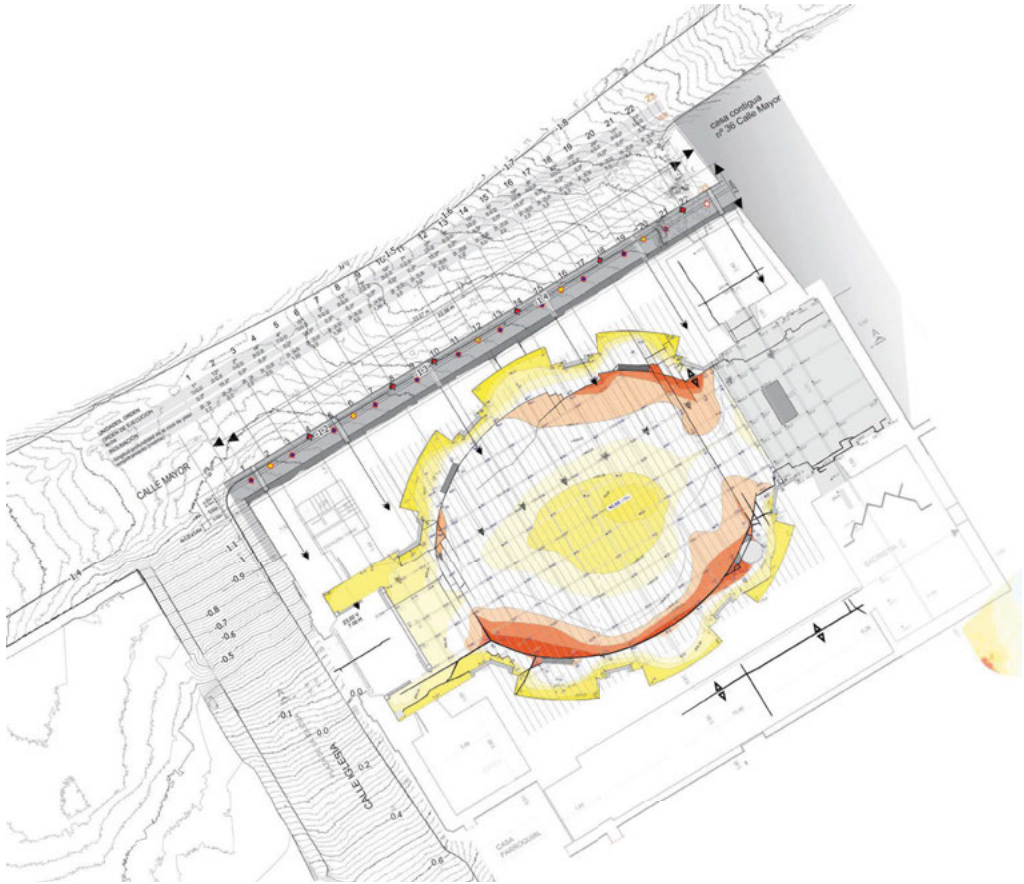
However, very few years later, deformations began to be registered that fundamentally affected the floor of the church. This began to rise forming an inner ring; a meter or so from the walls, reaching to break the floor. Control of these deformations has been carried out for more than ten years and it has been verified that it maintains a fairly constant progression. The registered relative ascents reach more than 15cm.

Fig. 9. Plan layout of the areas that register the greatest deformations in the floor of the church. Carried out by means of a self-levelling precision laser level, it registers the relative elevations of the floor.
