# Of earth, stone and wood: the restoration and conservation of a Buddhist temple in Ladakh, Indian Himalayas

Edoardo Paolo Ferrari

## 2. The Conservation of the Dukhang Yokma

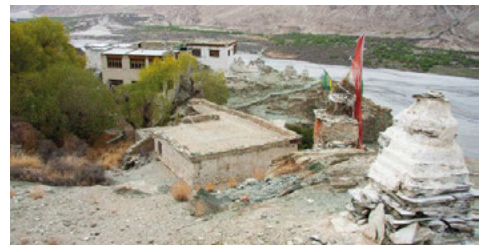
Fig. 1. The dilapidated roof of the Dukhang Yokma (middle ground) and the main monastic complex in the background.

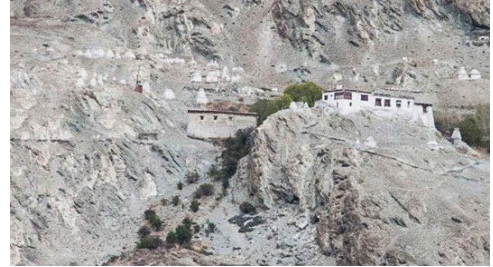
According to the monk, it was necessary to erect a small temple to host the sacred object. This is the reason why the temple, as compared to most of the local buildings, rises in a very inappropriate location for construction (Fig. 3). This concave area is prone to water accumulation due to the presence of a natural underground spring. In the past, water coming out in winter was freezing in layers and slowly flooded the porch, thereby damaging the mud mortar in the plinth. The damage caused a progressive bulging of the

Fig. 3. The Dukhang Yokma seen from Panamik (centre).

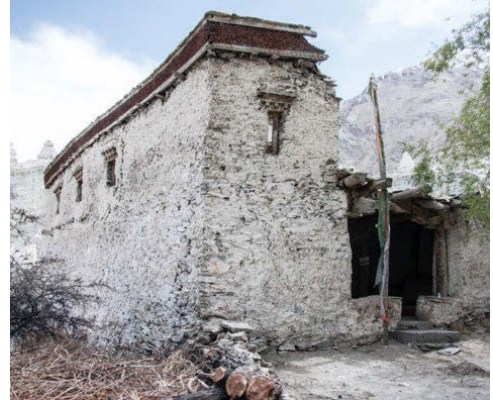
Fig. 4. Main entrance and porch. The temple started to shift from this corner at the base of the walls (North-east).

This shift firstly involved the porch and the room above it, which dragged all the rest of the structure towards North (Fig. 4-5-6). Oral accounts reported that this process began early after the construction, until large cracks appeared. The upper room on the first floor was completely dismantled as a precaution measure (Fig. 4), and the deity statue inside the temple was also removed. The temple quickly decayed, especially in the last 20 years.

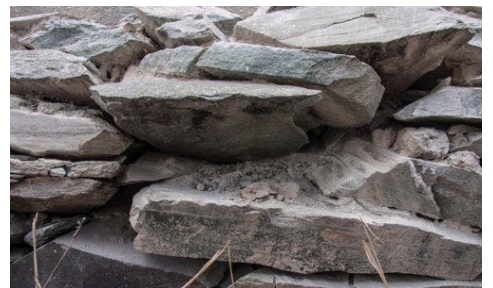
foundation of the highest wall, and the temple started an unstoppable rotatory and shifting process.

Fig. 5. Bulging plinth with eroded mud mortar (North-east).

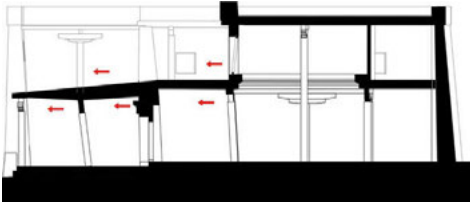
Fig. 6. Vertical section North-South (2016). The structure progressively shifted towards North. Image credit: Hilde Vets architect.

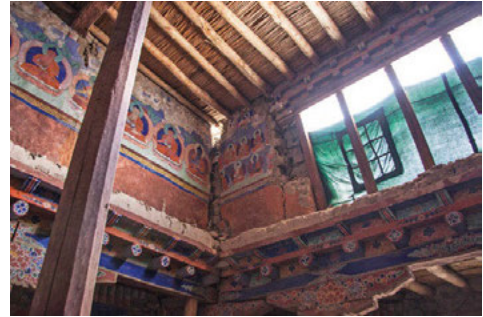
Fig. 7. The severely damaged, tilted, and detached walls on the first floor of the temple's chamber (North-west corner).

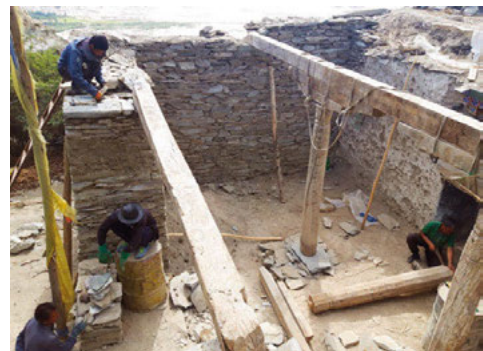
Fig. 8. Reconstruction of the porch with new dry-stone foundations.

This section presents a summary of the works that were carried out in three phases. The coverage is too short to present all details, thus the main focus is on phase two and the solution of the main structural issues, which included the straightening of the existing tilted inner structure of the temple. In phase one, the whole porch was dismantled until the foundations. A new and deeper trench of 120cm depth was dug (the original was often only 30 cm or less).

All of the three walls were rebuilt utilizing the older material integrated with larger stones taken from the mountain to form a stronger plinth and better interconnections for the corners. All masonry that was underground was rebuilt with the dry-stone technique (Ladakhi: *skam rtsig*)<sup>1</sup> to avoid any possible erosion of the

mortar at the base. New walls were rebuilt of the same size (120 cm at the base), only enlarging the one on the western side which had to be increased due to its original thickness (60 cm only) and with an average batter on the external side of 10-12°. The main stabilisation of the wall painting was also carried out during this initial stage. With the new porch walls in place, phase two of the project could commence. Phase two brought forth the most challenging structural issues of the building, which were related to straightening the two-storey structure inside the inner chamber of the temple (Fig. 9).

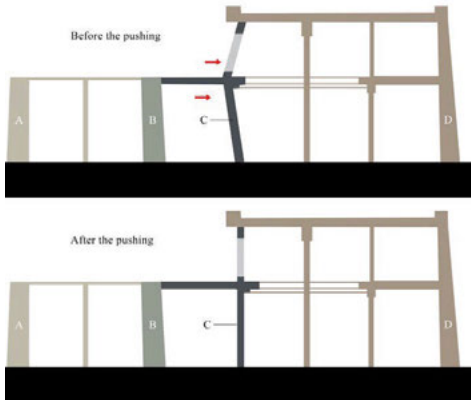
Fig. 9. Schematic view of the structural intervention concept. A - rebuilt porch (phase 1); B - tilted wall of the entrance with paintings; C - mixed structure on two storeys with paintings (phase 2); D - rest of the temple (phase 3).

This section is constituted by a mixed material structure. On the ground floor, there are four wooden columns with capitals, topped with wooden beams and a composite frieze of wood, mud bricks, and stone. While on the first floor, is a thick wall of mud bricks (50-60cm) and stones with a large wooden sky light/window (Ladakhi: *rgyam thong*) (Fig. 10). The main challenge was to preserve the integrity of the mural paintings on the first floor during the pushing and repositioning of the entire two storey structure. This meant that it was not possible to simply dismantle the wall and roof above it, straighten all wooden ground floor structural elements, and rebuild the masonry on

top of it. This two-storey mixed structure had to be pushed entirely, while still attached to the rest of the temple, avoiding any collapse in order to save the murals.

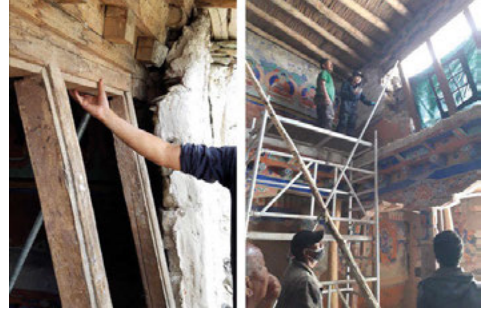
Fig. 10. Tilted wooden opening on the first floor (left); covering the paintings with a protective cloth near the wooden window (right).

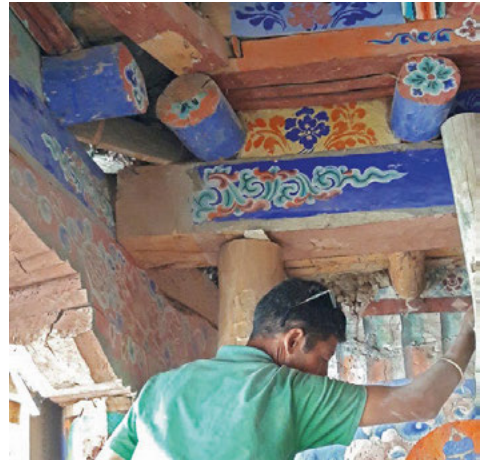
Fig. 11. One of the main beams slid 25cm outside its original position (North-eastern corner).

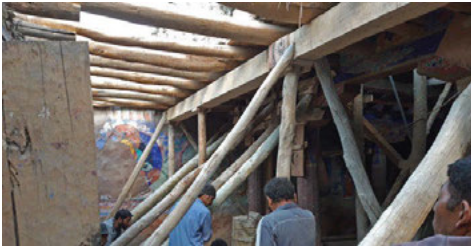
Fig. 12. Temporary beam at the entrance of the chamber.

This work took a considerable amount of time during phase two and consisted of: creating a composite wooden beam in three pieces propped on all sides to support the roof in between the main temple's door and the inner chamber (Fig. 12); erecting three high wooden composite props with supporting beams (9m) for the roof of the inner chamber (Fig. 13);

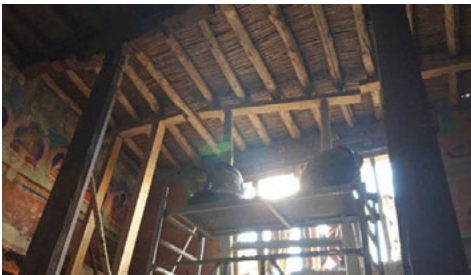
Fig. 13. Composite props of pre-cut timber and local poplar.

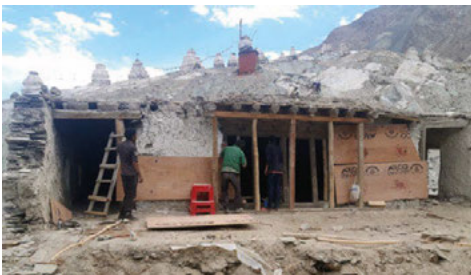
Fig. 14. Installation of plywood panels to temporarily lock the mud brick and stone walls with paintings. In the centre, a series of props are put under the cantilevered poplar beams.

building a wooden frame for the projecting beams above the skylight (*rgyam thong*) (Fig. 14); fitting temporary shutters made of plywood fixed with steel rods crossing the wall through its cracks in order to stabilize the mud brick structure for the time of the pushing and avoid any severe damage to the walls and paintings (Fig. 14); and inserting a pushing system made of wooden members attached to hydraulic jacks for the mechanical straightening of the structure (Fig. 15-16).

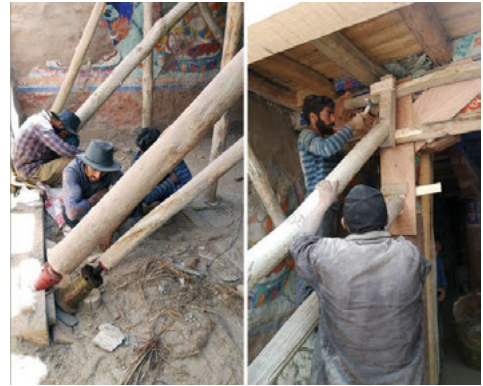
Fig. 15-16. Installation of the props with hydraulic jacks (left). Fixing a temporary load distribution timber frame on the columns and beams (right).

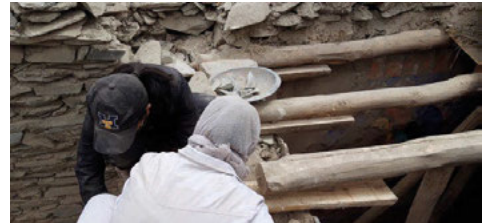
This operation was mandatory since the tilted stone wall could not be straightened back to its original position. The reason is that by pushing these beams back towards the inner chamber, many of the wooden elements would have fallen outside the wall edge that could not be shifted with them.

Fig. 17. Placing cantilevers under some of the beams of the entrance hall and fixing them to the stone wall.

Along with these preliminary works it was necessary to insert cantilevers under some of the beams resting on the entrance wall once all of the beams in the walls were uncovered (Fig. 17).

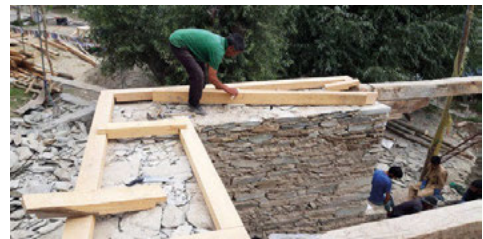
Fig. 18. Insertion of wooden tie beams (*sket shing*).

Other works carried out in phase two were: the construction of dry stone foundations for the pillars in the porch (not existing before) (Fig. 8); the insertion of wooden tie beams (Ladakhi: *sket shing*) inside the porch wall (not existing before) (Fig. 18); the erection of new walls for the

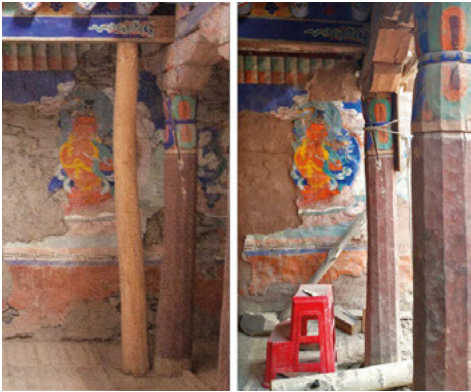
Fig. 19. Tilted structure with prop (left). The unpainted part of the beam marks the extent of the rotation of the column. The structure after it had been straightened (right).

first floor room above the porch, the reconstruction of one of the lost wooden windows of the first floor based on a model of its symmetric window found on site, the new design and making of a wooden window frame with composite beam for the traditional Ladakhi balcony (*rab gsal*)<sup>2</sup> for the room on the first floor (based on similar examples of the same age in Nubra); the addition of a large dry stone staircase to access the building from the main terrace, and the reconstruction of a small stone stair for the porch. Phase two was successfully completed after the straightening of the two-storey structure (Fig. 19).

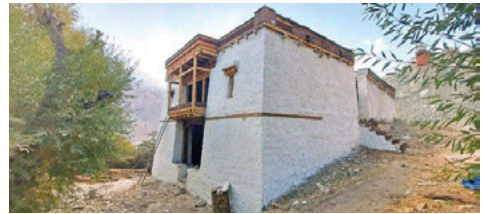
Fig. 20. View of the white-washed reconstructed porch and upper room with balcony (North-western side). Image credit: Javed Hanif architect.

Once the tilted structure was brought back to its original position, it was possible to complete the building with the roof on the main entrance and constructing the walls and ceiling of the room on the first floor above the porch. Phase three was the last stage, and involved the completion of the reconstruction process and most of the finishing works. This phase included: the reconstruction of the upper wall section on the Eastern side of the temple and its three windows; the complete reconstruction of the temple's roof with an appropriate slope (2%) for drainage. A waterproof sheet was added between the earth layers of the roof since nowadays roofs are not commonly maintained as they should. The dam-

aged wooden beams were substituted and additional new beams were added to improve the overall strength of the horizontal structure. Water spouts made of local slate were also added since no gutters were previously inserted inside the parapet, causing water infiltration inside the temple's walls. The mud brick walls on the first floor around the chamber were reinforced with a double wooden tie beam and extra wooden columns in the corridor were added around these walls. In addition, a wooden skylight window was lifted and realigned, cracks in the mud brick walls were stitched, the parapets were rebuilt, and the outer and inner walls were replastered and white washed.

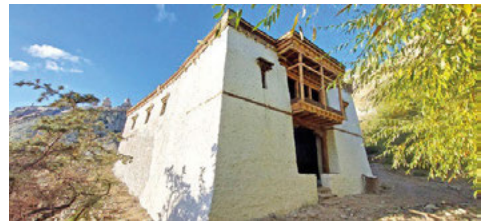
Fig. 21. View of the white-washed reconstructed porch and upper room with balcony (North-eastern side). Image credit: Javed Hanif architect.
