## Judgment of collapses and settlements from orthoimages: the method of pathological analysis in the Escuelas Pías church (Valencia)

Keywords:  
collapses; settlements; orthoimages; Escuelas Pías

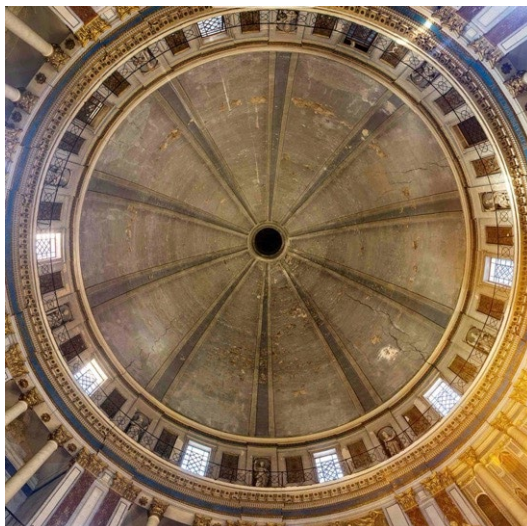
The mentioned cracks follow the direction of the meridians and are more or less centered. Located in the base of the dome, they extend up to approximately 3/5 of the development of the dome, approximately 10'74m, and in four of the ten sectors into which the dome is divided. Associated to these cracks, there are many other that may only correspond to cracking in the coating.

Fig. 1 - Interior view of the dome with the cracks.

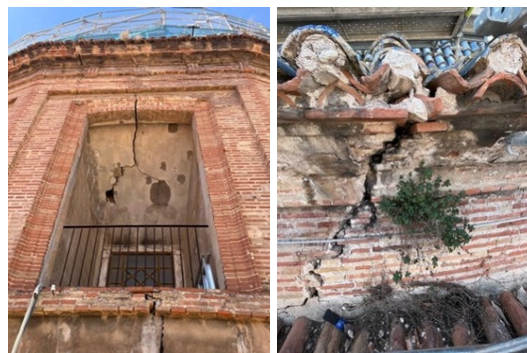
Fig. 2 - Cracks in the lintel and flare of the drum window (left) and in the second ring of the drum where it meets the roof (right).

The cracks in the vertical walls of some sectors of the church, especially in the sectors facing the light well, sectors H and I, gave false evidence of a possible settlement of the ground as the main cause of the structural pathology of the dome. These sectors are the ones that face a common light patio with the residential buildings located to the east of the plot and that present a very high slenderness, 0.5 m thick and 24 m high. These cracks can be considered as secondary being the consequence of a movement of the building, but without having to be directly related to a ground seat. Continuing with the reading of the exterior cracks, these would be concentrated mainly in four sectors, B, D, G and I (figures 9 and 10), specifically splitting the lintels of the openings of the windows in the drum and the masonry in the ring top of the drum (figure 1).

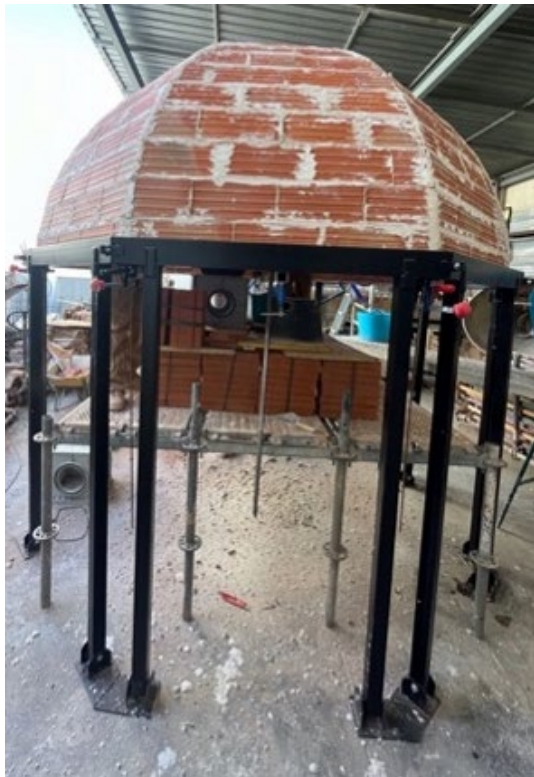
Fig. 8 - Real model built to test settlement cracks.

Parallel to this study, through the EMR chair of the Universitat Politècnica de València and taking advantage of the restoration process of the dome, a masonry model was made with adjustable metal feet to check the shape and arrangement of cracks when giving way controlled by one of the feet (Fortea, 2013). The result of the test was that when the bases were moved, cracks appeared on the edges.

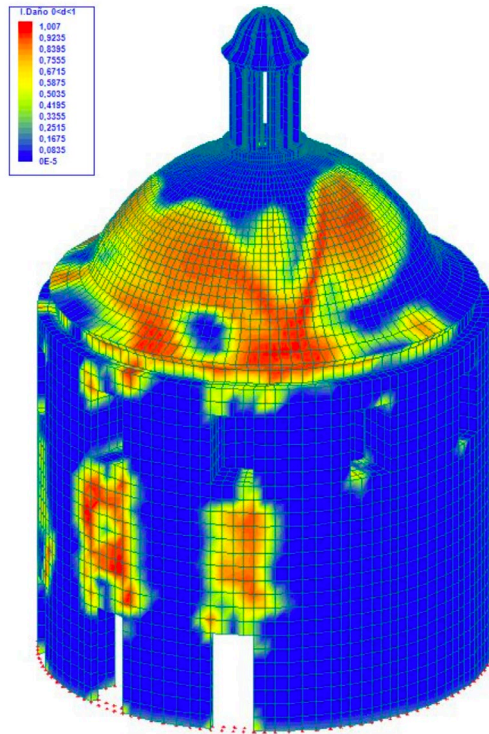
Fig. 9 - Verification of the structural behavior of the dome by settlement in Angle.

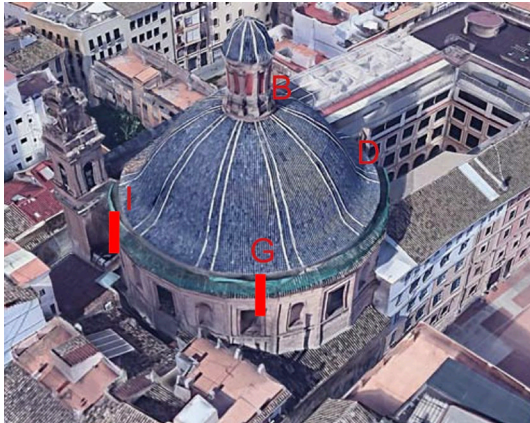
Inside, the cracks mainly affect the four sectors mentioned above, the most important being sector G and whose cracks ascend from level 2, starting from the floor level of the false organ and going up to 2/3 of the level of the dome in that sector.

Fig. 10 - Aerial view from a northeast orientation with the definition of the sectors that present the large cracks.

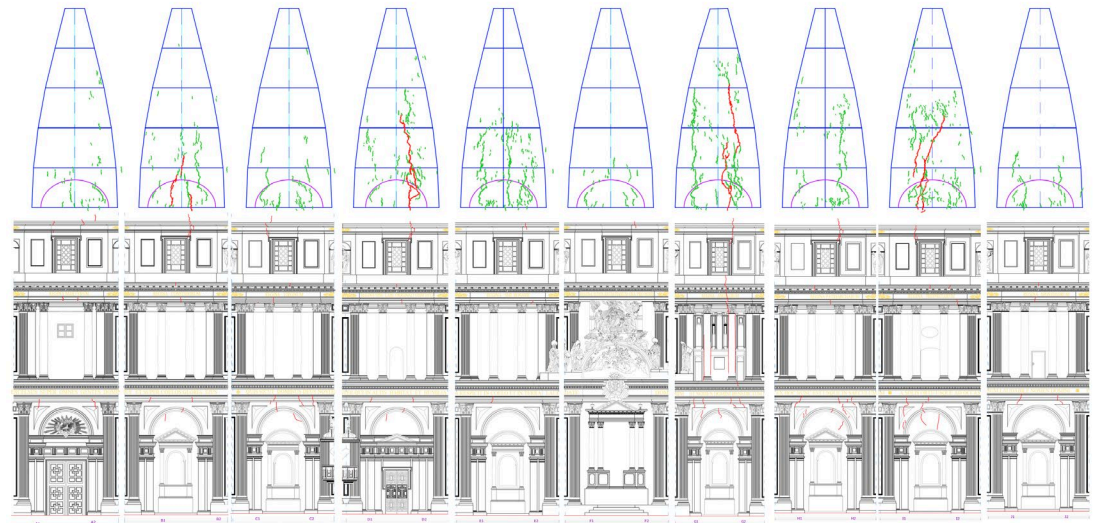
Fig. 11 - Graphic description of the cracks (in red) and fissures (green) inside the church. Named from left to right, the first being sector A and the last being J.

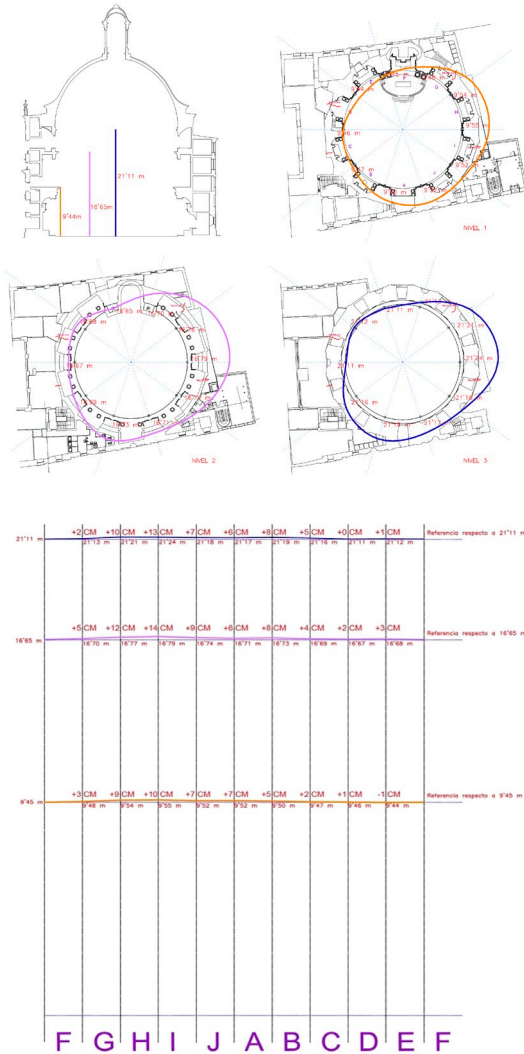
this elevation difference, for optimal visualization the axes are scaled from the reference elevation, obtaining a circular graph to be interpreted that represents the level curve. The results of this data collection show height differences in each of the levels, with the maximum height differences being 11 cm at level 1 (tribune cornice), 14 cm at level 2 (upper ring cornice) and level 3 (dome start cornice) of 13 cm. The graphs obtained are similar, posing different hypotheses, from the possible site of the factory in the DEFG sectors and that overlook the alley and/or the turn of part of the wall. Following a logical sequence of work and using a similar methodology, on an orthophoto of the section of the wall that is supposed to have collapsed, the collapses of the rear elevation and the seats in the drum are analyzed, drawing lines perpendicular to the level plane 0 to obtain the slumps and horizontal reference lines for the seats. In this case, there is a drop towards the alley of the rear elevation (DEFG sectors) of about 36 cm, and there is also a seat of the entablature of the drum of 14 cm and both the starting of the lantern and

Fig. 12 - Interpretation of the data collection of the heights in the 3 levels marked in a circular graph.

its entablature a seat of 12 cm. cm. The data obtained inside and outside are very similar and all lead to the fact that there has been a collapse or twist -we won't say a seat for the moment- of the church towards the alley, which could be the main cause of the cracks in the dome. This collapse could have been caused by the lack of rigidity of the wall or lack of counterbalancing of the drum's thrusts, given that in other sectors there are annexed buildings and they act as the buttresses and buttresses of the Gothic cathedrals. On the other hand, thanks to the precision of the graphic survey, it is manifested that the lantern is displaced 29 cm from the axis of the dome, without attributing it to any pathology. It should be stated the difficulty of surveying to raise a 1000 m2 dome, 24.5 m internal light, at a height of 21 m and with the auxiliary means and technology of the 18th century.

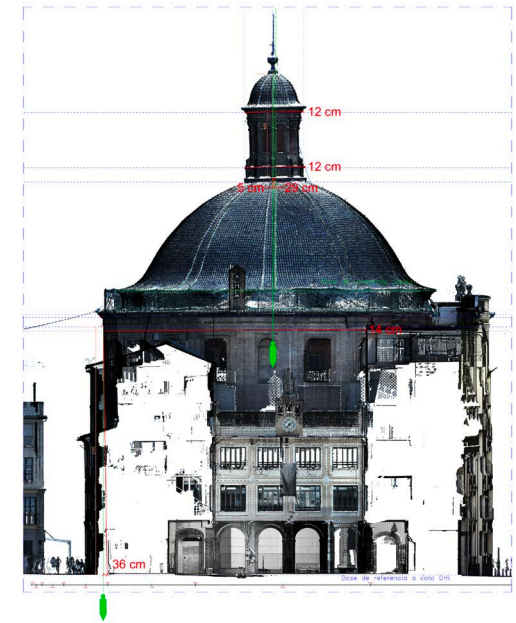
The collapse of the exterior wall facing the alley, as seen in figure 12, would correspond to the interior sectors with the greatest unevenness, making it very difficult to numerically correlate the exteri-

Fig. 13 - Interpretation of collapses of the alley's elevation and turns of the drum and lantern.

or collapse with the interior unevenness. The external unevenness in the cornice of the drum and in two planes of the lantern is similar to that of the interior, about 14 cm, evidencing a turn and collapse of the wall towards the alley due to lack of counteracting thrusts.

Having carried out an exhaustive study on walls thanks to an optimal graphic survey has allowed us to quantify collapses and unevenness, in addition to being able to determine that the origin of the cracks in the dome may be due to a twist and/or collapse of the masonry, reaching to recommend the installation of a compression ring in the upper body of the drum to avoid excessive stresses of the dome on the drum and even the provision of some constructive element to counteract the thrusts in the enclosing wall facing the alley. This last suggestion will be contrasted with the information available after the monitoring of the building and
