Alija, S.; Torrijo Echarri, FJ.; Quinta Ferreira, M. (2013). Geological engineering problems associated with tunnel construction in karst rockmasses: The case of Gavarres tunnel (Spain). *Engineering Geology*. 157:103-111. doi:10.1016/j.enggeo.2013.02.010.

Title: Geological engineering problems associated to tunnel construction in karst rock masses: The case of Gavarres tunnel (Spain)

Keywords: Tunneling in karst, karstified rock masses, retrospective analysis, Gavarres tunnel, NATM

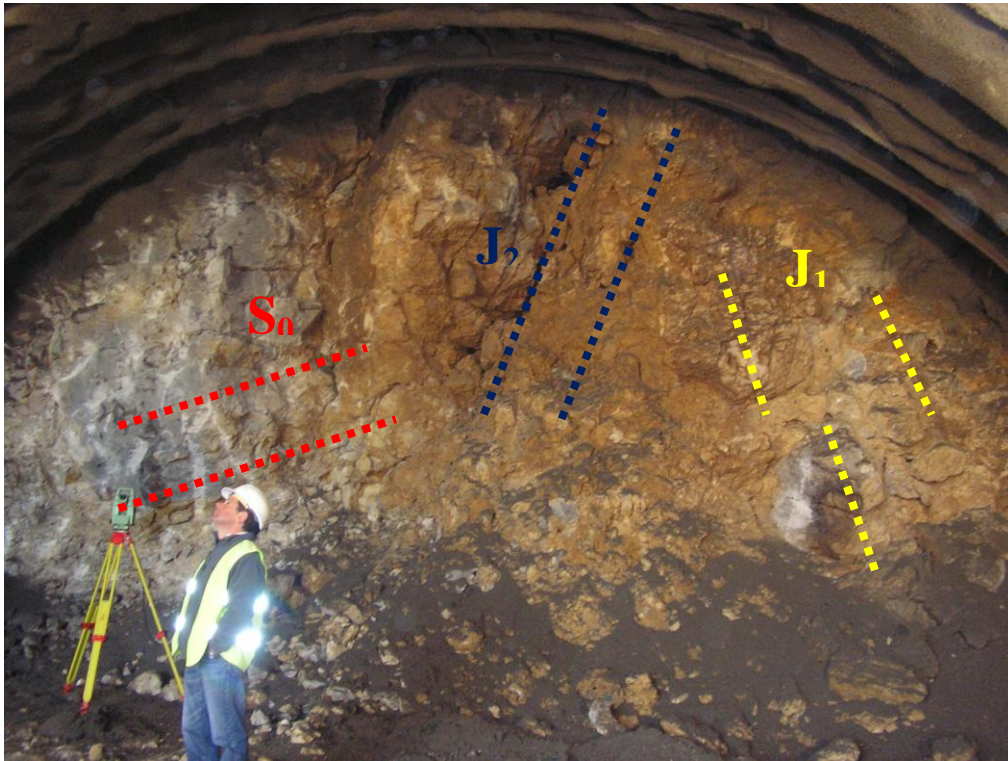
Figure 2
[Click here to download Figure: Figure 2.docx](#)

188 ○ S_0 : oriented between 200/15 – 200/30 (dip direction/dip angle), with some
189 continuity and some roughness. Between layers, openings of 5 to 10 mm were
190 observed, filled with clay or even calcite.

210 Fig. 2. Tunnel-working face view of section 19 with details of the stratification (S_0) and joints
211 (J_1, J_2). Marl and limestone blocks, some broken, in a clay matrix.

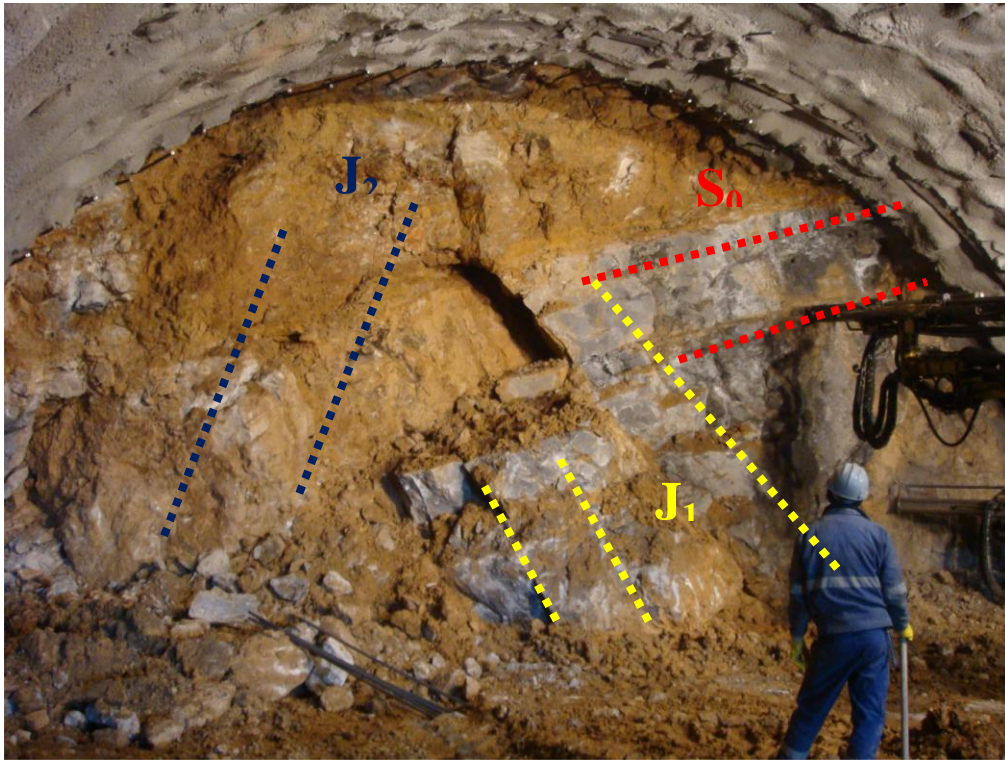
Figure 3
[Click here to download Figure: Figure 3.docx](#)

227 • *Zone 2 (sections 38 – 91)*. Corresponds to 53 meters with moderate karstification.
228 Several instabilities occurred, composed of highly fractured marl-limestone rock
229 fragments embedded in a clay matrix. The weathering grade of this zone ranges from
230 III to IV (Fig. 3).

232 Fig 3. Tunnel-working faces with weathering degree III in Zone 2 (section 61). Highly fractured
233 marl-limestone rock fragments embedded in a clay matrix.
