1  
2  
3 **Determining corrosion levels in the reinforcement rebars**  
4 **of buildings in coastal areas. A case study in the**  
5 **Mediterranean coastline**

16  
17 This paper describes a study of the damage caused by corrosion to the reinforcement rebars of a 40-  
18 year old building used as a car park at a distance of 20 metres from the sea. The corrosion levels of  
19 the building's structural elements, including beams, joists and columns were analyzed by optical  
20 and electron microscopy. Carbonation depths and chloride contents (Vorhard method) of the  
21 concrete cover were measured in situ. EDX was used to analyze the condition of the reinforcement  
22 surfaces and the morphology and composition of the oxides. A high degree of corrosion was  
23 observed in all the above elements, carbonation had reached the depth of the reinforcement in all  
24 the samples studied, and the concrete chloride levels were far in excess of the recommended  
25 maximums. The study of the reinforcement rebars revealed different types of oxides of varying  
26 morphologies, compaction and colouring according to chloride content. A comparison with

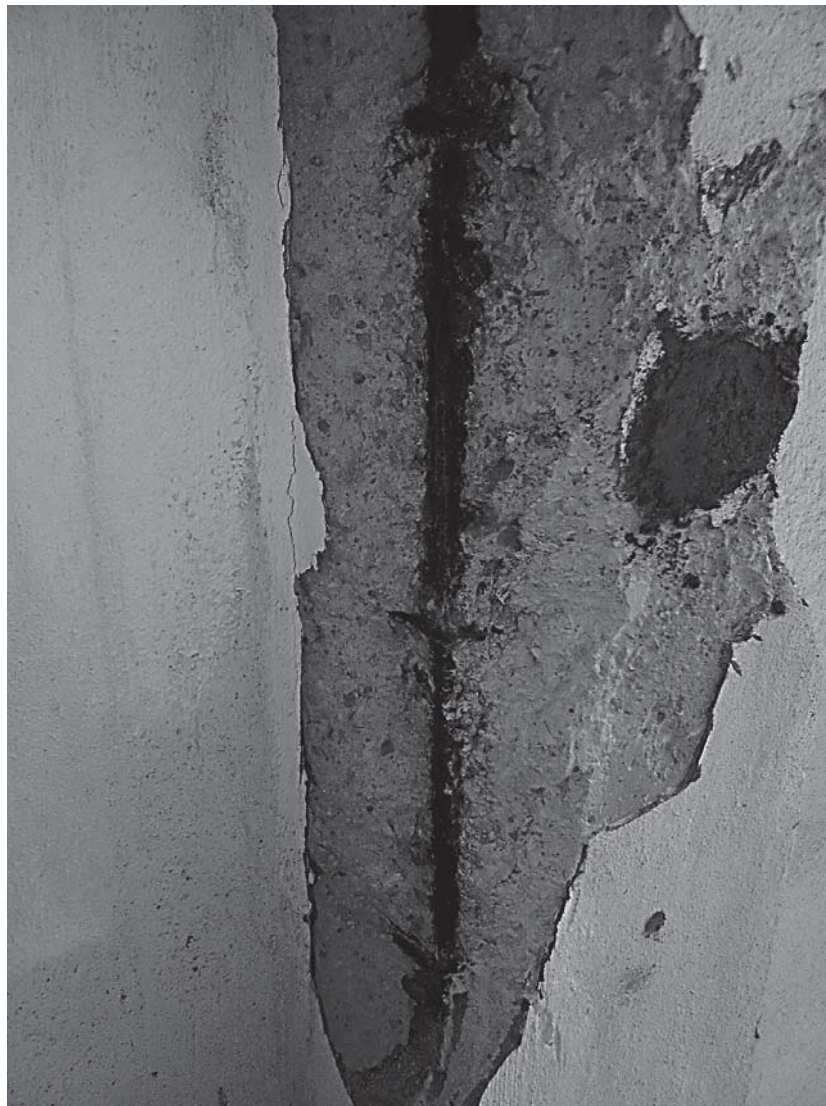
183 In the specimens described in this paper, spalling is observed in the concrete cover due to corrosion  
184 of the reinforcement rebars. The least severe case described here is a column (Fig.1) in which the  
185 cover can be seen to have separated from the rebars, which are severely corroded and have lost  
186 cross-sectional area (Figs.1 and 2). In one of the beams the spalling is seen to have been due to the  
187 corrosion of the rebars (Fig.3).

Fig.1. Spalling in cover of column

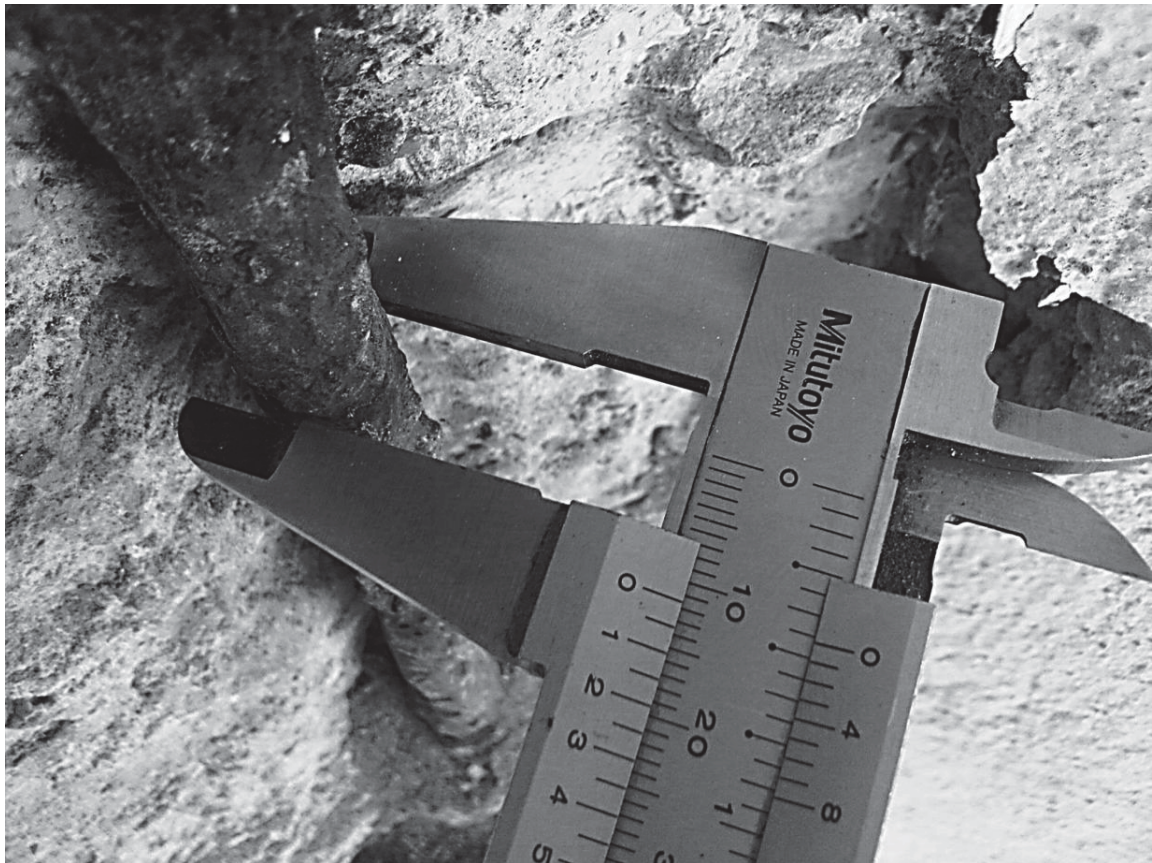
Fig.2. Corroded rebars in column

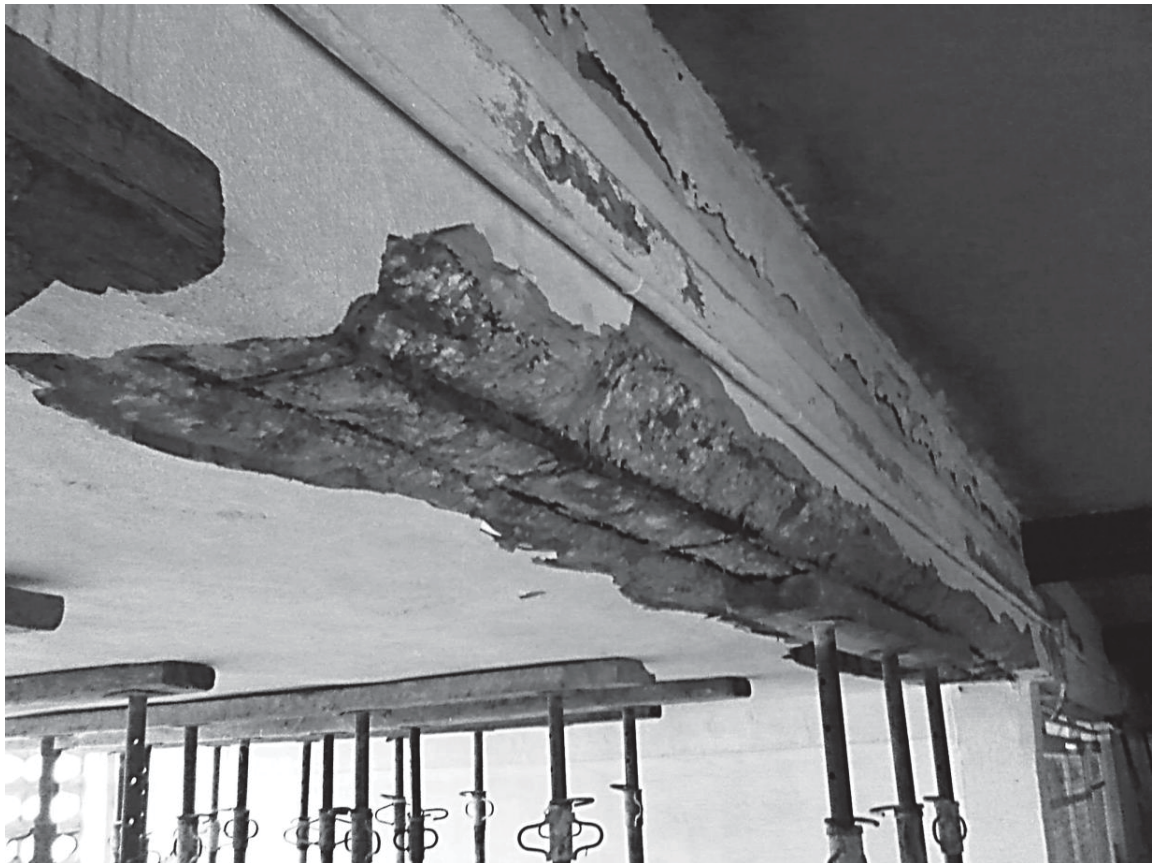
Fig.3. Spalling in beam cover

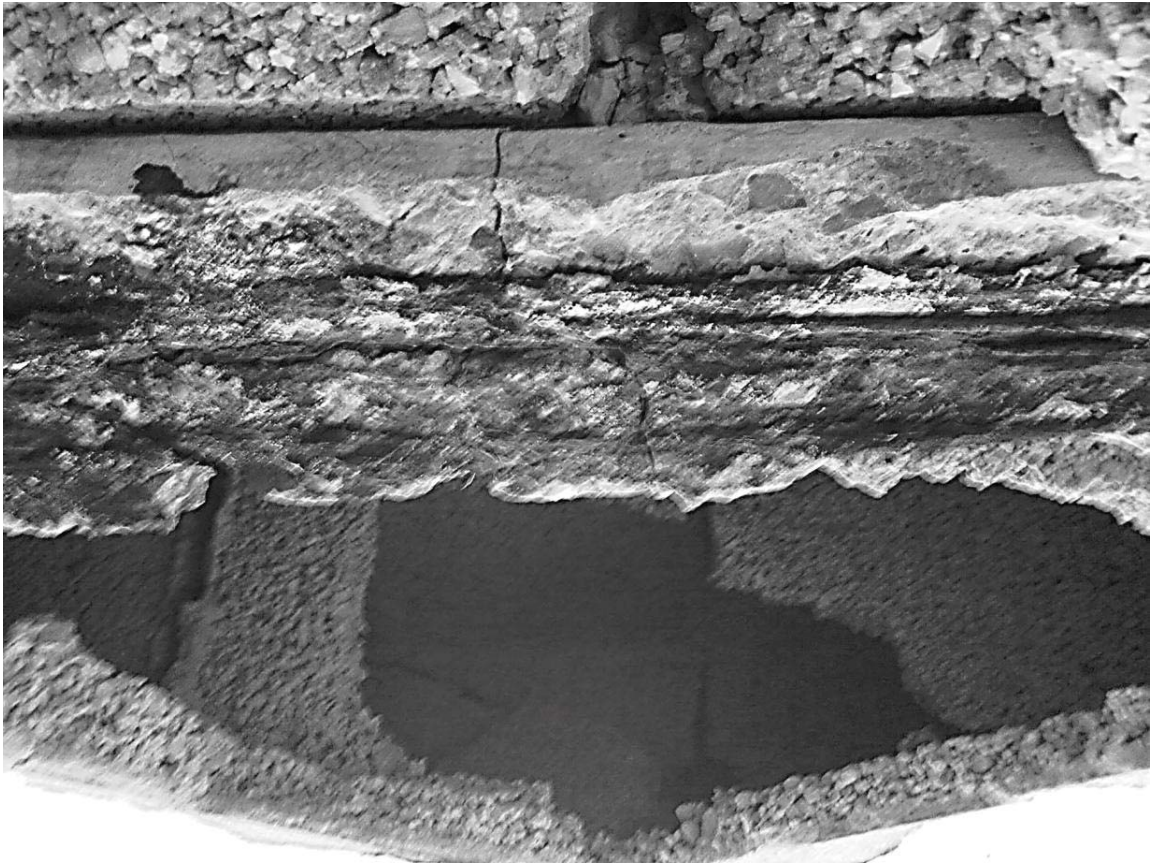
189 The most severe case of corrosion was found in a joist (Figs. 4 and 5) which can be seen to have  
190 lost its entire concrete cover from the bottom section. The prestressing wires are highly corroded in  
191 a large part of the zone affected by oxidation and have almost completely disappeared. It is worth  
192 mention here the possibility of stress corrosion cracking in wires.

Fig.4. Spalling in joist cover

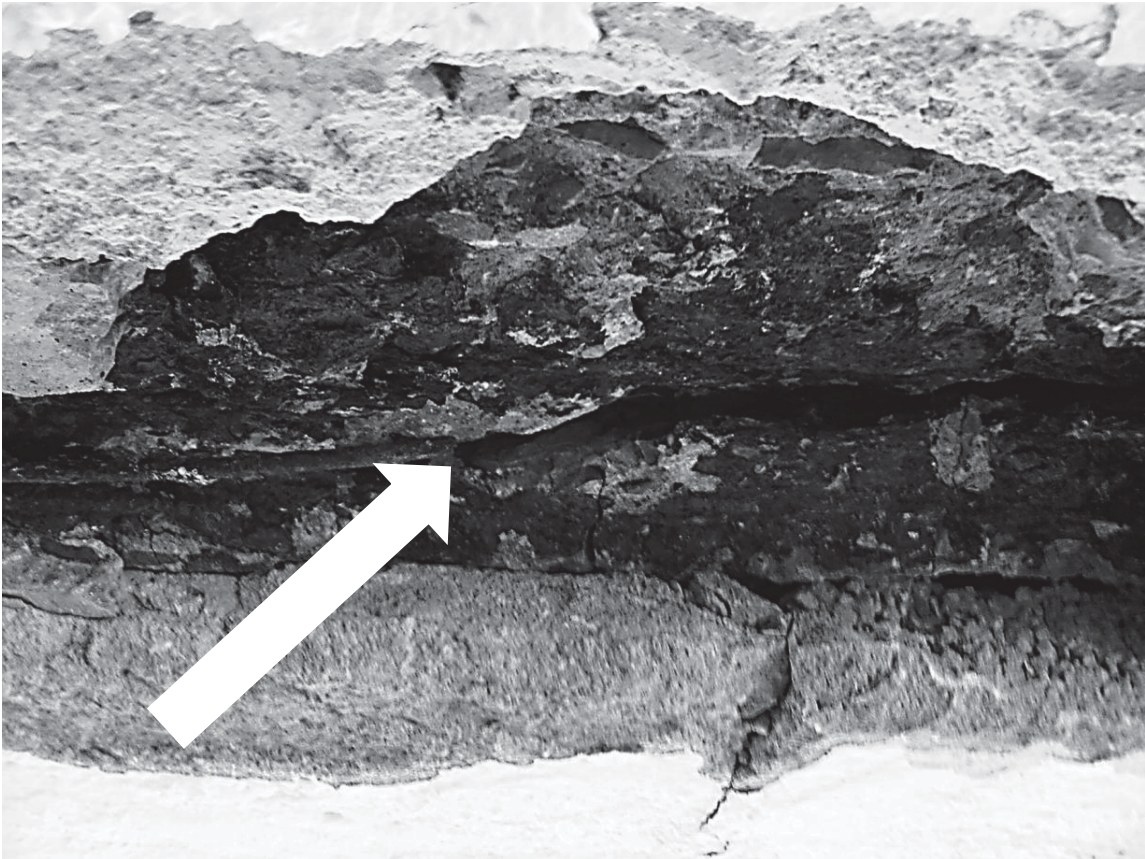
Fig.5. Loss of concrete and broken wires

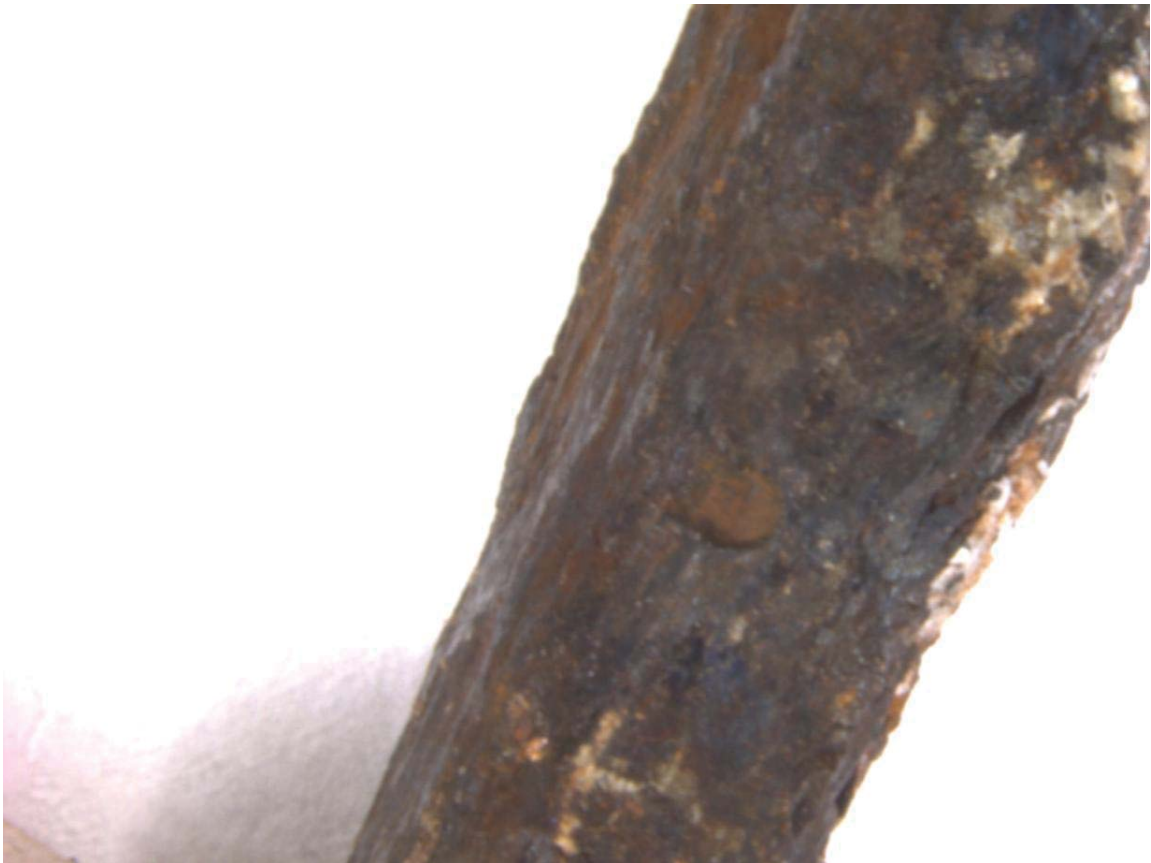
230 Figs. 6, 7 and 8 show 8x magnified optical microscope images of samples taken from a joist steel  
231 wire with pitting corrosion (Fig.6) plus a section from the column reinforcement (Figs.7 and 8),  
232 previously treated with nitric acid to eliminate impurities. Fig. 6 shows the typical pitting and  
233 reduced cross-sectional area of wires subjected to a marine environment. Fig. 7 shows a rebar  
234 sample taken from the corroded section of a column in which the steel-oxide interface can be  
235 clearly seen. Also visible are corrosion stains inside the steel itself. Fig. 8 shows the area of the  
236 reinforcement affected by pitting.

Fig.6. Joist wire with pitting corrosion

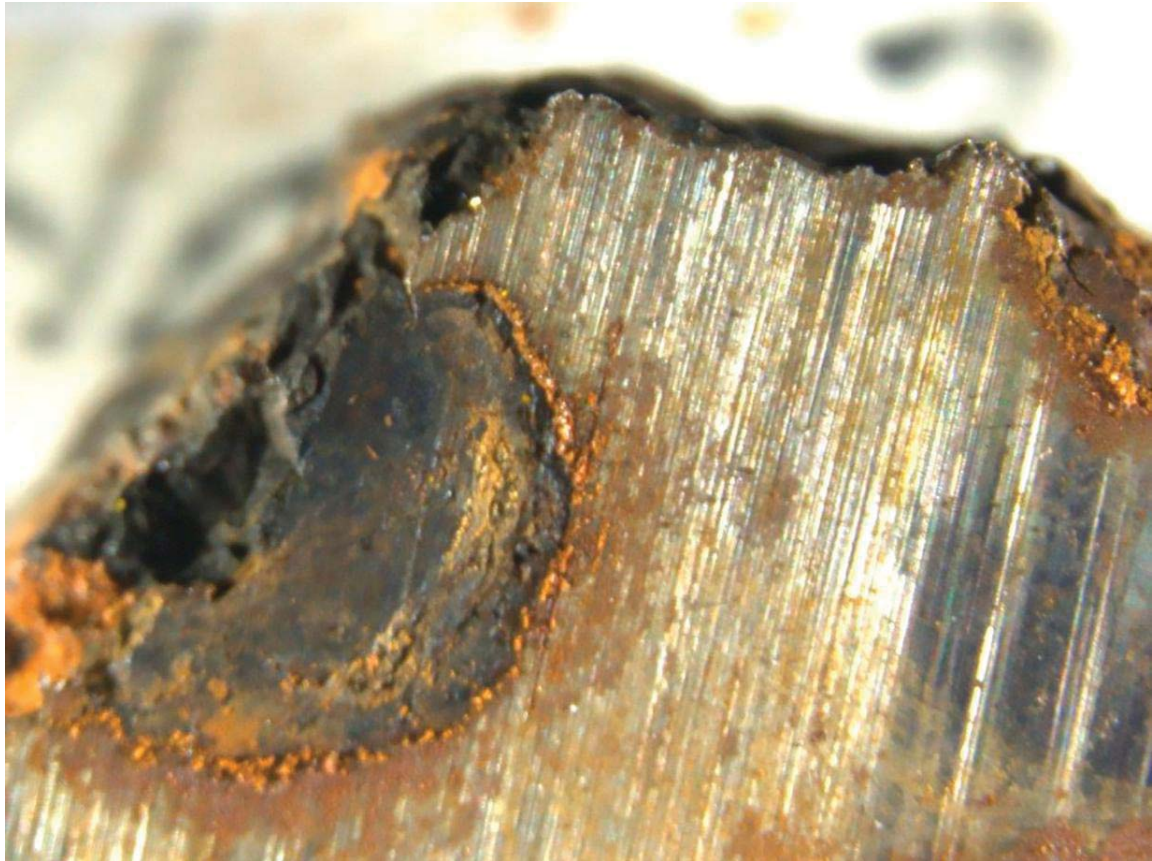
Fig.7. Section of column rebar with pitting corrosion

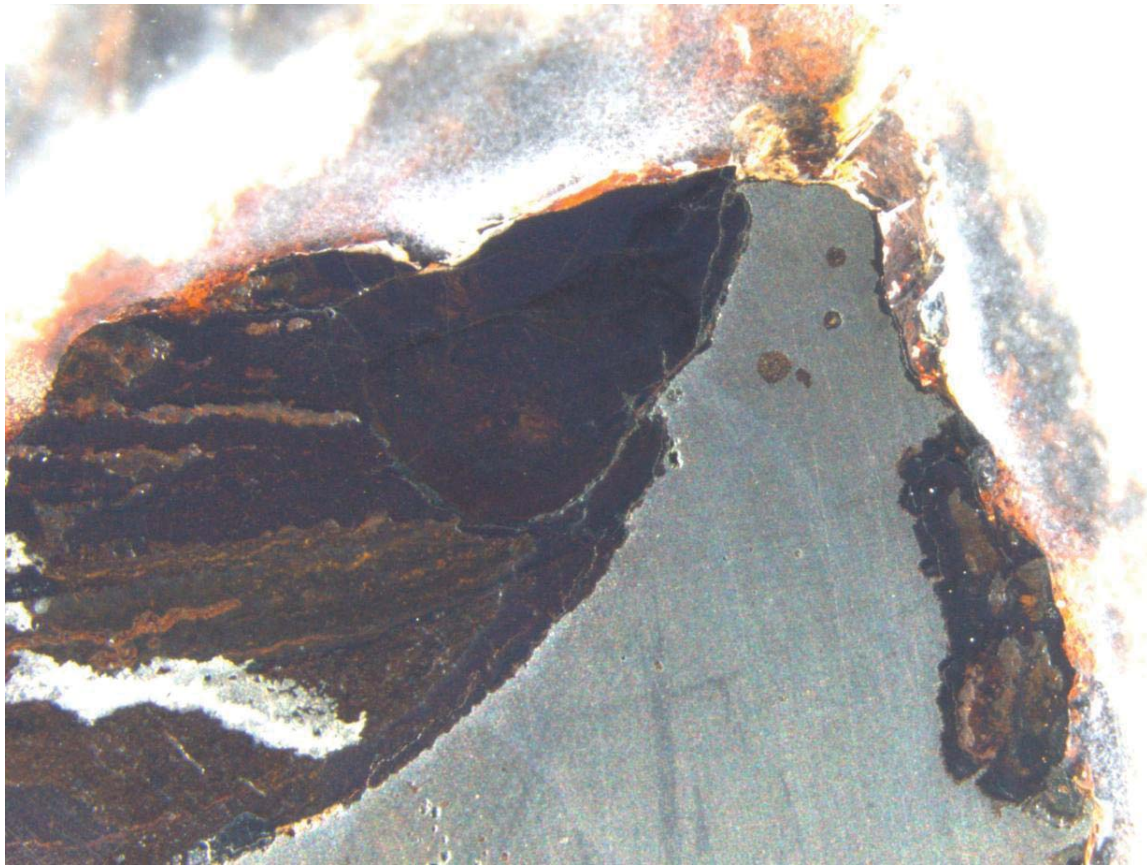
Fig.8. Area of rebar affected by pitting

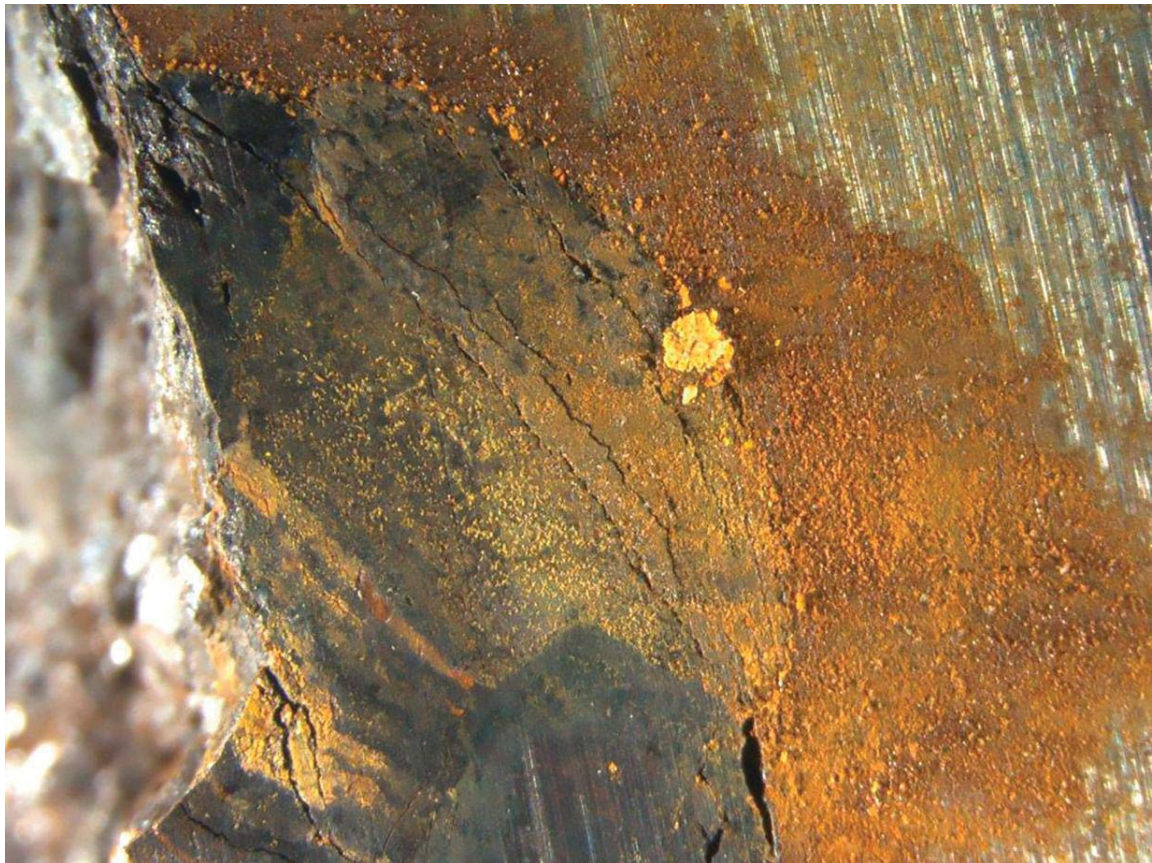
238 Fig. 9 shows salt deposits embedded in the interior of the steel-oxide interface in contact with the  
239 steel, which appears to be the start of a pitting process due to high chloride content. Fig. 10 is a 25x  
240 magnification of the steel-oxide interface in which cracks can be seen in the interior of the corroded  
241 zone. Fig. 11 is a 25x magnified image of a corroded area with black, yellow and brown patches,  
242 indicating the presence of different corrosion products [14]. The black patch can be attributed to the  
243 presence of magnetite [23] and wustite [24], while the yellow and brown are due to the presence of  
244 iron oxyhydroxides, mainly akaganeite, lepidocrocite and goethite.

Fig.9. Detail of pitting with a crust of saline particles

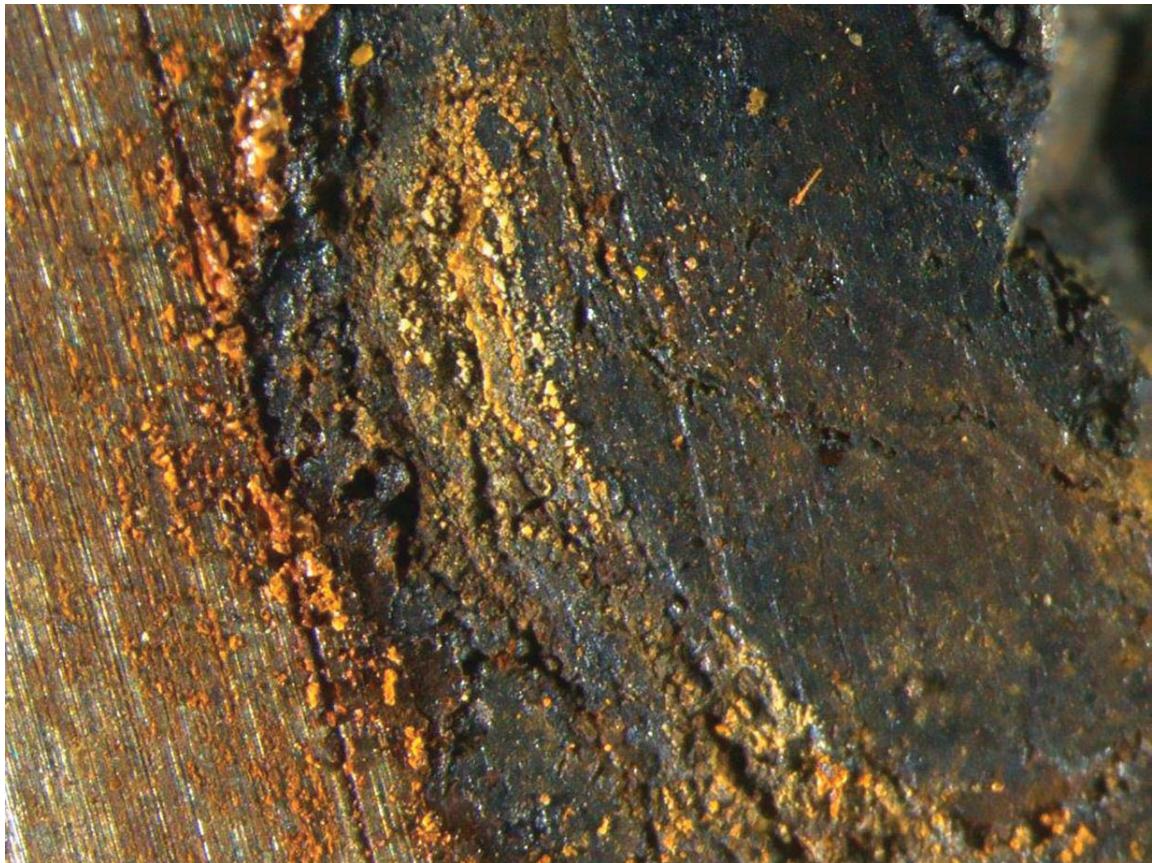
Fig.10. Pitting with cracks due to different oxide composition

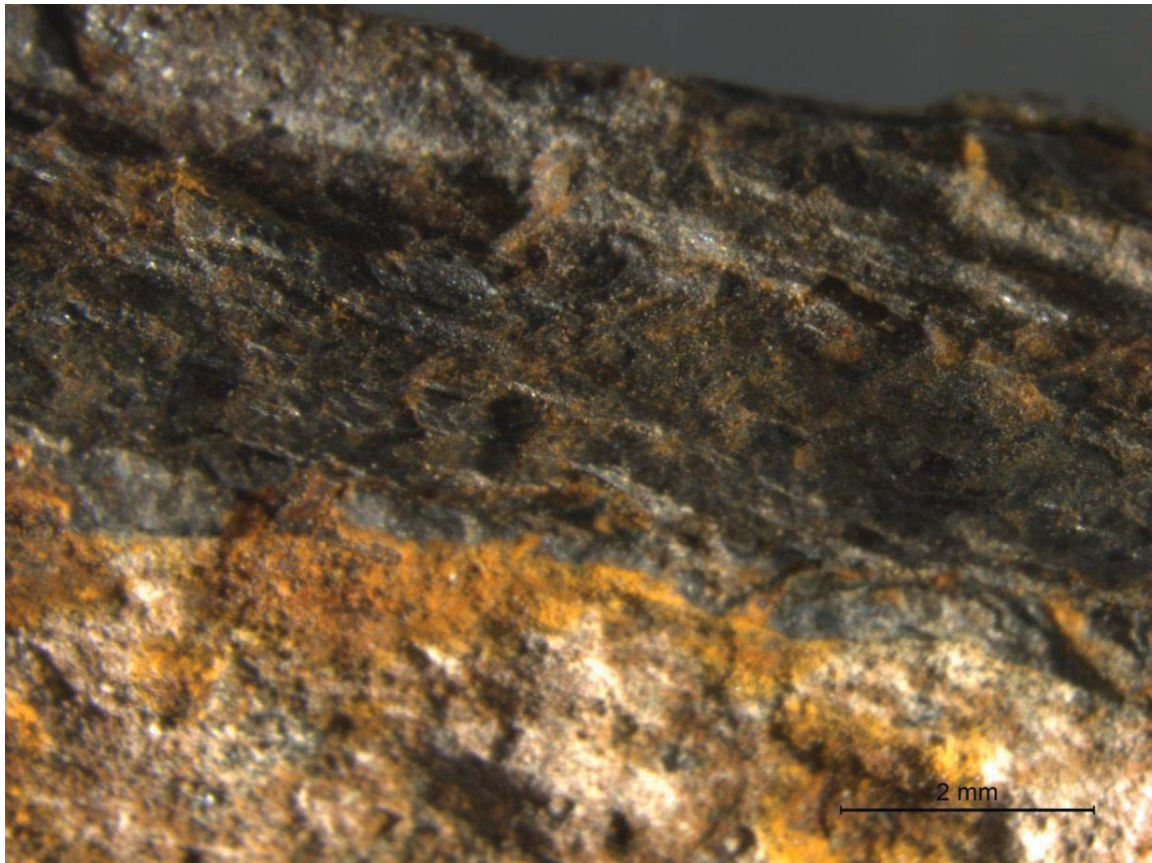
Fig.11. Different morphologies of oxides in pitting

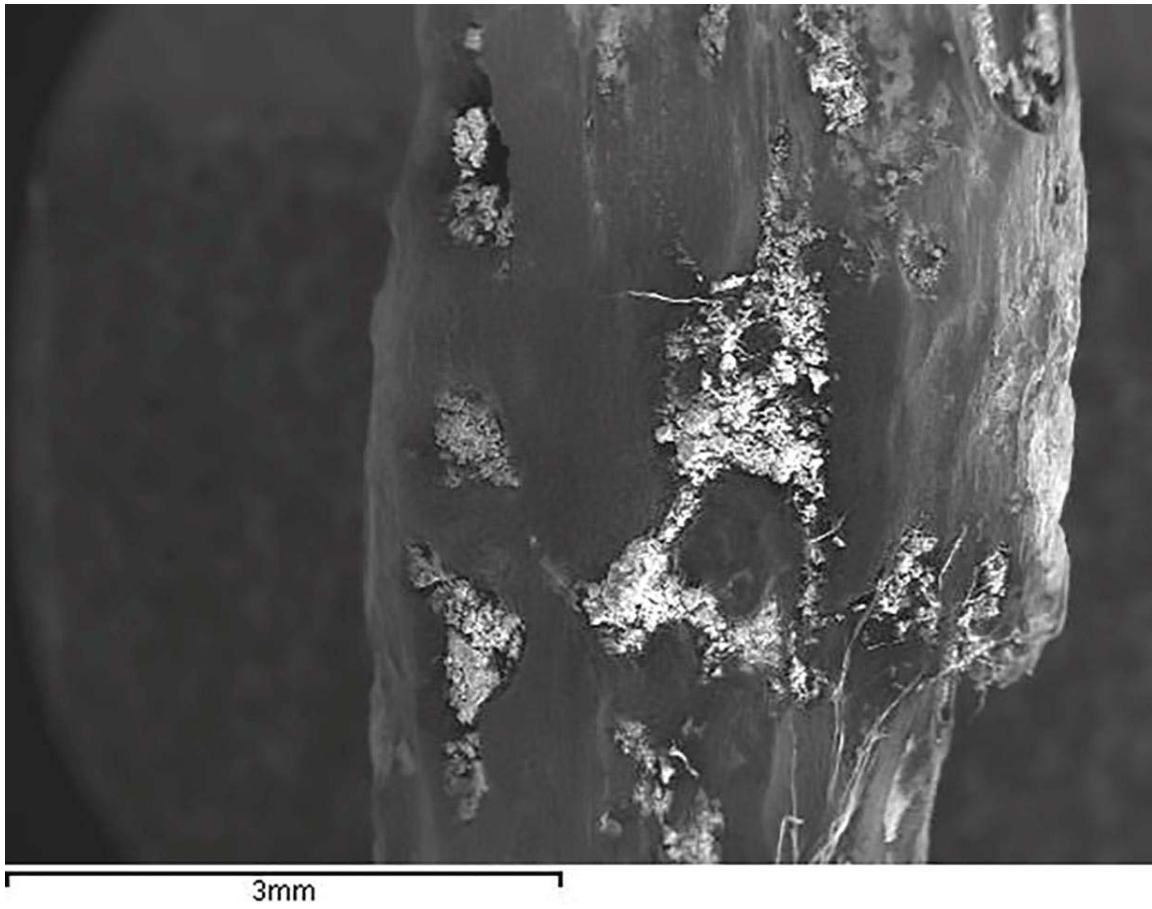
246 The SEM study of pitting between 20x (Fig.12) and 150x (Figs.13 and 14) shows the presence of  
247 crystals due to salt deposits around and inside the pitting. The crystals composition it shows in  
248 Table 1.

Fig.12. Joist wire with pitting corrosion

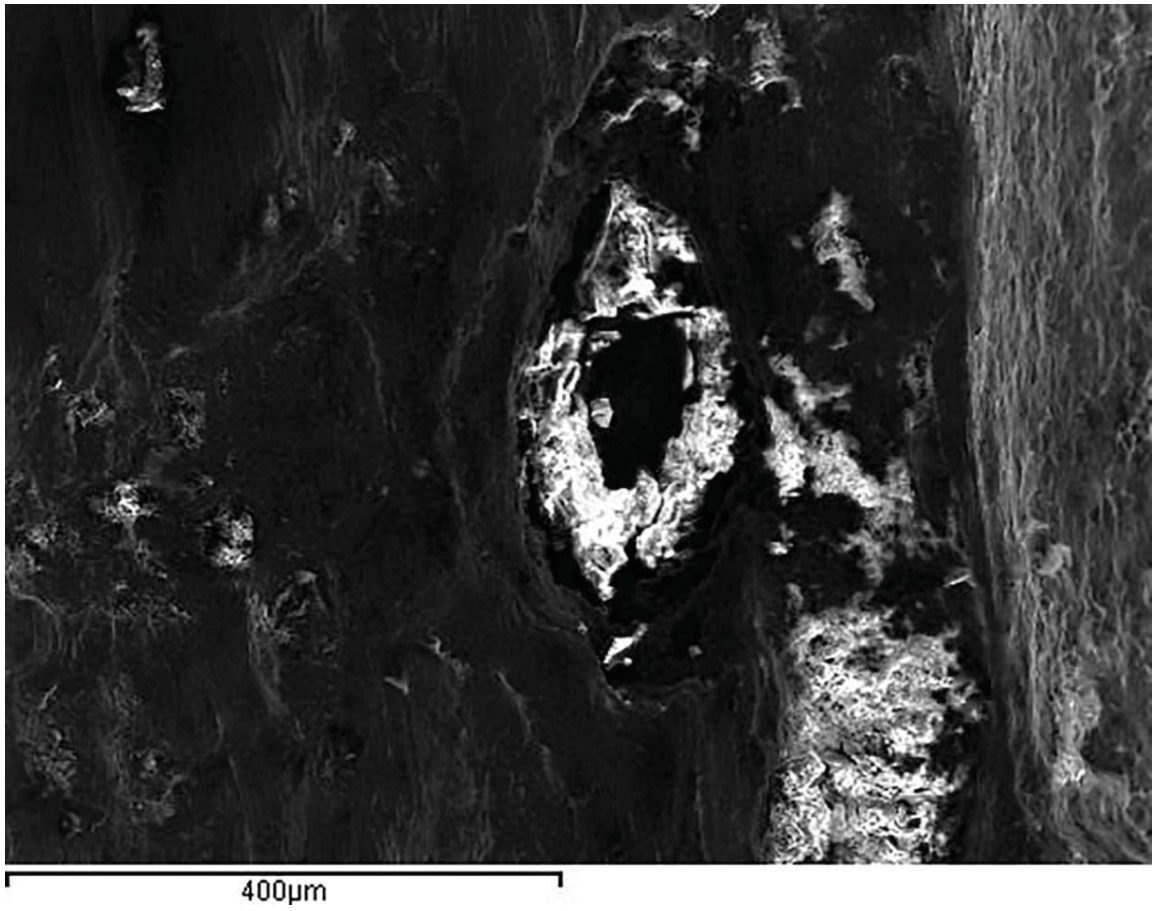
Fig.13. Salt deposits on the surface of a pitted zone

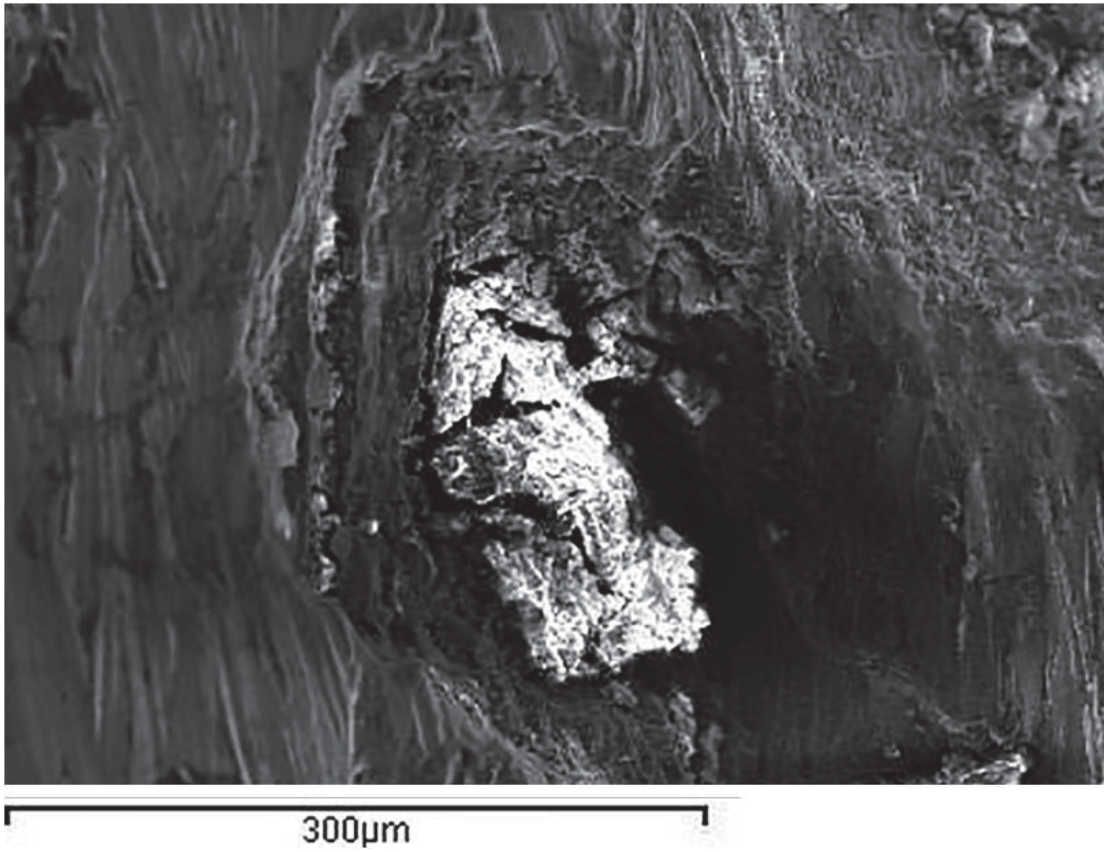
Fig.14. Salt deposits inside a pitted zone

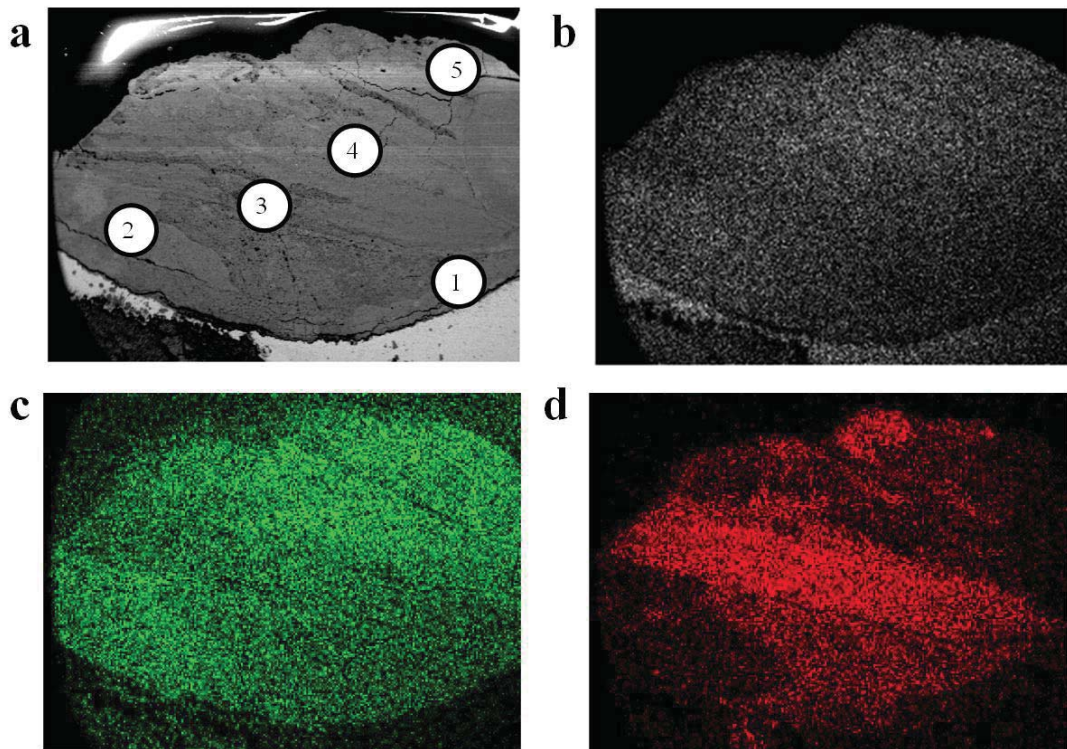
250 In order to study the composition of the pitting in the rebars, bearing in mind that they had been  
251 exposed to the marine environment for 45 years, a microstructural analysis of the oxide layer was  
252 carried out, as seen in Fig. 15, which shows corroded zones of different colours. The same effect  
253 was noted in the pitting seen through the optical microscope (Figs.7-11). Table 2 gives the atomic%  
254 composition of the analysed elements by zone. A mapping study was also carried out to detect the  
255 regions with the highest (lighter colour) and lowest (darker colour) presence of iron (Fig.15b),  
256 oxygen (Fig.15c) and chlorine (Fig.15d). These images helped us to determine the thickness of the  
257 pitting, the different types of oxide present and the zone with the highest concentration of chloride  
258 ions.

260 In the SEM image shown in Figure 15a, five different coloured zones can be clearly identified.  
261 Zone 1 is that of non-corroded steel. Zones 2 – 5 are made up of different oxide compositions, seen  
262 as variations in the greyish tones and compactness related to different concentrations of chloride.  
263 Zone 2 is the deepest, at the rebar-oxide interface, where the chlorine ion content is lowest and most  
264 compact. Zones 3 and 4 have a more porous oxide layer with a higher chlorine content (slightly  
265 lower in Zone 3). Zone 5 contains the outside layer, again more compact and with a lower  
266 concentration of chlorides than the intermediate zone. It should be emphasized that chloride ions  
267 together with a large number of cracks were found in all the pitted regions, undoubtedly caused by  
268 the different volumes of the oxides present. The atomic % O/Fe ratio is equal to 1 in the deepest and

269 most compact part of Zone 2, indicating that the type of oxide in this layer is FeO contaminated by  
270 chlorides. All the other layers have an O/Fe ratio >1, which implies that they contain iron

Fig.15. Microstructural analysis of oxide layer on rebar. a) Different oxide morphologies and identification of analyzed zones; b) mapping of the presence of iron; c) mapping of the presence of oxygen; d) mapping of the presence of chlorine.

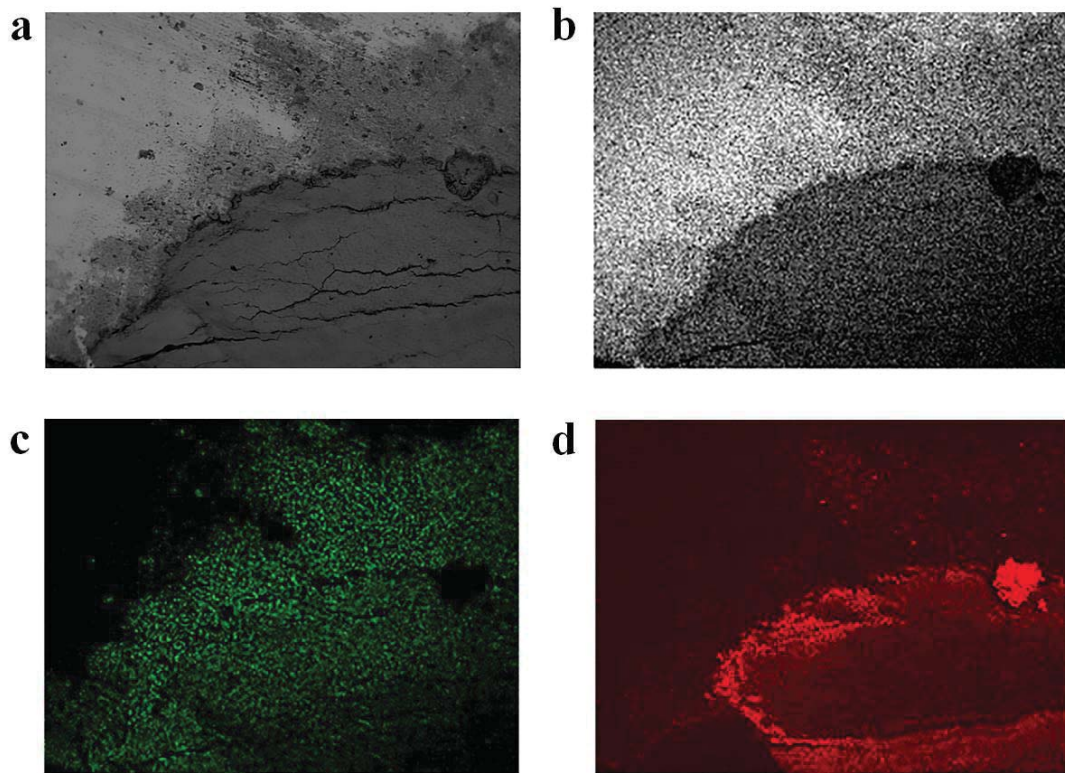
274 Figs. 16 and 17 contain SEM maps of a detail of the rebar/oxide interface with the notable presence  
275 of chloride ions. In Fig. 16, an agglomeration of salts can be seen, evidently due to the absence of  
276 iron (Fig.16b) and oxygen (Fig.16c) in this zone, which indicates a high concentration of chlorine  
277 (Fig.16d). Here again numerous cracks can be seen in the oxide layer. In this case the chloride ion  
278 content in the rebar/oxide interface is very high and there are chlorine crystals encrusted on the  
279 metal surface (Fig.16d).

Fig 16. Detail of the oxide-steel interface in corroded area. a) SEM image; b) mapping of the iron content; c) mapping of the oxygen content; d) mapping of the chlorine content

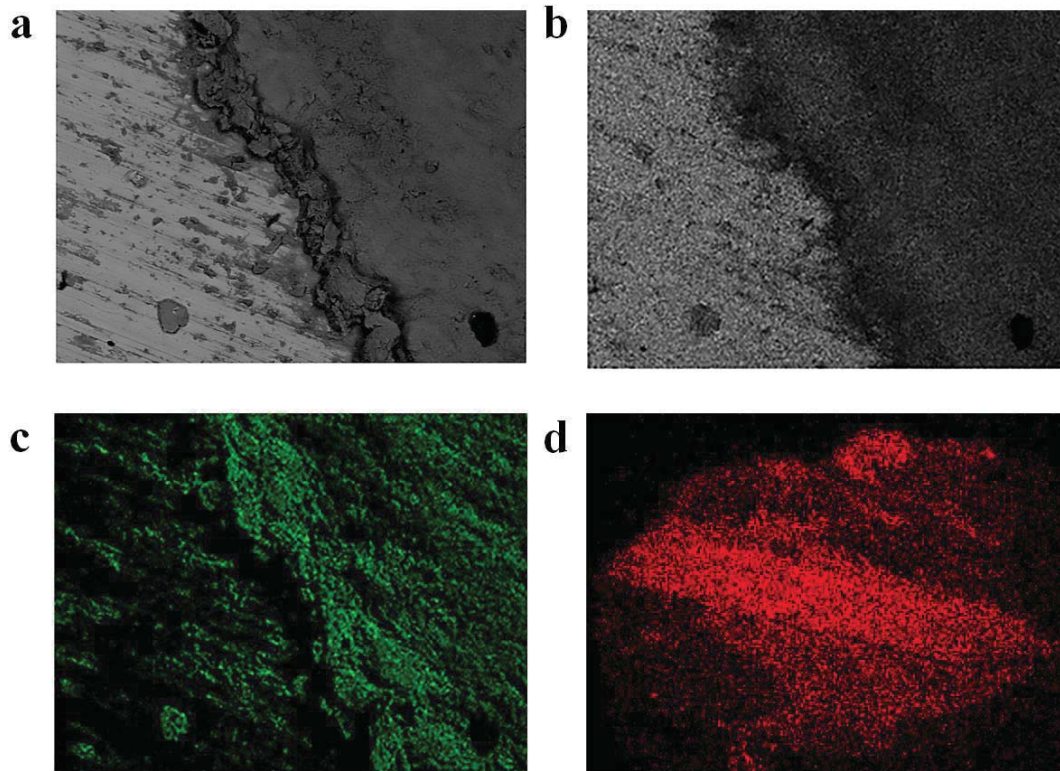
Fig. 17. Detail of rebar (left)/oxide (right) interface of pitted area. a) SEM image 150x; b) mapping of the iron content; c) mapping of the oxygen content; d) mapping of the chlorine content.

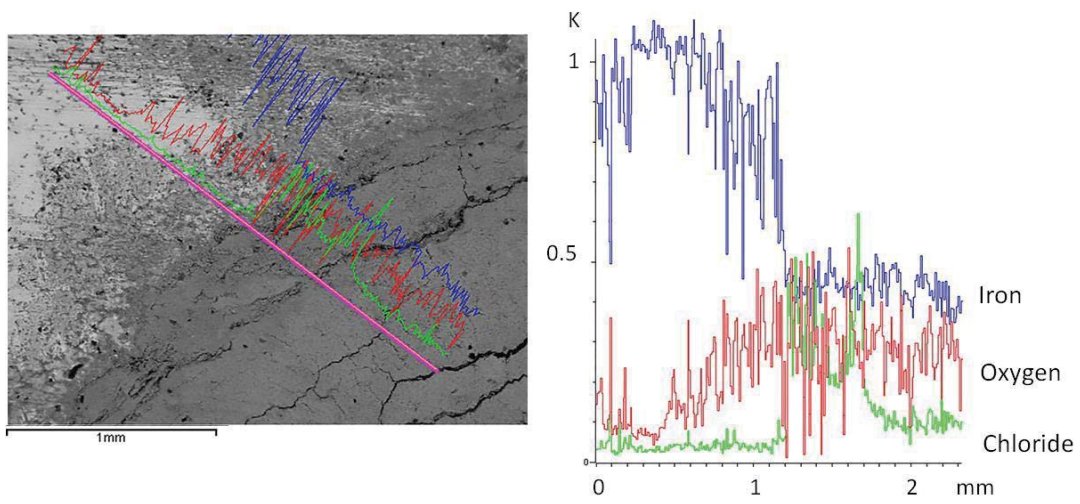
Fig.18. Scan of steel/oxide interface. The figure on the right shows a detail of the relative contents of the elements studied

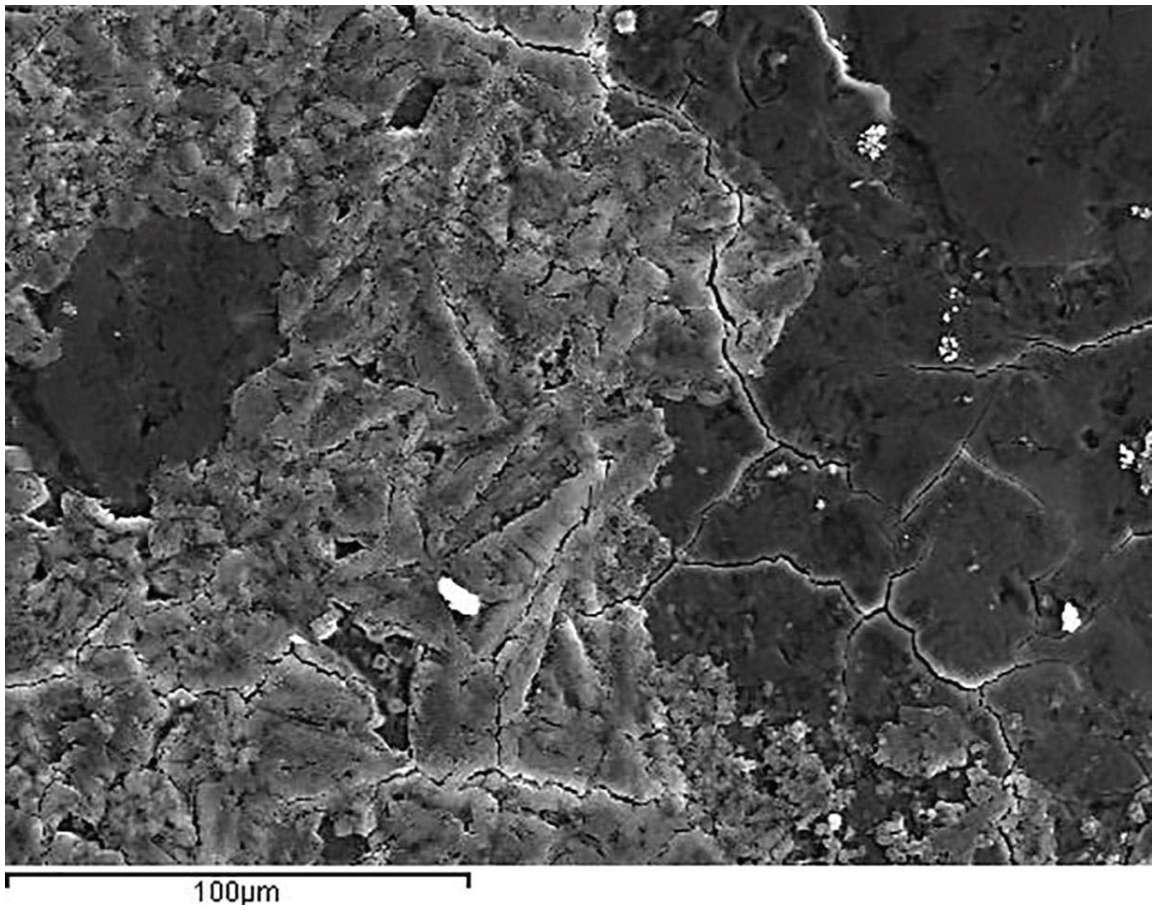
287 Figs. 19 and 20 show some details of the different morphologies of the oxides in one of the pitted  
288 zones. In both SEM images the oxide on the lower right-hand side has a more porous structure with  
289 the presence of more open zones; the oxide on the right-hand side has a more compact structure.  
290 Note once again the presence of numerous cracks due to the different expansion rates of the oxides  
291 (Fig.21).

Fig.19. Morphology of oxides in a corroded zone

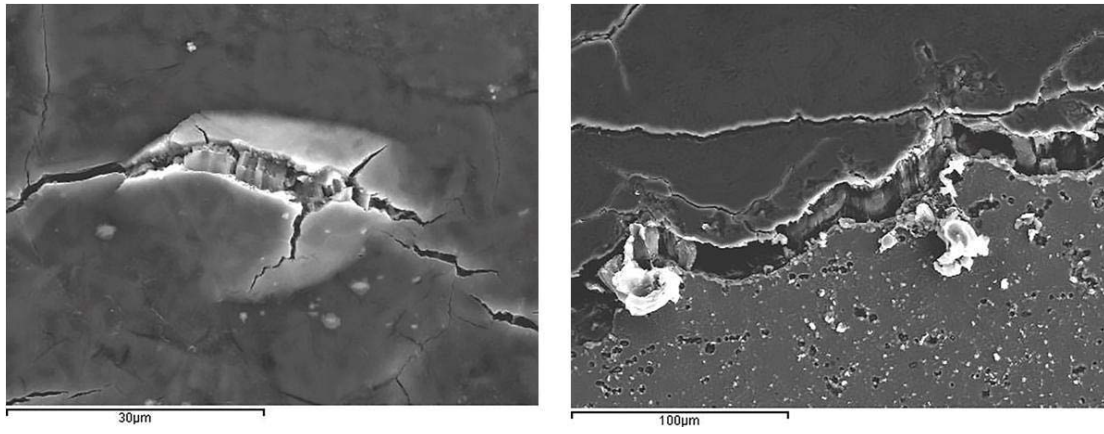
Fig 21. Detail of cracks showing different oxide expansion rates

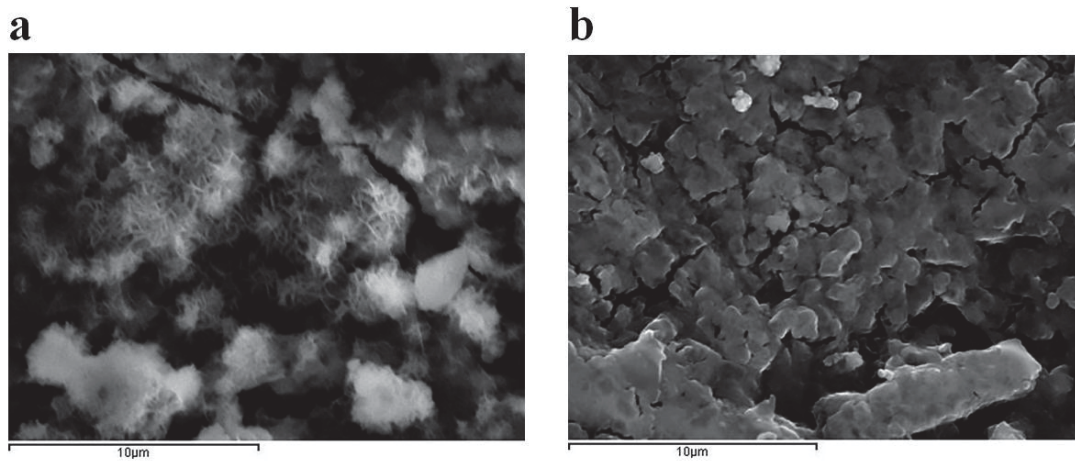
Fig.22. Morphology of oxides in pitting of column reinforcement rebars. a) Crystalline formations found in zones with highest concentration of chloride ions; b) formations in zones with lowest concentrations of chloride ions.

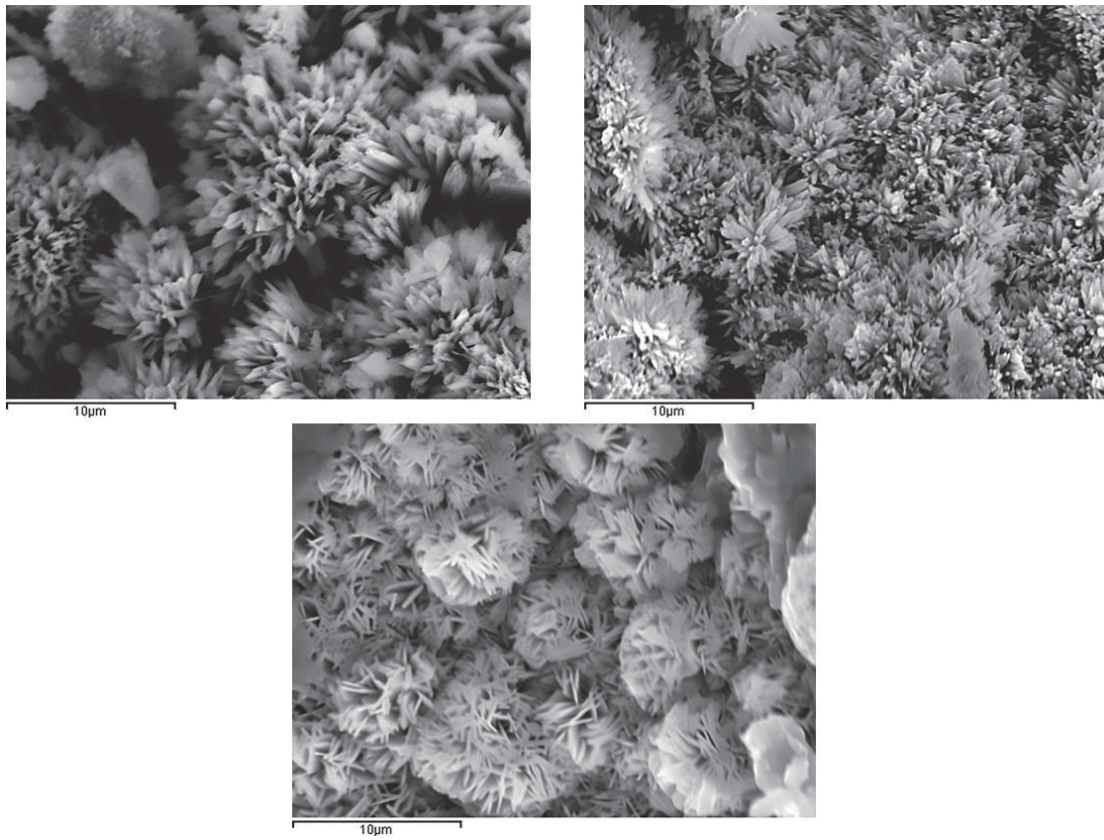
304 In Fig. 23 the morphology of the oxides in the rebar samples taken from the column and joist are  
305 shown in SEM images. The layers are in general highly porous, as can be expected from steel  
306 subjected to a marine environment for an extended period. Acicular morphologies can be observed  
307 in the form of *cotton balls* and *rosettes*. Even though the shape of the oxide surface can vary  
308 significantly for different types of exposure [13], in a comparison with the bibliography [7,15,16] it  
309 seems clear that the shapes are due to the presence of akaganeite ( $\beta$ -FeOOH).

Fig.23. Morphology of oxides in column reinforcement rebars and joist wires

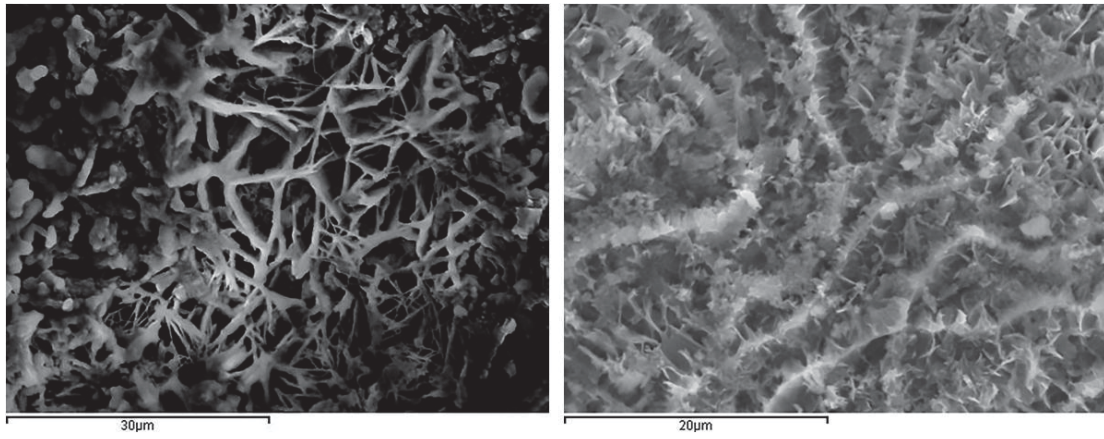
311 Fig. 24 shows images of some oxides with open-structured crystals present in the corrosion layer of  
312 the joist wire, previously treated with HNO<sub>3</sub> to eliminate traces of mortar and non-adhering  
313 impurities. References in the bibliography identify these as lepidocrocite crystals ( $\gamma$ -FeOOH)  
314 typically found in highly corroded samples [7,13,18].

Fig. 24. Morphology of oxides in joist wires
