1  
2  
3 **Determining corrosion levels in the reinforcement rebars**  
4 **of buildings in coastal areas. A case study in the**  
5 **Mediterranean coastline**

16  
17 This paper describes a study of the damage caused by corrosion to the reinforcement rebars of a 40-  
18 year old building used as a car park at a distance of 20 metres from the sea. The corrosion levels of  
19 the building's structural elements, including beams, joists and columns were analyzed by optical  
20 and electron microscopy. Carbonation depths and chloride contents (Vorhard method) of the  
21 concrete cover were measured in situ. EDX was used to analyze the condition of the reinforcement  
22 surfaces and the morphology and composition of the oxides. A high degree of corrosion was  
23 observed in all the above elements, carbonation had reached the depth of the reinforcement in all  
24 the samples studied, and the concrete chloride levels were far in excess of the recommended  
25 maximums. The study of the reinforcement rebars revealed different types of oxides of varying  
26 morphologies, compaction and colouring according to chloride content. A comparison with

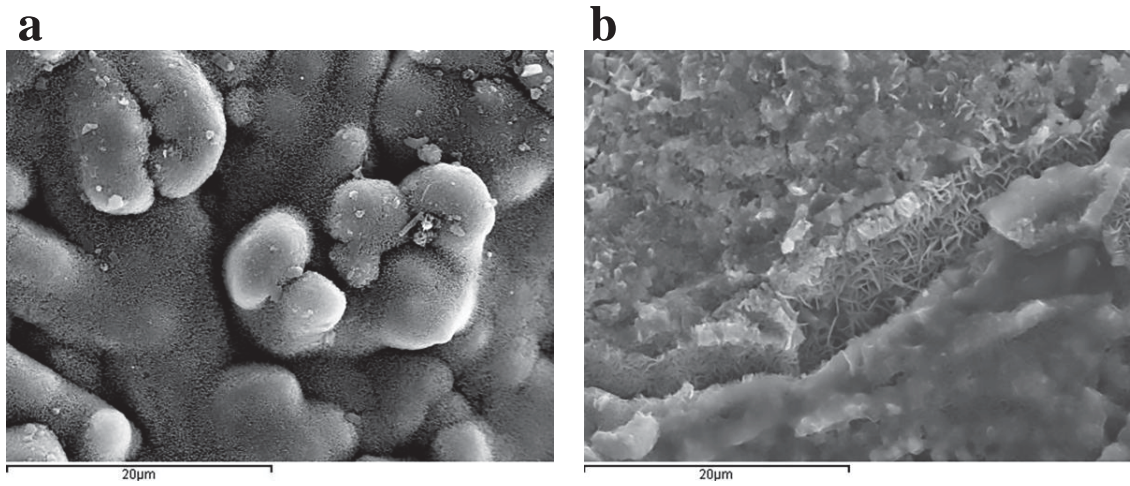
316 Typical goethite ( $\alpha$ -FeOOH) formations can be seen in Fig.25a. According to the literature, these  
317 crystals are usually found together with magnetite (Fe<sub>3</sub>O<sub>4</sub>) in the type of formations seen in Fig.25b.  
318 The EDX analysis indicates the presence of FeO oxides in the darkest and most compact zone of the  
319 pitting/steel interface (see Table 3 and Fig.26). This could be attributed to the formation of wustite, a  
320 phenomenon which has apparently not been found in previous studies.

Fig. 25. Formations of oxides in rebars (3000x). a) Presence of magnetite and goethite b) typical goethite crystals

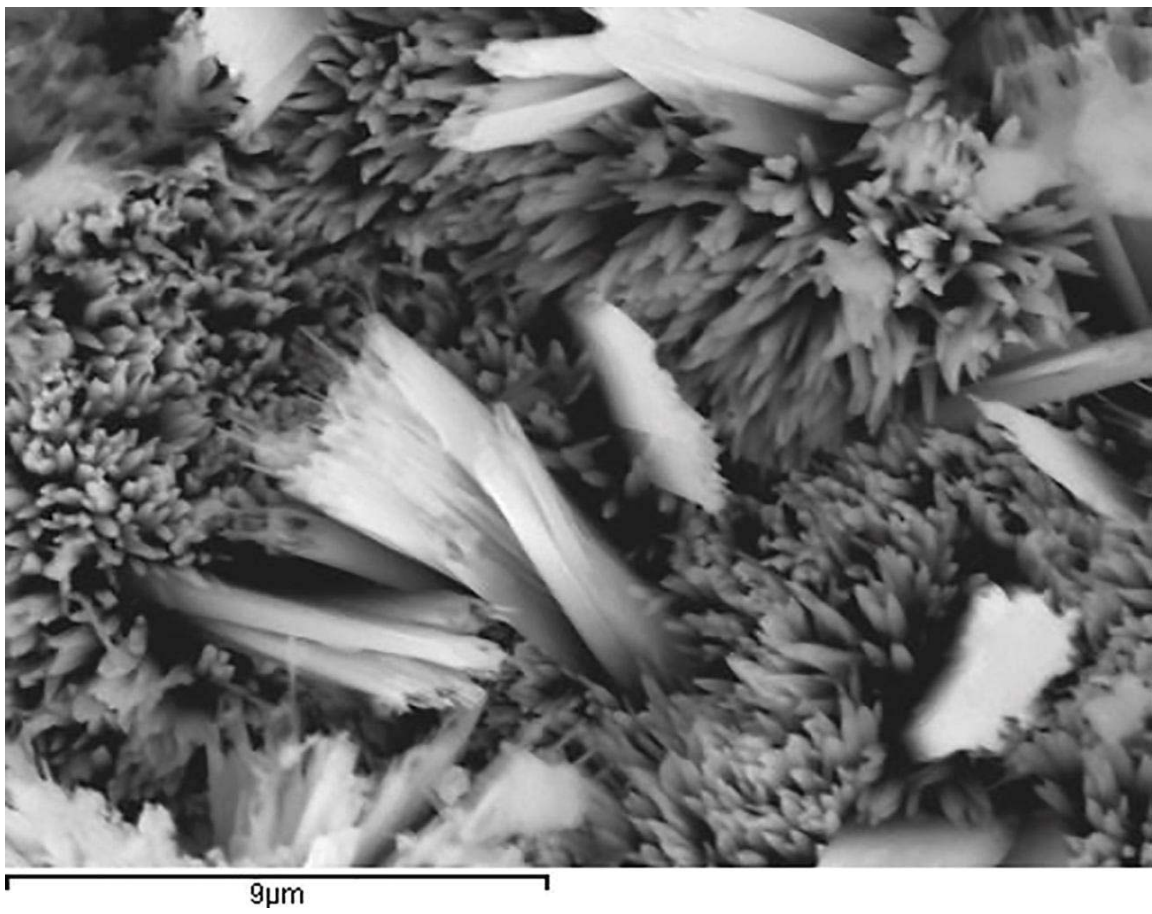
Fig.26. Morphology and EDX analysis of FeO in joist wire
