# Reconstruction of Space Steel Constructions

## Abstract

## **2. Appraisal of the technical condition of the steel structures of clinker silos**

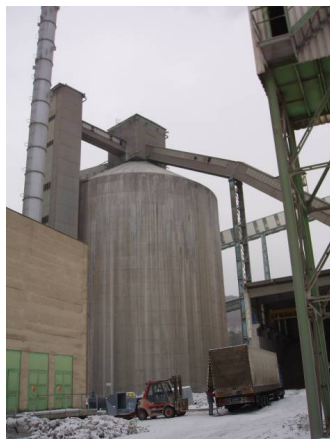
Figure 1: View of Clinker Silo PC2 with Technology

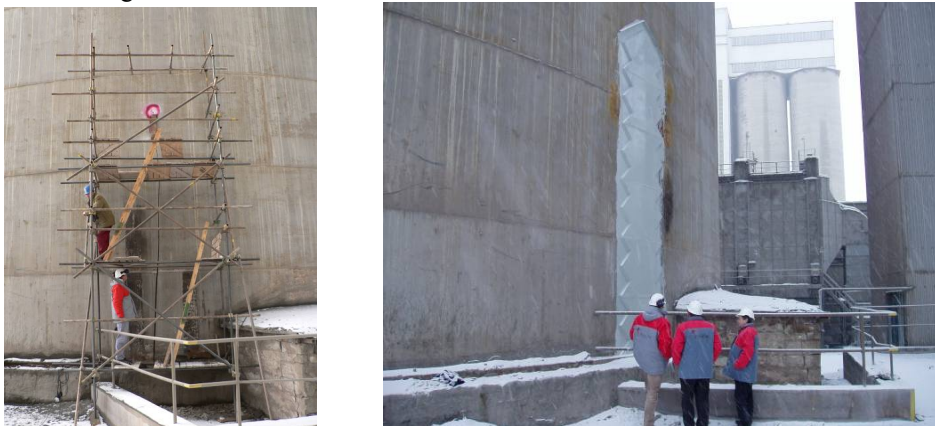
During operation (more than 30 years) two vertical cracks with a length of ~ 6.0m developed in the bottom part of each silo. Views of the repair of the last crack in the clinker silo are on Fig. 2.

Figure 2: View of the Crack in Silo (November 2005)

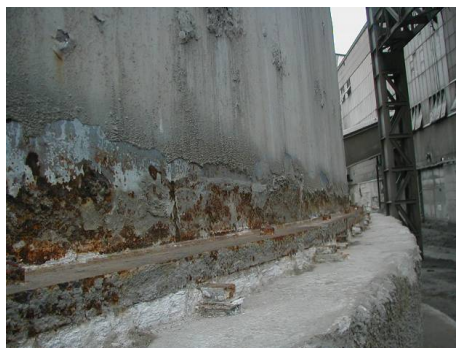
The largest corrosion losses were at the connection of the bottom plate strip of the shell with the base plate (Fig. 3). After cleansing a value  $t \hat{=} 30.1\text{mm}$  near the weld was measured at probe S3. Measurements of the roof plate were also carried out. The mean value of the 3 probes was  $t \hat{=} 6.2\text{mm}$ .

Figure 3: State of the Shell in Contact with the Base Plate

- the measured, real plate thicknesses mainly in the bottom part of the silo are smaller than the projected ones. During operation a wear of mainly the internal side of the shell occurred and the original thickness is decreased also by corrosion losses. The largest corrosion losses were determined at the connection of the bottom shell plates to the base plate; the real thickness was  $t_p = 30.1$  mm against the original one 33 mm. The loss is up to 3 mm.
- the strength of the silo shell, determined by a non-destructive method, by a hardness test with a dynamic hardness tester EQUOTIP PICCOLO reaches only  $421 \div 435$  MPa against the expected one 520 MPa (steel "52"), that is only  $81 \div 84\%$ . The real mechanical and technological material characteristics of the shell can be determined only by test specimens taken from the silo shell.

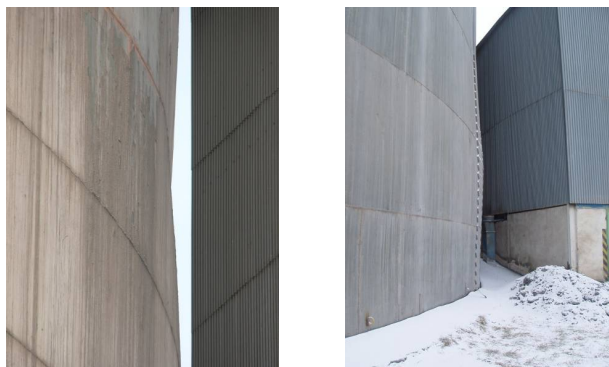
- height differences of the bottom steel ring were at silo PC1 -4.0 to 50.0 mm; the upper edge of the foundation strip was not horizontal. The ring of silo PC2 was not accessible for control.
- deviations from the theoretical shell diameter  $r = 18.0$  m had been found out in various heights. At silo PC1 the maximal deviations were in profile B -57 mm (into the silo's interior) and +94 mm (out of the silo). In profile F the silo shell was deformed into the silo's interior -76 to -29 mm. At silo PC2 the largest deformations were in profile I -50 and +105 mm. Because of the magnitude of deformations, it was necessary to make once in a year a control of the geometric shape of the silos (on the set marks) and in the case of an increase of deformations to take adequate action to ensure silo operation.

Figure 4: Local Deformation of Silo PC1 Shell

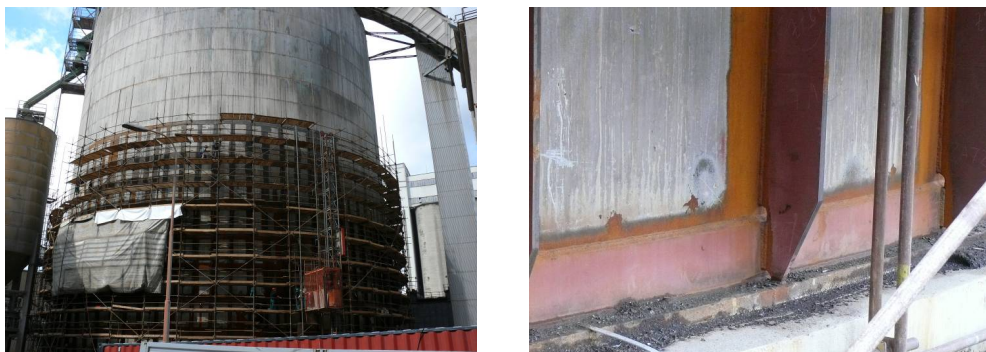
Figure 5: Reconstruction Works on the Clinker Silo

The steel silo shells will be strengthened by a system of vertical stiffeners and horizontal rings. After strengthening, the cylindrical shell will act as an orthotropic (orthogonal anisotropic) shell (fig. 5).

Horizontal rings are divided in primary and secondary. The primary rings have an angular shape, they are made of web (400.12 - 115768) and flange (250.25 – 115768).

There are five intermediate rings and one upper ring, which will be situated closely below the silo roof level.

The secondary rings are from flat steel 250.25 – 113154. The bottom ring is located over the foundation ring, the other 4 secondary rings are always minimally 200mm above the existing horizontal weld. This rule is valid also for the location of the primary horizontal rings.

The vertical stiffeners are from flat steel with variable dimensions. They will be located around the outer silo perimeter (totally 80pcs) in spacing  $\sim 1514\text{mm}$ . Their minimal distance from the original vertical welds is 150 to 200mm.

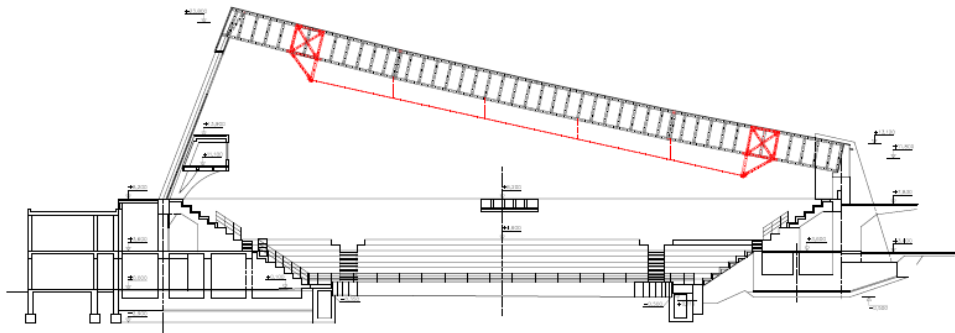
The main cause of the extensive deformations (the measured value in 2006 was 463.5mm) was an insufficient resistance of bolted connections.

Figure 6: Strengthening of the Timber Girders by Prestressing

Every original timber glued girder with a total height 2.6m (totally 34 pieces) was strengthened by means of prestressing according to Fig. 6. The assembly of the new steel members of anchor brackets and tie rods was performed from the inside of the building.

The steel truss anchor brackets were manufactured of steel S355. The anchorage trusses were supplied to the site as individual members from rolled U-sections of light weight. The members of the anchor brackets have been connected to the timber girders by means of steel bolts with diameter 24 and 32mm. The field joints of steel members were bolted to gusset plates with M16/10.9 bolts (fig. 7).

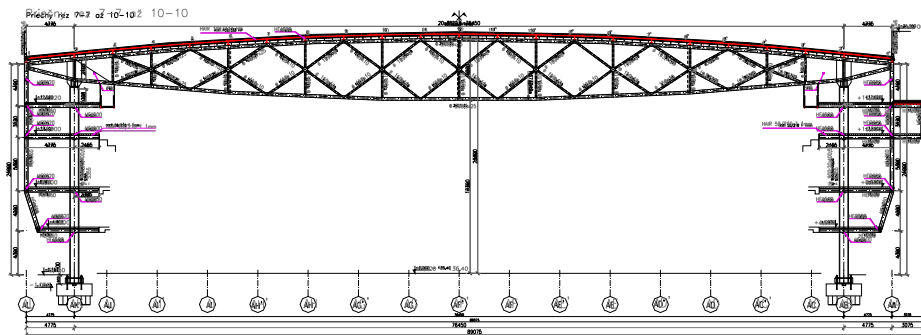
Figure 7: Scheme of the new steel structure

The columns of the original RC structure obstruct the view of the spectators, so the upper RC slab and the supporting columns will be removed. Only the RC structure of the stands will remain. During the third reconstruction, which started already, the steel structure of the roof will be completely dismantled. Due to the increase of the stadium capacity and modernisation of the building the original RC stands will be supplemented by a new steel

structure build around them. The span of the main hall is  $4.775+74.45+4.775$  , the theoretical width is 86m (fig. 7). The main hall plan dimensions are 86\*102m. 6m high truss girders with cantilever ends will be placed on the main columns.
