Durability of repair mortars used in restoration of a Sardinian coastal tower: assessment after ten years

Abstract

This study reports the results of investigations on conservation conditions of an ancient tower, called Torre del Pozzo, located in the S-W coast of Sardinia, restored about ten years ago. The tower suffers from serious problems related to vulnerability of building materials, particularly limestone and sandstones and aerial lime mortar with poor physical-mechanical properties. Over the centuries the materials were subjected to aggressive actions (wind corrosion and salt crystallization) causing an intense erosion of the walls with consequent partial collapse of the structure. About ten years ago a restoration involved the mortars and only the replacement and integration of ashlar deteriorated. After about 10 years from this intervention, some inspections have been carried out in order to assess the effectiveness of the intervention and the state of preservation of the tower. This paper focuses on analyses and tests carried out to assess condition and durability of the repair mortars.

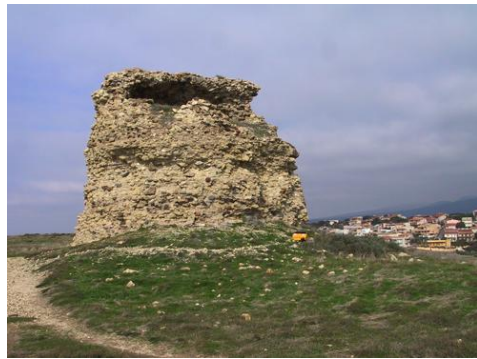
The artifact was in severe degradation conditions, almost in a state of ruin (Fig. 2).

Fig. 2- Torre del Pozzo before the restoration

Along the east side of the tower, although protected from the wind, the protective plaster had almost entirely disappeared. Along the wall surfaces, the stone materials showed obvious signs of erosion and washouts; the original lime mortars, though not so friable and sufficiently firm to the touch, in many cases, were no longer able to keep welded the ashlars. This fact is mainly due to the strong reduction of their thickness resulting from the marine erosion.

About 10 years ago, the critical conditions of the Tower required an urgent conservative action for containing the progress of degradation and the risk of collapse. The restoration works mainly focused on the repositioning and the rejoining of the most degraded wall and flaking portions (Fig. 3).

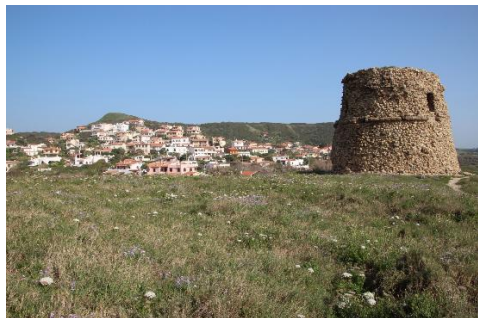
Fig. 3- Torre del Pozzo restored

In particular, the base of the Tower, affected by a substantial back weathering of surfaces, and all the masonry were repaired recycling collapsed materials for the consolidation and recovery of the geometry of the structure. A bedding NHL based mortar was made and loose materials

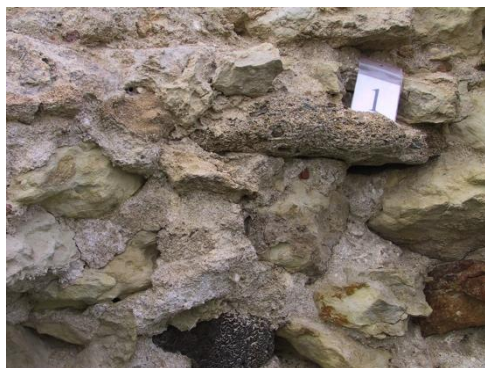
Several lithotypes form the walls of Torre del Pozzo, prevalently sandstones and biomicritic limestone but also basalt/andesitic ashlar are present (Fig. 4).

Fig. 4 – Detail of Torre del Pozzo building materials

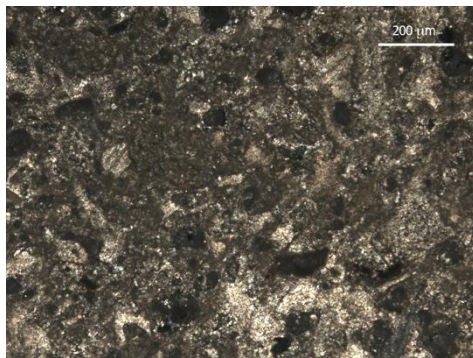
Fig. 5 depicts a microphotograph of the prevalent biomicritic limestone. A lime mud (micrite) surrounds and supports fossiliferous skeletons, mostly of crinoids (white fragments) and brachiopods (curved fragments), although bryozoans and other organisms can be present.

Fig. 5 – Microphotograph of biomicritic limestone

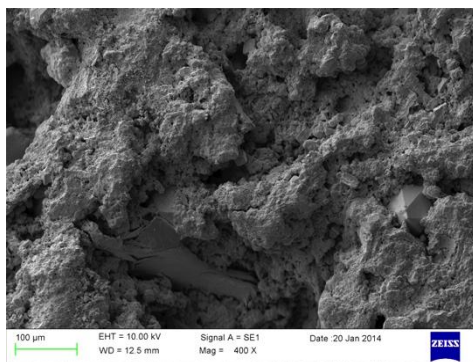
Fig. 6 – SEM image of biomicritic limestone

Fig. 6 shows the microstructure of the biomicritic limestone. As can be seen, it exhibits a high porosity, presence of silica minerals and phyllosilicates along with very fine carbonatic matrix. The same mineralogical composition is assessed by XRD analyses.

This lithotype appears intrinsically not durable, both for the poor mechanical properties (compressive strength of between 10-15 MPa) that for the high porosity (35%).

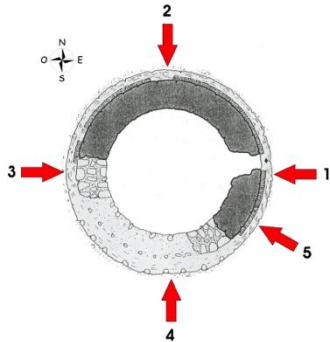
Fig.8 – Sampling of original mortars

In all the sampling points, indicated in Fig. 8, the finishing plaster was completely absent.

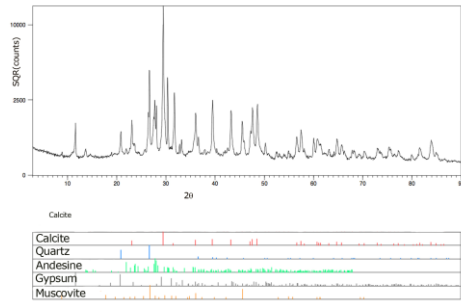
Fig. 9 shows a representative XRD spectrum for the original mortars taken at points indicated in Fig. 8. MIP investigations have revealed a total porosity of about 40% for the mortars exposed to sea side and 25% for those in the innermost protected side. Figure 10 shows pore sizes distributions of these two mortars

Fig. 9 – XRD pattern of original mortar

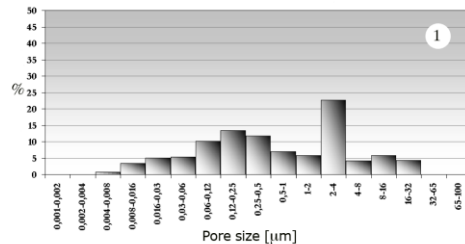
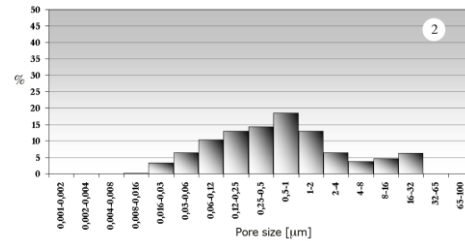
Fig. 10 – Pore sizes distribution of original mortars: 1) sea side; 2) protected inside

One can observe a shift of the distribution towards classes of larger pores, in the case of mortars critically exposed to the sea side.

The major problem related to the conservation of coastal towers can be identified in the strong aggressiveness of the marine environment, especially in areas particularly exposed to strong winds. The loss of material, resulting in the erosive action and therefore, the thinning of the wall structures, involves the consumption of mortars and detachment of ashlars, even the most intrinsically resistant like basalt. The original mortars, as stated above, are still sufficiently compact to the touch, typical texture of those made with ordinary aerial lime. The lack of a surface coating (only a few shreds found at that time) and high porosity of mortars,

induced by the salt crystallization, have been crucial factors to the degradation of the fortification.

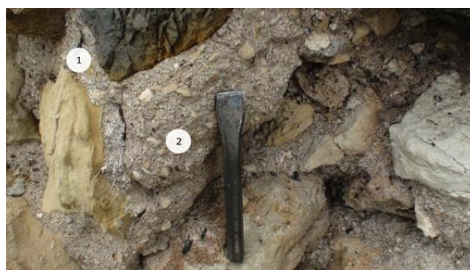
At a distance of 10 years from the restoration, some mortar fragments have been analyzed. The visual inspection showed no macroscopic phenomena of detachment, erosion and/or cracking of mortar, which is shown very tied to the stone substrate (2 as indicated in Fig.12).

XRD investigations have identified the following crystalline phases: Calcite, Quartz, Plagioclase, Sanidine and Halite. Fig. 12 shows a detail of the wall with indicated the two types of mortars: the original mortar (1) and the repair one (2). We observe a correct choice of the texture of the repair mortar, with a slightly darker hue that of the original mortar.

Fig. 11 – Detail of masonry with original (1) and repair mortars (2)

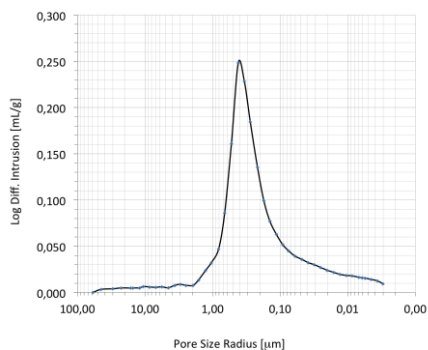
Fig. 12 – Pore sizes distribution of repair mortar

We observe a normal distribution extended in the range between 45 μm and 0.03 μm with median radius equal 0.3 μm .

The total porosity (average of 6 specimens) amounted to 27,2% \pm 3,4. The values of porosity are comparable to those of a mortar based on NHL.

The calculation was made by considering the interfacial tension of NaCl (γ) of 80 dynes/cm. The calculated value is equal to 2.5 MPa.

This value is higher than the theoretical tensile strength of the mortar and therefore the data derived from the application of the model would lead to assume a low durability of the mortar itself.
