## Treto Bridge Refurbishment (Cantabria, 1905-2016)

M. Ruiz-Bedia<sup>1</sup>, Felipe Collazos-Arias<sup>2</sup>

The paper delves into the process of refurbishment of an old metal bridge (year 1905) located in a marsh (mouth of the Ason river, Cantabria) of high environmental value. The repair was necessary to guarantee the structural safety of the bridge, which serves a national road (N-634). At the same time, it was necessary to preserve its cultural values and, during the work, to fulfill the environmental requirements.

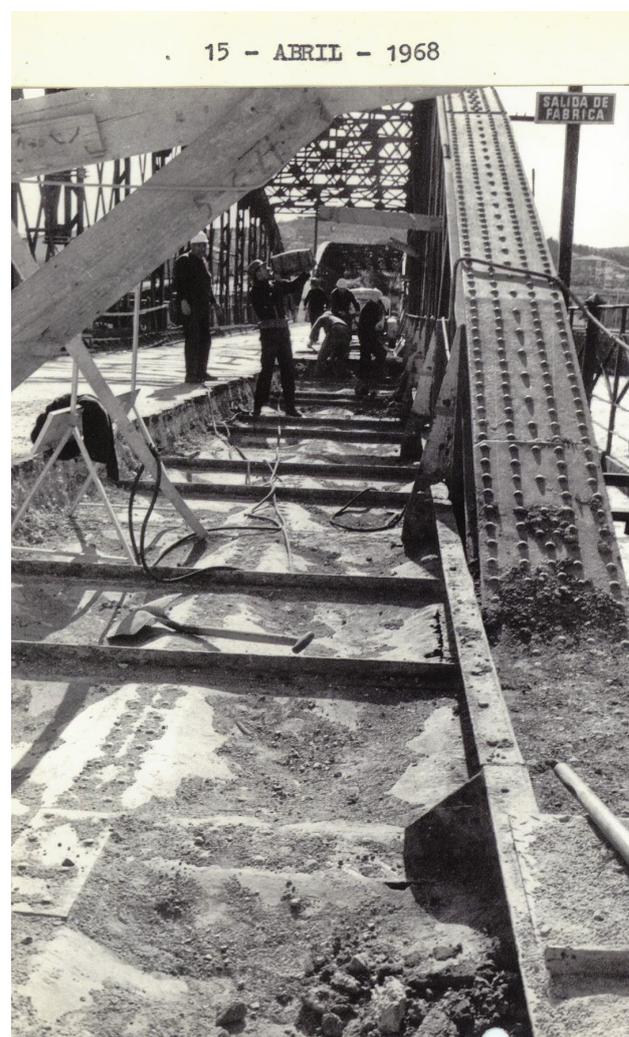
It analyzed for the first time the conditions of resistance and stability and looked for a solution to reactivate the turn of the mobile section, although finally it was blocked. To know the resistant characteristics, a load test was carried out, and it was observed that in all the sections the deflection produced (3 mm in the mobile and 12.5 mm in the fixed ones) recovered completely, from which it was deduced that the stresses were in elastic period. A chemical analysis of the steel of the bridge determined that the material was easily weldable by any procedure, and thus all the unions intervened, of more than half, were repaired. The stiffness of the diagonals was also increased by welding them a metal sheet because they were considered to be very slender and, in addition, they produced a lot of noise when the vehicles passed, causing them to vibrate and clash. The broken vaults were reinforced by adding pieces of sheet metal. And the slab made of planks of the board was replaced by another one made of steel sheet, and the sidewalks also of wood by others of 8 mm fluted sheet with an asphalt layer. The drainage was also improved and the entire metal structure was painted. The trace of this intervention has been observed and valued in the current intervention.

Figure 3.  
*The repair of the year 1968*

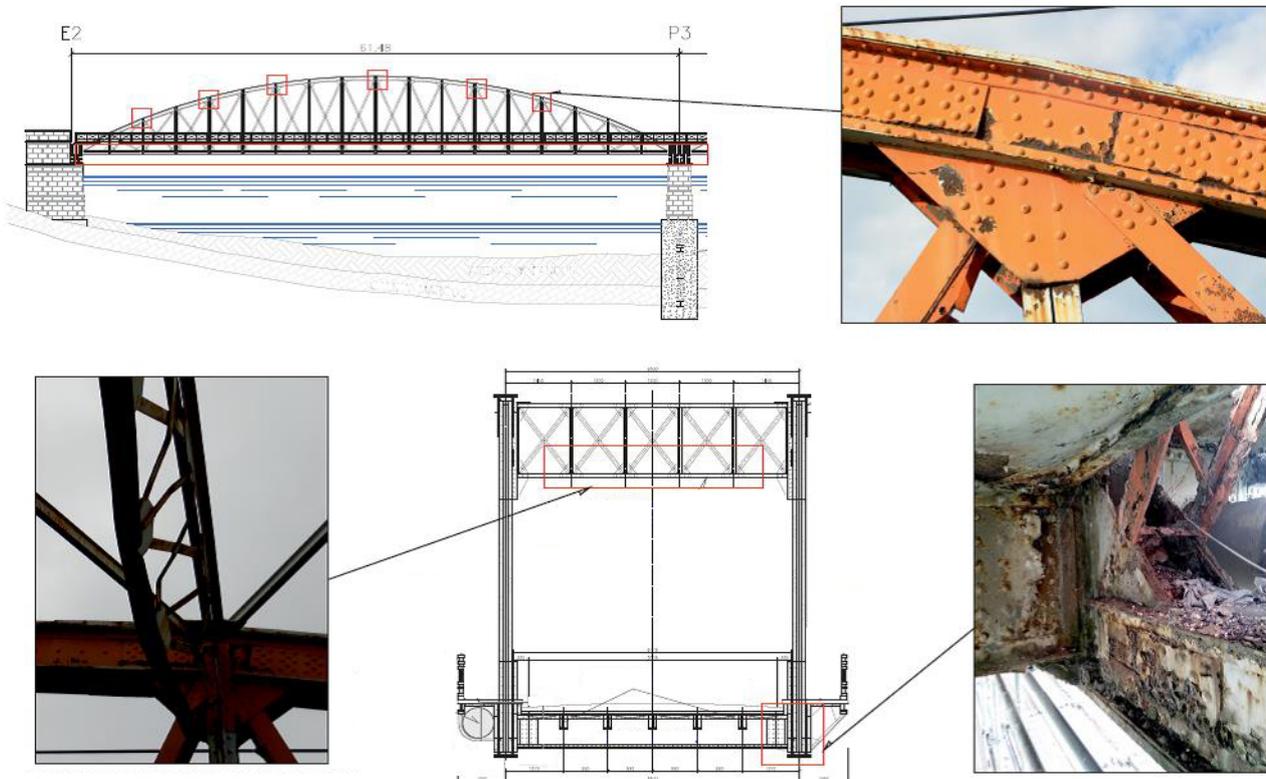
- Corrosion, up to breaking, in numerous elements of the structure, highlighting the connections between upright and diagonals, between ties, between joists and main beams. It is a generalized damage caused by the deterioration and / or absence of surface protection, and serious because it endangers the safety of inaccessible pieces. At the meeting points of the elements,

water accumulates easily, which intensifies corrosion, deteriorating the rivets and gussets and decreasing the strength of the joint. The same and with similar consequences has happened in the metal sheets that make up the support slab of the padding of the platform.

Figure 4.  
Corrosion in metallic elements. Situation of the arch.

Thus, all the lower knots of the transverse-tie and lower-upstright were reinforced in the fixed sections of the arches, as well as 32 upper knots in the upper-tie upstright connection. In the diagonals of the arches, all the unnecessary link lattices were removed, placed in previous repairs, getting back the transparency that it had in its original form. All upper bracing lattices between arches and 16 vertical struts have been replaced. In the case of the mobile section, the longitudinal beams and transverse beams have been reinforced.

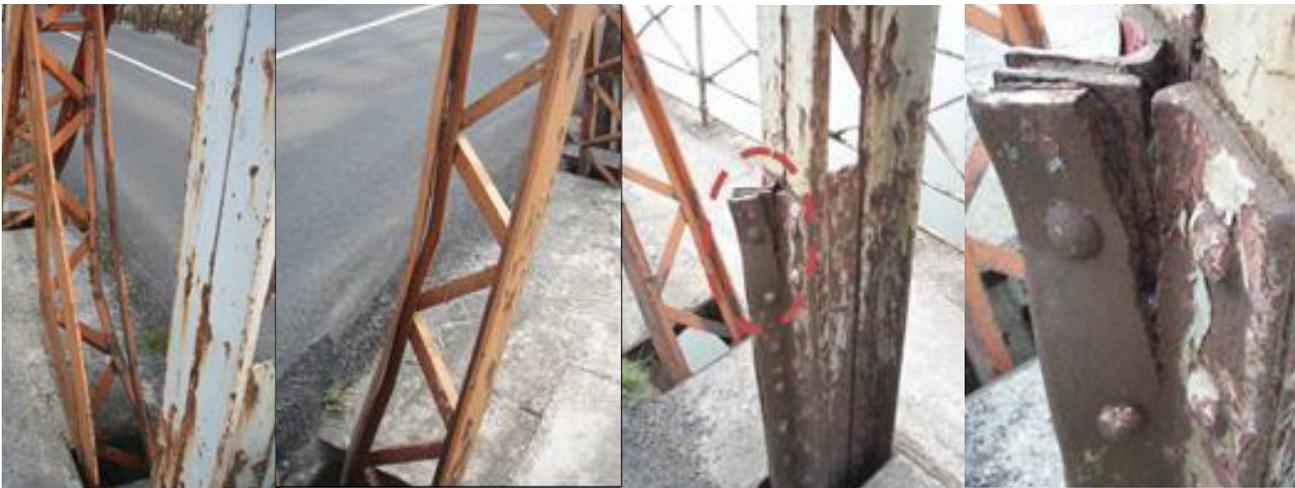
Figure 5.  
*Deformations and breaks due to impacts*

- Cavities in the floor, under the buttress.
- The damage caused by the use of the bridge are:
- Deformations in diagonals and upstright caused by vehicle impacts. The typology of the bridge, the scarce horizontal gauge and the absence of protection elements explain the numerous collisions that have occurred, leading to the breakage of elements (brackets, diagonals).
  - Bulges and displacements in masonry parapets of buttress.
  - Breakage of parapets and slab
  - Leaks

It has been verified the good functioning of the posts, which have not been replaced except those hit or those that have lost a lot of section. The lower part of them, usually deteriorated, has been reinforced by providing two "U" profiles in the anchoring areas of the transverse stringer.

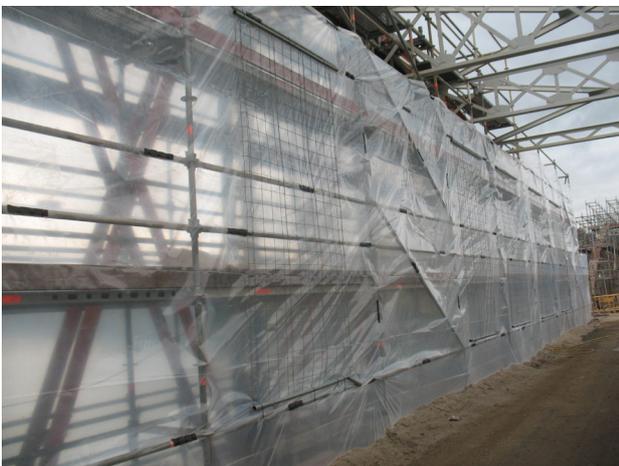
Figure 6.  
View of the encapsulated scaffold

For this, a scaffolding encapsulation system was designed, in sequential advance, consisting of an outer heat shrinkable plastic sheet that surrounds the scaffolding and a tarpaulin that wraps the upper face of the lower parts of the scaffolding, forming an enclosure to accumulate the waste generated in this cleaning operation<sup>14</sup>.

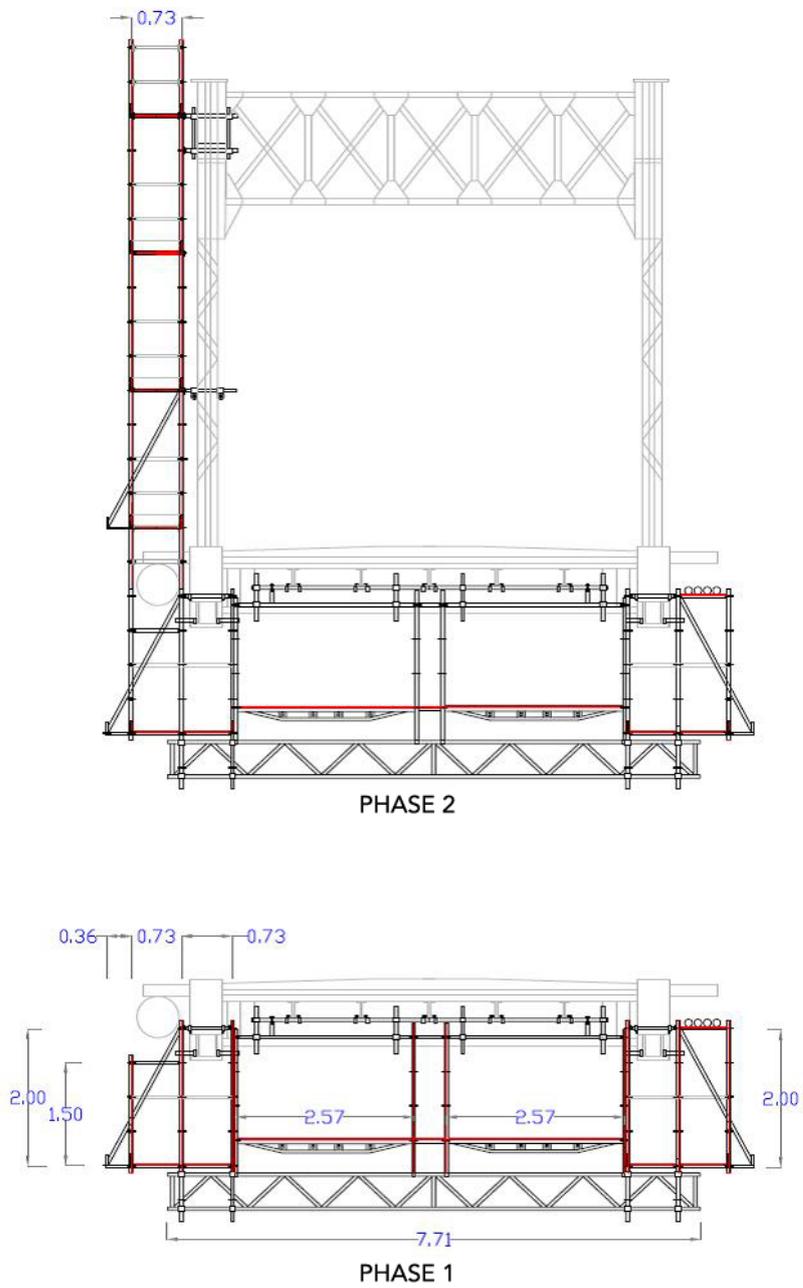
Figure 7.  
Modular scaffold Allround System by Layher

It was necessary to have a working platform under the bridge deck, which was made using modules of the Allround system by Layher. It was placed suspended from the deck by vertical tubes and anchored to it. It configured a scaffold that in addition to the suspended platform had four levels of modules placed on the outside of the arches.

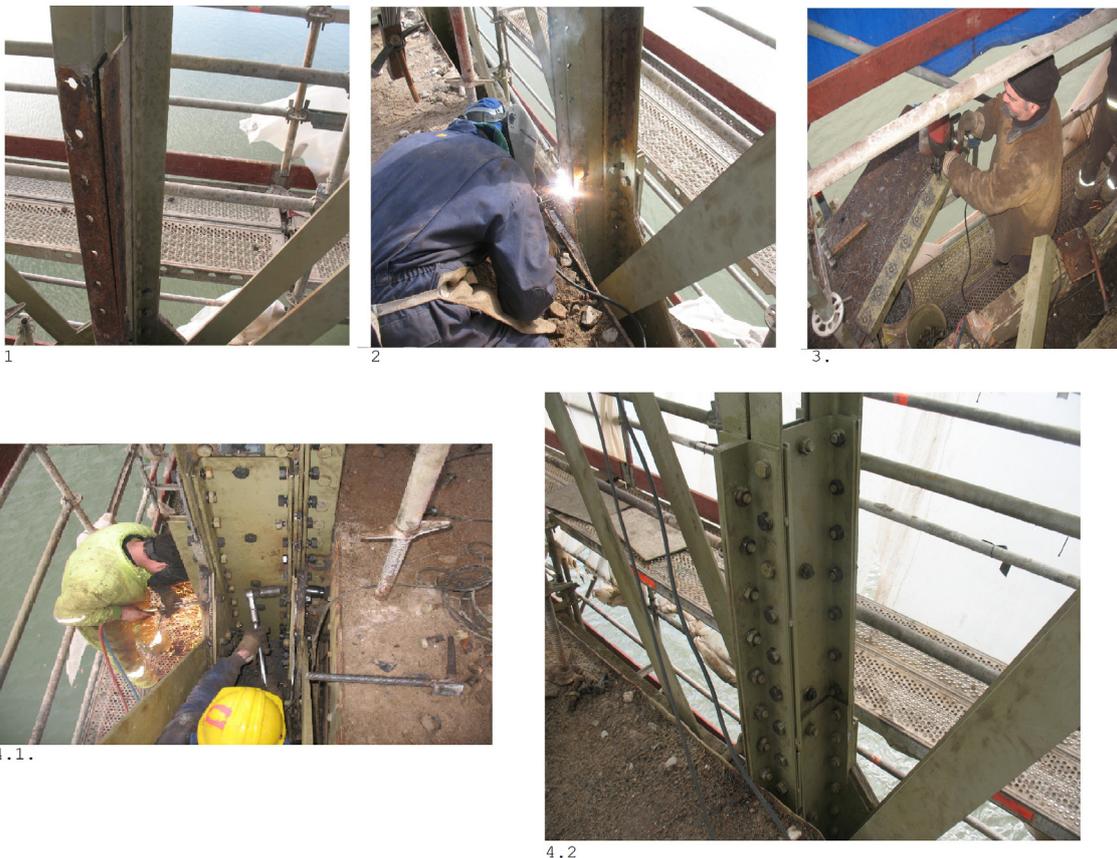
**Figure 8.**

*Angular reinforcement process: 1. removal, 2. installation, 3. welding, 4. strengthening parts*

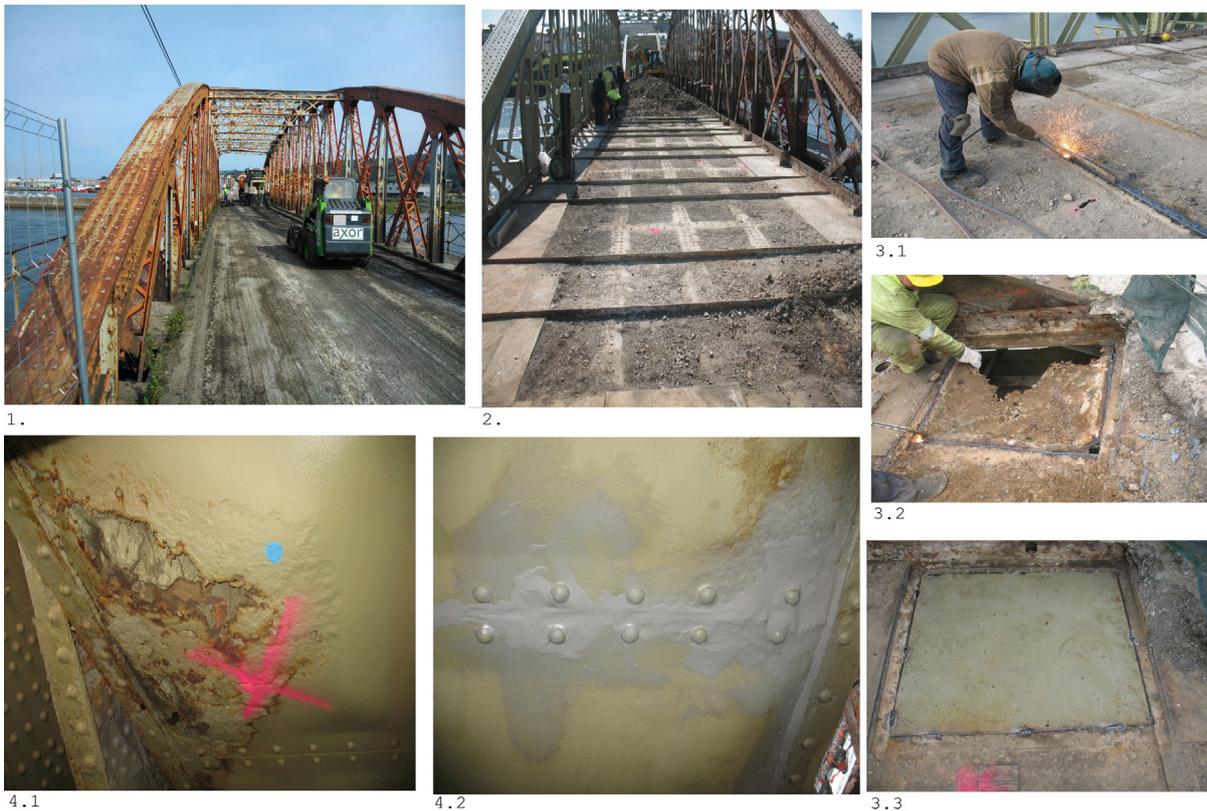
**Figure 9.**

*Deck repair process: 1. 2. removal road surface, 3. 4. replacement and/or repair of small vaults*

The actions on the platform began with the elimination (up to 44 cm thick) of the existing agglomerate on the metallic vaults (8 mm thick sheet) that make up the framework between transverse and longitudinal beams of the deck, which constitute a typological

singularity of this bridge. After the milling of the entire layer of the firm, the slab of the fixed sections of the bridge was analyzed. Based on the results of the structural analysis, a reinforced concrete slab (HA30 / B / 20 / IIIa) with nominal top face coating of 35 mm and a crack opening limit of 0.2 mm was executed. The slab is placed concreted on the original vaults and works without connection to the metallic structure except for the head of the transverse beams to which it is connected by two rows of connectors.

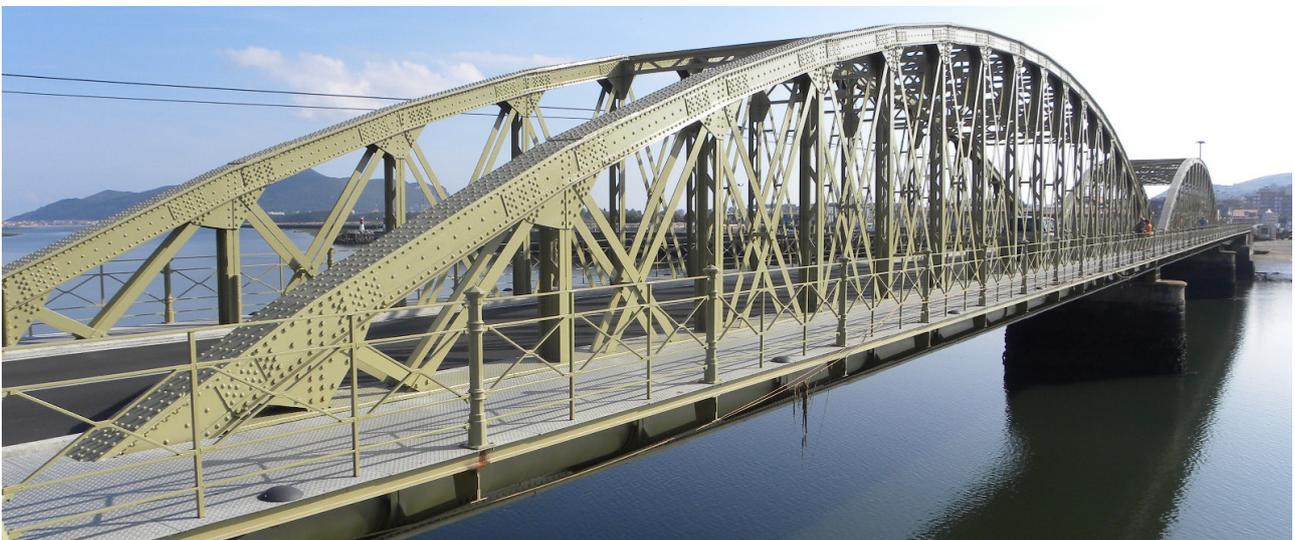
Figure 10.  
Current status of the refurbished stretches

The entire surface of the sanitized metal structure has been protected with a coating system resistant to the marine environment, with thickness between  $280\mu$  and  $400\mu$ , which involves the following steps: sealing of the joints capable of retaining water by means of a sealing bead and a thixotropic adhesive, a component based on polyurethane, of permanent elasticity and fast curing (Sikaflex 11FC); to improve the appearance of the surfaces, thicknesses are recovered with a special putty formed by a thixotropic structural adhesive, bicomponent based on epoxy resins without solvents and selected fillers (Betopox 920P Propamsa); degreasing with application of a solvent and cleaning with absorbent rags of the residual cutting oil and burned areas; mechanical and manual brushing of the welds, returning to sandblast the rusted areas and repainting; To eliminate the
