Learning from failures in an emblematic building in Valencia, Spain

Jose M. Adam*, Manuel Buitrago

ICITECH, Universitat Politècnica de València. Camino de Vera s/n, 46022 Valencia, Spain

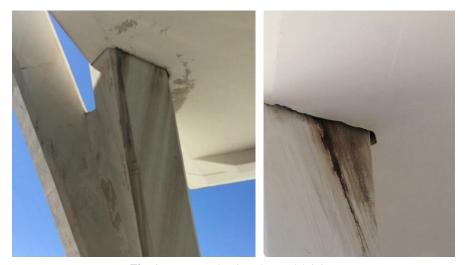
Some damp patches can be seen in column-slab joints in Fig.5. These joints have the special characteristic that the columns are not actually connected to the slab and their insufficient waterproofing means that the rain running down the columns creates these stains. Damp patches can also be found in some wall-slab joints, such as those in Fig.6, or where stairs are joined to slabs, as seen in Fig.7.

Fig. 1. Damp patches in column-slab joints

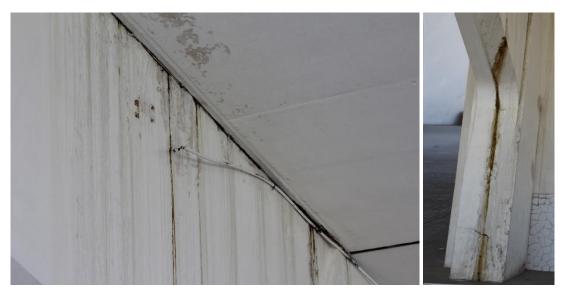
Fig. 2. Damp in wall-slab joint (left) and on base of wall (right)

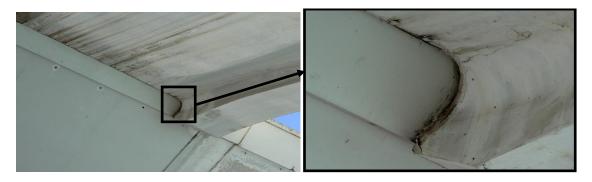
Fig. 3. Damp in stairs-slab joint (left) with detail of most affected zone (right)

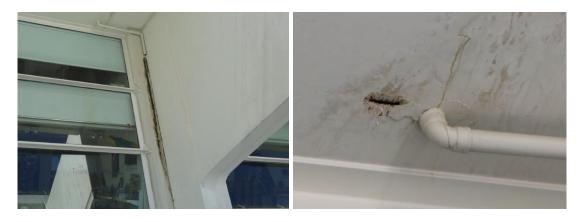
Damp can also be seen close to some waste water pipes (see Fig.8). The position of some down-pipes allows the rain to run down the concrete surfaces, leaving stains, with subsequent aesthetic and durability problems.

Fig.8. Deficient rain drainage on exterior wall. Generation of aesthetic defects (left) and corrosion of reinforcement (right)

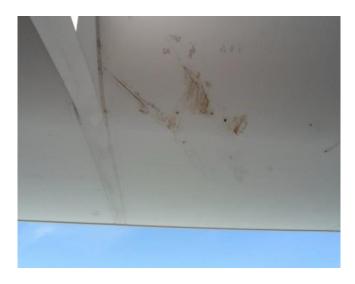
There is a general problem of damp in the concrete facings and is not only found in the cases cited above. Many cracks have appeared on surface elements such as reinforced slabs and walls accompanied by the presence of dampness. Fig.9 shows a floor slab with cracks through which rain has leaked. The rainwater has dissolved oxide from the reinforcement and left stains on the surface of the concrete. Fig.10 shows another slab zone where rainwater has passed through the cracks leaving calcium carbonate deposits similar to the stalactites found in underground caves.

Fig.9. Rust stains due to water leaking through a floor slab

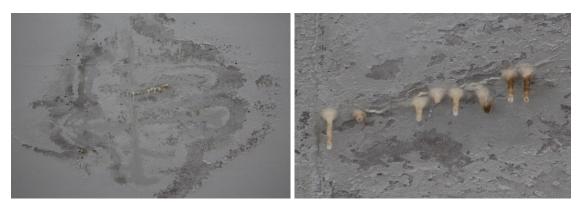
Fig. 10. Calcium carbonate deposits in the form of "stalactites"

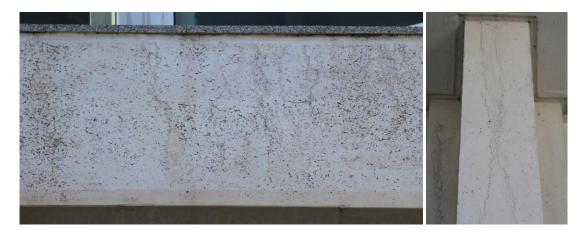
Fig. 11 shows surface pores in a cornice and column, due in both cases to shortcomings in the construction phase. Both these elements are inclined at an angle of less than 90° to the horizontal. The presence of pores in Fig. 11 (left) is due to the inadequate contact of the fresh concrete with the formwork. Because of the inclination of the formwork, the pressure of the concrete on the formwork may have been low, allowing air bubbles to form between both these elements. On the other hand, Fig. 11 (right) shows a defect that is repeated in almost all the columns along one façade and that appears to be due to a formwork problem that left pores on one of the column faces.

Fig.11. Surface pores in cornices (left) and columns (right)

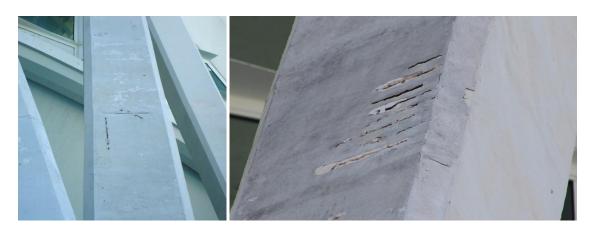
The presence of corrosion has been detected in the reinforcement of many elements and zones of the building. For example, Fig.12 shows the result of corroded reinforcement in a column due to insufficient concrete cover. These situations need to be repaired, as corroded reinforcement causes the steel to swell, which in turn causes peeling of the concrete cover. This type of damage can have serious effects on structural durability due to the building being little more than 1 km from the sea.

Fig. 12. Corrosion of column reinforcement

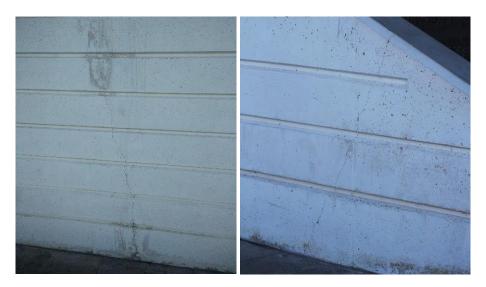
One of the defects that appear repeatedly on the external reinforced concrete walls of the museum is due to early age thermal cracking of the concrete, which causes cracks starting from the base. Due to the cement hydration reactions shortly after pouring, the temperature rises in the concrete and when it cools down again it tends to contract. However, as the contraction is

constrained at the base of the wall due to the foundations, the tensile forces caused by this effect are transformed into cracks such as those shown in Fig.13.

Fig.13. Early age thermal cracking in a wall

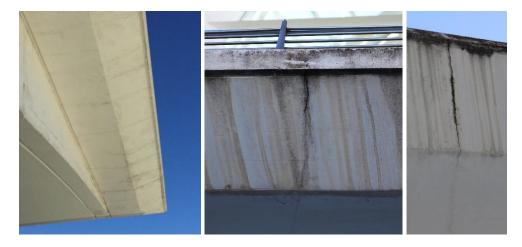
Some of the cornices present cracks perpendicular to the edge, as shown in Fig.14. As these are quite wide, they are highly visible. Considering the dimensions of these elements and the position of the cracks, concrete shrinkage can be considered as a likely cause. Since these types of crack can be deep, the structure's durability may be significantly affected.

Fig.14. Cracked cornices

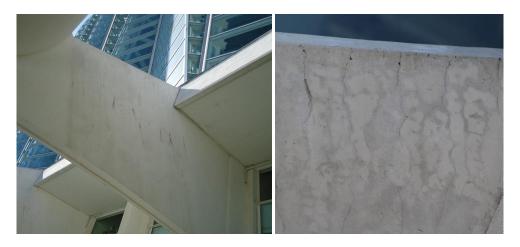
In one of the building's façades there are large concrete slabs resting on cantilever beams, as seen in Fig.15 (left). The entire volume of these beams presents a serious degree of cracking,

which is due to negative bending moments in their upper face. In many cases the cracks are accompanied by rust stains. The cracks are also considerably wide and, in some cases, reach to more than half the depth of the beam. Apart from their effects on the structure, these cracks can also seriously reduce the durability of the concrete and its reinforcement.

Fig.15. Cracks in cantilever beams

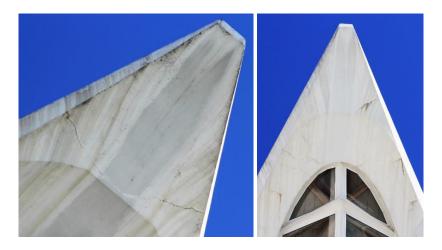
Another type of cracking can be seen in the cantilevered deck, as shown in Fig.16. These cracks can be seen from the ground, which gives an idea of their size, which clearly compromises the structure's service life. Some of the cracks have damp patches due to the penetration of rain water.

Fig.16. Cracks in the deck cantilever

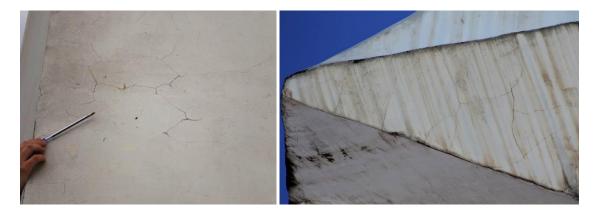
Some concrete surfaces show the effects of what is known as "map cracking" (see Fig.17), which can appear in very young concrete due to the evaporation of its water content after pouring,

possibly followed by inadequate curing. Although the cracks thus formed are normally shallow and are not serious, they can affect structural durability.

Fig.17. Map cracking

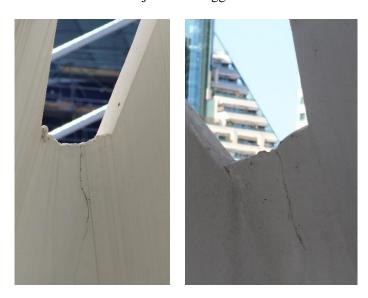
Fig. 18 shows a view of cracks in the joint between two columns on the front of the building. The columns are not vertical and meet over the foundations. The compressive load on the columns generates horizontal tensile forces in the joint and triggers the vertical cracks seen in Fig.18.

Fig.18. Cracks at the point where two columns meet

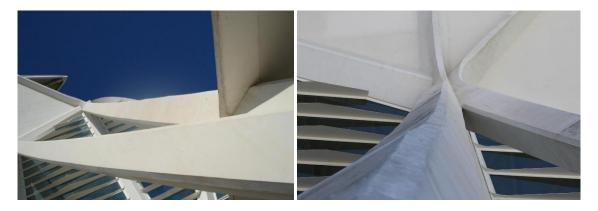
There are ten out-of-vertical columns at the front and back of the building which can be seen with the naked eye to be deformed with respect to their axes (Fig.19). The reason for this deformation is unclear and would require an in-depth study. Plausible causes could include

formwork distortion during the construction of the columns or the columns' own self-weight.

Under heavy compressive loads, this deformation could generate load eccentricity that would increase the bending moment on the column.

Fig.19. Deformation of columns at front and rear of the building.

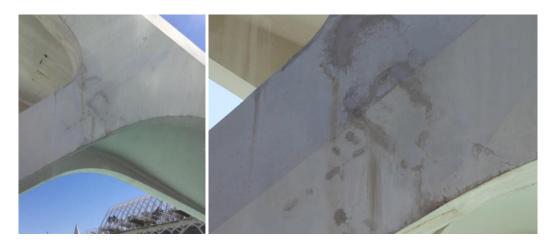
After the successive visits authors did, many local repairs were seen to have been carried out in form of patching with mortar. Fig.20 shows some examples on concrete surfaces, others can be seen on inter-column joints in Fig.21, while Fig.22 shows a view of mortar patches on columns. However, some of these repairs have not been effective, since the mortar applied has become separated from the concrete surface.

Fig. 20. Patching of concrete surfaces

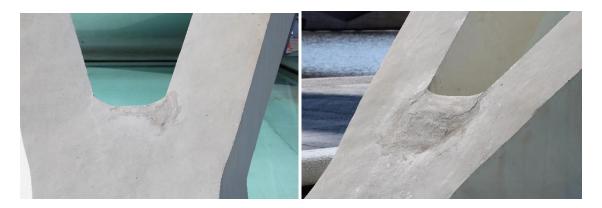
Fig. 21. Repairs with mortar on inter-column joint
