## UNDERSTANDING SPANISH TIMBER JACK ARCH FLOORS, EXAMPLES OF ASSESSMENT AND CONSERVATION ISSUES

Jack arch floor, timber, grading, on-site assessment, UNI 11119, Valencian Community.

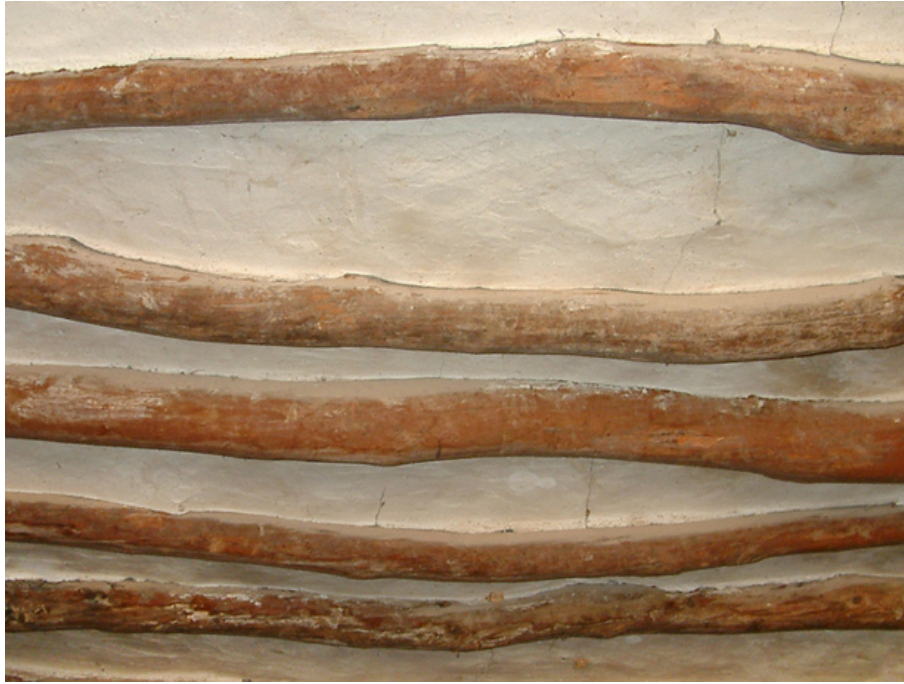
The most basic kind of joist is the bare trunk of a tree, simply debarked. In this case the bark is peeled and the branches cut so that on the surface it is possible to clearly see knots and grain. Usually the upper surface of these round joists is hit with a small hatchet in order to produce carvings that would improve the grip of the vaults, normally made of plaster conglomerate. The bottom exposed surface is generally coarse; however, at times these joists are smoothed or sanded to improve their appearance and in very few cases small longitudinal recesses are carved along the joist as a sort of decoration. This variant of joists is widely diffused in all kind of rural buildings and in houses located in small towns. Occasionally, because of the poor knowledge and skills of the constructors, they do not cut off the bark from the trunks before using them or they select twisted elements, unfitted for construction, producing unfortunate structures (Figure 4).

Figure 4.  
Twisted joists used as structural element in a homestead near Elda (Alicante)

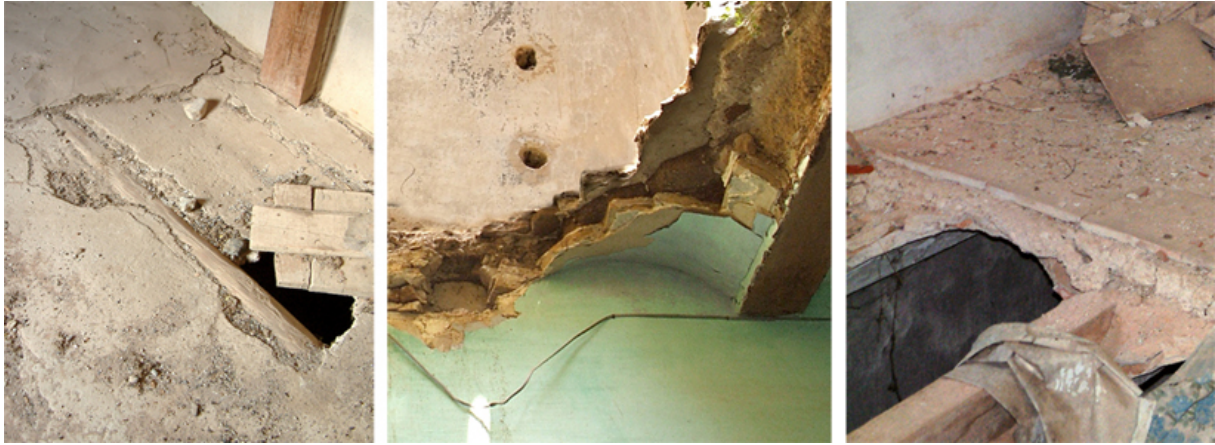
Figure 6.

usually the cause of the collapse because the reduced section of wood near the wall is not enough to tolerate the shear stress. Furthermore, when moisture is absorbed by the plaster vaults they become heavier and their mechanical properties are partially reduced triggering the disintegration and collapse of the vaults.

Three examples of collapsed structures where it is possible to appreciate both the coplanar condition of the joist and vault extradoses and the reduced thickness of the floor; buildings near Cabanes (Castellón de la Plana), Albalat de la Ribera and Gandía (both Valencia)

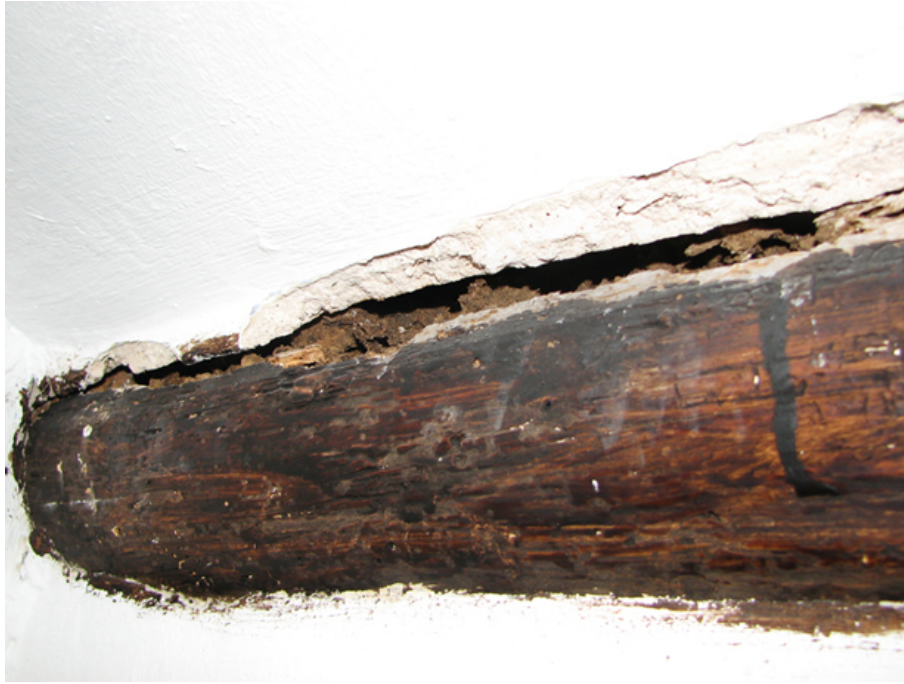
Finally, the joists may have a more or less relevant attack of wood boring insects, of the family of *Anobiidae* from the *Coleoptera* order and/or of the families of the *Cerambycidae* and *Curculionida*, but a part from a superficial reduction of one or few centimeters, these do not usually represent a problem for the structure if not in combination with other decays as frequently their attacks are not ongoing. Moreover, the superficial deterioration caused by their attack and detectable through the observation of the numerous holes on the surface of the wood, is often greatly overestimated; on the contrary the hidden damage caused by rot or termites can be dangerously underestimate as they are undetectable by a superficial untrained overview.

Figure 10.  
Degradation of the surface between the timber and the vaults caused by wood boring insects  
(Marquees of Benicarló's Palace, Benicarló, Castellón de la Plana)

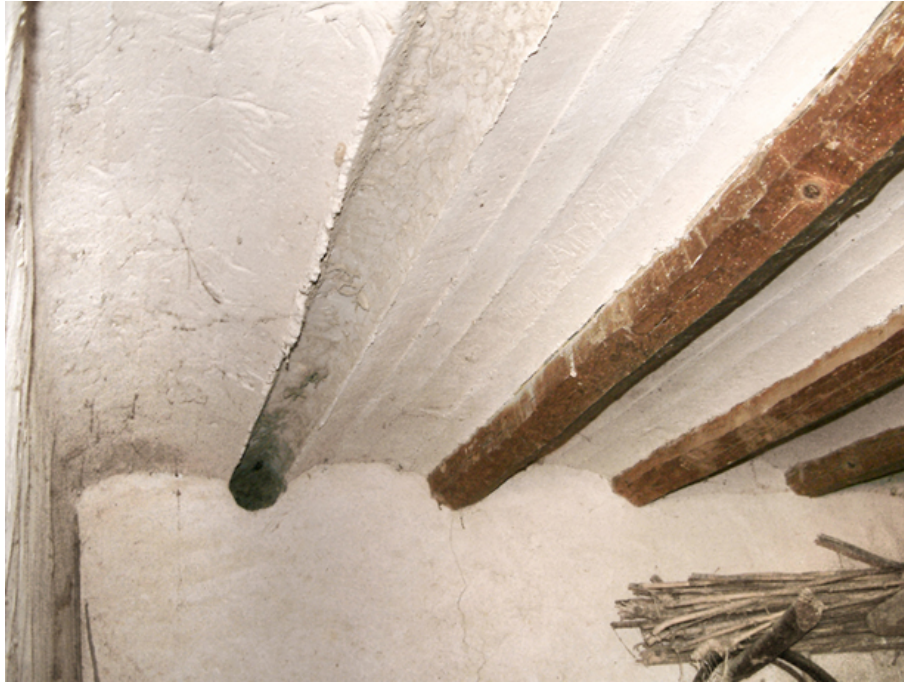
Figure 11.

The mentioned decays may cause a severe damage to the structure and a drastic reduction of the joist's section. As both termites and rot usually develop in concealed areas characterized by high moisture content, a thorough inspection is necessary to detect these problems because not always is possible to foresee how they will affect the structure (Figure 11).

Throughout the vaulted structure, especially in the case of plaster vaults, the forces distribute peculiarly, and it cannot be predicted how the structure will respond to a significant decrease of the joists' section. Even if the severe damage would need to be repaired, sometimes the structure collapses and sometimes stands confirming the structural properties of plaster (Vegas et al., 2013) and meaning that there might be no external visible indicators of the pathological process acting on the timber, therefore underlining once more the importance of a close inspection.

Jack arch structure with a missing joist, the plaster vaults are still standing even with the absence of an entire joist (homestead near Cabanes, Castellón de la Plana)

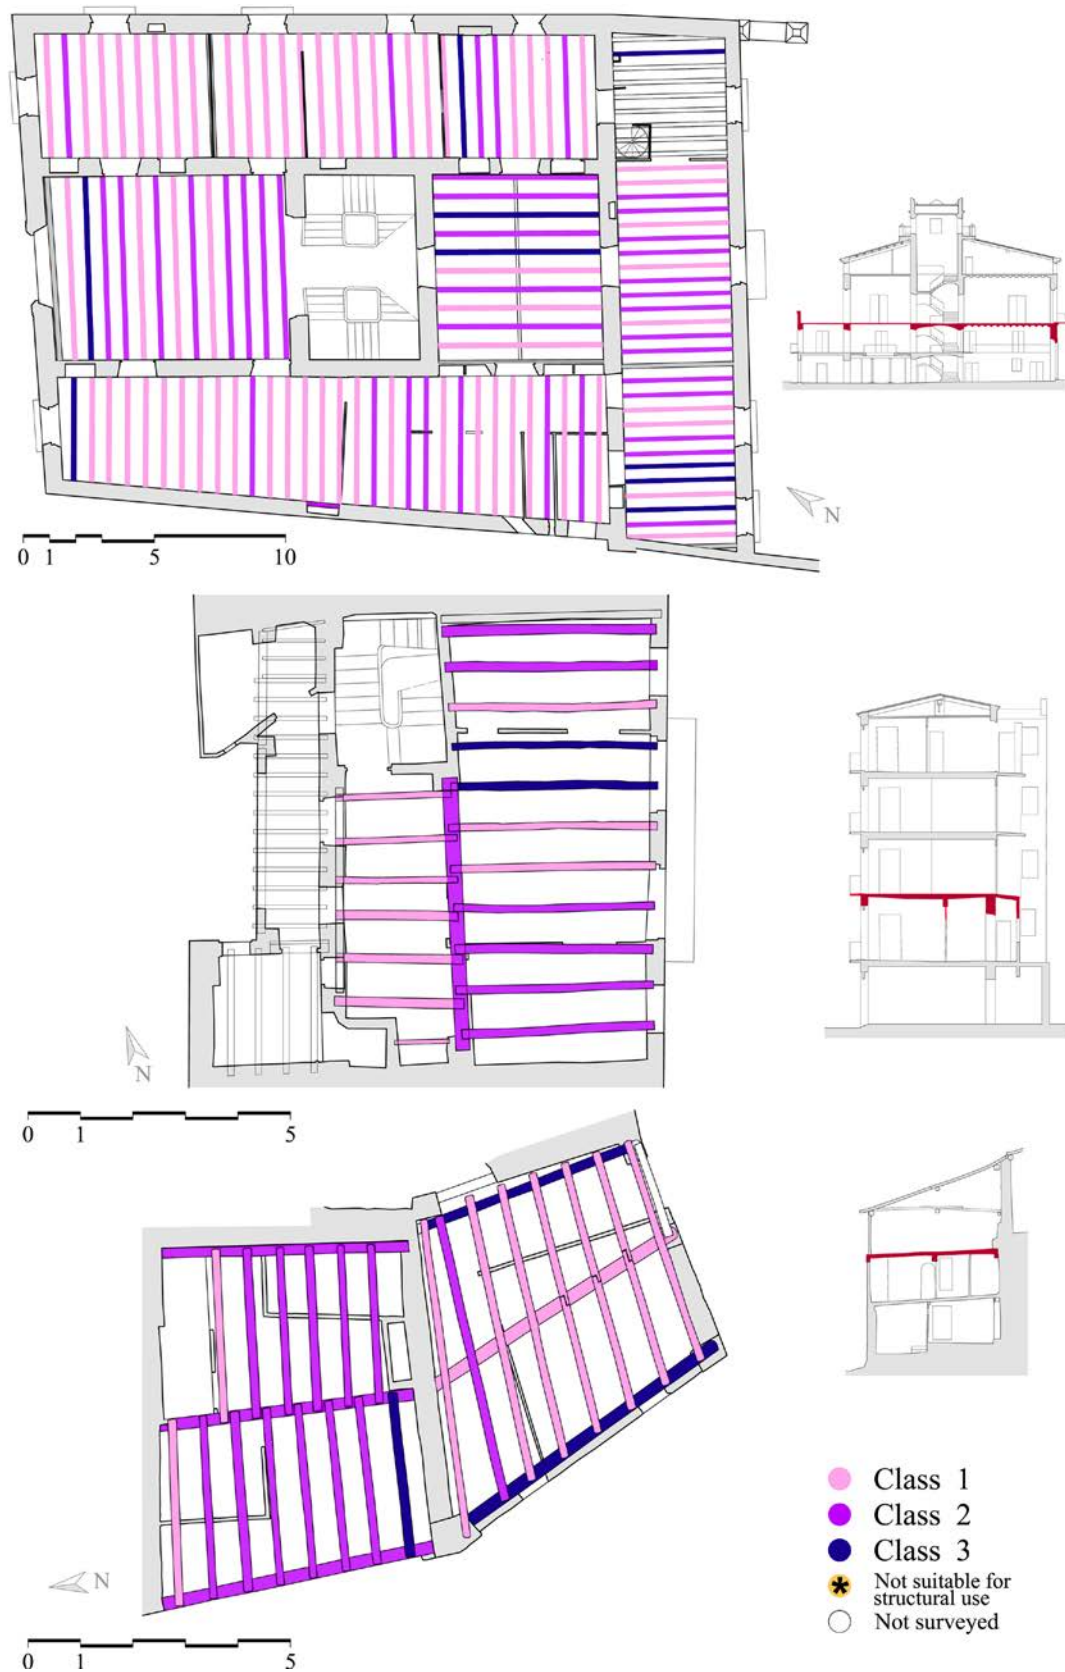
On the one hand, these codes have been marked in the floor plans of the buildings and on the other hand a table has been prepared for each structural element in order to collect all the data gathered both for the assessment and the grading (Figure 14). On this table, the dimensions of the element, the presence and size of wood singularities and defects as well as observations and tests done on the element were measured and registered on-site. Performed tests were moisture content measurement by means of a portable hygrometer and resistographic drills to check the possible presence of inner decays (Lear, et al., 2010). The information of the tables was put together in one chart and elaborated. The result is the structural grading of each identified element according to the Italian standard and the assignation of one of the three strength classes or the denomination of "not suitable for structural use". Finally the grading was reflected on the plans of the buildings with a color code.

Figure 15.  
Plans of the graded structures: Marquees of Benicarló's Palace (Benicarló, Castellón de la Plana), urban building in Valencia and vernacular building in Sesga (Ademuz, Valencia)
