2 Wind turbine tower collapse due to flange failure: FEM 3 and DOE analyses

9 ABSTRACT

96 In October 2008, two months after being out into operation, one of the *Abuela de Santa Ana* wind
97 turbine towers collapsed due to a catastrophic failure in the lower flange fixed to the foundations. An
98 on-site inspection of the damage was made the following day.

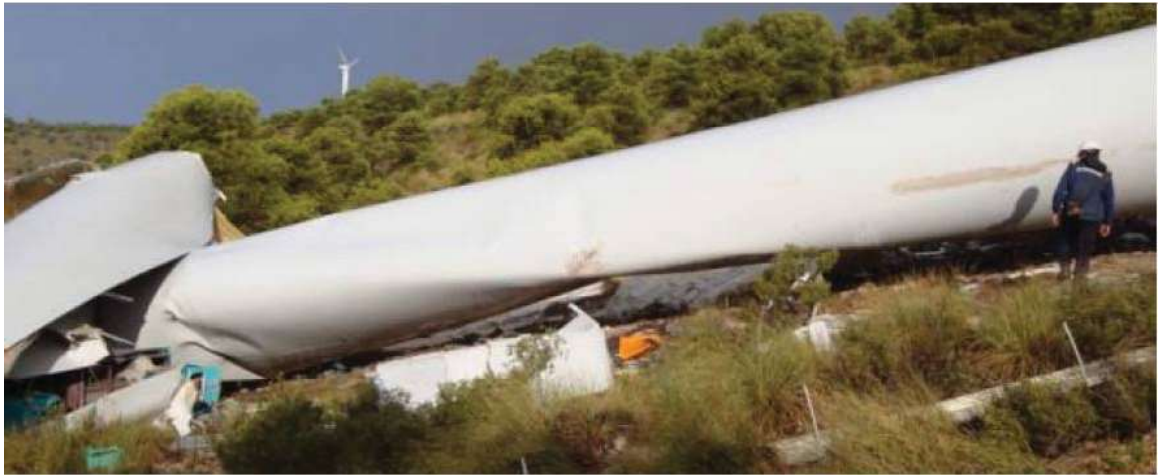
Fig. 3. View of the tower the day after collapsing

99 Firstly, the joint between the tower and the nacelle was seen to be in good condition with no evidence
100 of damage at this location having caused the failure. Secondly, the steel tube was buckled, as can be
101 seen in Fig. 3. Thirdly, the blades were seen to have damaged the steel tubes during the fall. After the
102 inspection, the most probable cause was therefore identified as the failure of the base of the tower,
103 which was made the focus of future tests to find the definite cause of the collapse.

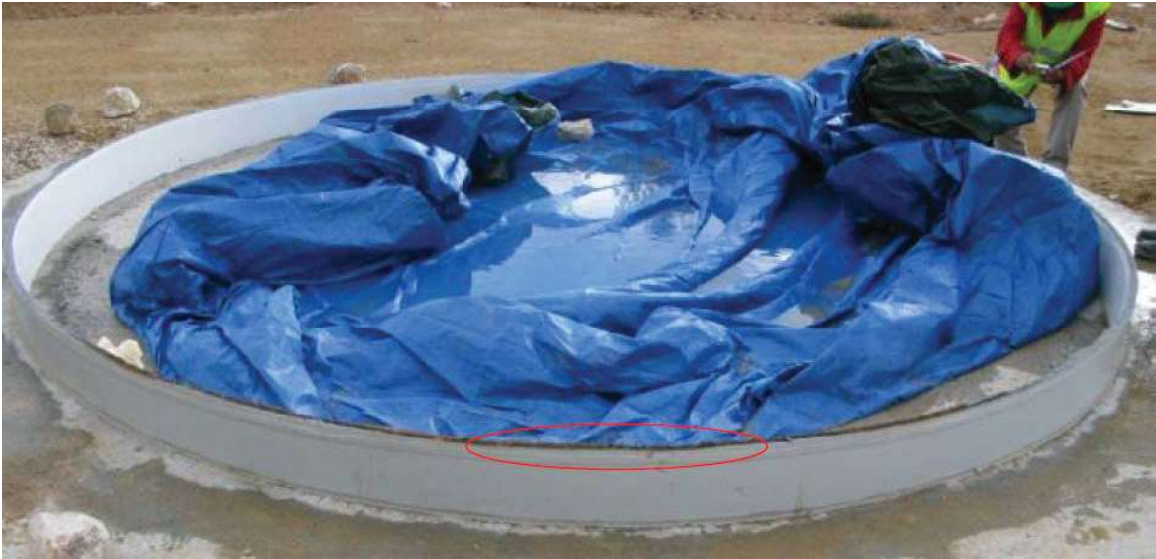
Fig. 4. View of the section in which the failure began

105 After the base had been analyzed in greater detail, the failure was located in the lower flange. This
106 component had been built from a bar of rectangular cross-section, curved and welded S-355-J2 steel

110 The damaged zone (See Fig.4) showed signs of corrosion, which would later be analyzed to identify
111 the type of failure and its causes. This section was covered with a plastic sheet in order to keep these
112 zones intact and avoid any deterioration in the material due to the weather subsequent to the collapse
113 that could possibly lead to errors in the conclusions of the analysis.

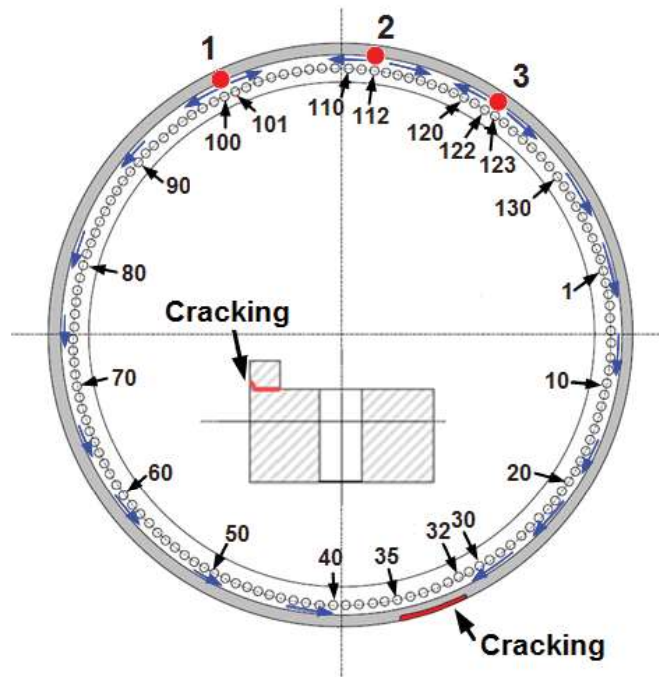
Fig. 5. Detail of the flange and position of the cracks

120 A scheme of the flange studied in this work can be seen in Fig. 5. The flange had been positioned in
121 order of the drill holes numbered from 1 to 138, number 1 being at the centre of the lower tower access
122 door. The broken section to be studied in detail was joined to the flange whose scheme is shown in Fig.
123 5.

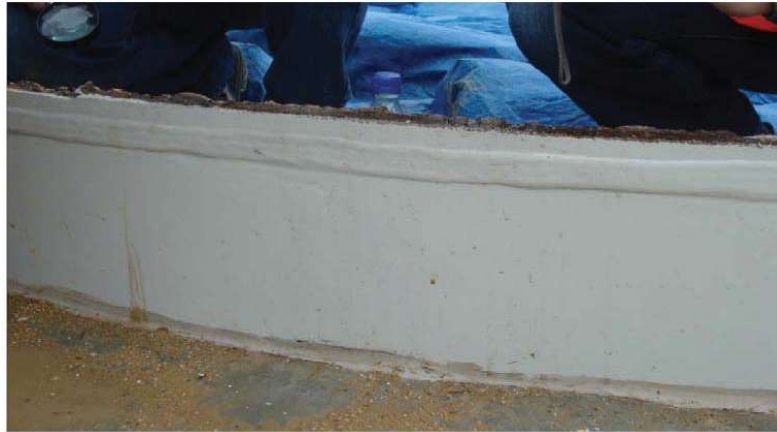
(a)

125 The broken section was found to have started and propagated in the base of the flange neck (see Fig.6a).
126 In photographs taken days after the collapse, various cracks were located in the flange cross-section, as
127 can be seen in Fig. 6:

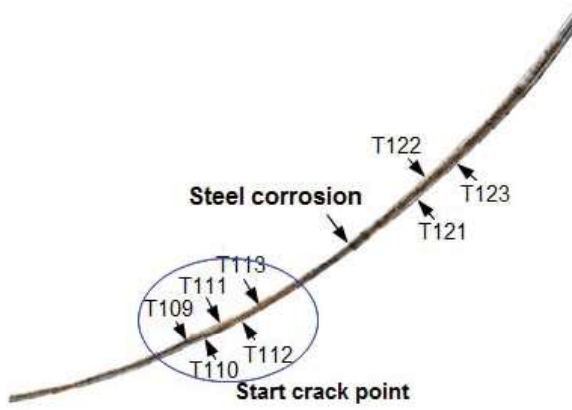
(b)

- 128 - The initial crack was located between drill holes 100 and 130 (see Fig.6c)
- 129 - Between drill holes 109 and 123 black and blue rust stains were observed (see Fig.6b). These
130 stains were visible in the on-site inspection and were thus assumed to exist before the collapse
131 of the structure.

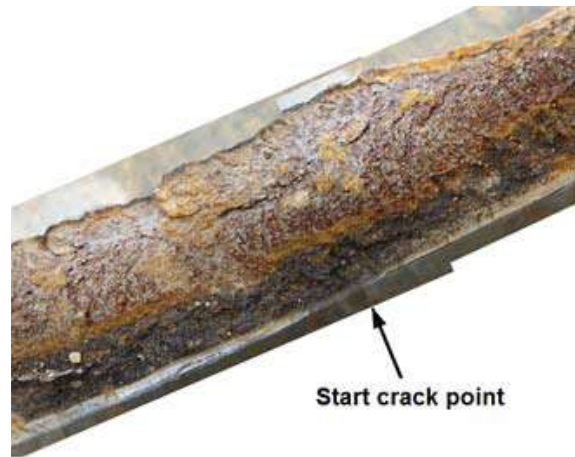
(c)

141 The detailed analysis of the oxides found in the damaged section included a large amount of blue oxides
142 organized into bands or groups of points (see Fig. 6c and Fig. 7) characteristic of the so-called *blue*

143 *brittleness* or *brittle martensite*. The former is often found in most steels and is due to the transformation
144 of austenite into cementite at the grain boundaries when the material is subjected to temperatures around
145 300° C. The decomposition of the austenite seriously reduces the toughness of the material. This type
146 of brittleness is accentuated by the segregation of impurities at the grain boundary, which promotes the
147 intergranular breaks typical of brittle fractures [19] and [20]. Some authors have observed that blue
148 brittleness when combined with corrosion cracks can cause disastrous failures in steel components [21–
149 23].

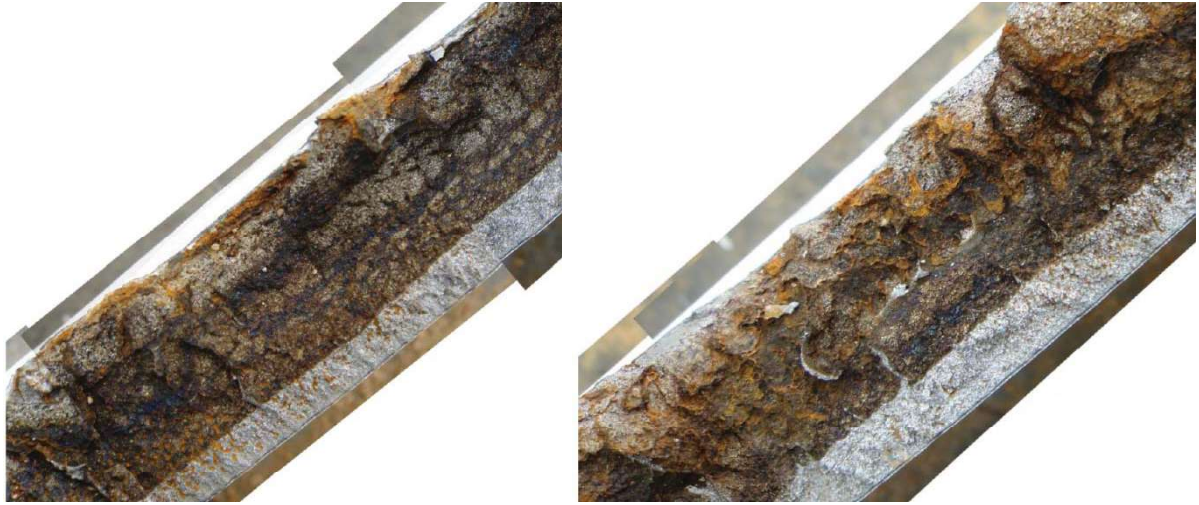
Fig. 7. Detail of the broken flange section

410 The presence of blue oxides in the fracture zone indicated the possibility of a defect in the manufacture
411 of the element. To verify this, experimental tests were carried out on the toughness of the steel used in
412 the tower and showed that the steel did not meet the requirements of the resilience test. The steel was
413 shown to have very low toughness and was not suitable for use in the structure.

444 In the present case, the failure could have been avoided if the material used in the flange had been
445 subjected to the appropriate quality control (toughness test). It could also have been avoided had the
446 flange been better designed to remove the maximum service stress away from the zone affected by the
447 welding, e.g. with a larger chord radius and longer neck.

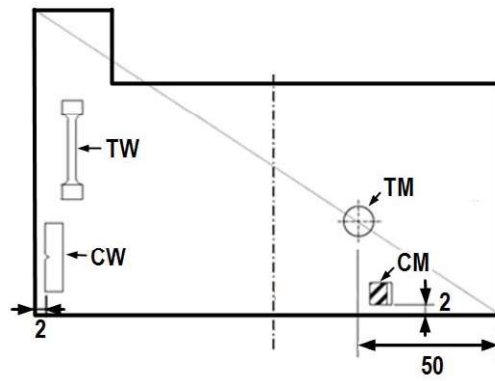
Fig. 9. Detail of the specimen extraction zone [23]

168 In view of the type of failure discovered in the flange, close to the welded zone, the material was
169 analyzed to obtain the fracture toughness parameters. Three Charpy specimens were extracted from the
170 flange between drill holes 112 and 114, as shown in Fig. 9 [24].

179 Since the value was below the 27 J given in the EN10025-3 Code [18], it was therefore concluded that
 180 the fracture toughness of the material was unsatisfactory in all directions. In view of these results, a
 181 serious weakness was identified in the material that could have been responsible for unforeseeable
 182 failures in the behavior of the structure. The experimental results show that the material does not possess
 183 the properties required by the current code and this anomaly could have caused the abnormal behavior
 184 of the structure that had not been considered in its design.

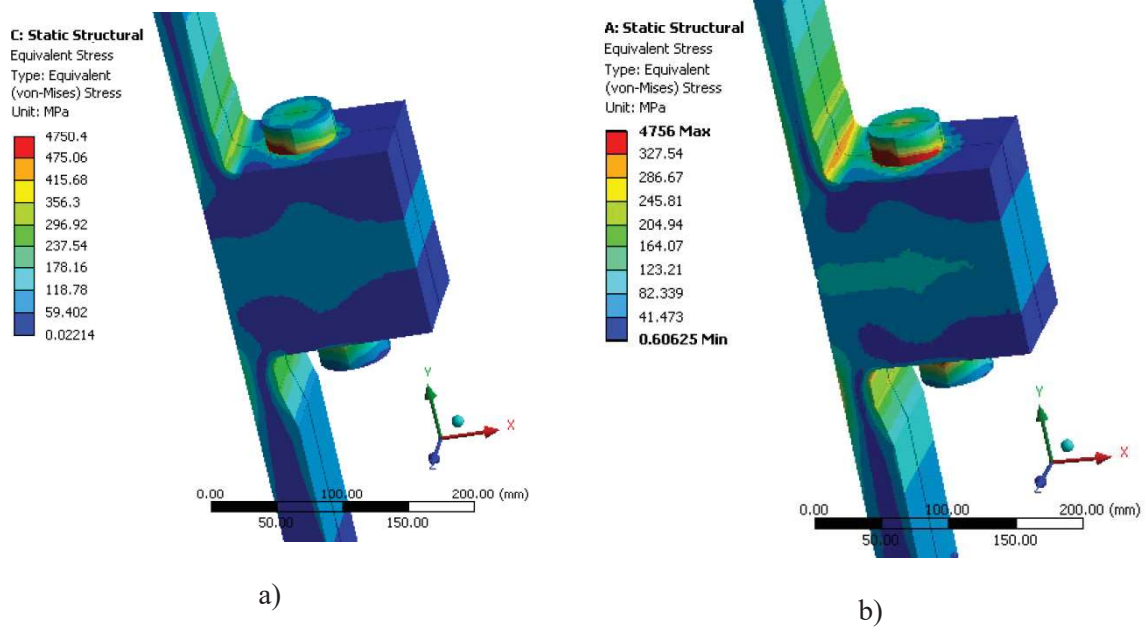
Fig. 14. FEM model results, equivalent Von-Mises stress. a) applying bolt pretension only (in Pa); b) for all applied loads (in Pa)

326 The results obtained from the numerical simulations provided interesting information for an exhaustive
327 analysis of the tower failure. On analyzing the stresses in the joint it was seen that the prestressing of
328 the bolts, before considering the other loads, exerts high forces on the joint, as can be seen in Fig. 14a,
329 since the flange steel’s yield strength is exceeded. As a result, the flange is already in a highly stressed
330 state even before the other loads on the structure are taken into account.

331 After applying loads on the structure, the numerical model showed a high concentration of stresses on
332 the flange neck that coincided with the point of the failure observed in the visual inspection. After
333 analyzing the results of the numerical model, it is shown that the Maximum Von-Mises stress exceeded
334 the material’s yield strength (see Fig.14b).
