FIRST APPROACH TO THE INTERVENTION OF THE PALEOICHO- LOGICAL HERITAGE ON LA VIRGEN DEL CAMPO SITE. ENCISCO, LA RIOJA (SPAIN).

TITLE: *First Approach to the Intervention of the Paleoichnological Heritage on la Virgen del Campo Site. Encisco, La Rioja (Spain).*

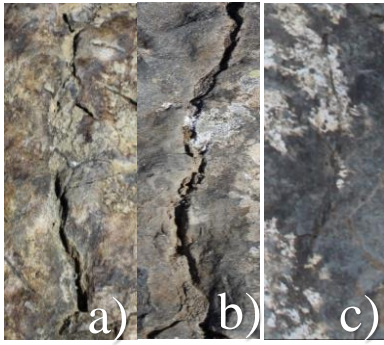
1) Crack (Fracture, Hair crack, Splitting): Fissure, clearly visible by the naked eye, resulting from separation of one part from another of the stone (Figure 5).

Figure 5 (a-c). Different kind of cracks. a) Fracture, crack that crosses completely the stone piece; b) Hair crack, minor crack with width dimension < 0.1 mm; c) Splitting, fracturing of a stone along plans of weakness such as microcracks or clay/silt layers, in cases where the structural elements are orientated vertically. For instance, a column may split into several parts along bedding plans if the load above it is too high.

In the present case, the presence of cracks increases the loss of material in the site. The sealing and filling of the cracks is chosen in order to solve such damage. For the treatment of filling, as mentioned above, the recovery of lime mortar widely used in the restoration of stone heritage is chosen.

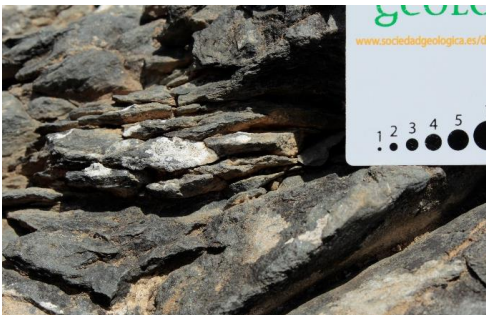
2) **Splitting:** Fractured stone long plans of weakness such as microcracks or clay/silt layers, sometimes where the structural parts are orientated vertically. For example, a column may split into a lot of parts along plans if the load above it is too high (Figure 6).

Figure 6. Splitting example from the site.

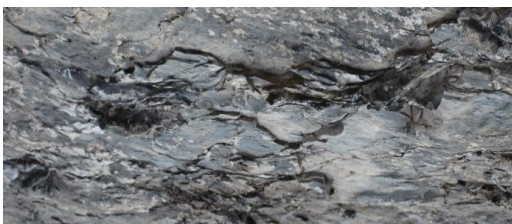
3) **Delamination:** Detachment process affects the laminated stones (especially of sedimentary rocks, and some metamorphic stones). This corresponds to a physical separation into one or few layers following the laminated stone. The density and the shape of the layers are changeable. (Figure 7).

Figure 7. Delamination example from the site.

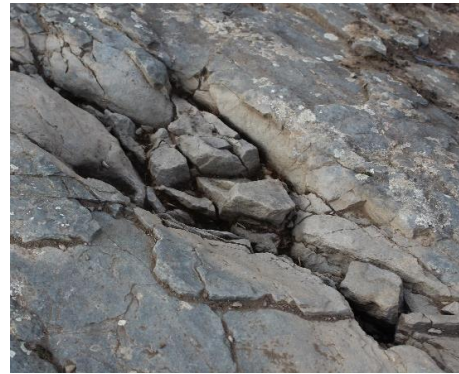
5) **Fragmentation:** Complete or partial scatter of the rock, into portions of variable size, that are irregular in form, density and volume (Figure 8).

Figure 8. Fragmentation example from the site

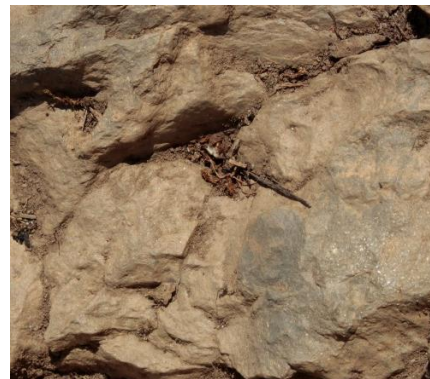
6) **Erosion (Differential erosion):** Loss of original surface, leading to smoothed shapes. (Figure 9)

Figure 9. Differential erosion occurs when erosion does not proceed at the same rate from one area of the stone to the other. As a result, the stone deteriorates irregularly.

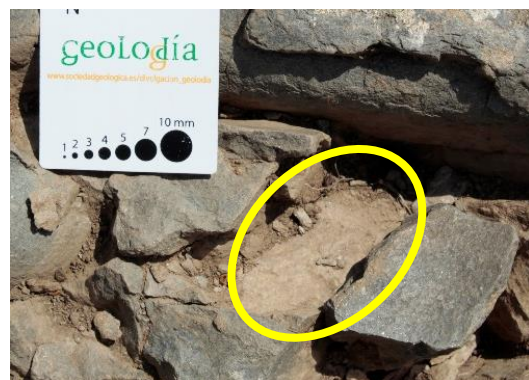
7) **Missing part:** Empty space, without contents located in the place of some formerly current stone part. Come through and particularly exposed parts are normal location for material loss (Figure 10).

Figure 10. An example of a missing part. In yellow is located a missing part in a footprint.

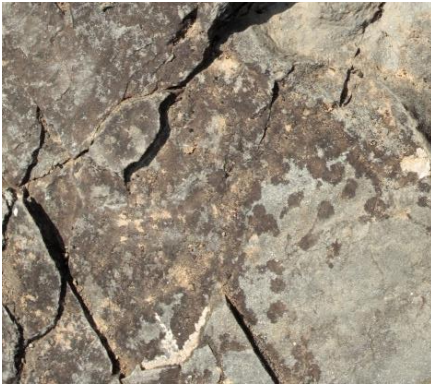
8) **Crust:** Usually consistent accumulation of materials on the surface of the rock. A crust may include exogenic accumulation in combination with other materials derived from the stone. (Figure 11).

Figure 11. Crust example from the site.

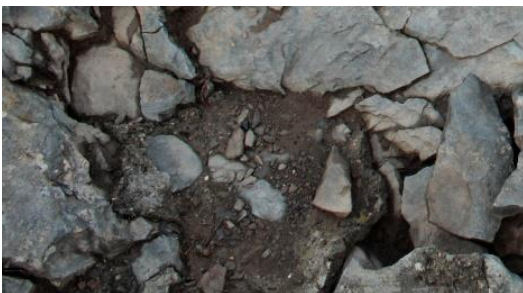
9) Deposits: Accumulation of exogenic material of variable density. For example: splashes of paint or mortar, atmospheric particles such as soot or dust, remains of conservation materials, blast materials, etc (Figure 12).

Figure 12. Deposit example from the site. It has, essentially, clay, small rocks and sand.

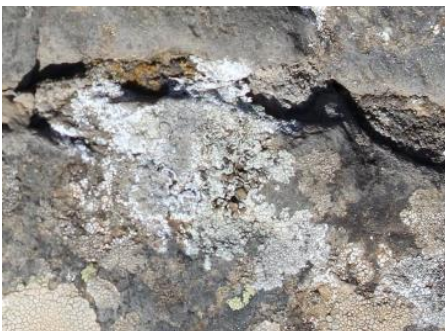
9) Efflorescence: Generally whitish, powdery or whisker-like crystals on the surface. Efflorescences are generally poorly cohesive and commonly made of soluble salt crystals (Figure 13).

Figure 13. Efflorescence example from the site

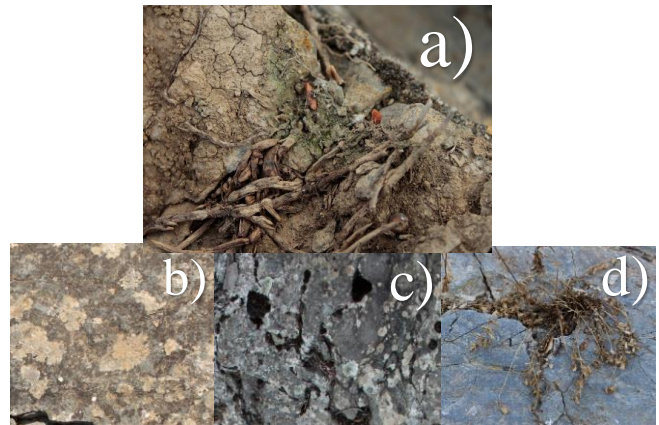
11) Biological colonization (Lichen, moss, plant): Colonization of the stone by plants and micro-organisms such as moss, lichen, algae, and lichen (symbioses of the latter three). Biological colonization also includes

influences by other organisms such as animals nesting on and in stone. (Figure 14).

Figure 14. (a-d) a) Different kinds of biological colonization. b) Lichen, vegetable organism forming rounded millimetric to centimetric crusty or bushy patches, often having a leathery appearance, growing generally on outside parts of the stone. Lichen are most commonly grey, yellow, orange, green or black and show no differentiation into stem, root and leaf. c) Moss, vegetable organism forming small, soft and cushion greens of centimetric size. Mosses look generally like dense micro-leaves (sub- to millimetric size) tightly packed together. Mosses often grow on stone surface open cavities, cracks, and in any place permanently or frequently wet (masonry joints), and usually shady. d) Plant, plant living being, having, when complete, root, stem, and leaves, though consisting sometimes only of a single leafy expansion (e.g. tree, fern, herb).

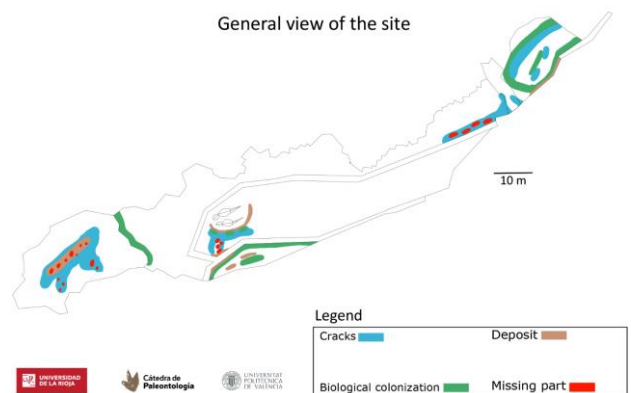
Figure 15. Damage map. Aerial view of the site. At the right part is the crocodile site. At the left part of the map, you can see the sculpture's part of the site. The legend shows the colours of the main damages of the site, which are coloured in it.

In the image above, the amount of damage such as cracks, fractures, sediment accumulations, splitting and delamination mainly can be seen. In turn, the site has loss of parts, followed by the large biological colonization, mainly lichens and mosses. It also contains the presence of plants, both inferior and superior. All other damages were located in more specific areas.
