MORE COMPREHENSION, MORE PROTECTION: NON-DESTRUCTIVE TECHNIQUES IN THE SURVEY OF THE FORMER S. SALVATORE HOSPITAL IN L'AQUILA, ITALY

*Mariangela De Vita**, *Giulia Massari***, *Pierluigi De Berardinis***, *Luis Palmero Iglesias****

Abstract

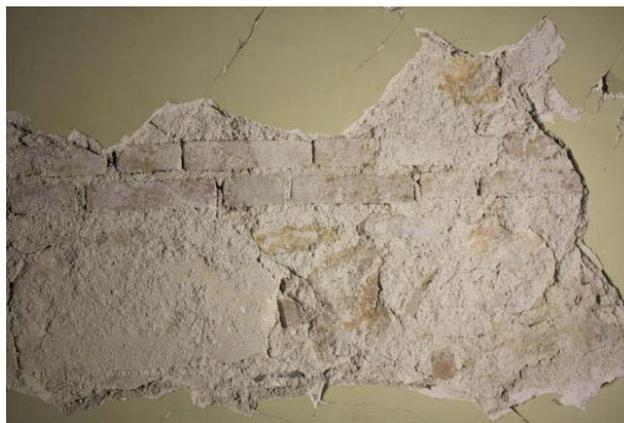
Fig. 3: The *muratura listata* visible thanks to the detachment of the plaster

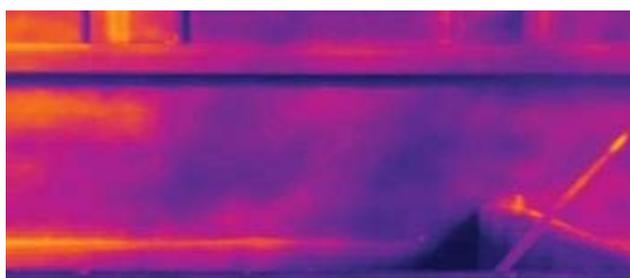
The objective of this specific test was the thermohygro-metric verification of the masonry, which results in determining the presence of water inside the wall caused by water infiltration, or the lack of it, as shown in figure 8.

Fig. 8: Presence of water detected on the South façade

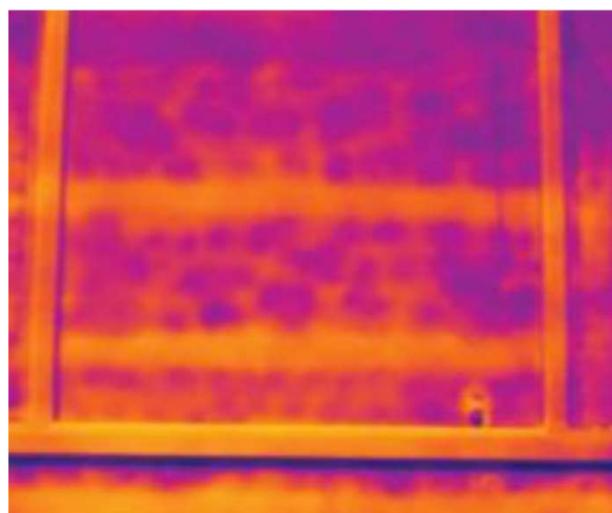
Fig. 9: Wall texture - masonry striped with stones with double recourse of brick

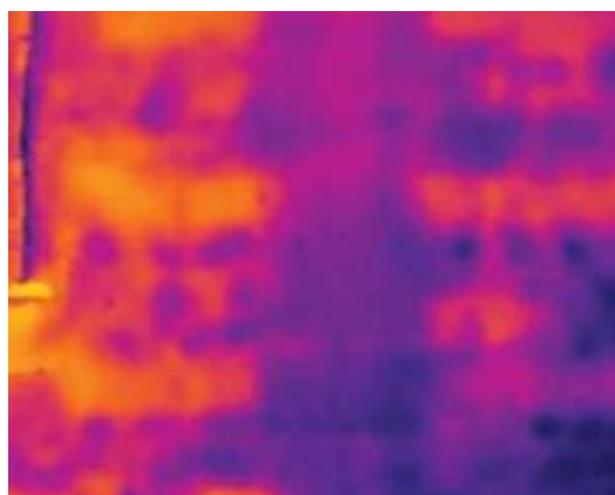
Fig. 10: Wall texture - mixed structure consisting of masonry walls and reinforced concrete pillar

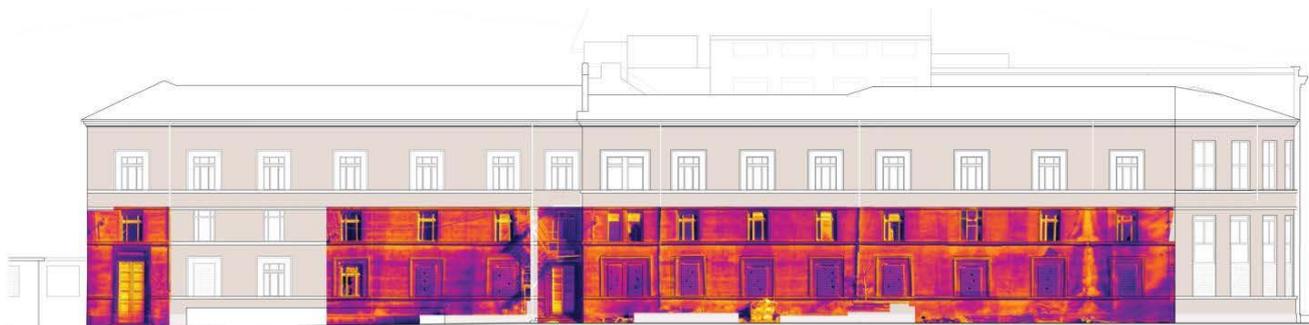
Fig. 11: South façade - time: 10:00

In the figure 11 it is possible to see the reconstruction of the south façade analysed in passive mode and in the figure 12 the reconstruction of the south façade analysed in active mode. The reconstruction of the north and west façades is shown in the figures 13 and 14.

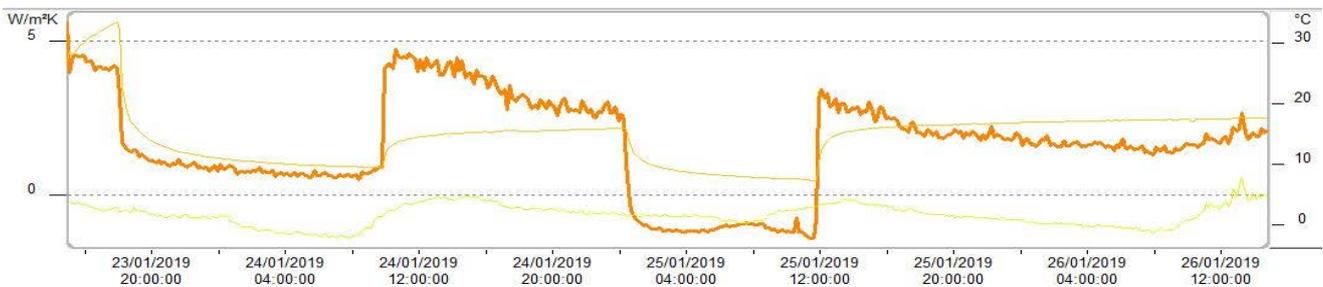
The values were analysed using the Testo Comfort Software Professional 4, which can store and read the collected data and draw graphs with it. In figure 18 it is possible to see the graph of the monitoring data: in the first hours of it, the values were very fluctuating while in the last 24 hours they stabilized, providing the correct U-value (W/m²K).

Considering the last 24 monitoring hours, during which the internal conditions of the room have been stabilized (constant temperature), the U-value has been measured making an arithmetic average of all the valid values obtained (table 2).

Fig. 18: Graph of the monitoring results
