Preliminary Analysis of Material Degradation Processes in Half-Timbered Walls with Earth Infill in Spain

Alicia Hueto Escobar

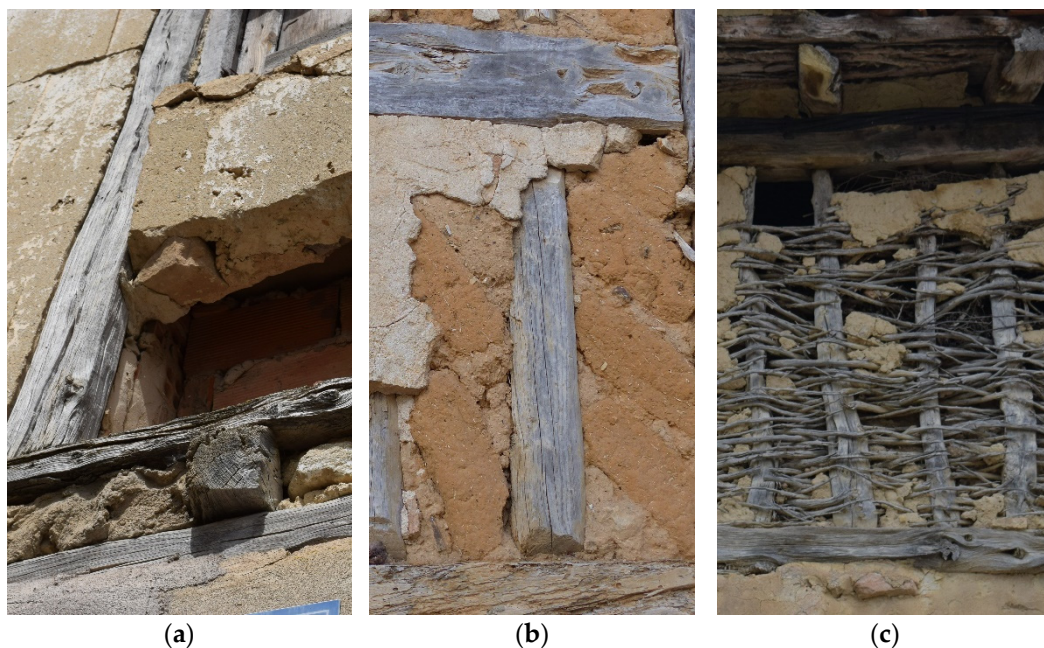
Figure 1. Different material variants identified in the study: (a) half-timbered wall with monolithic infill, based on the piling or pouring of earth into formwork; (b) half-timbered wall with brick infill, based on piling prefabricated pieces like adobe; (c) woven wall based on the use of light screens made up of braided plant elements or rigid boards.

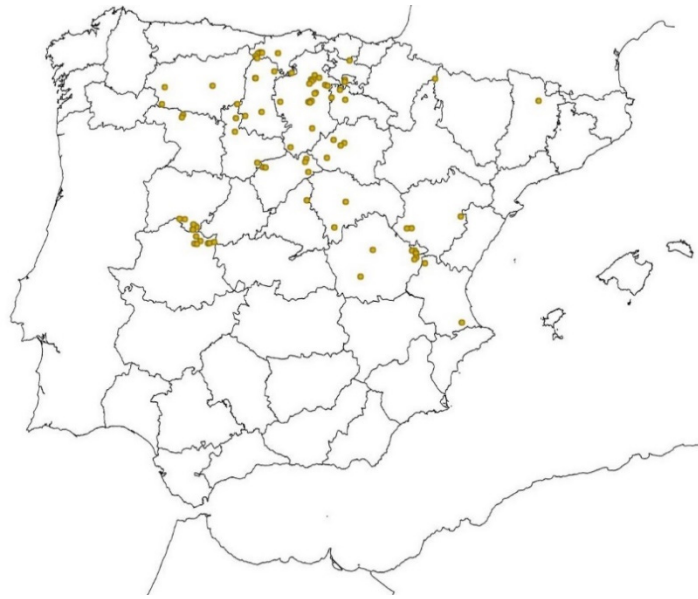
Figure 2. Geographical distribution of the 83 sites where earth and wood mixed walls have been located.

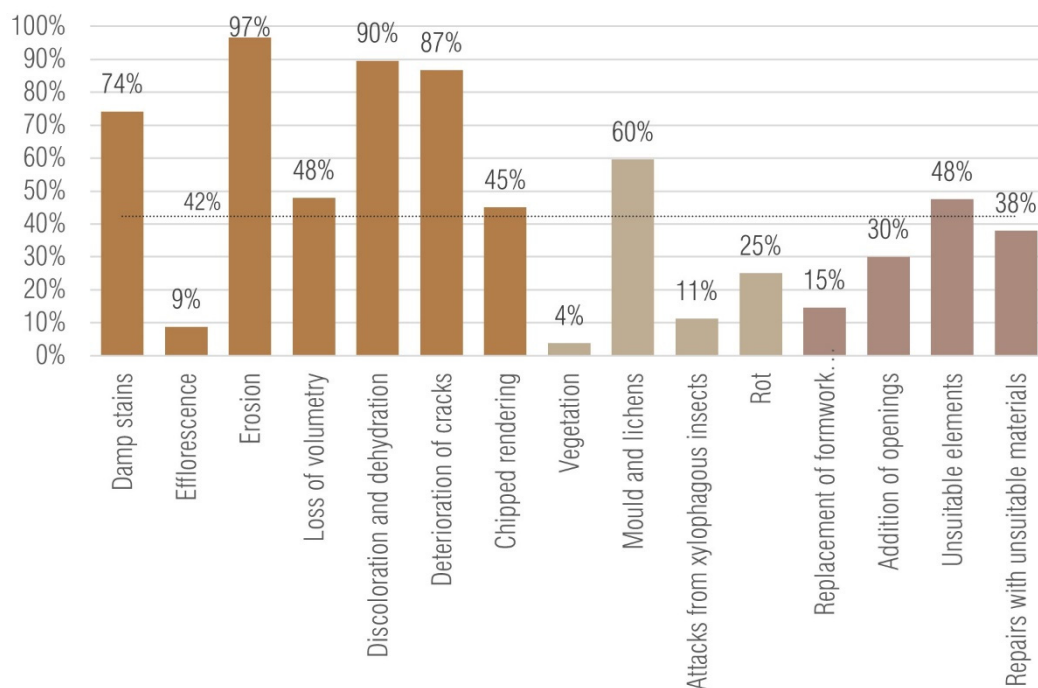
Figure 3. Mean presence of the different material degradation phenomena analyzed.

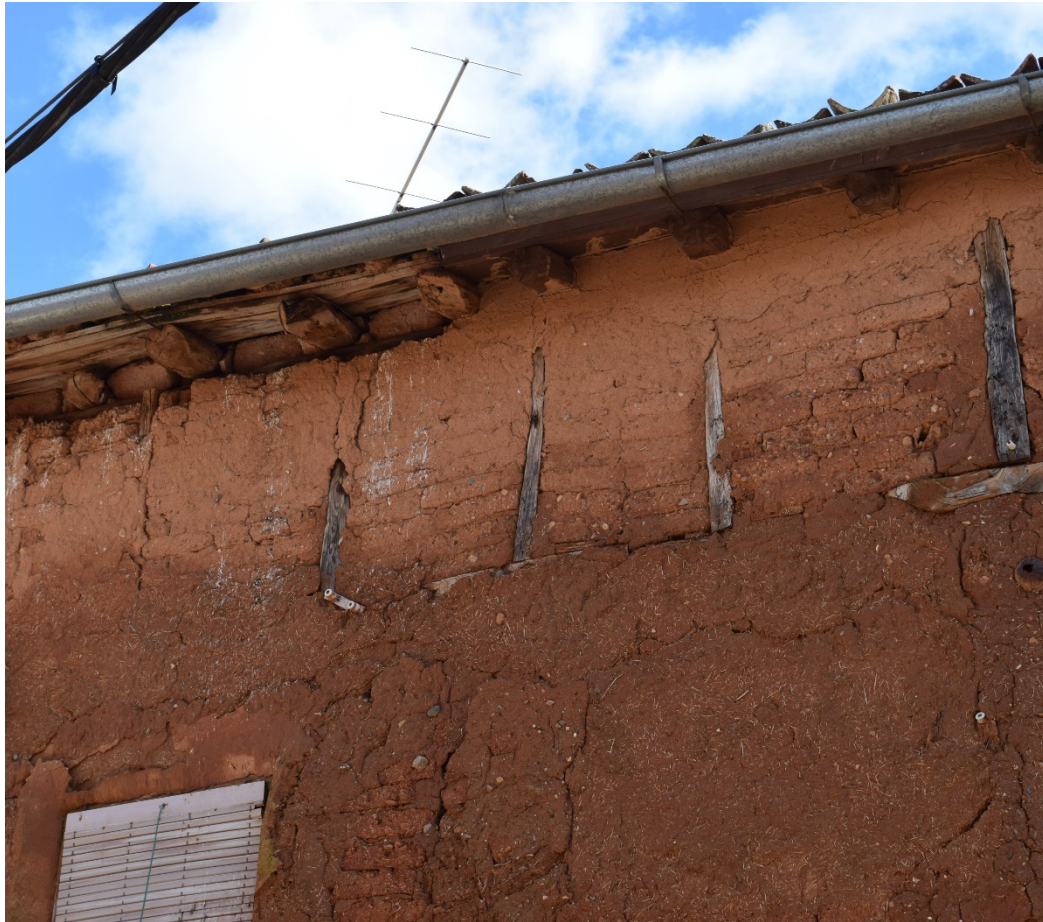
Figure 4. Damp stains in the lower part of a half-timbered wall in Ayllón (Segovia), where the eaves do not protect from the incidence of rain.

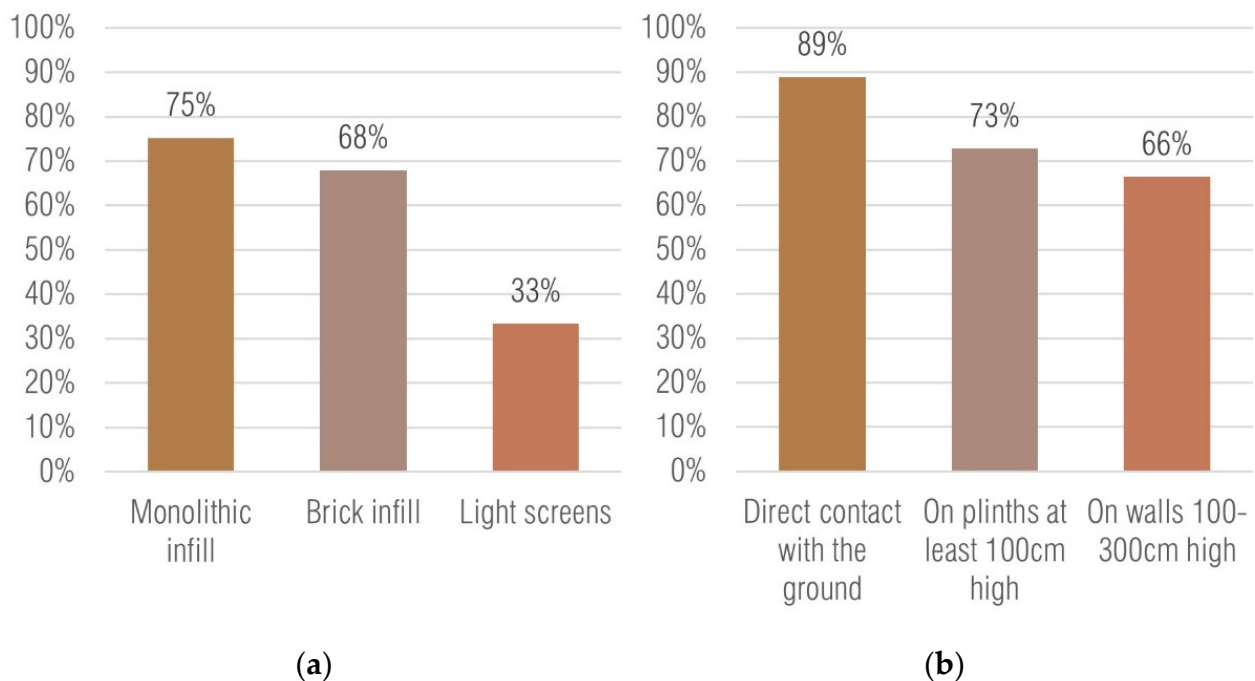
Figure 5. Analysis of the occurrence of damp stains in the walls studied: (a) presence of damp stains with half-timbered walls with monolithic infill, with brick infill and with light screens; (b) presence of damp stains in half-timbered walls in contact with the ground, built on low plinths and on higher walls.

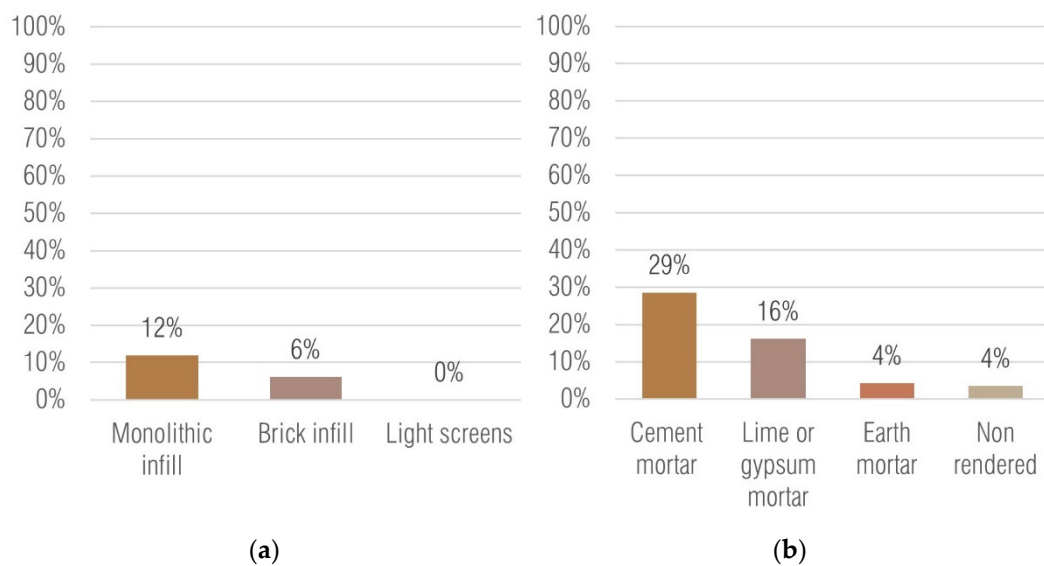
Figure 6. Analysis of the occurrence of efflorescence in the walls studied: (a) presence of efflorescence in half-timbered walls with earth infill, with brick infill and with light screens; (b) presence of efflorescence depending on the renderings used, either cement mortars, lime or gypsum mortars, earth mortars or walls left bare.

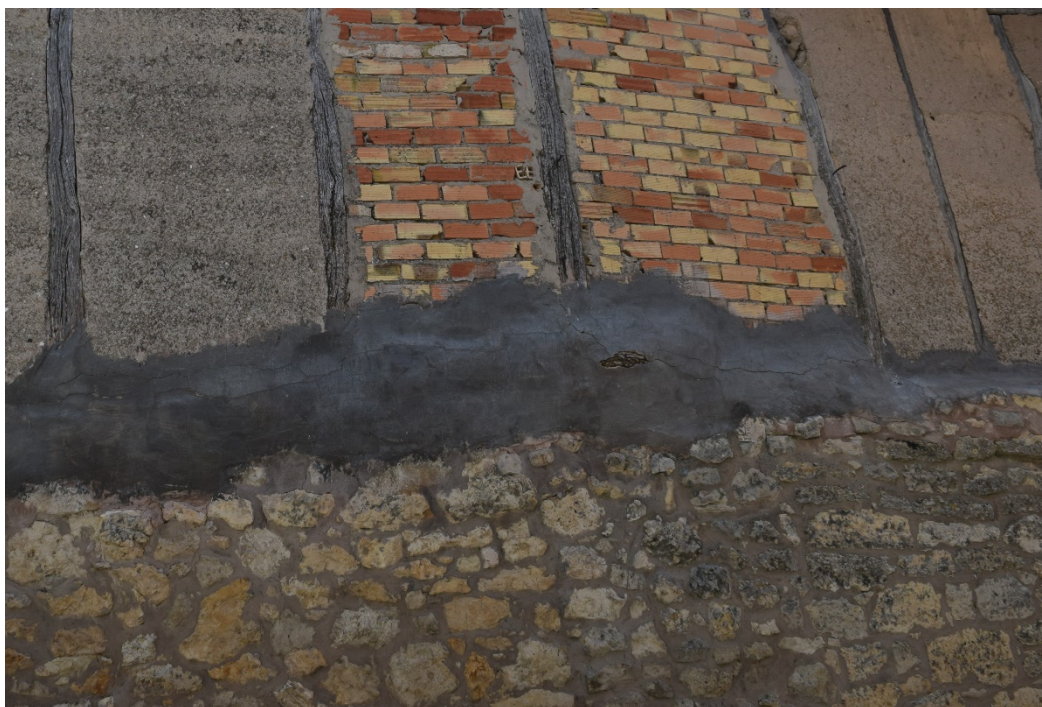
Figure 7. Efflorescence on a half-timbered wall in Reinoso (Burgos), where concrete mortar has been used to repair the encounter with the lower wall.

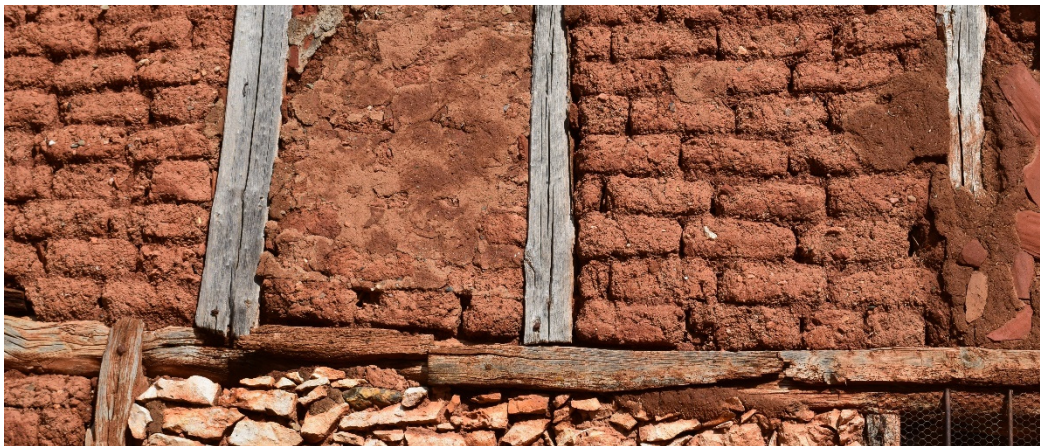
Figure 8. Different degrees of erosion in a half-timbered wall in Ayllón (Segovia).

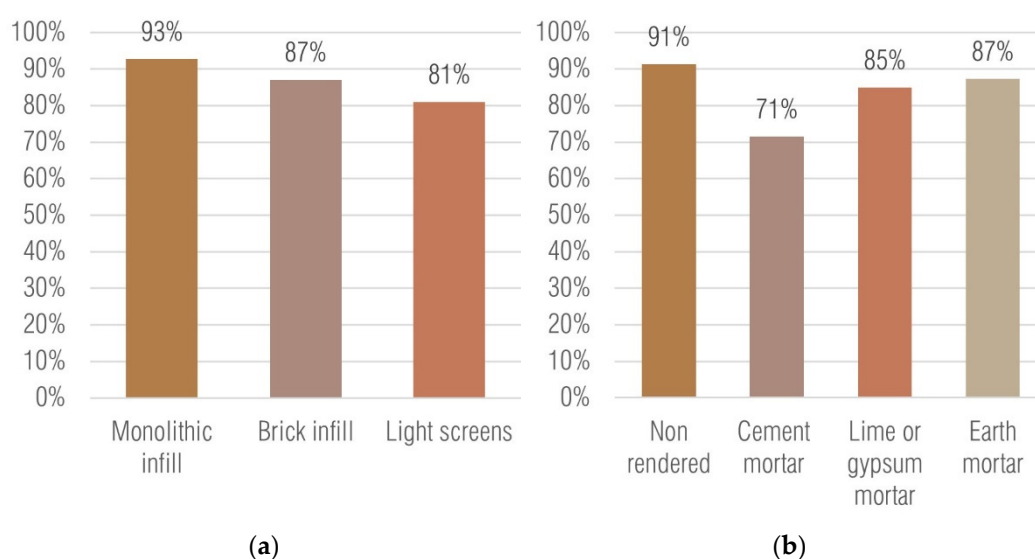
Figure 9. Analysis of the occurrence of erosion on the walls studied: (a) presence of this pathology depending on the material variant of the infill; (b) presence of this pathology depending on the renderings used, whether cement mortars, lime or gypsum mortars, earthen mortars, or bare walls.

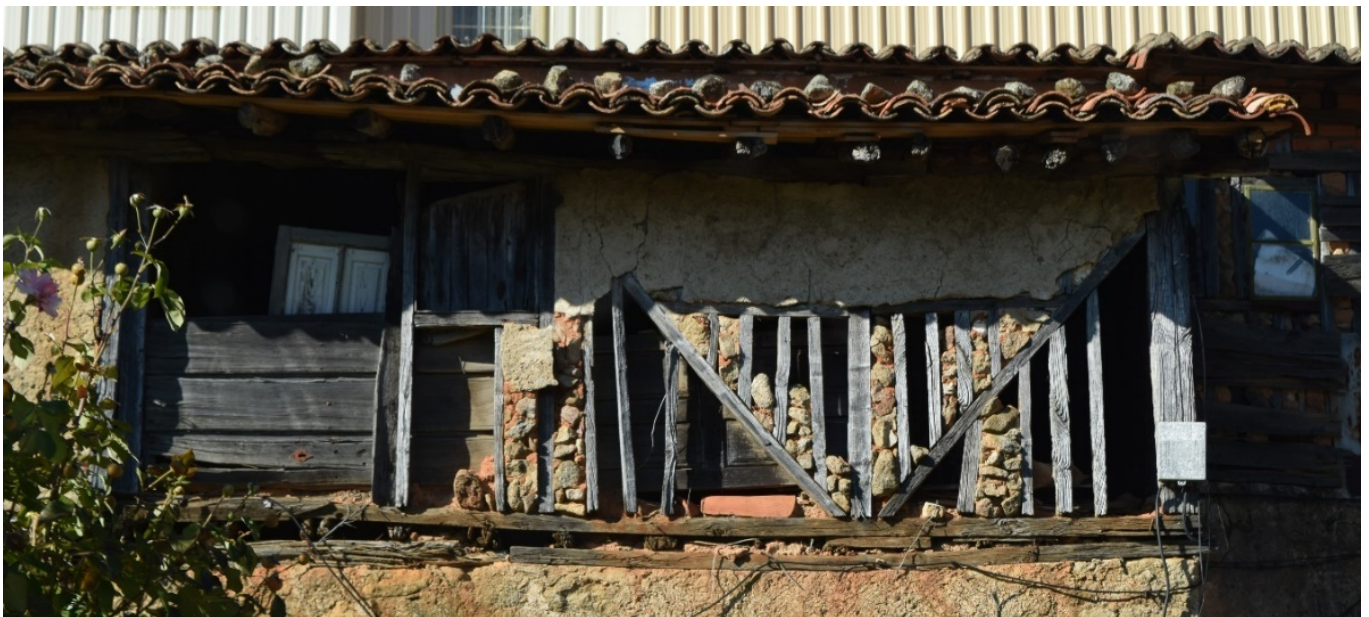
Figure 10. Volumetric loss of the monolithic filling of a half-timbered wall in Cepeda (Salamanca).

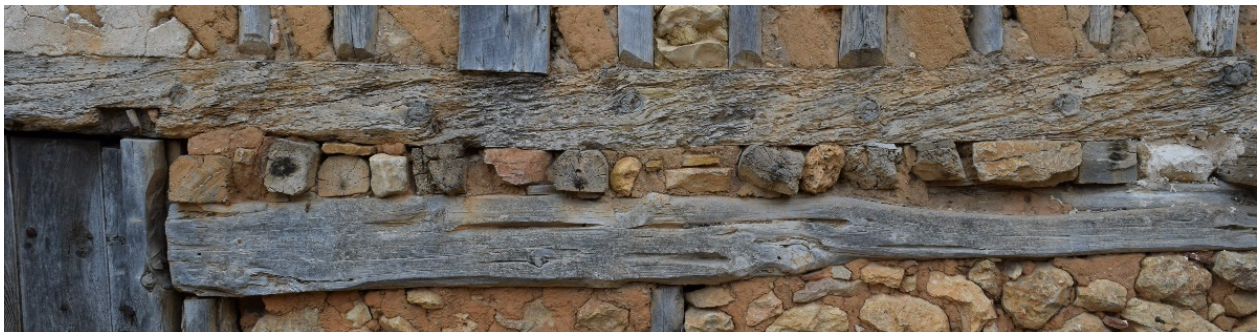
Figure 12. Discoloration and dehydration of timber of a half-timbered wall in Calatañazor (Soria).

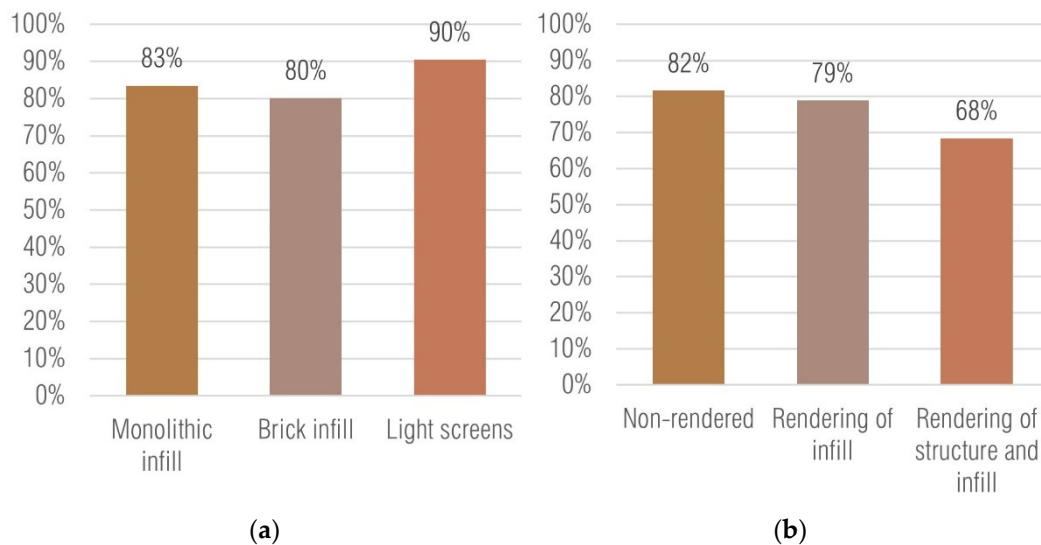
Figure 13. Analysis of the occurrence of the chromatic alteration and dehydration of timber in the walls studied: (a) presence of this alteration depending on the material variant of the infill; (b) presence of this alteration depending on the presence and extent of the rendering.

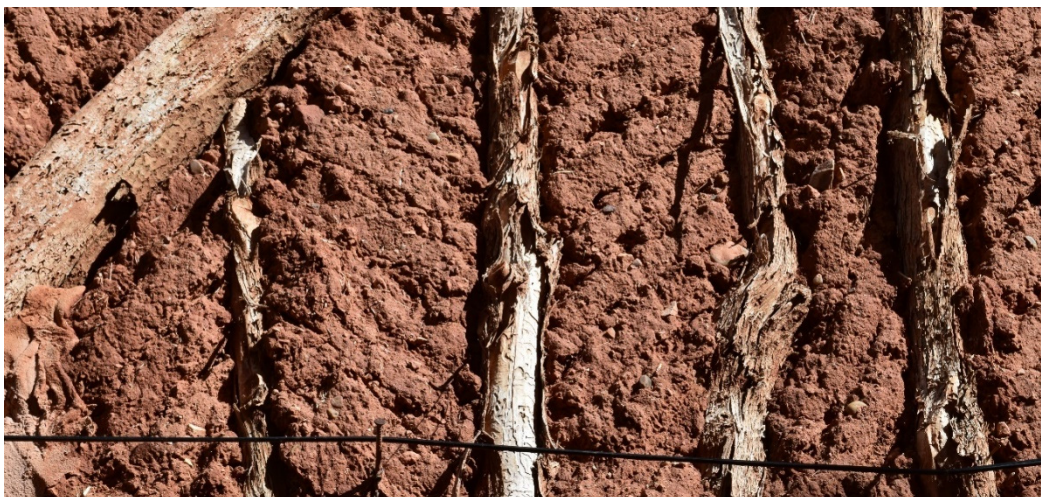
Figure 14. Significant deterioration of the wood cracks in a half-timbered wall in Ayllón (Segovia).

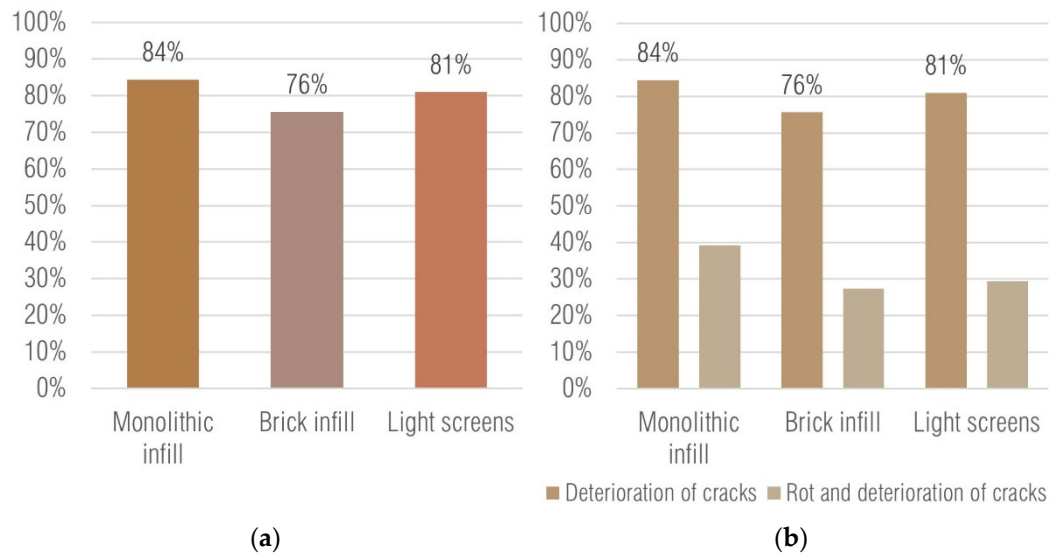
Figure 15. Analysis of the occurrence of deterioration of cracks in the timber in the walls studied: (a) presence of this alteration depending on the material variant of the infill; (b) presence of this alteration depending on the presence and extent of the rendering.

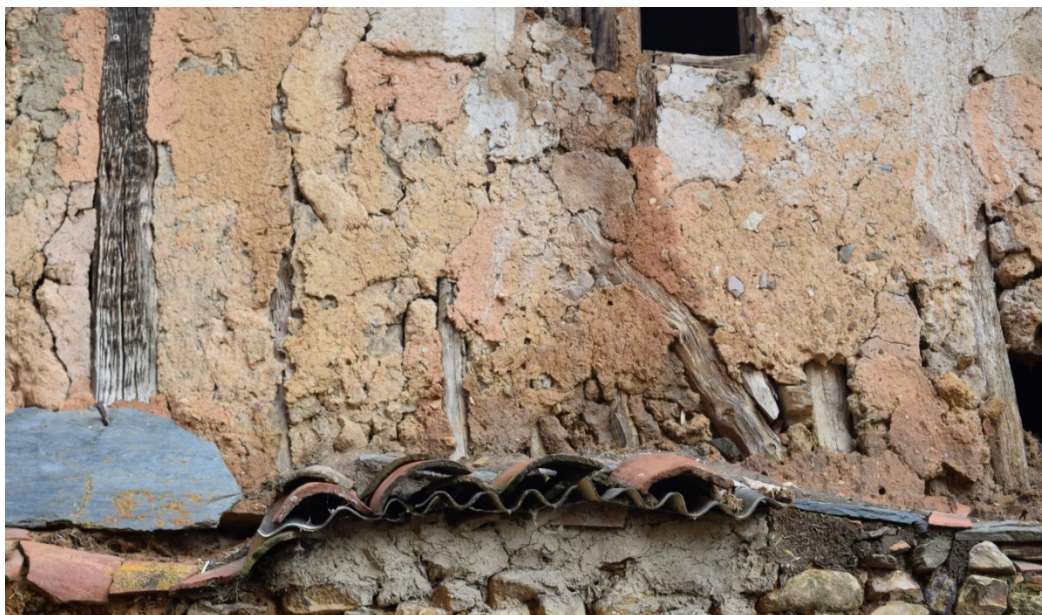
Figure 16. Chipping and gaps in the lime or gypsum mortar rendering of a half-timbered wall in Santibañez de Ayllón (Segovia).

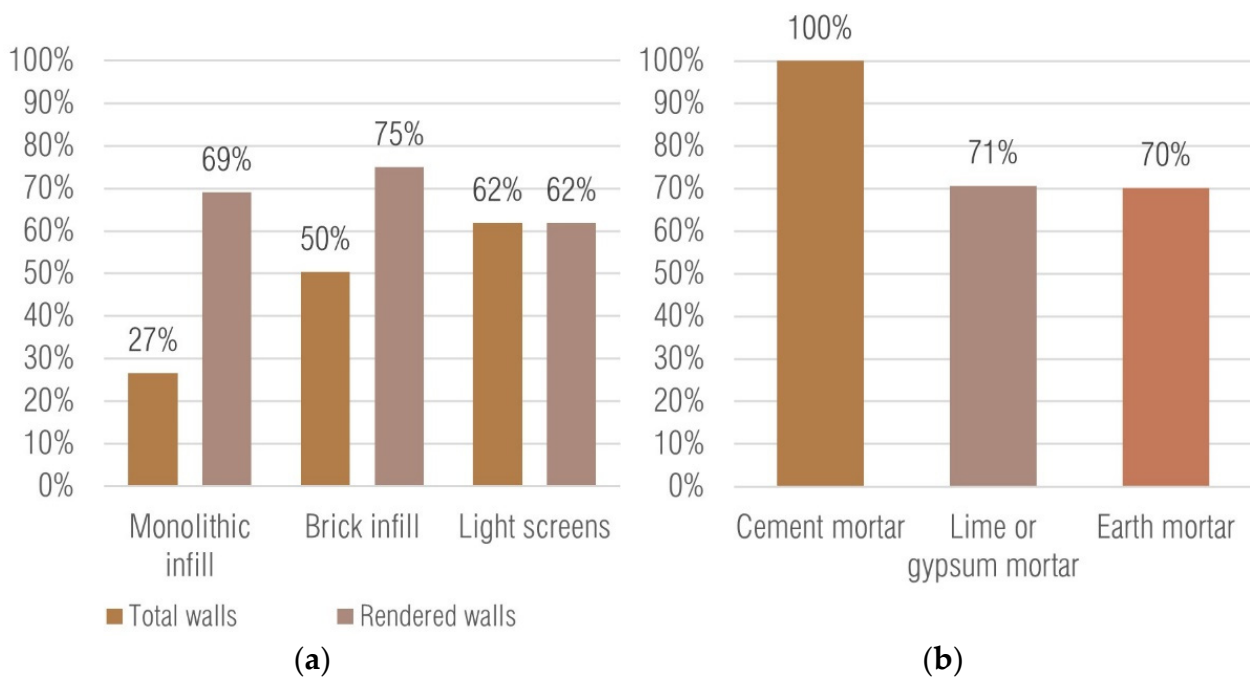
Figure 17. Analysis of the occurrence of chipping and gaps in half-timbered walls studied: (a) presence of this pathology depending on the material variant of the infill in relation to the total of walls analyzed and in relation to the rendered cases; (b) presence of this pathology in relation to the types of rendering identified.

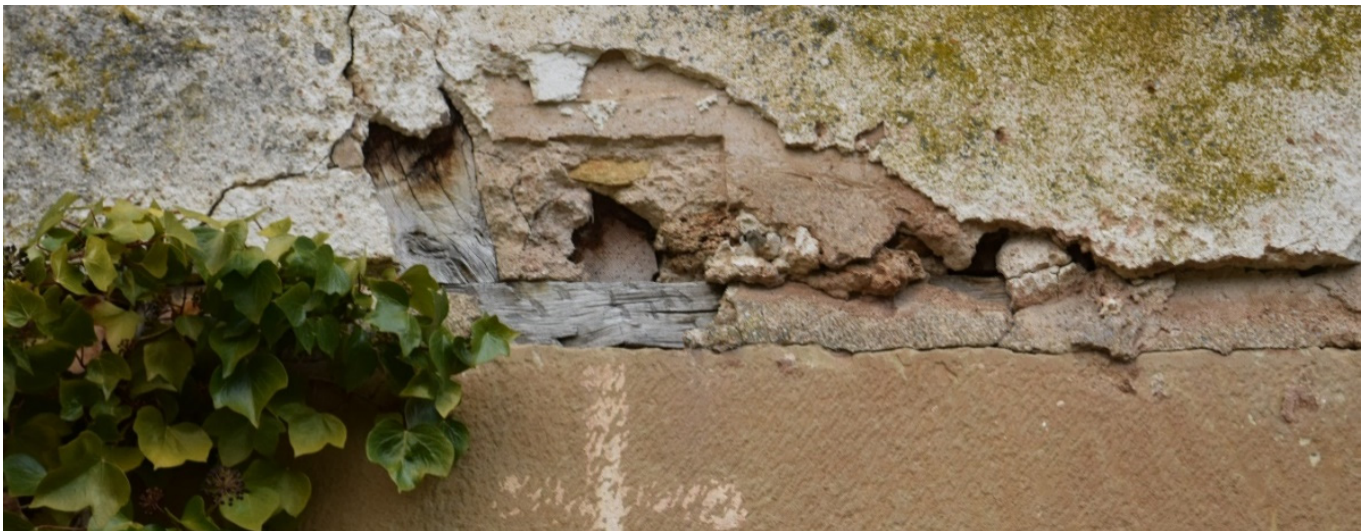
Figure 18. Vegetation and lichens on a rendered half-timbered wall in Paúl (Alava).

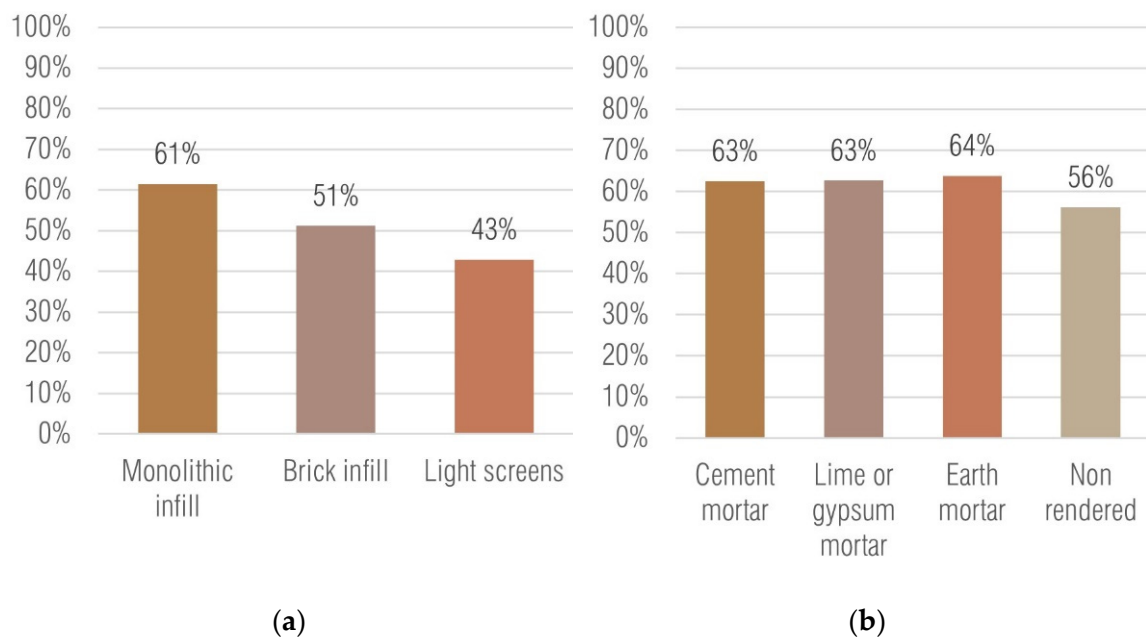
Figure 20. Analysis of the occurrence of mold and lichens in the half-timbered walls studied: (a) presence of this pathology depending on the material variant of the infill; (b) presence of vegetation depending on the types of rendering identified.

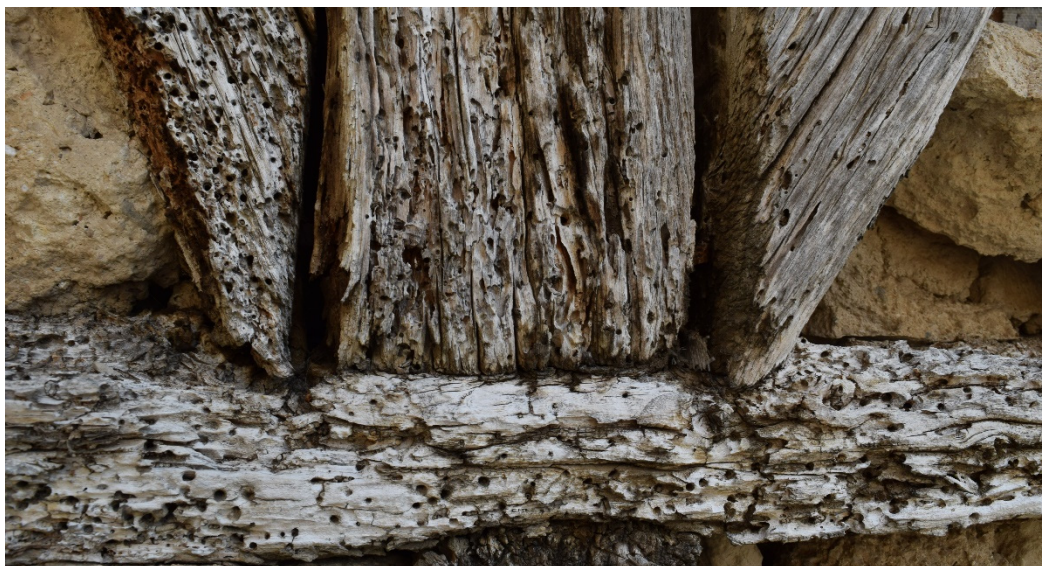
Figure 21. Attack by xylophagous insects at the meeting of wooden elements where moisture accumulates, in a half-timbered wall in Valdazao (Burgos).

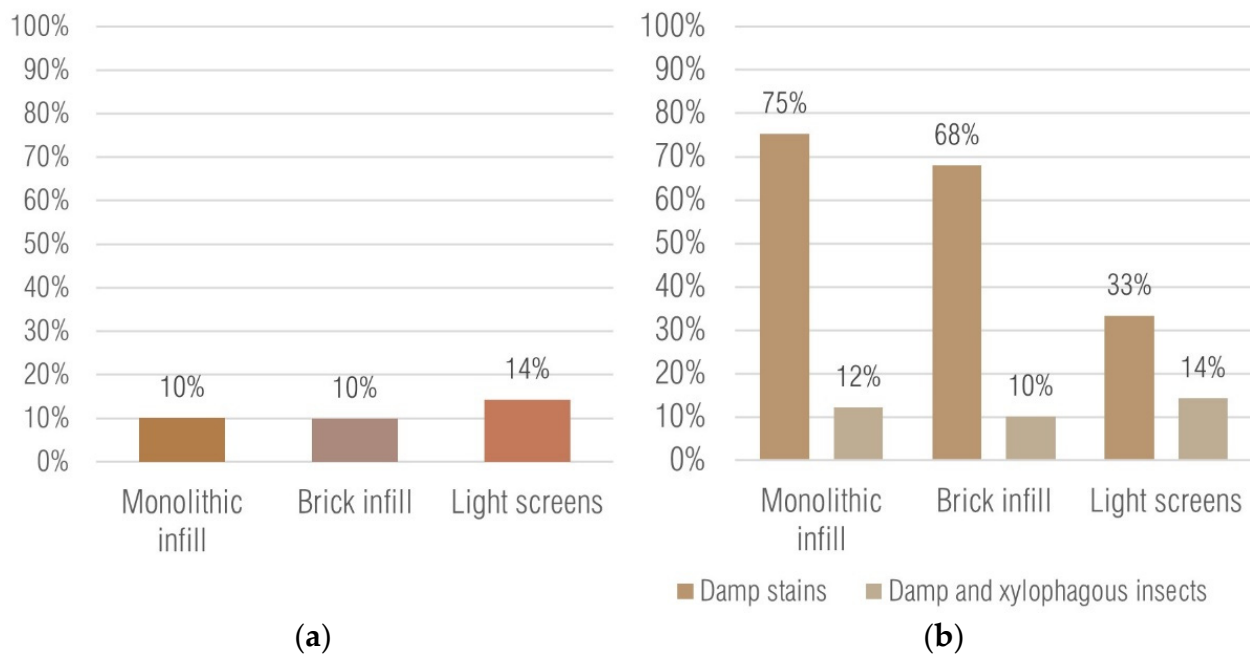
Figure 22. Analysis of the incidence of the attack of xylophagous insects on the half-timbered walls studied: (a) presence of this pathology depending on the material variant of the infill; (b) combined presence of damp stains and xylophagous insects on the half-timbered walls studied based on the type of infill.

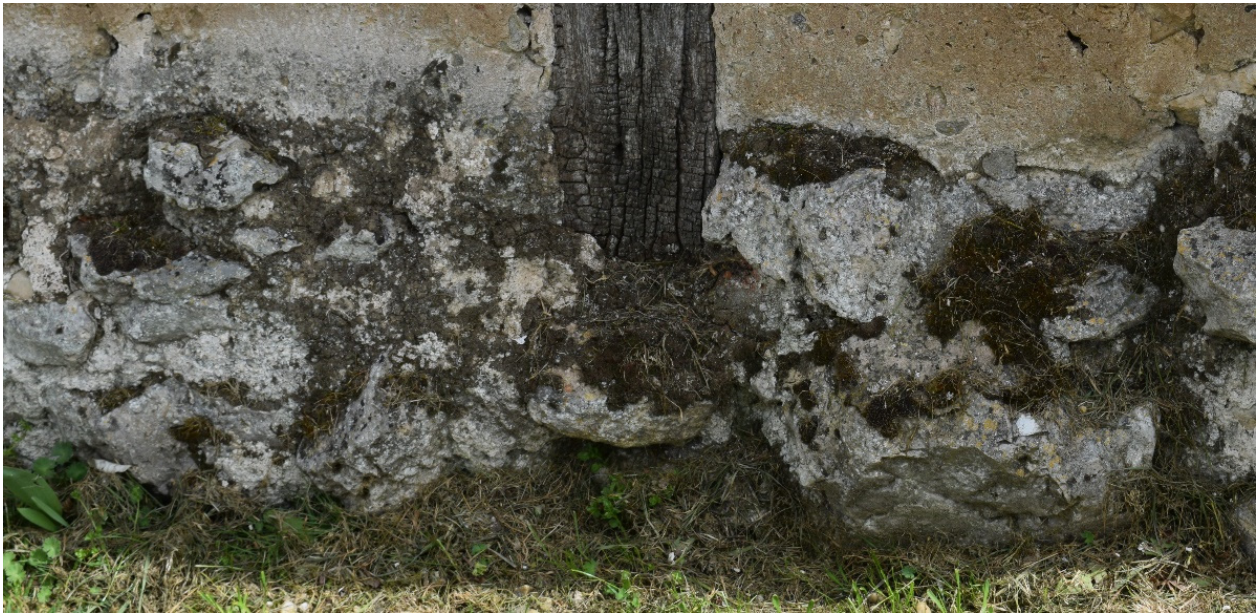
Figure 23. Cubical brown rot in the lower part of a pillar in contact with the humidity of the ground, in a half-timbered wall in Ages (Burgos).

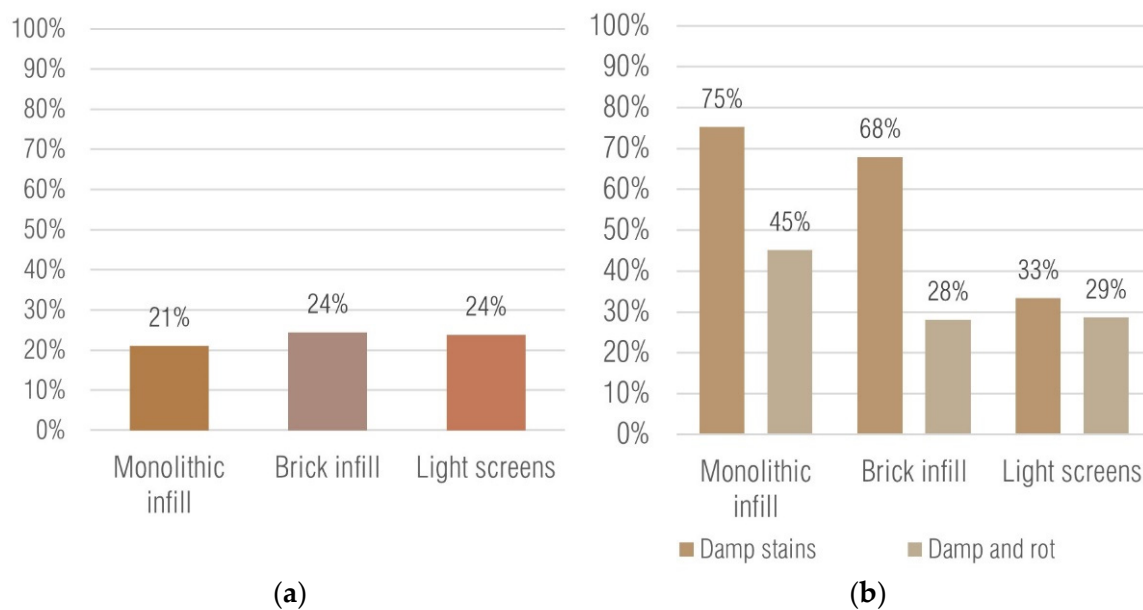
Figure 24. Analysis of the occurrence of rot in the half-timbered walls studied: (a) presence of this pathology depending on the infill material; (b) combined presence of damp stains and rot in the half-timbered walls studied depending on the type of infill.

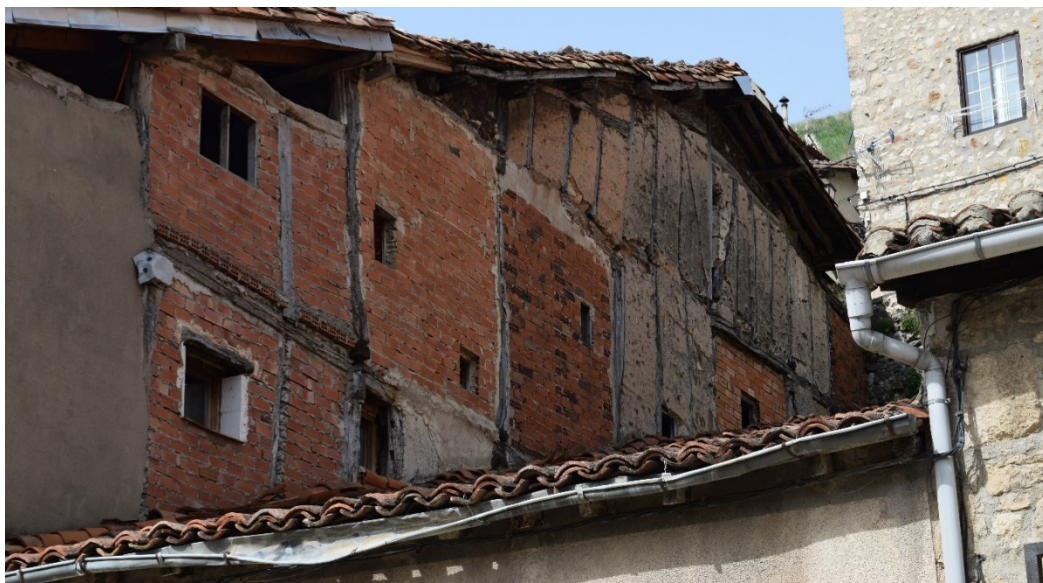
Figure 25. Replacement of the monolithic traditional filling with industrial brick and modifications of the timber structure, in a half-timbered wall in Pancorbo (Burgos).

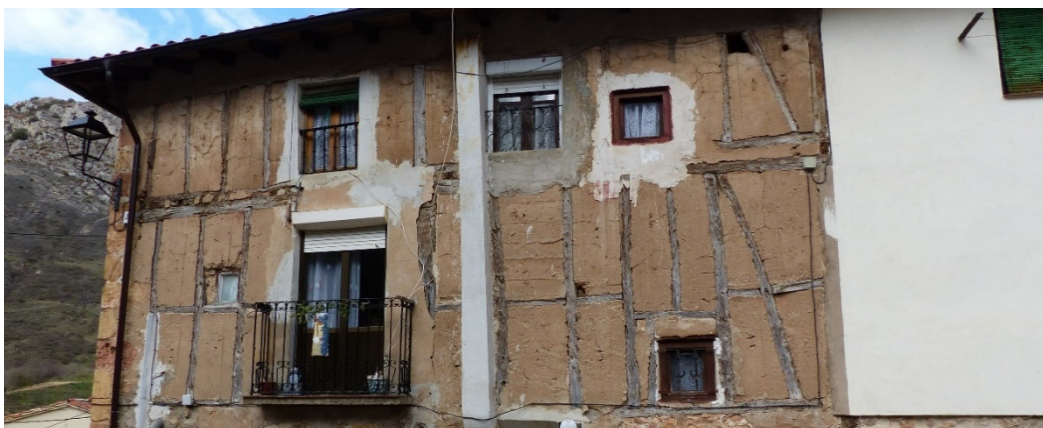
Figure 26. Addition of openings and installation of unsuitable elements such as shutter boxes and ventilation chimneys in al half-timbered wall in Poza de la Sal (Burgos).

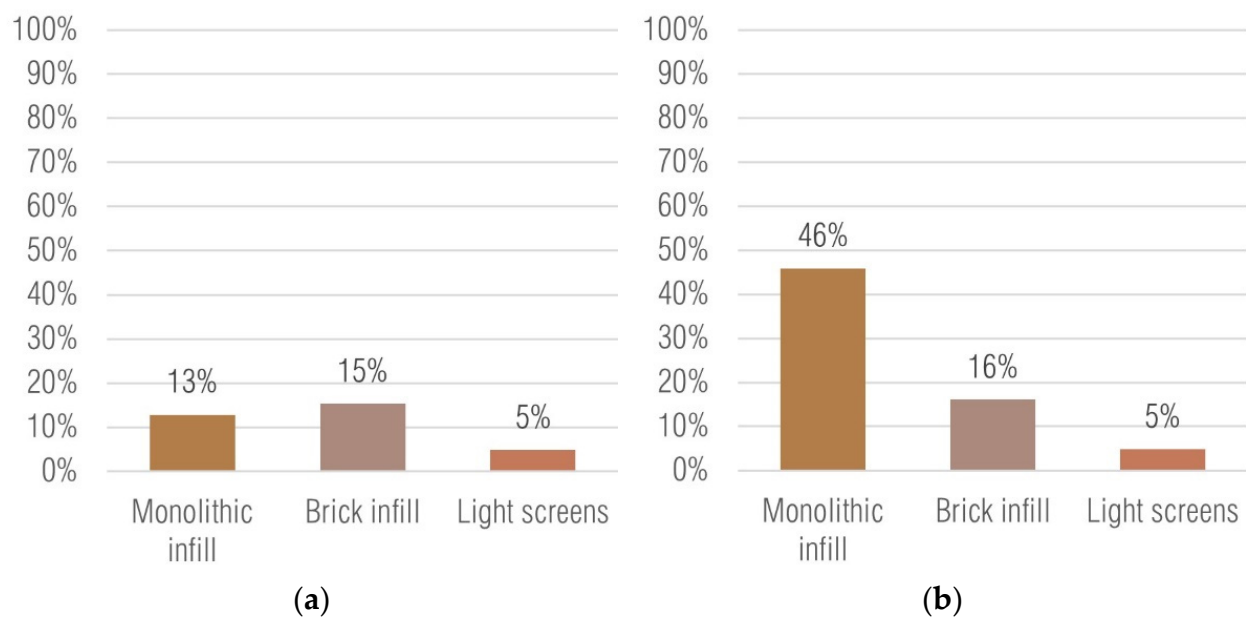
Figure 27. Analysis of the occurrence of weathering entailing structural changes in the walls studied: (a) presence of replacements of infill in some formwork sections depending on the material variant of the infill; (b) presence of improperly added openings depending on the material variant of the infill.

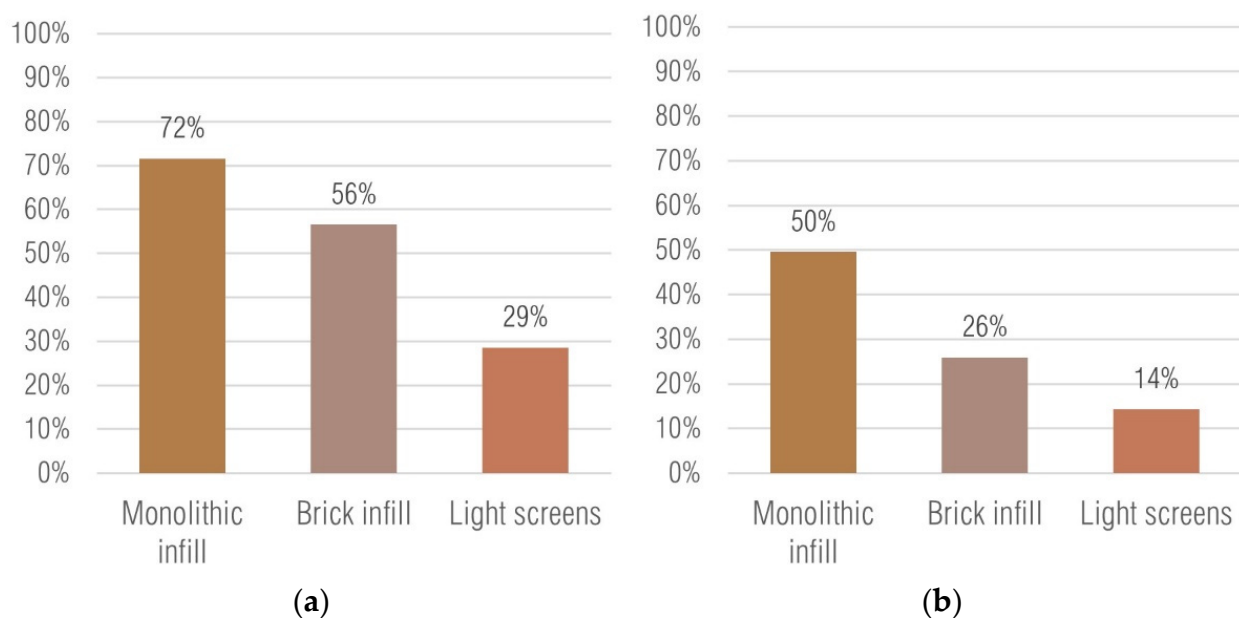
Figure 28. Analysis of the occurrence of weathering involving incompatible elements and materials: (a) presence of unsuitable elements depending on the material variant of the infill; (b) presence of repairs using unsuitable materials depending on the material variant of the infill.

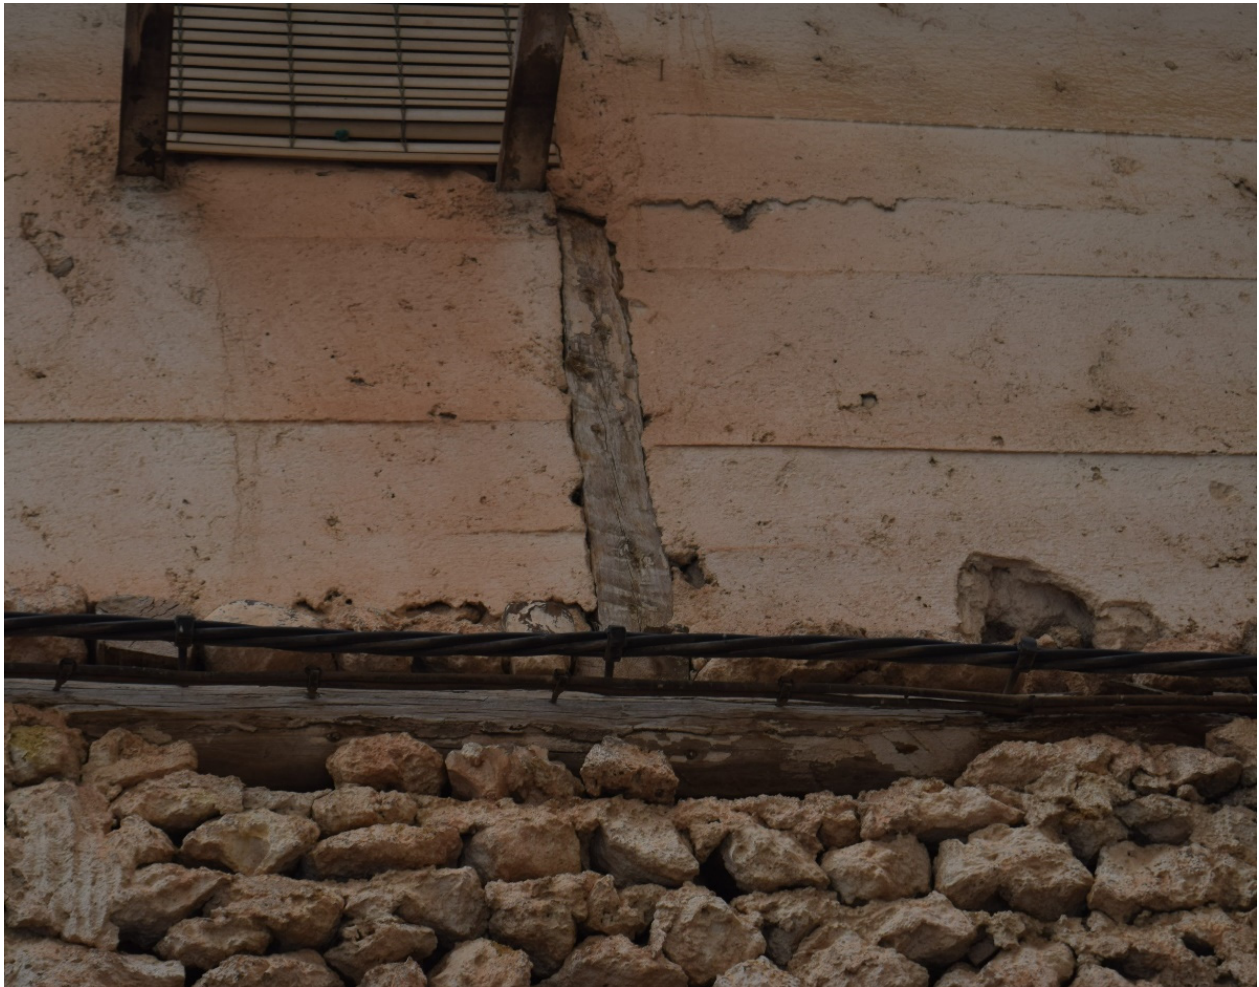
Figure 29. Cables installed following the geometry of the timber structure in a half-timbered wall in Santa Cruz de Moya (Cuenca).

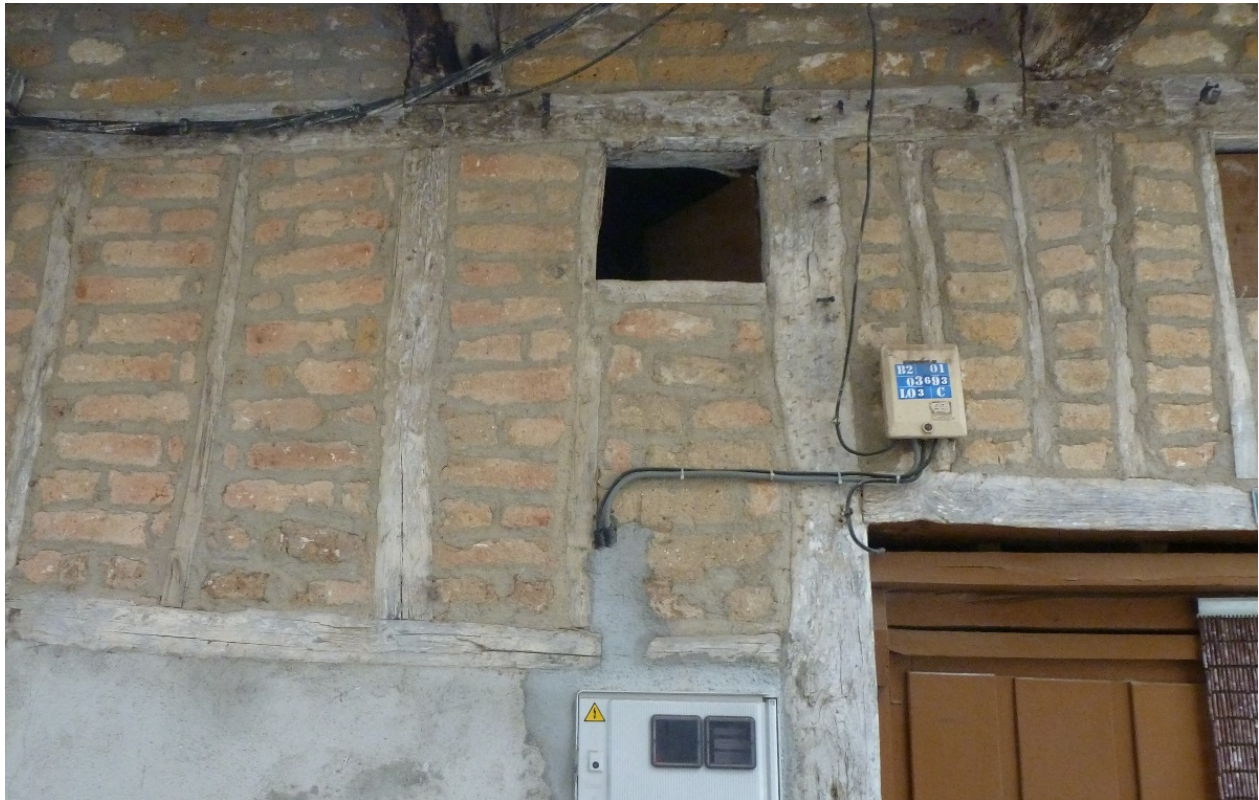
Figure 30. Rejoint of a fabric filling of a half-timbered wall in Garganta la Olla (Cáceres).

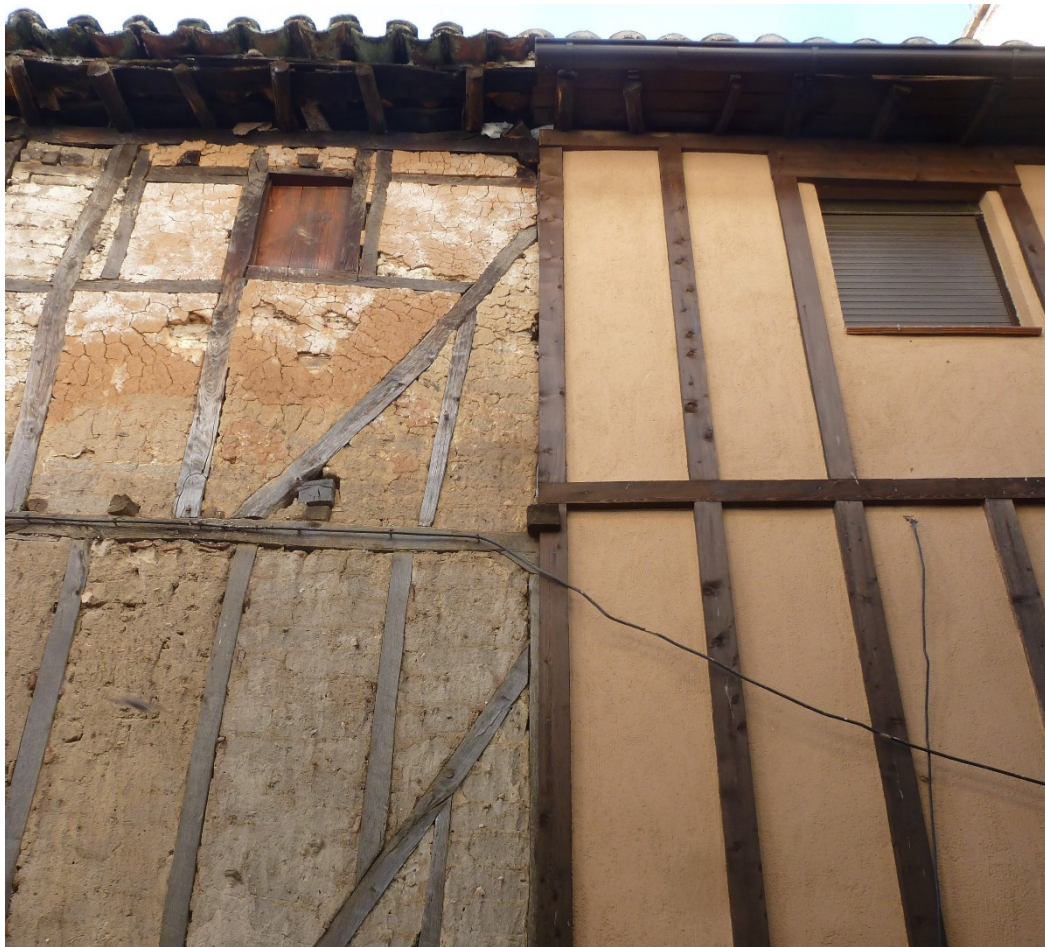
Figure 31. The difference between a traditional brick wall and a new building that aims to follow the same aesthetic, in Madrigal de la Vera (Cáceres).
