Material weathering and structural damage in historic adobe constructions in Spain: preliminary results of a quantitative approach.

This article presents the study of the main phenomena of material weathering and structural damage that affect traditional architecture built in adobe, analysing the damage found in 553 case studies, representative of different technical varieties of adobe construction in Spain. The analysis methodology proposed in this text made it possible to quantify and identify the risks of damage appearing, establishing its impact and identifying its main mechanisms and causes. At the same time, the behaviour of adobe construction systems was further studied, observing how specific modifications in technique can promote or hinder deterioration and establishing the probable causes of the different responses to these phenomena.

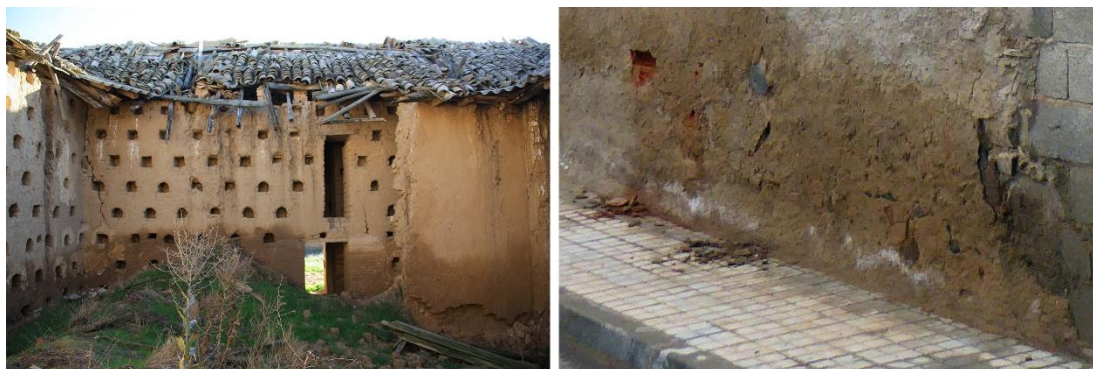
Damp stains are alterations in the colour of the earth mass due to an increase in its humidity (Fig. 6a). This type of weathering was identified in 20.8% of cases studied, mostly affecting the bottom of the walls due to rising damp from the ground.

The damp in the mass of a wall can cause soluble salts to migrate to the surface. When water evaporates, salts dissolved in it crystallise in the walls forming the deposits known as fluorescence (Fig. 6b), found in 5.42% of cases studied.⁴⁵ The formation of fluorescence is more likely following the use of products with cement content during the repair or intervention of traditional buildings, as the composition of these materials includes salts that are likely to dissolve in water⁴⁶.

Figure 6. Damp stains (left) and fluorescence (right).

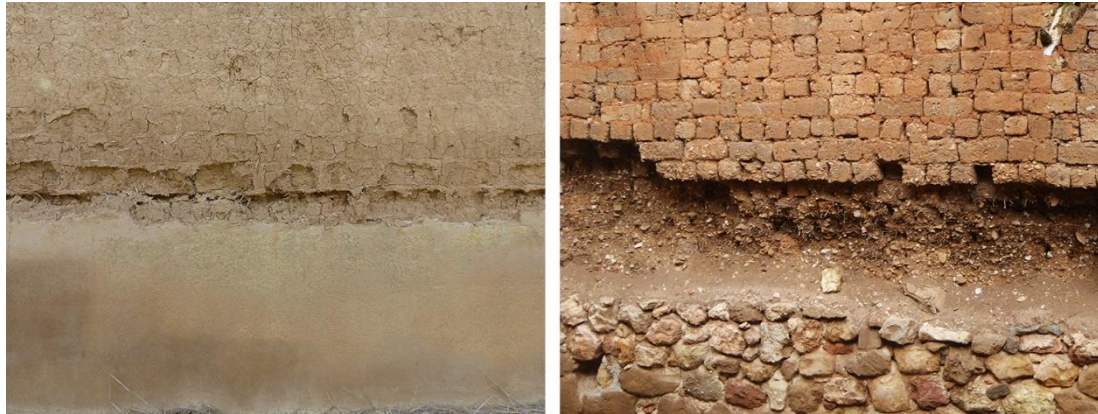
The water found in the ground can rise by capillarity towards the bottom of the earthen walls in direct contact with it. When this happens, the damp content of the wall mass increases and the material weakens, temporarily returning to its original plastic state. If this situation persists, resistance is lost, encouraging the surface to come away at the bottom of the wall⁷ (Fig. 7a).

8.68% of the case studies showed signs of superficial erosion caused by rising damp. In 48.7% of the buildings affected by this kind of weathering – that is 3.98% of the whole studied sample –, erosion had developed to produce significant problems of loss of volume, sometimes even menacing the stability of the walls. This data demonstrates the high potential for these phenomena to evolve into damage capable of jeopardising the same survival of earthen constructions.

Figure 7. Superficial (left) and volumetric (right) erosion due to rising damp.

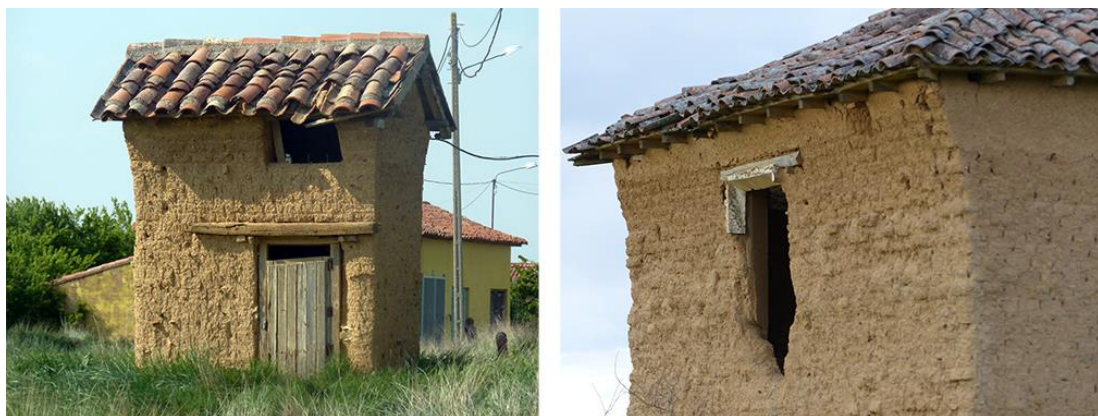
The particles suspended in the blowing air impact against the most exposed areas of the wall, wearing their surfaces (Fig. 9). Therefore, immediate surrounding conditions are key factors in the vulnerability of a building, especially in the direction of the prevailing winds, as close structures or nearby vegetation can shelter it from this kind of weathering⁹.

Corners are highly susceptible to this type of weathering, as they normally are the most exposed areas of a building, being in this part of the isolated case studies built completely with earth where wind erosion focuses. Therefore, the corners of earthen constructions are often built using materials such as stone or brick, which are more resistant to abrasion. During this study, clear evidence of erosion on walls due to the action of wind appeared in 14.65% of the cases analysed. The execution of plasters provides a resistant envelope, which can be easily replaced and can slightly lower the appearance of this type of weathering (12.22%) compared to walls with no plaster (15.12%).

Figure 9. Erosion through the action of the wind.

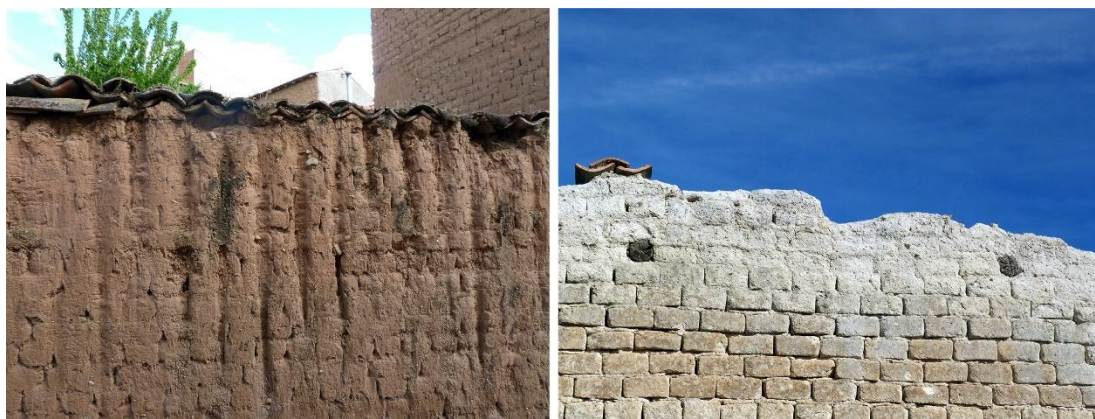
Superficial signs of erosion due to washing are slightly more common in study cases without plasters (14.90%) than in those rendered with lime or gypsum (12.22%). Regarding only affected case studies, it can be observed that this weathering has evolved from superficial erosion to loss of volume in 42.02% of the buildings that have no plasters, in contrast with only 9.09% of the rendered ones. Based on the comparison of this data, it seems clear that plasters are efficient in preventing the evolution of wall washing.

Figure 10. Superficial (left) and volumetric (right) erosion due to washing.

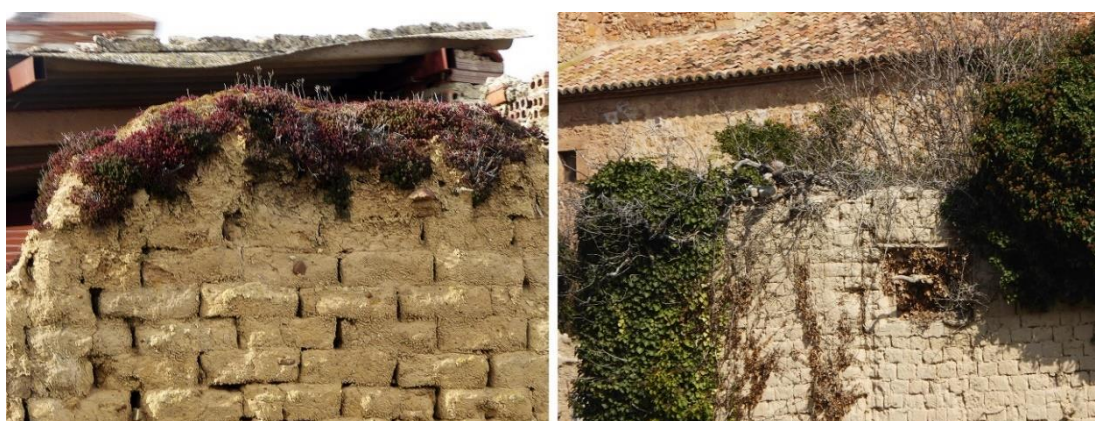
The constant presence of damp in earthen walls favours the proliferation of fungus, mould and lichen (Fig. 11a). As they expand, these colonies of organisms hinder the dissipation of humidity, damaging the cohesion of the outer faces of the wall and causing detachment from the surface¹¹.

In suitable hygrothermal conditions, earthen buildings are ideal settings for the growth of vegetation (Fig. 11b). The germination of seeds transported by the wind and deposited in

As they grow, the plants form a network of roots which spreads throughout the mass of the wall, causing cracks and endangering stability¹². In the course of this study, vegetation growth was detected on walls in 7.96% of cases analysed.

Figure 11. Proliferation of mould and lichen (left) and vegetation growth (right).

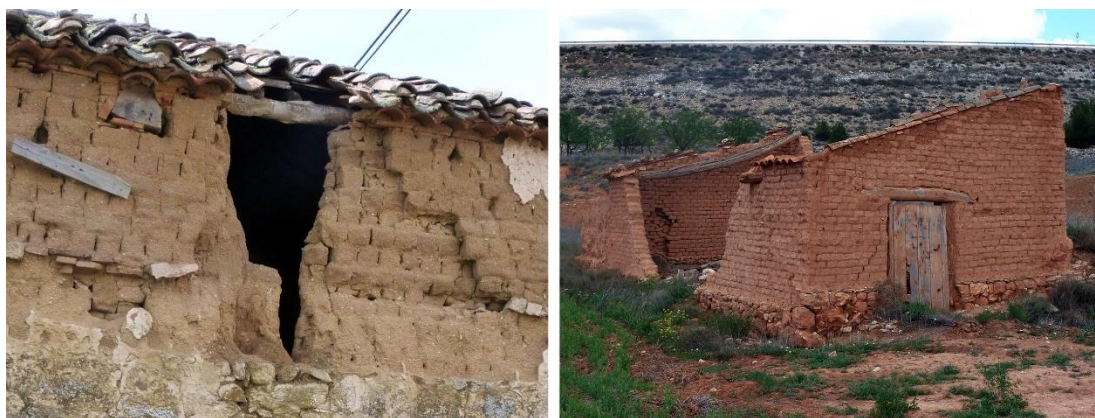
Roofs are constructive elements which are especially sensitive to the lack of maintenance. If an individual leak on a roof is not repaired, it can lead to beams rotting and the partial loss of the roof. The remaining constructive elements in the building are then left exposed, and their weathering speeds up (Fig. 12a).

Figure 12. Localised (left) and complete (right) loss of the roof and subsequent collapse of the wall.

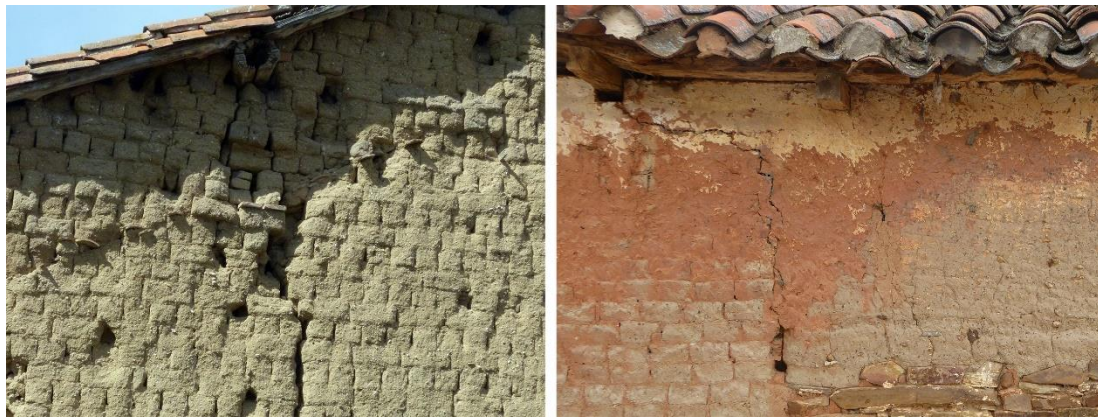
The absence of timber sleepers to support beams of floors and roofs can lead to highly concentrated loads on the point of the wall on which they rest, leading to topical crushing and shear failure. The appearance of this kind of cracks is highly probable in cases where the loadbearing elements of the horizontal structure transmit their load irregularly due to the concentration of weight or the absence of a timber slab over the beams to distribute loads.

This type of damage appeared in 6.69% of cases studied and is usually manifested through the appearance of cracks, starting below the support of the beams and moving downwards, almost vertically, in the transmission direction of the loads⁸ (Fig. 14a). Weak points in the area of influence of the load tend to attract these cracks, which move away from the vertical direction (Fig. 14b).

This type of damage is slightly less frequent in buildings using mortars with added binders (4.49%) than in those bonded in earth mortar (7.11%). The use of mortars with added binders can noticeably improve the mechanical properties of adobe walls, enhancing their response to concentrated actions^{49, 50}.

Figure 14. Cracks due to concentrated loads introduced by beams.

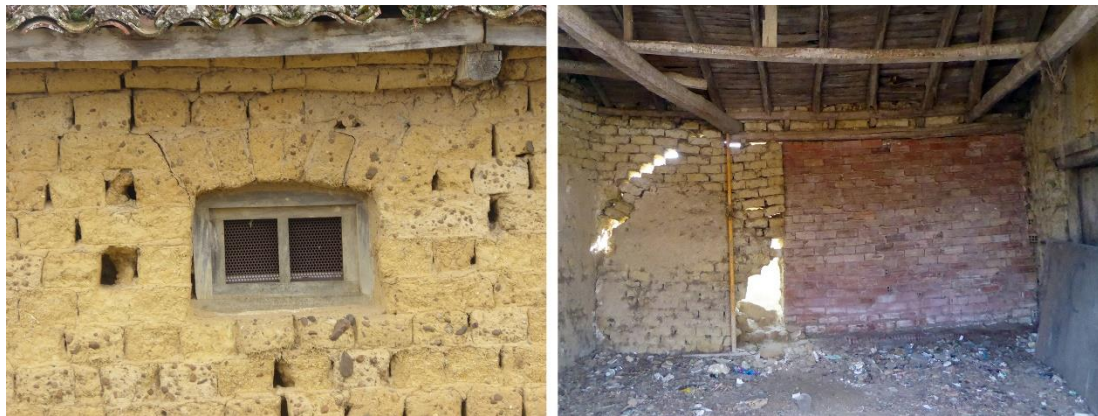
Door and window openings always introduce discontinuity into the adobe structure, at times leading to the appearance of cracks and deformations in these walls (Fig. 15). The analysis included in this section shows case studies that reflect structural problems

Masonry walls act as homogeneous structures in which openings introduce discontinuity, adding stress in some sections and lightening it in others, encouraging stress concentration at specific points¹⁰. According to the study results, the use of mortar with added binders does not improve the response of walls to the discontinuity caused by openings and this damage is found in both groups in similar proportions (8.19% compared with 7.87%).

Figure 15. Cracks due to structural weakness introduced by openings.

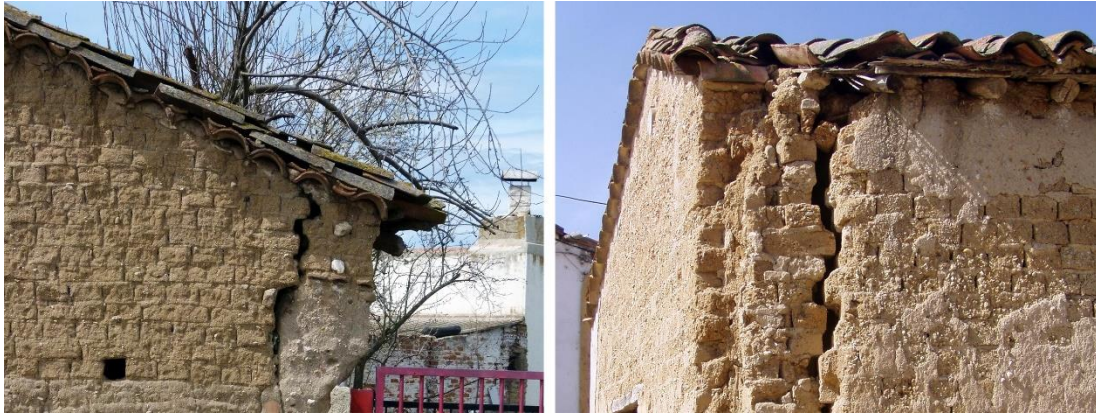
Poor fixing of the rafters in the loadbearing structure at the ridge can lead to major horizontal thrust in the crowning of the walls below the eaves. These intense stresses, far from the bottom of the wall, can shift the façades from their plane, giving rise to deformation and cracks¹⁰ (Fig. 16).

As the weights that the rafters of a sloping roof are usually similar, they tend to transmit similar horizontal loads to the crowning of the wall. From wall rotation, these concentrated loads appearing at constant gaps are equivalent to a homogeneous one positioned along the entire crowning of the wall. The deformation usually manifests through vertical cracks in the joint between the wall under rotation and the perpendicular elements. However, at times transversal walls retain the ends of the roof, which is mostly exerting thrust in the centre. In these cases, the deformation concentrates in the central section of the façade, where vertical cracks appear⁵¹.

7.59% of the case studies included in the sample are affected by cracks due to roof thrust, being far more common in walls bonded with binders (13.48%) than in walls bonded with earthen mortars (6.47%).

Figure 16. Cracks due to wall rotation from roof thrust.

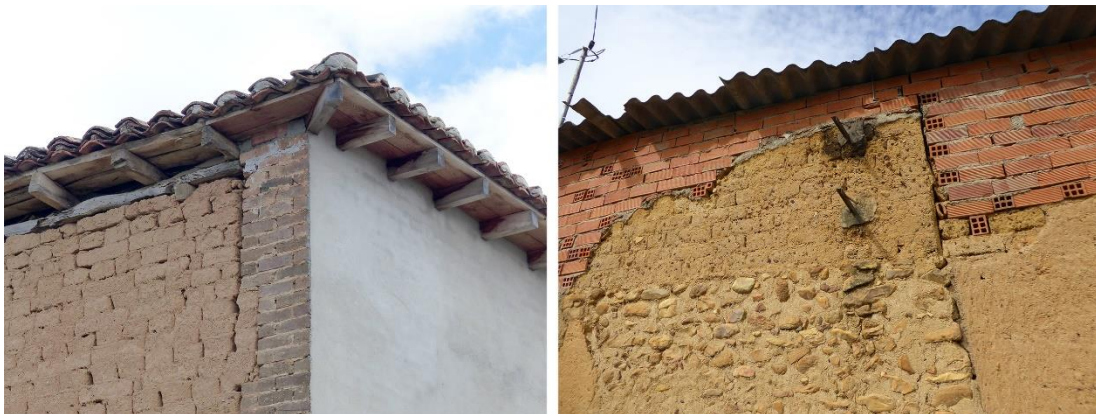
Construction of elements which are adjoining but poorly interconnected can bring about major material discontinuity in earthen constructions⁵² (Fig. 17). These poorly connected elements are weak points which show cracks caused by limited stress and deformation. The risk of these cracks appearing is even greater when the materials of the poorly connected elements have different rigidity and thermal expansion properties.

Cracks due to poor bonding are common phenomena are found in 12.30% of cases studied. This behaviour was slightly improved in constructions with mortar with added binders (10.11%) compared to those with earth mortar (12.72%), probably due to a slight increase in cohesion and solidness.

Figure 17. Cracks due to lack of interlocking between constructive elements.

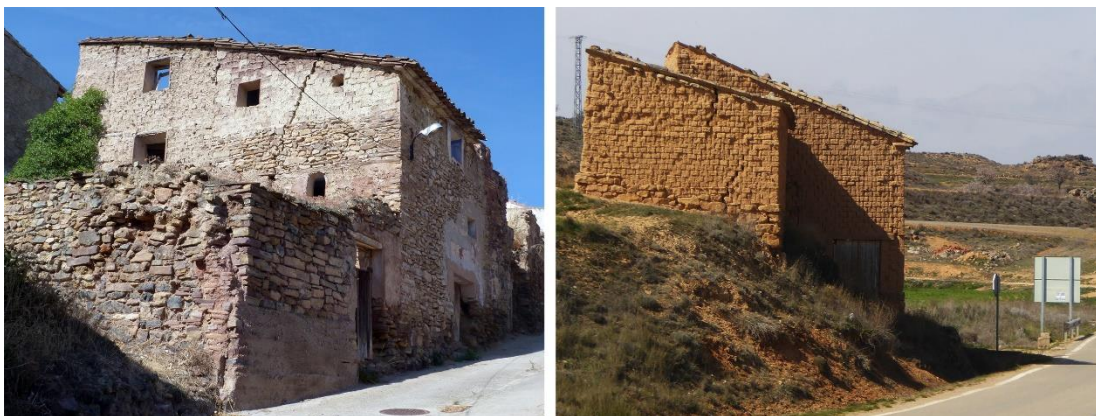
Buildings exert pressure on the ground they stand on, progressively compacting it, and gradually causing the construction to settle. When this compacting occurs homogeneously, the load transmission scheme of the structures does not suffer major alterations. However, some soils – such as expansive ones, those including compressible strata of a variable thickness or soils whose water table experiences significant seasonal fluctuations – can lead to irregular settlements and cause major stress to the construction, bringing about the appearance of major cracks and deformations. Missing or insufficient foundations can also hinder the dissipation of the loads transmitted to the ground, generating higher tensions at localised points of the ground and triggering irregular settlements. Buildings constructed with superficial foundations in steeply sloping land are also likely to suffer sliding movements able to distort the structure, producing cracks.⁵³

The analysis featured in this section has identified all the cases manifesting problems deriving from their support on the ground (Fig. 18), which affect 2.71% of the sample. There is virtually no distinction in the frequency in which this kind of damage

appears in adobe walls bonded either with mud mortars (2.59%) or other binders (3.37%). Deformations triggered by foundation movements can introduce very intense stress into the structures, turning the variation of the mechanic strength of the walls due to the use of a specific type of mortar into almost negligible.

Figure 18. Cracks due to foundation failure.
