A Case Study of a Large Unstable Mass Stabilization: “El Portalet” Pass at the Central Spanish Pyrenees

Abstract: This case study presents the engineering approach conducted for stabilizing a landslide that occurred at “El Portalet” Pass in the Central Spanish Pyrenees activated due to the construction of a parking lot. Unlike common slope stabilization cases, measures projected here were aimed at slowing and controlling the landslide, and not completely stopping the movement. This decision was taken due to the slow movement of the landslide and the large unstable mass involved. The degree of success of the stabilization measures was assessed by stability analyses and data obtained from different geotechnical investigations and satellite survey techniques such as GB-SAR and DinSAR conducted by different authors in the area under study. The water table was found to be a critical factor in the landslide’s stability, and the tendency of the unstable slope for null movement (total stability) was related to the water table lowering process, which needs more than 10 years to occur due to regional and climatic issues. Results showed a good performance of the stabilization measures to con

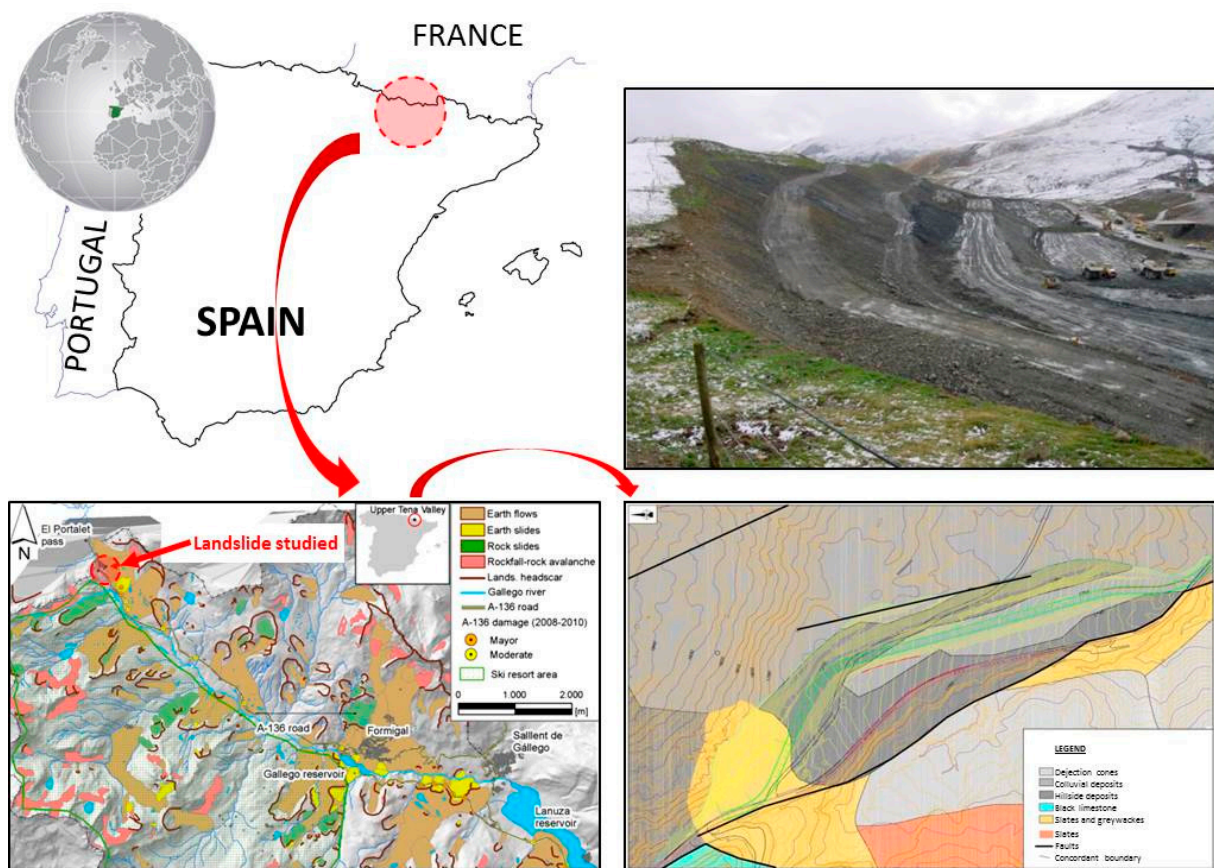
Figure 1. Geographical and geological setting of the area under study in the Central Spanish Pyrenees and view of the parking excavation works (note: bottom left image modified from [22]).

One of these slumps was mapped by García Ruiz [16,17]. Two parallel tension cracks, which form successive steps (see Figure 1), match the southern slope of the Petrusos spurs and they also overlap with the convex surface presented by the rocky hillside. At its toe, the slumps can be found with two coalescent lobes that reach the fracture northwest of the sunken block of “El Portalet”. The high density of such morphologies can be found on the Gallego head of the slope, especially between “El Portalet” and Formigal ski station in addition to the Peña Foratata southwestern slope, where superposed landslides tend to form great slumps. Most of them do not look very active, but other slumps are still moving or show a local reactivation.

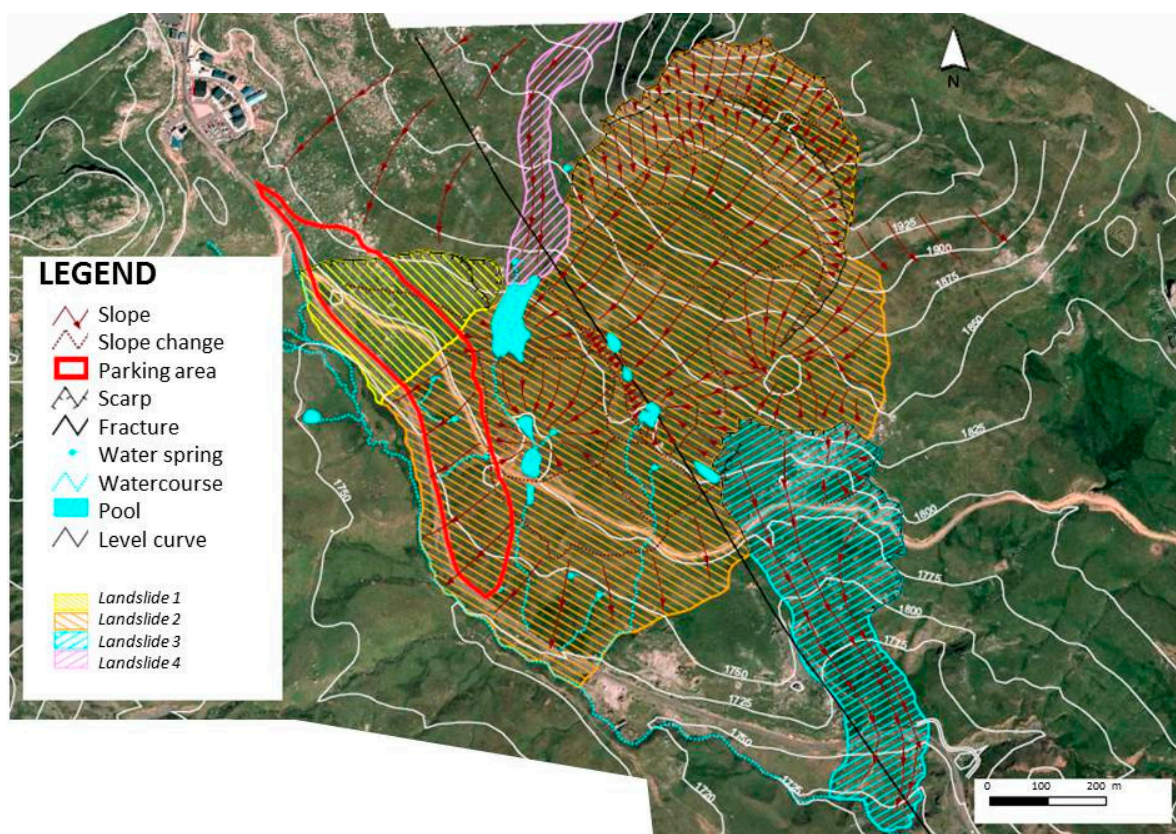
Topographical works developed during the previous investigation [15] detected the existence of three main landslides in the area under study (landslides, 1, 2 and 3 in Figure 8). This information was confirmed by the DinSAR data [21,22]. One of those landslides (landslide 3) was not affected by any anthropogenic activity (i.e., was not the consequence of the parking excavation) and was an extremely slow movement [46,47] with an estimated average velocity [22] of approximately 16 mm/year and affected by seasonal rainfalls. The second landslide (landslide 1) was activated by the parking excavation and corresponds to the slope movement under study. Its movement rate, estimated by the auxiliary DGPS campaign of approximately 0.1 m/year, meant it was not possible to compute its velocity with the DinSAR technique [22]. The third landslide (landslide 2) was located next to the previous one, was also activated by the parking excavation and its average velocity was estimated [22] at approximately 25 mm/year. The ALOS PALSAR differential interferometry [24] was also applied to this last landslide, obtaining similar results.

Figure 8. Main landslides detected in the area under study.

DGPS measurements [14], conducted after performing the stabilization work on the slope (i.e., landslide 2 according to Figure 8), showed that maximum displacement rates were around 1 mm/day in the summer while rates increased up to 2 mm/day in the fall. Those measurements also identified that the landslide's most active part was an area located below the main scarp. GB-SAR technique discovered that the landslide displacements were fairly linear in time, although slight differences were observed due to daily rainfall variations. Generally, an acceleration of the landslide occurs when rainfall events take place.
