## Repair grants for historic farm buildings in Dartmoor National Park

Nils White<sup>1</sup>

**Topic:** T4.1. Conservation and restoration projects of vernacular architecture

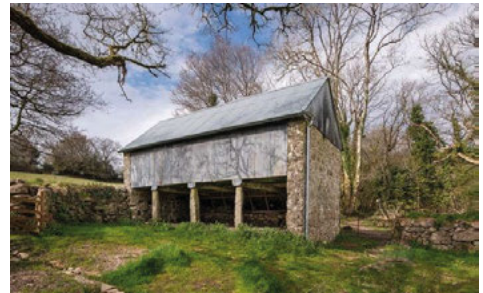
Fig. 1. Beckhams Linhay. East elevation following repairs (Source: Copyright Historic England Archive, Davies, 2021).

The structural survey found the corrugated iron roof to be corroded and leaking, and the rudimentary asbestos rainwater goods to be inadequate.

The roof cladding was replaced with new corrugated galvanised steel sheeting, and new galvanised rainwater goods were installed. Reinstatement of thatch would not have been practicable due to its high cost and ongoing maintenance liability; it would not be considered a suitable material in this wooded location (with overhanging trees preventing the roof from being dried by the sun and risking drip damage). In any case, corrugated iron has essentially gained honorary vernacular status in Devon, having been the material of choice in the 20<sup>th</sup> century to replace failing thatch. It should be mentioned that thatching today is often carried out using water reed harvested overseas in Turkey, or even China, rather than wheat from Devon, and where this is so, it is clearly neither authentic nor vernacular. On the other hand, corrugated iron provides an honest, cheap and durable substitute.

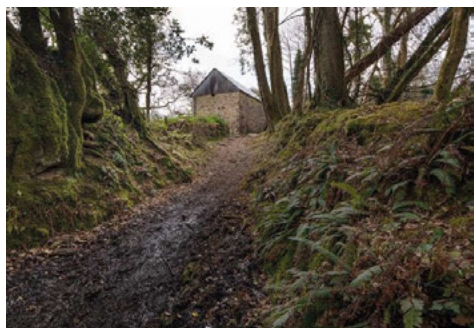
Fig. 2. Beckhams Linhay. North elevation following repairs (Source: Copyright Historic England Archive, Davies, 2021).

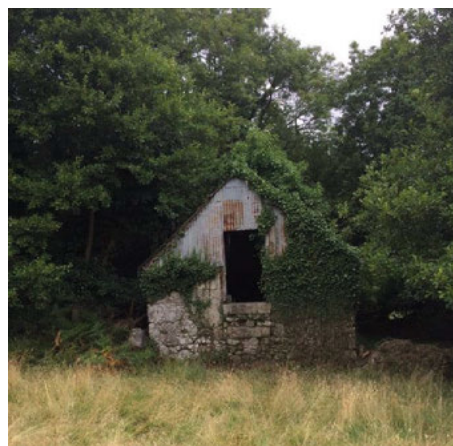
Fig. 3. Beckhams Linhay south gable before repair (Source: Jonathan Rhind Architects, 2019).

Once abundant ivy had been removed, the masonry was revealed to be generally sound, though there was a full-height vertical crack in the west wall caused by historic differential movement. In addition, significant water ingress was occurring at the base of the walls (caused in part to a natural spring) which had washed out bedding mortar and loosened the masonry. The joists and boards of the tallet floor were rotten in places, again as a result of water ingress.

To address the crack in the west wall, stitch repairs were carried out using *Helibar* ties bedded in lime mortar. Elsewhere, masonry was consolidated with lime mortar and re-used stone.

Existing bedding and pointing mortars were analysed in order to achieve as good a match as possible. The grawn originally used as aggregate would have been quarried near the site, but in this case, following mortar analysis by The Cornish Lime Company, was substituted with local sands and grits matching it in colour

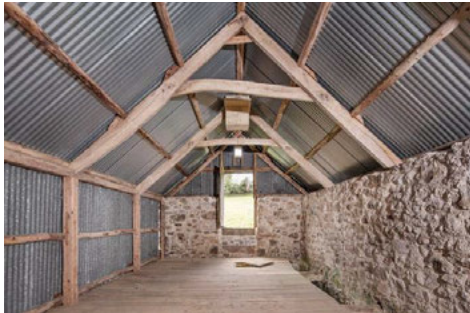
Fig. 4. Beckhams Linhay. Tallet interior looking south following repairs (Source: Copyright Historic England Archive, Davies, 2021).

and grain distribution. Lime putty was used as the binder. Following replacement of rotten joists, a new floor of replacement Douglas Fir boards was laid in the tallet. The existing corrugated iron cladding was retained on the east wall of the tallet for the sake of practicality, continued wildlife use and prevention of water ingress. An owl box was introduced to encourage their continued presence in the building.

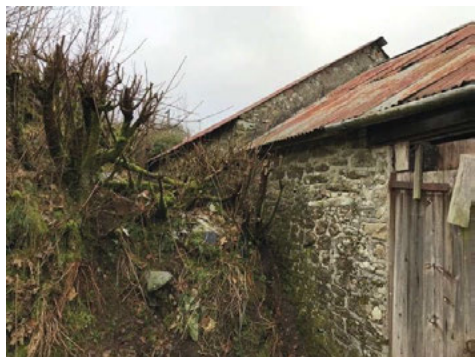
Fig. 7. Build-up of spoil and tree growth against south wall prior to excavation (Source: Jonathan Rhind Architects, 2019).

The buildings had suffered from the twentieth century build-up of rubble and earth spoil against their south wall. This had exacerbated water penetration, washing out pointing and bedding mortar and loosening the masonry. Furthermore, both the south and west walls had been further damaged by the roots of adjacent ash trees. A full-height vertical crack in the NW corner had been made worse by attempted repairs using Portland cement. The corrugated iron roof was rusty and let in water, and door lintels were rotten, or had been replaced with slender angle irons.

The first task specified was to remove the ash trees and excavate the spoil build-up on the south and west sides. This allowed a thorough inspection of their outside face and revealed the

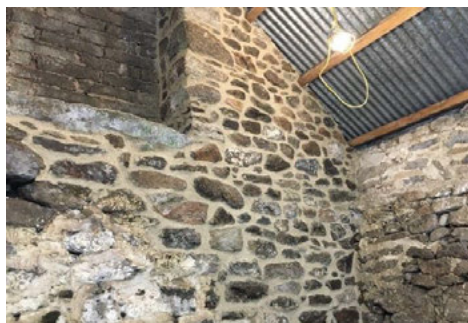
Fig. 8. North side of west gable following rebuilding (Source: Jonathan Rhind Architects, 2021).

extent of damage caused by tree root penetration. In the event, part of the west gable had to be rebuilt. As at Beckhams, stainless steel Helibars were used to tie old masonry to new. Another modern intervention was the placing of a root barrier membrane between the wall and earth to help prevent root penetration from reoccurring.

The extent of repointing was greater than had been originally specified due to water damage on the south and west walls; even so, it was only carried out where absolutely necessary. As at Beckhams, Full mortar analysis was carried out and matching material specified.

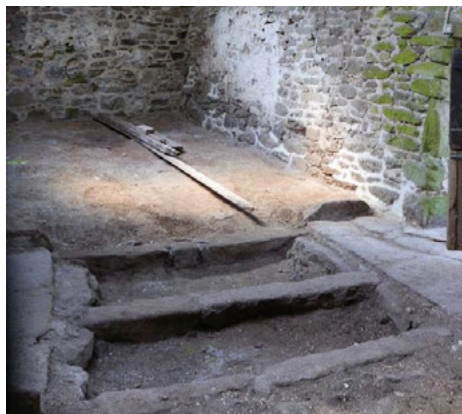
Fig. 9. Sleeper walls of former suspended threshing floor (Source: White, 2021).

During the course of works, the granite sleeper walls of a rare, suspended timber threshing floor were discovered and these were duly recorded by the archaeologist. The floor have been formed of oak baulks laid over the exposed void, with granite flagstones on either side. Once recorded, the voids were back-filled with subsoil from the rest of the site to match the surrounding area.

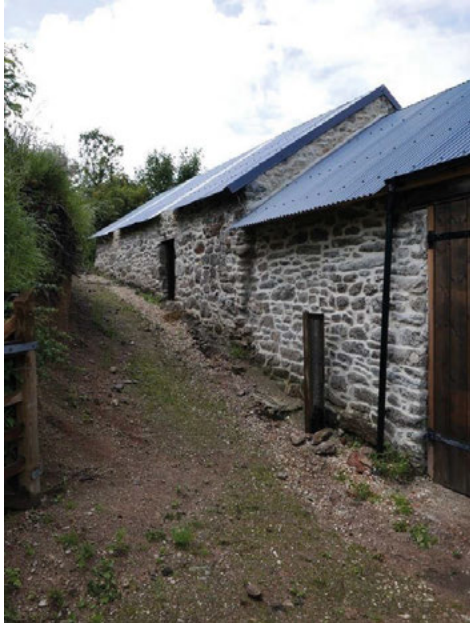
Fig. 10. South wall following repair (Source: White, 2021).

The corrugated iron roof was replaced and new seasoned oak lintels put in place. As there are no gutters or downpipes, a French drain was installed along the south wall to divert water away from the building.

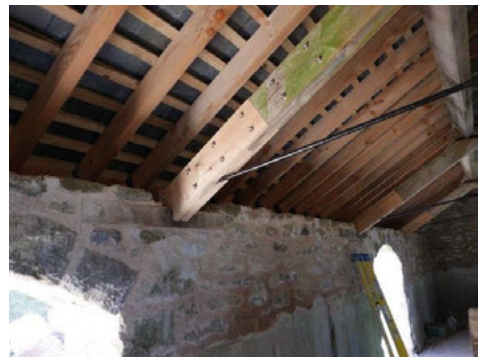
Fig. 12. Flich plate repairs to feet of principal rafters at Great Cator (Source: White, 2021).

In all cases, an ethos of repair rather than replacement has been followed; take for example the roof at Great Cator, where only the rotten ends of the Baltic Pine principal rafters were replaced, with flitch plate repairs ensuring minimal replacement of original material.
