State of conservation of half-timbered walls in Burgos (Spain): Quantitative analysis of material and structural degradation

Alicia Hueto-Escobar¹, Fernando Vegas², Camilla Mileto³, María Lidón de Miguel⁴

Topic: T1.3. Studies of traditional techniques and materials

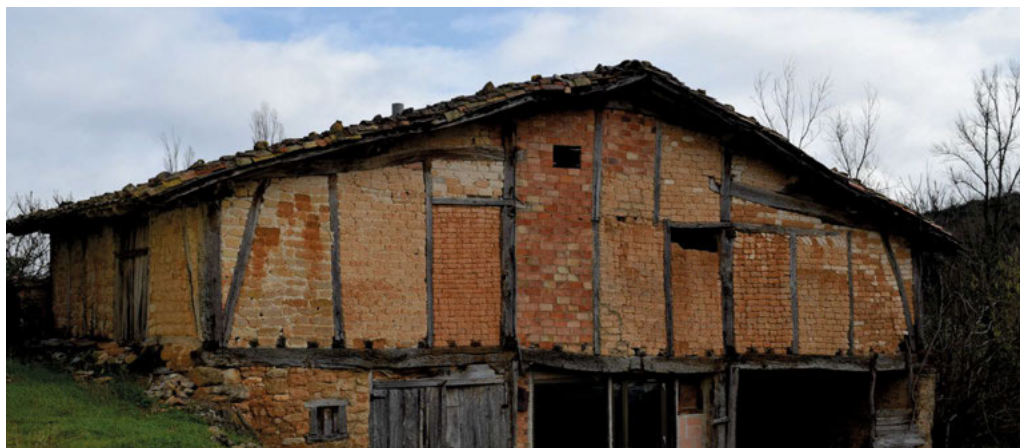
Fig. 2. Building in Villanueva de Tobera (Burgos), showing material lesions (damp stains, erosion, loss of volumetry, rot, replacement of infill, elimination of structural elements) and structural lesions (excessive buckling of timber, lack of bonding and fissuring of the infill) (Source: Hueto-Escobar, 2022).

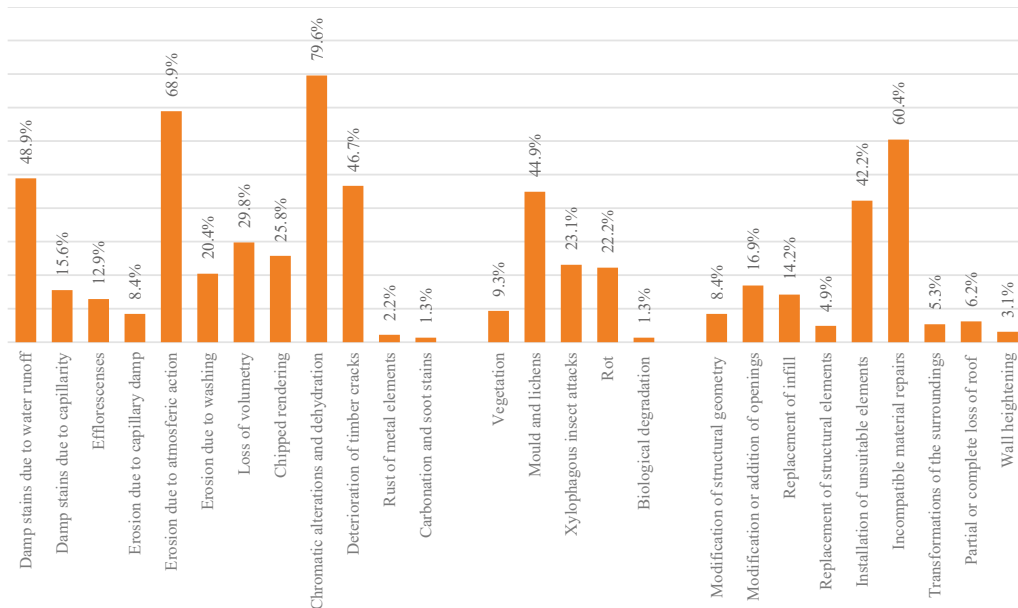
The pathologies most frequently detected were the atmospheric erosion of infill (68.9%) and the chromatic alteration and dehydration of timber (79.6%). Among the lesions due to biological and anthropic agents it is particularly worth noting the presence of mould and lichens (44.9%), unsuitable anthropic interventions for the installation of foreign elements (42.2%) and repairs with incompatible materials (60.4%).

Fig. 3. Incidence of the different material degradation processes identified (Source: Hueto-Escobar, 2022).

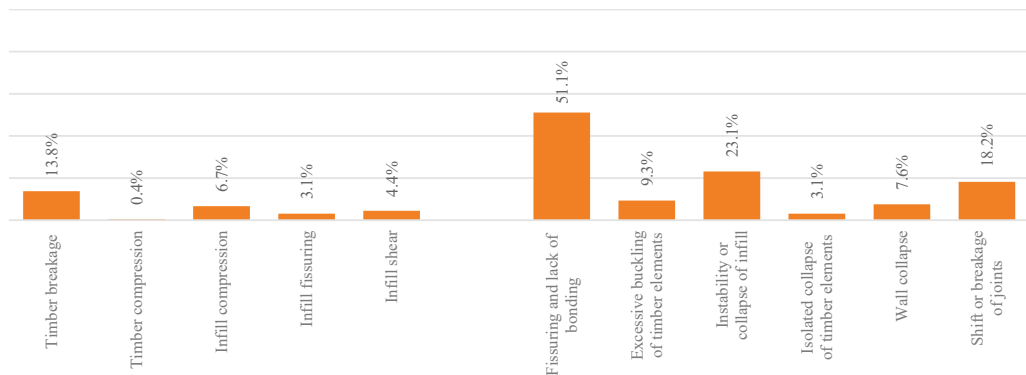
The lesions caused by excessive deformation are more common than those generated by excessive stress, mainly fissuring and lack of bonding (51.1%) in the first case and breakage of timber elements (13.8%) in the second.

Fig. 4. Incidence of the different structural degradation processes identified (Source: Hueto-Escobar, 2022).
