Restoration of the stained glass windows of the British Cemetery of Valencia

Carmen Burguete Gil¹

Topic: T4.1. Conservation and restoration projects of vernacular architecture.

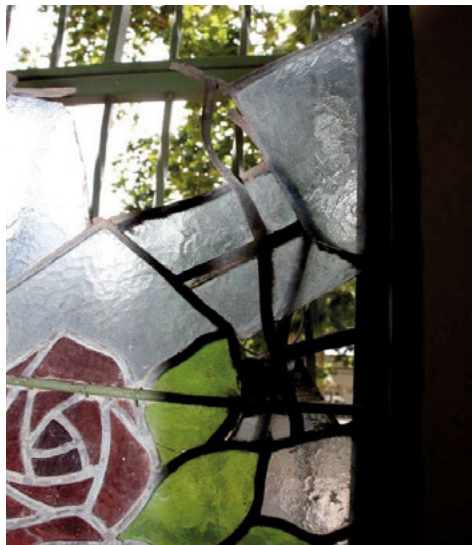
Despite being located inside the cemetery, protected from vandalism, the stained glass windows showed cracks and the loss of part of their design. These panels displayed a serious deterioration of the lead, with around 10% missing. It also presented damage mainly through the passage of time (dirt, discolouration).

Fig. 4. Detail of the stained glass window on the chapel door. British Cemetery, Valencia (Source: Burguete, 2017).

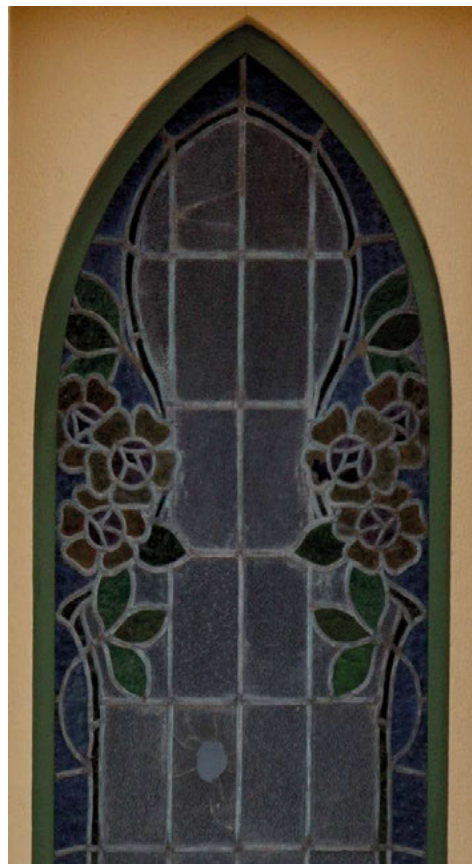
Located on the left side of the façade, it filled a pointed arch, a characteristic Gothic shape and copied by Vicente Sancho in this neo-Gothic façade. The stained glass window occupied an area of 1.025 m². It had a similar design to the chapel door, a plant network with leaves and daisies. Due to its outdoor situation, this made it more sensitive to acts of vandalism which had broken the lower part. The loss of the lead had also caused the glass pieces to bulge. It was observed in the study carried out, that the stained glass window had undergone previous restorations. These were carried out in situ (without dismantling) and had caused damage to the lead, weakening the consistency of the stained glass. Missing joints had been replaced by lead adhesive and pieces shown in the original drawing had been removed.

Fig. 5. Chapel window. British Cemetery (Source: Burguete, 2017).

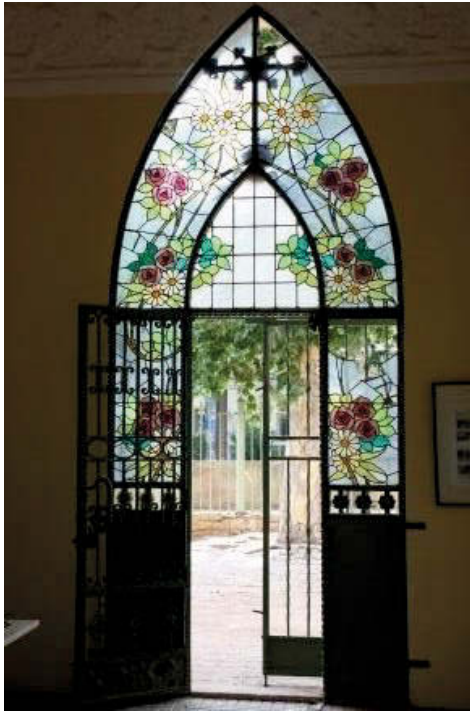
window is 2.6 m². Its structure meant that the lower glass pieces supported a great weight due to their dimensions. This caused the lead that held the pieces to lose its consistency causing bulging and detachment of pieces over the years.

Fig. 6. Cemetery gate. British Cemetery, Valencia (Source: Burguete, 2017).

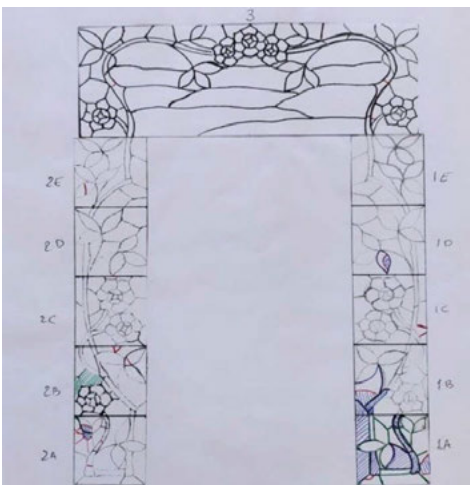
Fig. 7. Damage scheme. Chapel door. British Cemetery (Source: Benavent, 2017).

Initially, all the pieces were drawn in a diagram in which all the observed damage was recorded: broken glass (red), missing glass (blue), broken lead (green), missing lead (blue), and glass from previous restorations (green). The damage was classified into three types. One was caused by vandalism. It caused glass breakage and loss of lead sections. The second one was due to the passage of time and lack of maintenance, leading to a build-up of dirt and loss of lead. Finally, the damage caused by previous restorations that had been poorly executed. Those interventions aimed to correct the loss of parts and the deterioration suffered by the lead, and even by acts of vandalism, but they caused even greater damage to the state of conservation. These interventions were carried out without dismantling the stained glass windows. Likewise, they were not dated by those responsible for the maintenance of the cemetery. For this reason, it was believed that they were made solely in an attempt to maintain the structure of the window without any prior study. This fact not only caused damage to the window, but also complicated the restoration work and the adjustment of the budget.

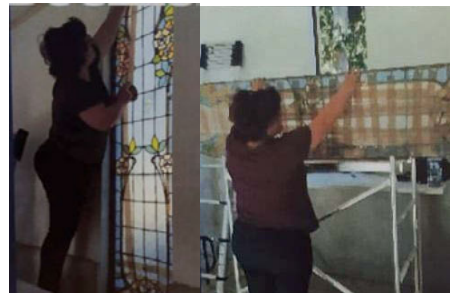
Fig. 8. Disassembly works. British Cemetery (Source: Benavent, 2017).

Once the four pieces were catalogued in terms of their shape, design, condition and damage suffered, they were prepared for disassembly. For this step, the loose parts were secured with non-aggressive adhesive tape. This step ensured that once they had been disassembled, an exact tracing of the stained glass could be made. It could then be returned to its original shape once the restoration work had been carried out.

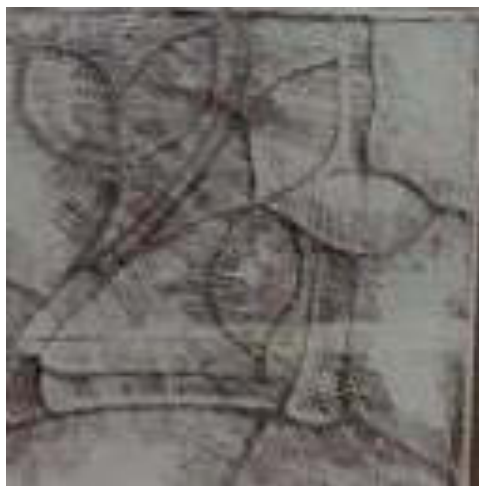
Fig. 9. Charcoal copy (Source: Benavent, 2017).

After dismantling, the pieces were placed horizontally on workshop tables. There, a life-size copy of each window was made by copying with charcoal on onion paper to guarantee the correct restitution of the parts that had to be disassembled.

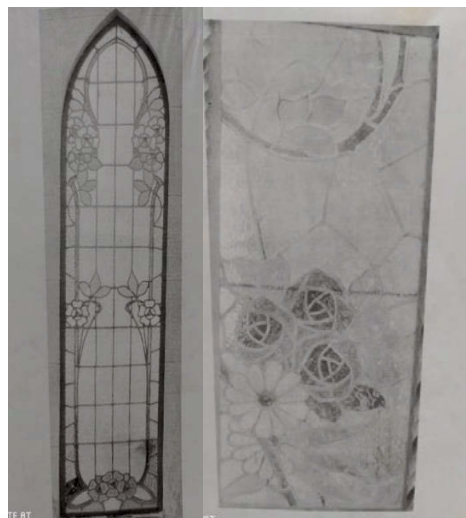
Fig. 10. Cardboard drawings. Chapel window. British Cemetery. Valencia. (Source: Benavent, 2017).

In those parts with broken glass or where cord was damaged, the lead was removed to allow proper cleaning of glass and replacement of broken panes. The panes of glass that had been replaced in the previous restorations were replaced by glass in original colours. As an example, the daisies, incorrectly glazed with white glass, had their original yellow glass restored. Once the glass was prepared, it was welded. Following the restoration criterion that was to preserve the original glass to the maximum, the new weld beads were made with tin, following the Tiffany technique so that the restored parts were differentiated from the originals. Finally the beads were restored and cleaned. The original state was reconditioned after removing two-thirds of the stained glass to give consistency.

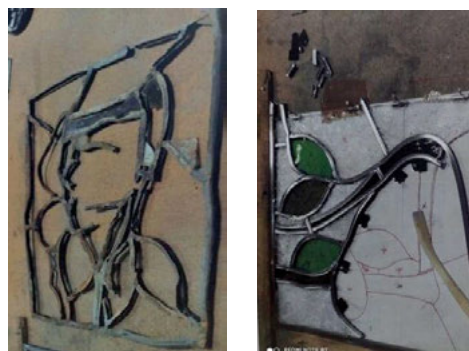
Fig. 11 & 12. Disassembled stained glass lead cord.; stained glass reassembly (Source: Benavent, 2017).

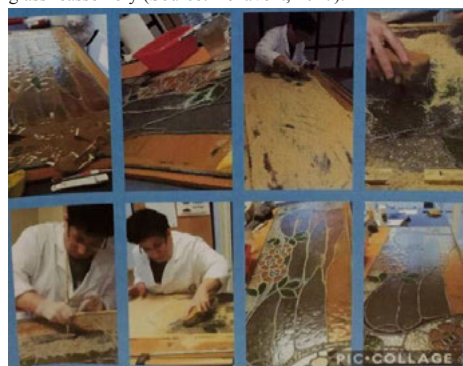
Fig. 13. Restoration process (Source: Benavent, 2017).

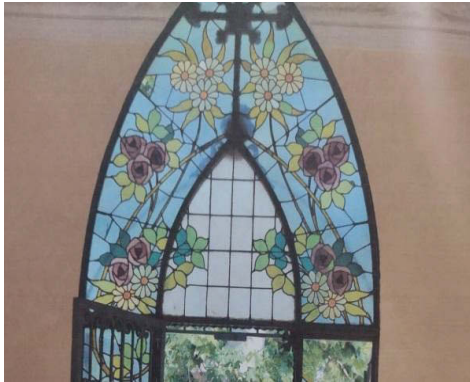
Fig. 14. Restored stained glass window, gate, British cemetery, Valencia (Source: Benavent, 2017).

Once restored, the initial process was followed in reverse. The pieces were packed and returned to their original place. Then, it could be observed that they had recovered their transparency and original colour. In that way, they once again endowed the rooms that were illuminated with colour.
