Rigour, methodology and use, success in heritage conservation: The tower of the St. Mary Magdalene`s church.

Pedro Rodríguez Cantalapiedra¹

¹Architecture, urban planning and restoration studio, Valladolid, Spain, pedro@pedrorcantalapiedra.es

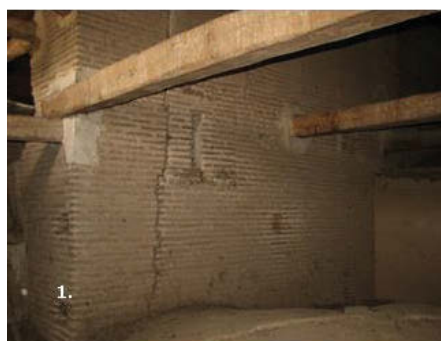
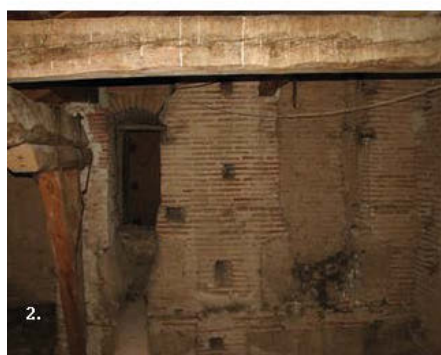
Fig. 3. 1. View of the exterior of the old tower. 2. View of the interior of the old tower with the holes for the bells.

Formerly to the construction of the original tower, another tower had been built. The tower was knocked down due to structural problems and some elements that were not demolished, still remain (Fig. 3).

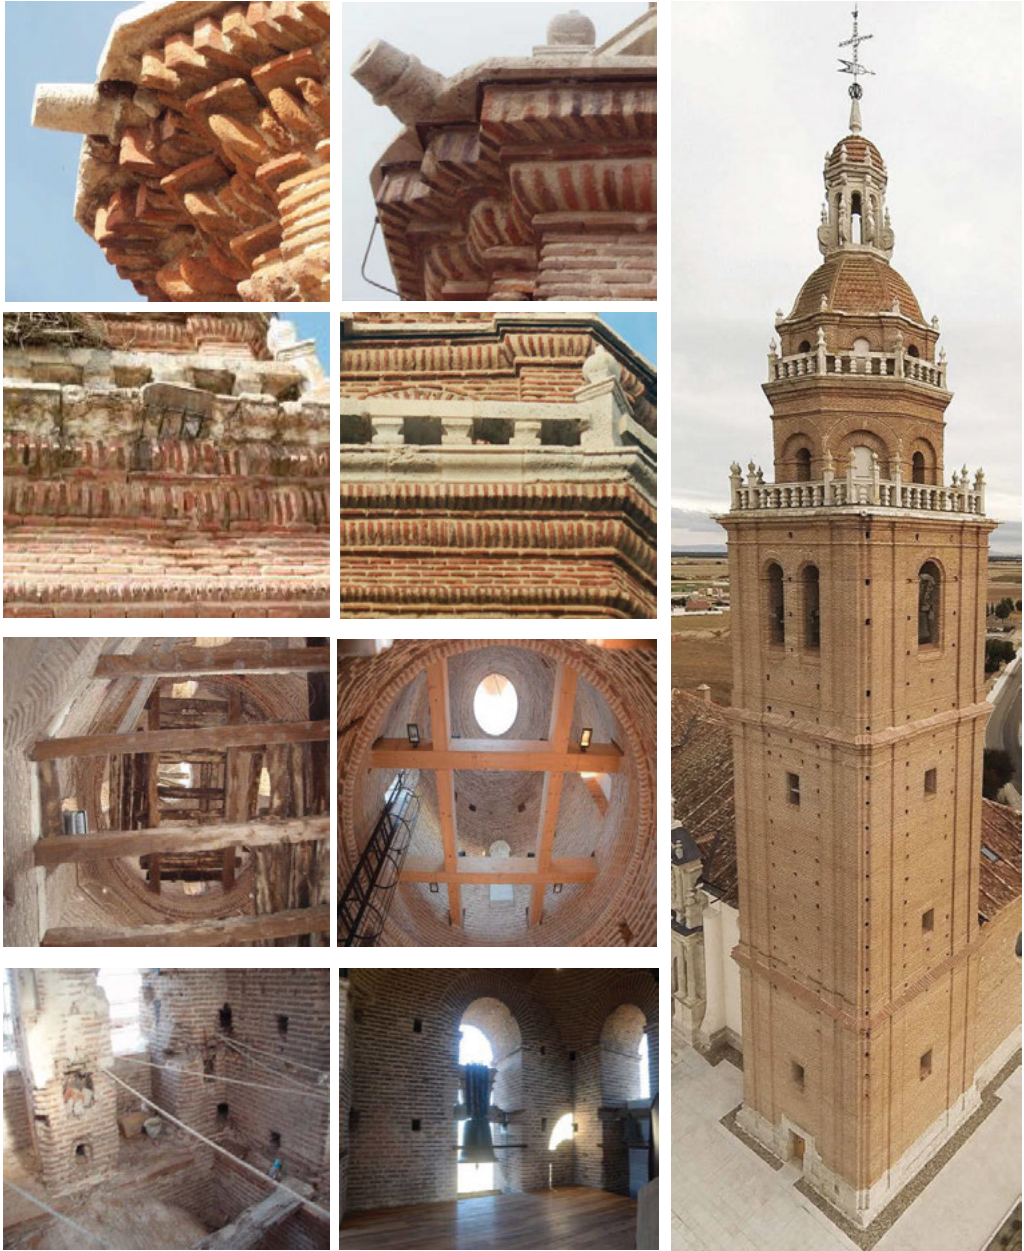
appreciated before, was verified. It was also found that certain elements did not fulfil the functions that were expected. Significant loss of material was centred on cornices, imposts, spandrels, balustrades and pinnacles, and this loss was particularly accentuated, especially in the octagonal finial, and the cornice on the terrace level.

The biggest of the new problems encountered was the breakage of the small dome of the lantern and the top of the stone pinnacle of the top where the weather vane is located. In order to successfully repair it, the origin of the breakage was analysed, and the cause was diagnosed as being wind whipping the weather vane and the lightning rod cable, which, in a tense manner, descended through the small dome and the lantern, transmitting horizontal movements to the pinnacle.

Fig. 5. Comparison of the previous state and the renovated state. Summary images of the final state.

The restoration process began with the selective cleaning of the masonry, the sanitization of the deteriorated joints, and later with the particularised grouting according to the facade plans, the replacement of the missing ceramic pieces (new pieces made by hand and according to size), and the repositioning and reintegration of all the balustrades, pinnacles and finishes.

The roof of the dome is subject to a detailed restoration and cleaning program. This included the sanitization and removal of lime scale from roof tiles, stone elements and cornice details with minimum degradation. All added materials, such as Portland mortars or deteriorated metal elements, are chopped and removed. It is noteworthy that two ceramic pieces with unique markings were discovered on its summit: one with the full name of Machuca, and two others with handprints, as signatures of the author or authors of the work. (Fig. 4).
