RURAL ARCHITECTURE. REHABILITATION AND PUTTING IN VALUE. MOYA

Emma Barelles-Vicente

Department of Architectural Constructions, Universidad Politecnica de Valencia, Spain.
ebarelle@arq.upv.es

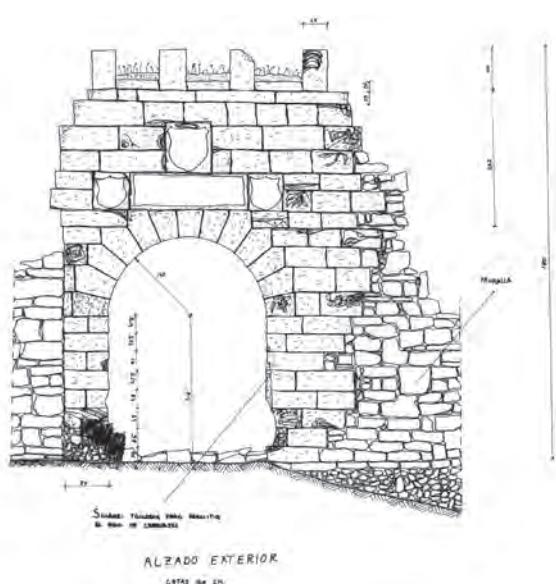
Fig. 9. Drawing showing the gate of the Villa. (Source: the author).

Its state of conservation is very poor, offering a desolate image. Of the two faces or façades of the façade, it is the southern zone that offers a worse state and where some provisional shorings have been able to prevent the collapse.

On the north face of the doorway, the ashlar are moved and displaced, with open joints and with the voussoirs and the keystone of the arch clearly displaced by the lateral thrusts.

We believe that what has been previously described is due to the lack of protection that the doorway has with respect to the walls, especially in the pilaster or side facing the "east" façade.

The lack of lock between the semicircular arch (north façade) and the lowered arch of the south façade are those that have considerably influenced the damage produced.

The two sheets (north and south) of the arches contained a masonry fill with a defective upper finish that allowed continuous wetting of this fill over the years, which has been generating strong lateral thrusts and also dead weight on the arches.

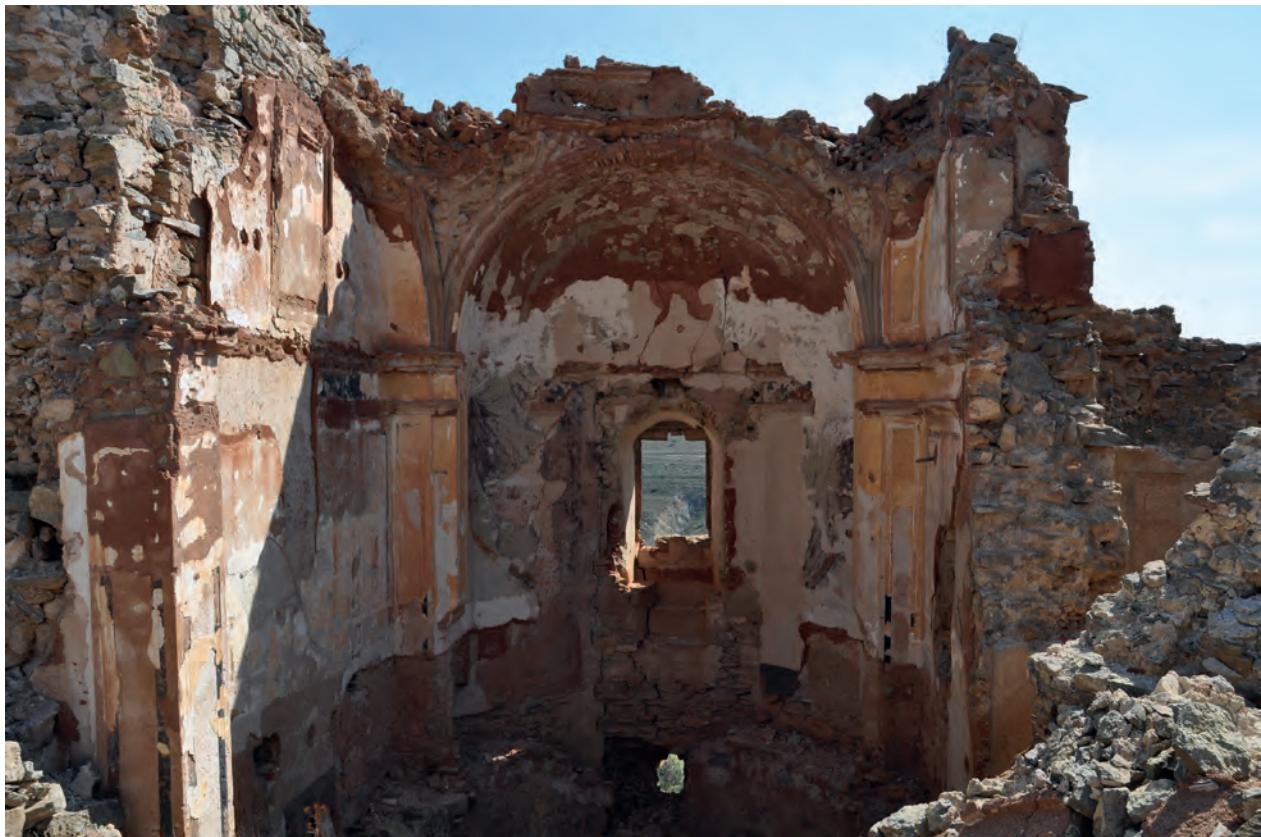
Fig. 12. The interior of the church of San Bartolomé. (Source: the author).

The lesions found in the building are summarized as follows: humidity by capillarity, loss of interior lining, loss of decorative paintings inside, breakage of interior moldings, dirt on ornamentation, fissures and cracks in lining, loss of section in walls, landslides in different elements, loss of verticality in elements and loss of mortar in ashlar or masonry joints (Barelles & Gimenez 2015).

Within the possibilities of intervention and focusing on the case study of the Church of San Bartolomé, whose level of deterioration is considerable, we have opted for preserving by carrying out the necessary operations on the property, guaranteeing its survival against environmental incidents. and the passage of time. In this way, it is committed to consolidating the structural elements, providing them with greater consistency and solidity, in order to avoid the imminent collapse of some of its parts. Always through the use of materials and techniques compatible with those existing in the building (Gómez de Terreros & Pérez-Prat 2018).
