# **Seismic vulnerability and heritage losses of rammed earth minor heritage in Mula (Murcia)**

Luisa Basset-Salom; Arianna Guardiola-Víllora

Focused on a small sample of rammed earth residential dwellings in the city of Mula, one of the areas of highest seismic hazard in Spain, the seismic vulnerability has been assessed adapting the Vulnerability Index Method (Risk-UE) to tackle the specificities of earthen residential buildings.

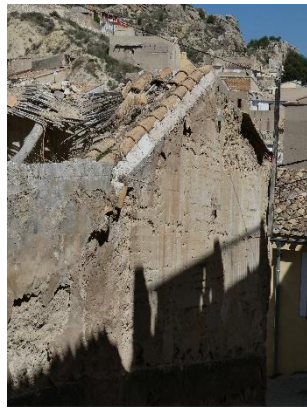
**Very bad**  
Roof and/or floors seriously damaged.

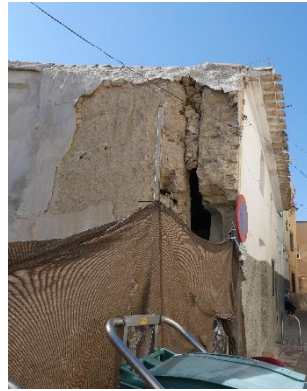
**Very bad**  
Lack of connection between orthogonal walls

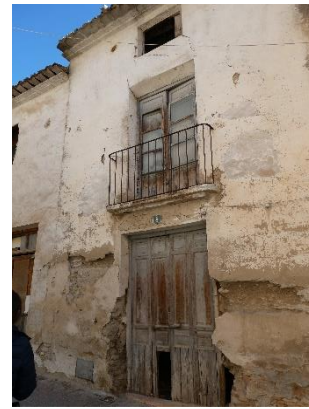
**Bad**  
Bearing walls seriously damaged

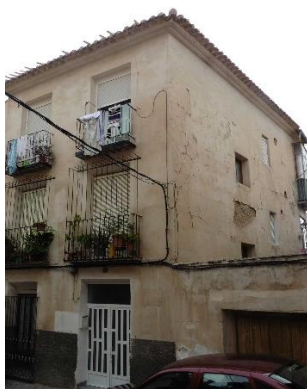
**Medium**  
Cracks in bearing walls, extended moisture in the lower part.

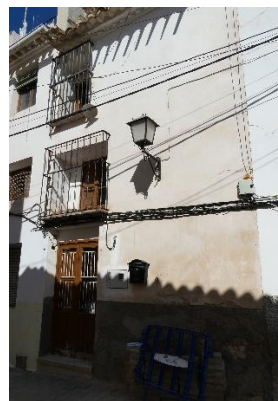
**Good**  
Small cracks in the renderings.  
Small stains of moisture

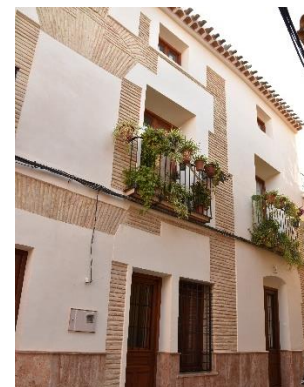
**Very good**  
No presence of cracks nor moisture

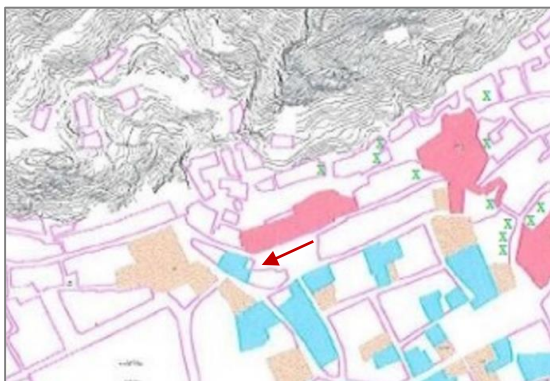
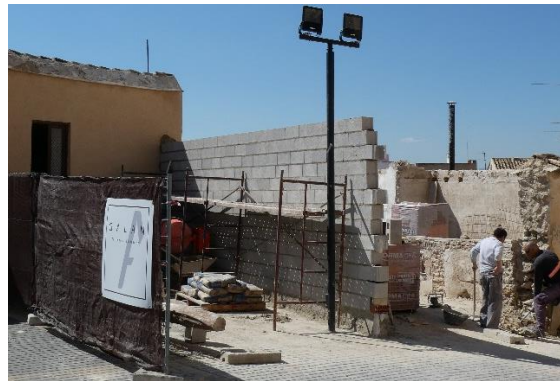
Figure 21. Rammed earth building being demolished. Source: The authors 2021

From the point of view of the authors, it is important to take action as soon as possible to minimise any future damage, as well as to prevent any seismic event to be used as an excuse to demolish the damaged buildings, despite their listing grade. It is a pity that rammed earth houses within the area of influence of the ACI are demolished and replaced by new ones with load bearing concrete blocks walls, as observed during the fieldwork (see figure 21).
