# Analysis of the failure and remedial measures taken after the collapse of a historical bell

This paper describes the collapse analysis of the historical *El Jaume* bell, cast in 1429, one of the bells in the Cathedral of Valencia's *Micalet* bell tower (Spain). In 1992 the yoke was completely restored and given a new steel axis. The failure occurred when the bells were being rung on Christmas Day 2014, fortunately without any casualties. After several field visits to assess the damage and failure “in situ”, a diagnosis was made of the causes of the failure. The diagnosis was the result of (1) a detailed visual inspection, (2) a metallographic and fractographic analysis of the fractured steel axis, (3) a fatigue damage analysis by finite element modelling software and (4) an estimation of the bell's remaining fatigue life cycle using Whöler S-N curves. In view of the results obtained it was concluded that the fatigue life cycle should have been reached between 300,000 and 400,000 cycles, while the failure occurred at 346,500 cycles. Although these elements are usually designed to not fail during its life, they can sometimes suffer cracks during cyclic ringing. One of the main cau

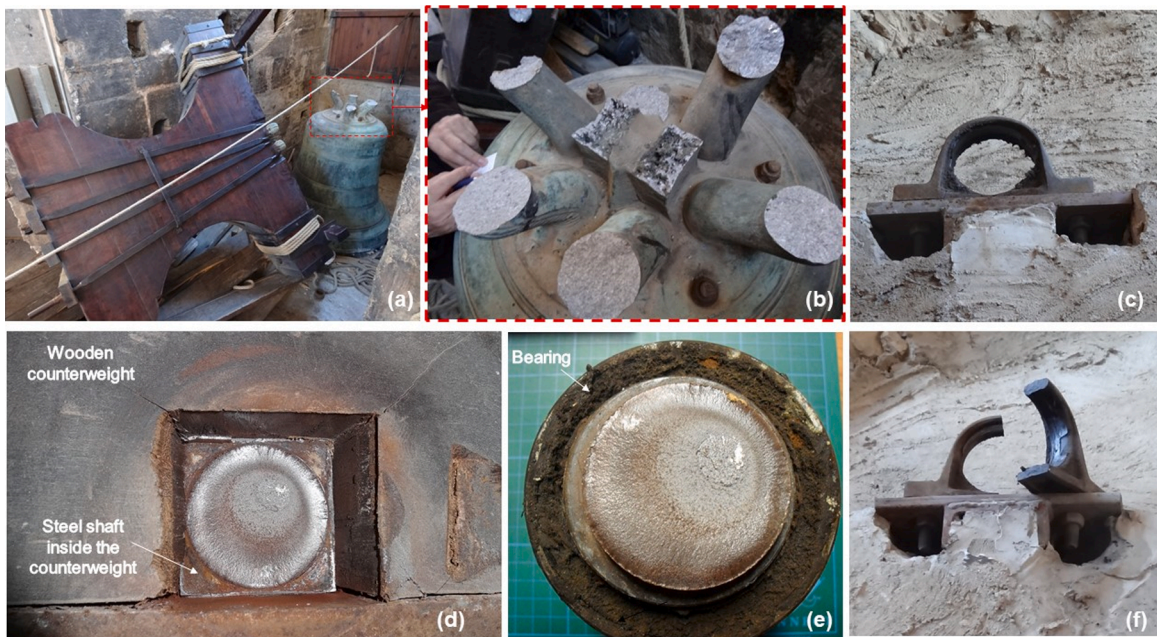
Fig. 2. Photos taken after the collapse of the bell.

- The bell canons, which join the bell to its counterweight, were completely fractured (Fig. 2a and b).
- The circular gudgeon left the support. The left-hand bearing anchorage suffered no apparent damage (Fig. 2c).
- The bell's left-hand steel shaft gudgeon was also broken (Fig. 2d-e).
- The right-hand bearing anchorage was split (Fig. 2f).
- The bell's right-hand steel shaft gudgeon was out of his position but not broken.

The bright colour of the cross-section of the five broken canons without signs of oxidation or to the sudden application of higher stresses than they could resist. The bell was in a vertical position on the floor, indicating that the fracture occurred with the bell horizontal to the outer tower wall.

The fracture of the bell's left-hand steel shaft gudgeon occurred just where the square section joined the circular section (Fig. 2d and e). The fact that there is no gradual transition between the square and circular sections is of special importance as this creates a zone with high stress concentration. The visual inspection of the fracture (Fig. 3) revealed four clearly different circular zones (A, B, C and D). The centres of the first three zones are out with respect to the geometric center of the steel axis while D is concentric with the axis. A section is approximately circular, rough and was the ultimate section to resist stresses so that the final break was ductile once the cross section was yielded by overload. B is less rough than A and is due to the cyclical tension-compression stresses on the axis, and moved upwards due to most of the cracks being on the underside of the gudgeon. Zone C was reddish due to oxidation, indicating that it had been open to the atmosphere for some time. D was brightly coloured and smooth due to the friction between the two sides of a crack and this was where the fracture of the axis began.

Finally, Fig. 2c and f show the steel shaft gudgeon supports: in Fig. 2c it can be seen that the circular gudgeon left the support – which suffered no apparent damage – after the break, while 2f shows the destroyed right gudgeon support.

From the above evidence it can be said that the collapse took place in the following phases: 1) fracture of the left-hand gudgeon when the bell was practically horizontal to the outer wall, probably due to a fatigue crack initiated in the transition of the circular-to-square section; 2) when the gudgeon broke it was forced out of the right-hand support and the weight of the bell together with its inertial forces caused the fracture of the bearing anchorages; and 3) the bronze and the counterweight fell to the floor at an angle no greater than 50° causing the brittle fracture of the canons. The bell itself remained mouth-down and the counterweight fell beside it.

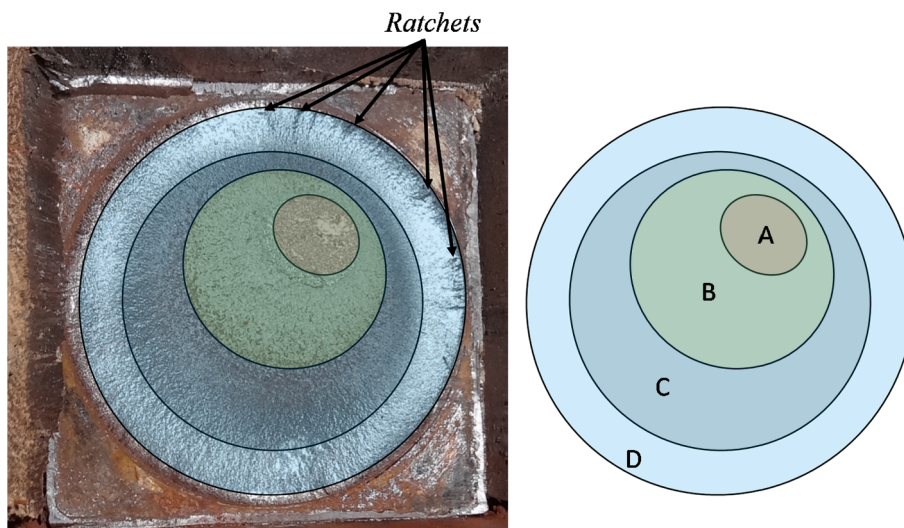
According to [30], this type of failure is typical of a shaft subjected to tension-compression stresses derived from positive-negative bending under low stresses – the bell goes through relatively few revolutions compared to an industrial machinery - but with severe stress concentrations (Fig. 4). Presence of ratchets is another characteristic feature of fatigue failures in rotating bending shafts (Fig. 3).

Fig. 3. Cross section of the different zones of the fractured axis.

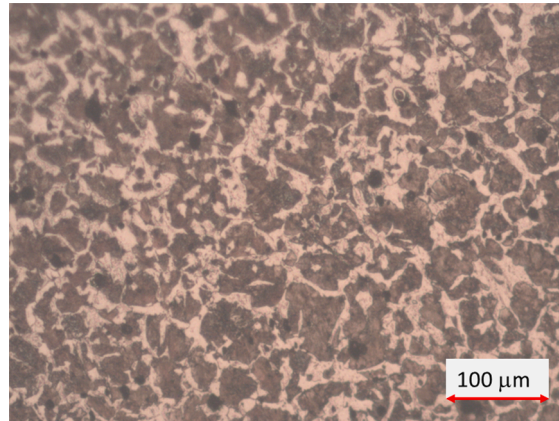
Fig. 5 shows the sample microstructure as observed in an optic Nikon Microphot microscope after polishing and etching with Nital3 reagent. It consists of proeutectoid ferrite (creamy color grains) and pearlite grains (brown grains).

The average microstructural grain size is very fine. The intercepted length by each grain ranges between 0.018 mm and 0.030 mm, which corresponds to a normalized grain size of index  $G = 7 \sim 8$  according to the standard measurement method EN-ISO 643: Steels. Micrographic determination of the apparent grain size [37].

This fine grain size and the ferritic-pearlitic microstructure is typical of medium carbon 0.40–0.50% C hypo eutectoid steels in a normalized condition or heat treatment. The exact type of steel is unknown, but both microstructure and properties observed are similar to those corresponding to the widely used and well-known non alloyed C40 or C45 construction steels [38]. Table 3 gives the composition and properties of these steels.

**Fig. 5.** Microstructure of the gudgeon steel after polishing and etching with Nital 3. 100X.

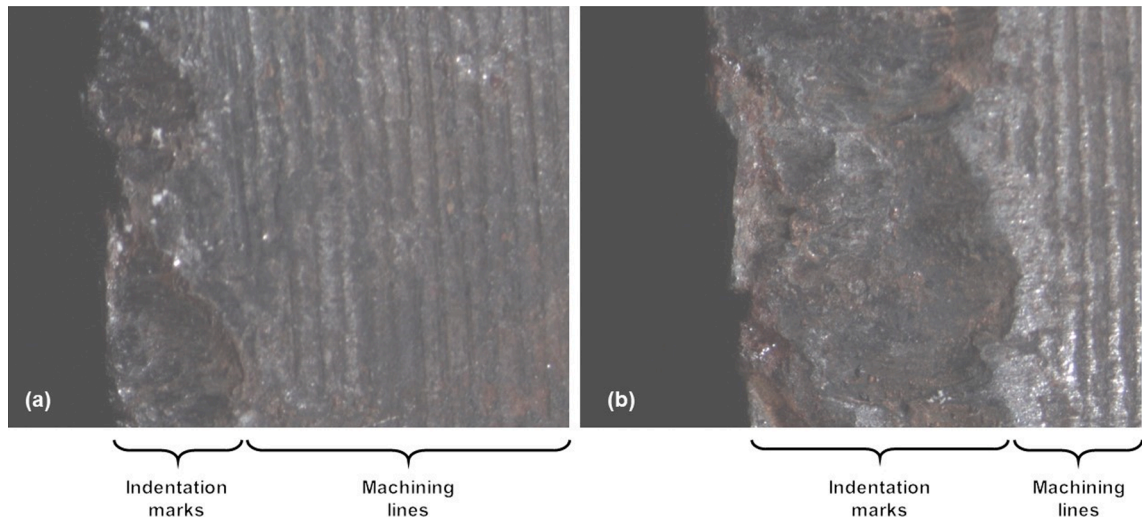
A fractographic visual inspection near the fracture section of the steel shaft gudgeon was carried out using a Nikon stereoscopic microscope. Some surface irregularities that could act as crack initiation sites can be seen in Fig. 6 (fracture section on the left of the image). These indentation marks were probably caused by the tool used to insert and fix the gudgeon into the wooden counterweight. The fine surface and parallel line marks due to machining can be observed on the right side of the images.

Fig. 6. Stereoscopic images of the gudgeon surface immediate to the fatigue fracture. (a) 10X, (b) 50X.

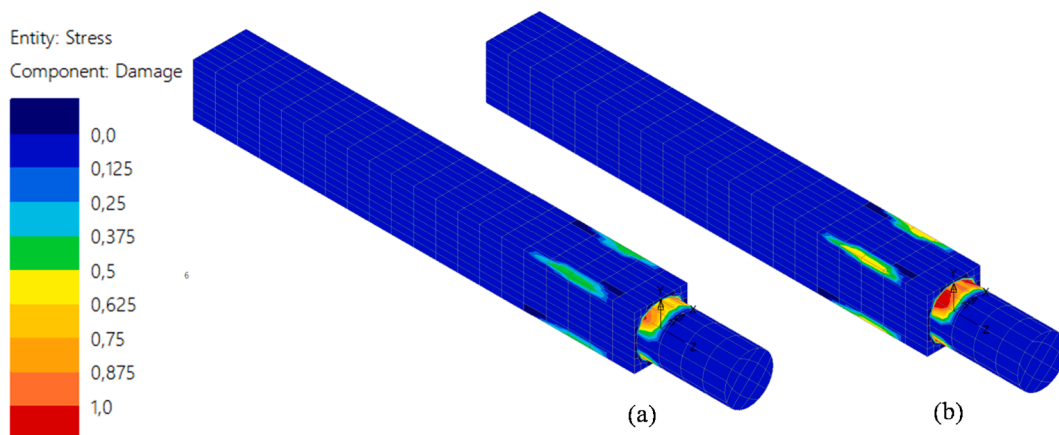
Fig. 9 shows a 3D plot of the damage distribution along the steel gudgeon for numbers of cycles corresponding to 300,000 (Fig. 3a) and 400,000 (Fig. 3b) cycles. In view of the results, it is observed that fatigue damage is concentrated and accumulated in the perimeter of circular section transition to square section. Around 300,000 cycles starts the fatigue damage, with damage values of  $D = 1.06$  in certain small areas of the perimeter. For a value of 400,000 cycles, damage has spread along the perimeter, extending the damage zone and reaching most of the perimeter.

Fig. 9. Fatigue damage in steel axis. (a)- For 300,000 cycles. (b)- for 400,000 cycles.

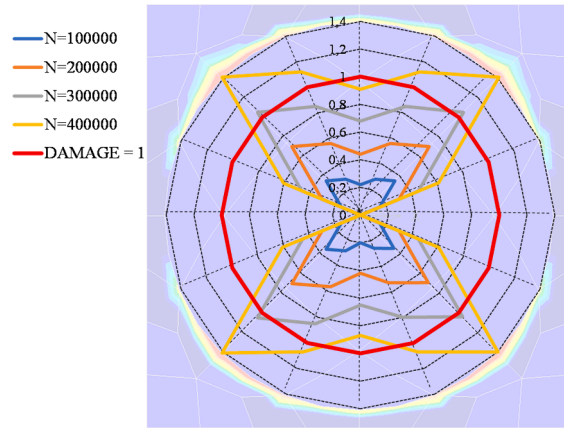
Fig. 10 shows the fatigue damage value and propagation in circular cross section for different number of cycles. In red colour, the fatigue damage value  $D = 1$  is shown, starting from where the failure is considered to start. Up to 200,000 cycles, maximum values of  $D = 0.65$  have been reached. However, for 300,000 cycles fatigue damage ( $D > 1$ ) starts in some small areas of the perimeter, although in most parts of the section there are values around 0.7 and 0.8, close to 1. For values of 400,000 cycles, it is observed that almost 50% of the perimeter presents values of fatigue damage  $D > 1$ , and other areas with values close to 0.6. For this level of fatigue damage, collapse of the bell should already have occurred. Based on the results of this theoretical model, fatigue failure can be expected to occur between 300,000 and 400,000 cycles.

Fig. 10. Fatigue damage propagation in cross section for different number of cycles.

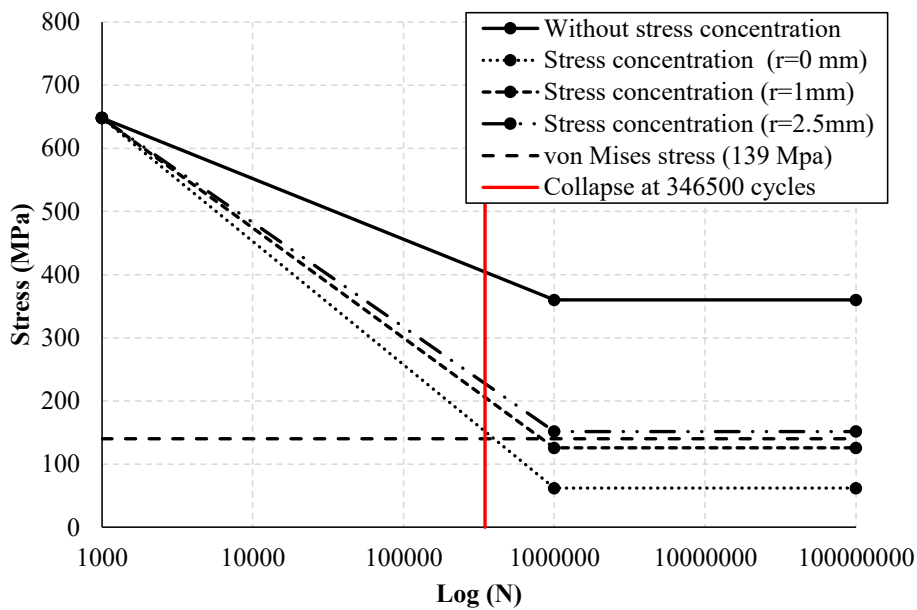
The fatigue stress  $S_n^A$  is obtained from a study of the effect of the transition radius. Fig. 14 shows the Stress S - Log (Number of cycles, N) curve, where the curve is considered without the stress concentration effect, the S-N curves considering a stress concentration for a transition radius of 0, 1 and 2.5 mm, and the von Mises stress in the critical shaft section dynamically amplified as indicated in [4].

It can therefore be concluded that the fracture would not have happened had there been no transition between the gudgeon sections as there would have been no stress concentration effect (Fig. 14). As indicated in Fig. 13, this effect practically disappears after a 30 mm radius, although it could be deduced that the failure would not have occurred had there been a minimum transition radius of 2.5 mm (Fig. 14).

Fig. 14. S-N curves for the broken shaft considering different  $K_f$  coefficients.
