## THE REFURBISHING OF THE BROTHERHOOD HOUSE AT SANTA LUCIA'S HERMITAGE

TITULACIÓN:  
GRADO EN ARQUITECTURA TÉCNICA

ESTUDIANTE:  
ELENA SERRA GARCÍA

FECHA DE PRESENTACIÓN:  
JULIO 2013

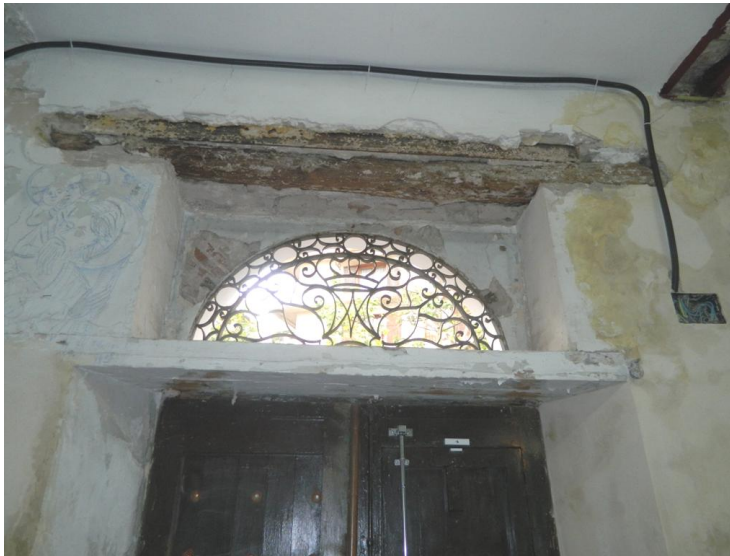
Picture 140. Loosening of the covering material

**Pathology definition:** as it can be observed, the covering material has become detached along the metallic lintel put on top of the wood beam.

This situation may be caused due to the lintel is supporting more weight than it's able to absorb. On supporting that much weight, it ended up bending and, consequently, the covering material that was situated over the lintel and the beam has been came off. As can be seen through the pictures, the lintel only supports one part of the load bearing wall (about 30 cm. from the 60 cm of its total thickness), because the other section rests over the layer of solid bricks brick forming the arch-shaped window.

The long term consequence of this lesion may create is the beam's degradation on being unprotected. In the same way, if the weight the lintel supports is very excessive, it may even collapse.

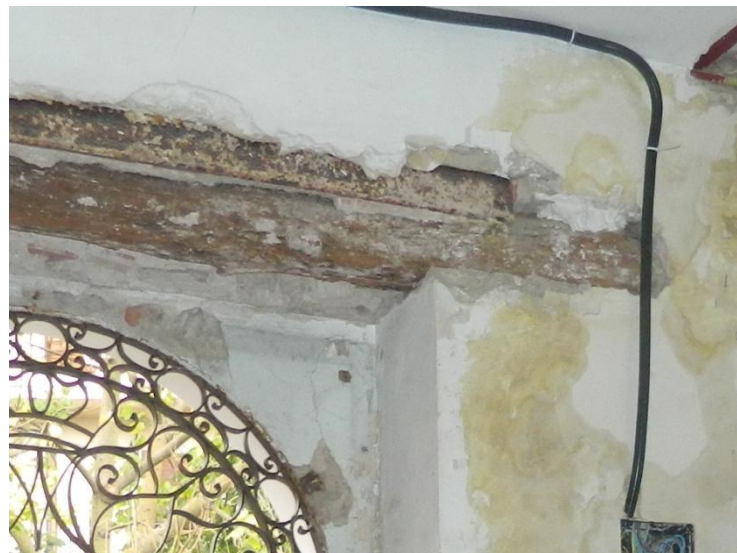
Picture 141. Metallic lintel bended over the Wood beam

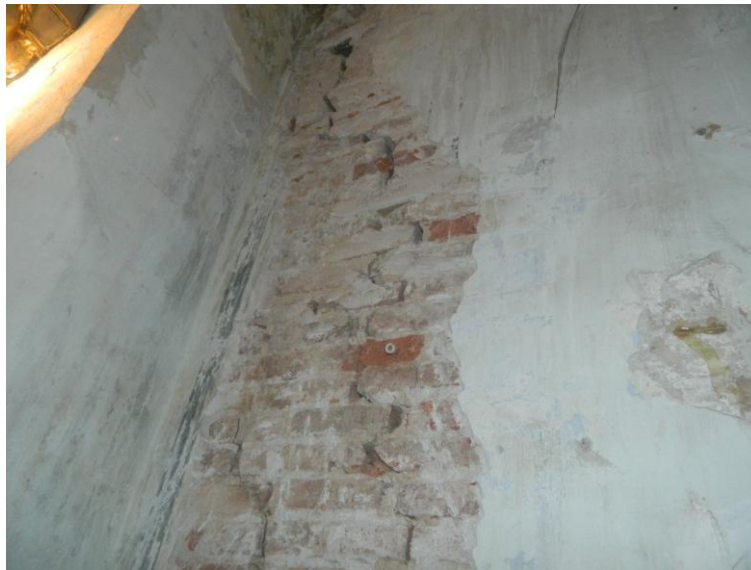
Picture 142. Vertical crack on the brick wall

On knowing a water line crosses the Hermitage underground, it is very possible that the building settlement comes from the foundations, because they may have been affected by the waterline.

The lesion long term consequences depend on the cracks state: if they are still alive, it would be necessary to reinforce the foundations in order not to aggravate the situation; if the crack isn't alive, there wouldn't be an important incidence

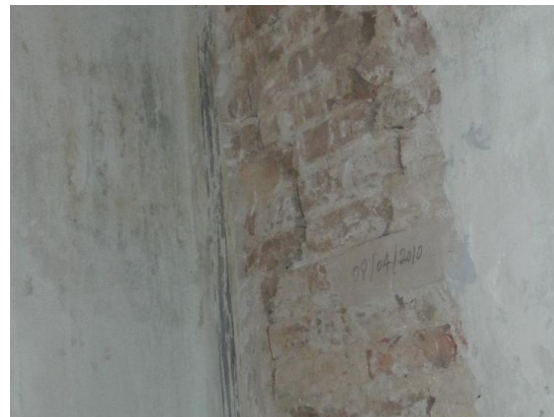
Picture 143. Plaster test for the crack's state check

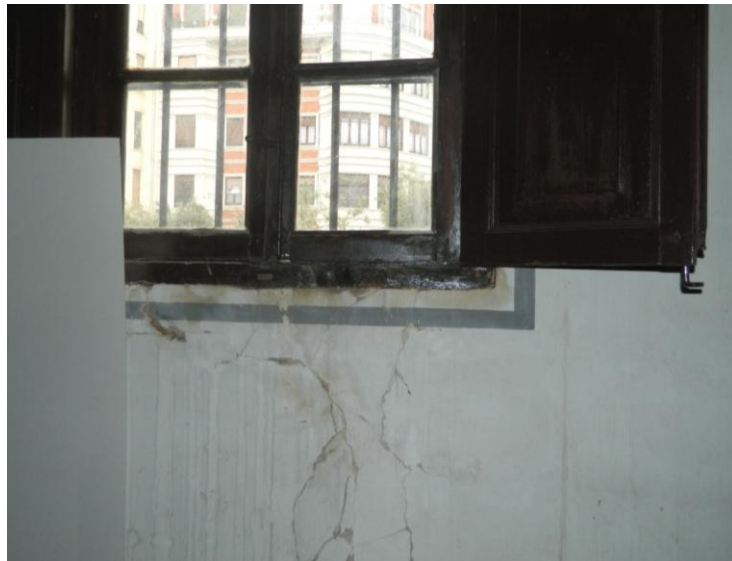
Picture 144. Vertical cracks under the window

It's a consequence of a wrongly weatherization and there have been producing water rain filtrations, which have produce cleanings in the vertical surface under the window.

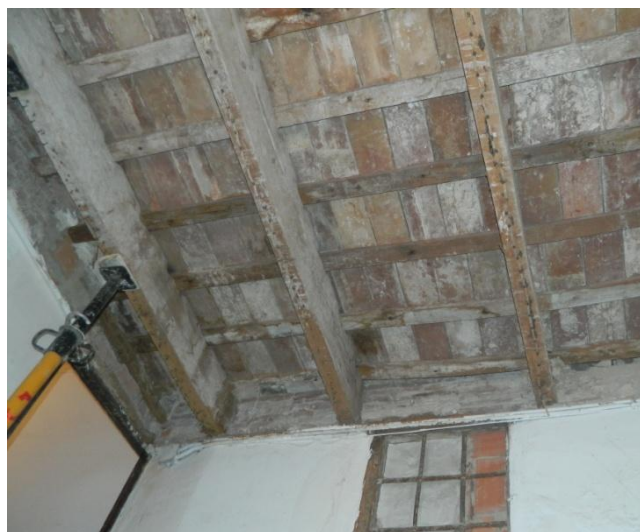
This pathology may cause in long term the structural framework collapse if the beams don't get fixed.

Picture 148. Wood beams fixed into the brick wall

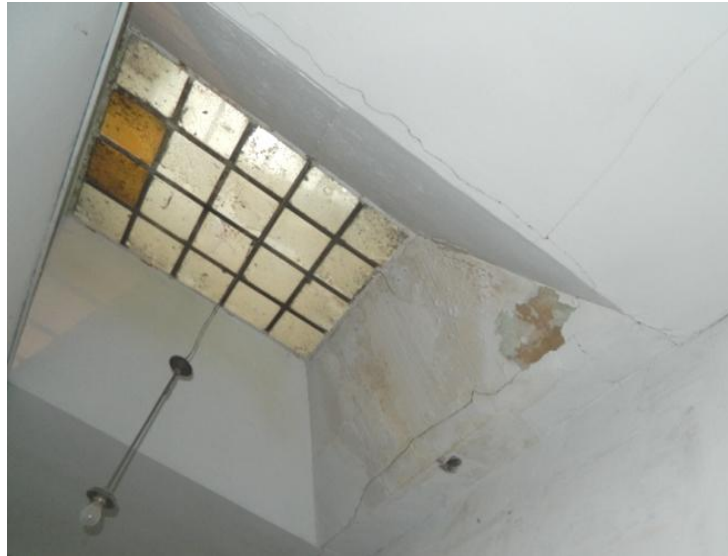
Picture 149. Skylight over the first floor corridors

On the other hand, there have been produced cracks along the skyline perimeter, marking the meeting with the parapet.

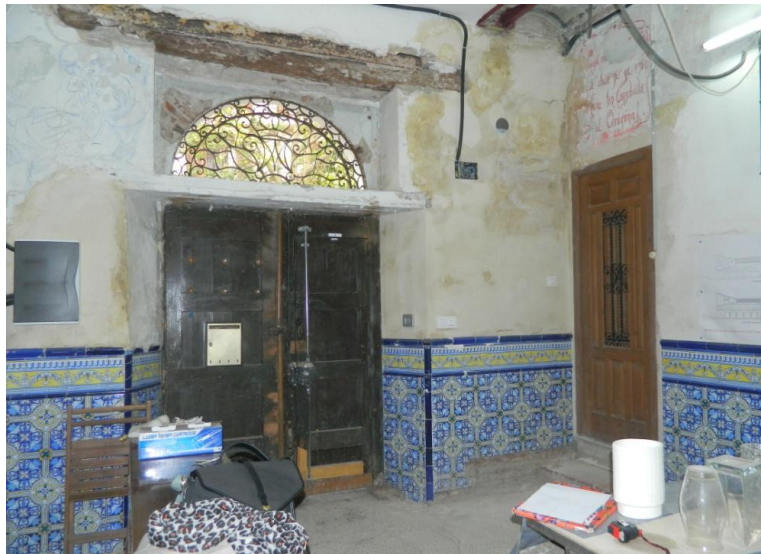
Picture 150. Filtration dampness

At long term, the dampness may cause healthiness and durability problems (painting bubbles, loosening of mortar fillings and even structural damages) in the constructive elements.

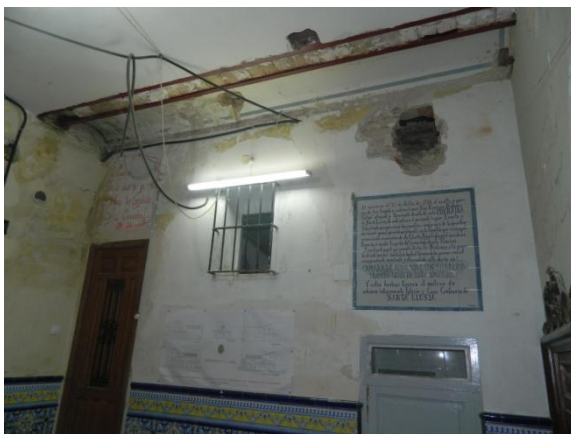
Picture 151. Filtration dampness

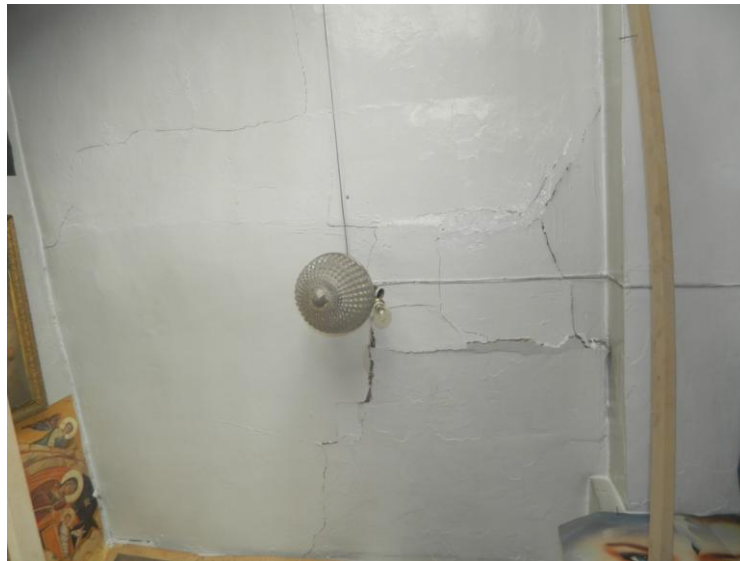
Picture 154. Fissures and cracks in the wattle ceiling

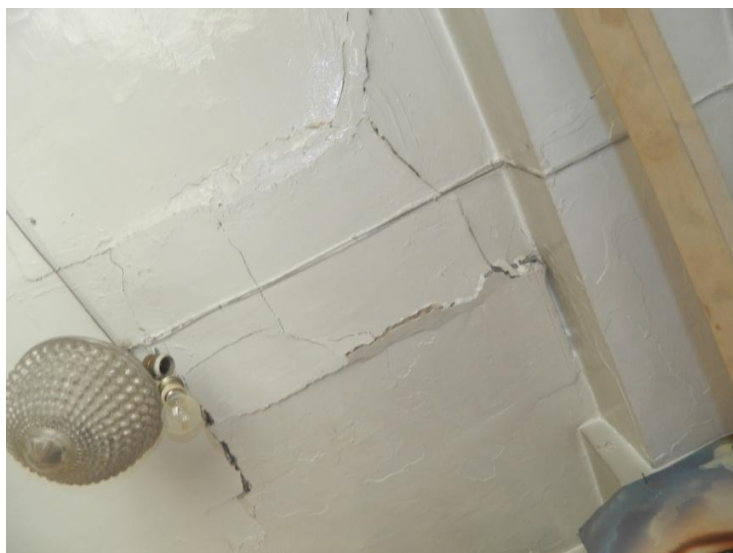
Picture 155. The ceiling about to collapse

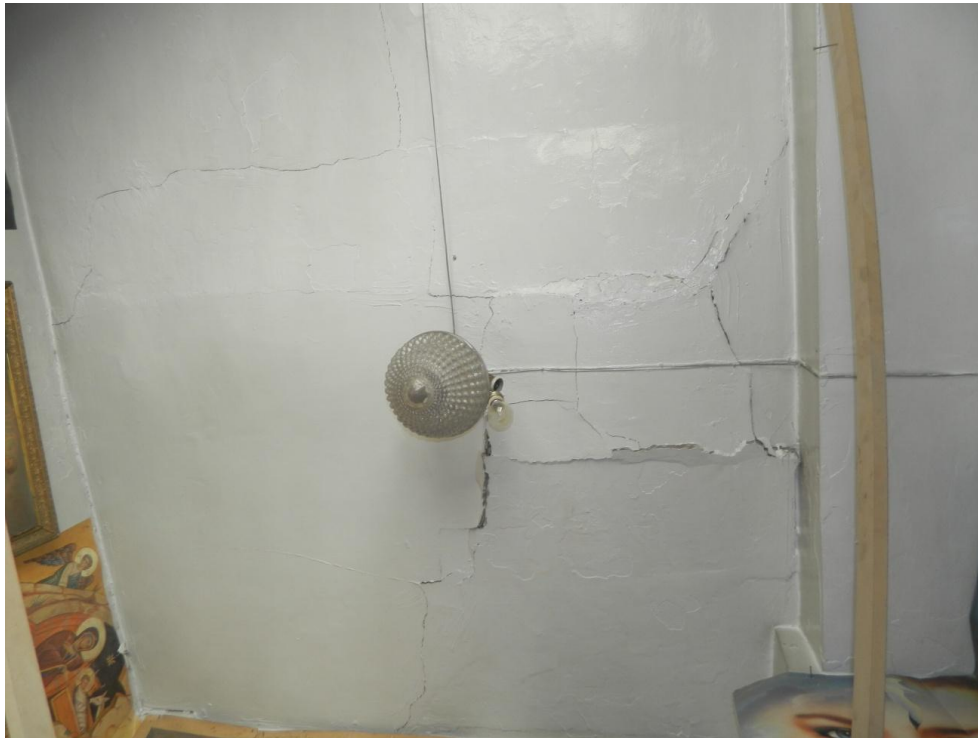
Picture 159. Craks in the gypsum ceiling
