PREVIOUS STUDY AND REHABILITATION OF A BUILDING

Jennifer Aroca Alarcón

June 2013

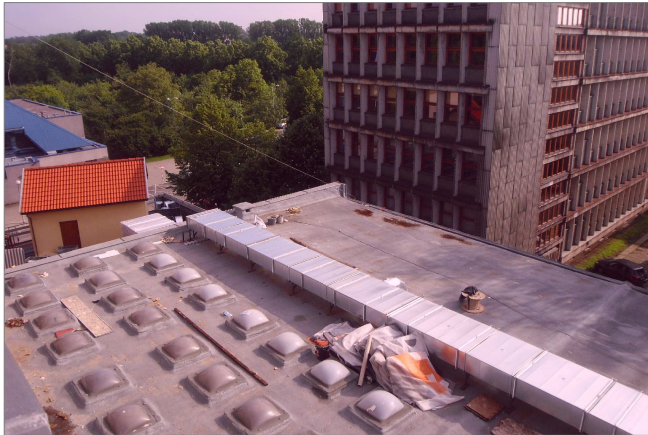
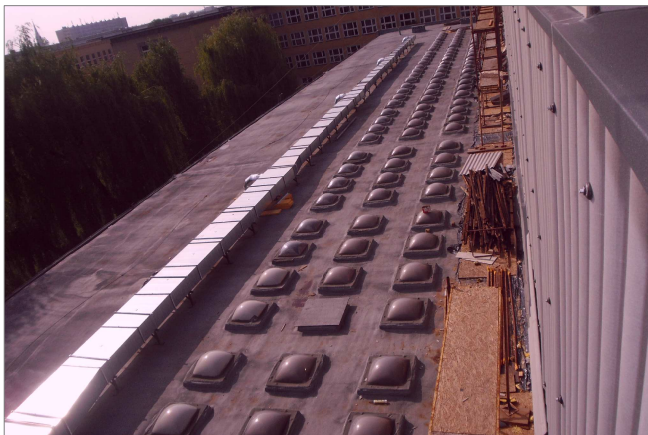
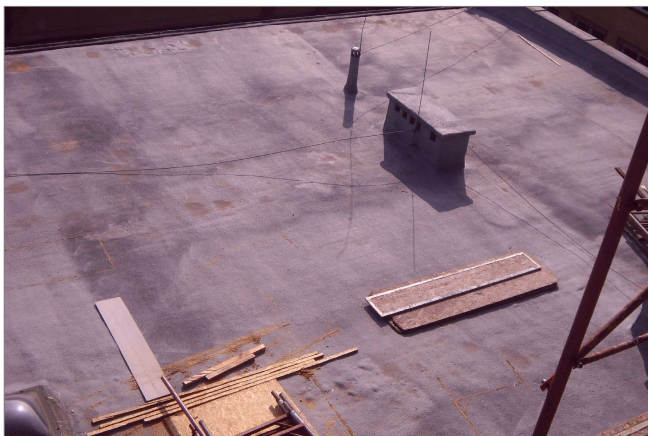
DESCRIPTION: Humidity in two different areas on the top floor of the building. Heating in the deck, It doesn't comply with thermal conditions

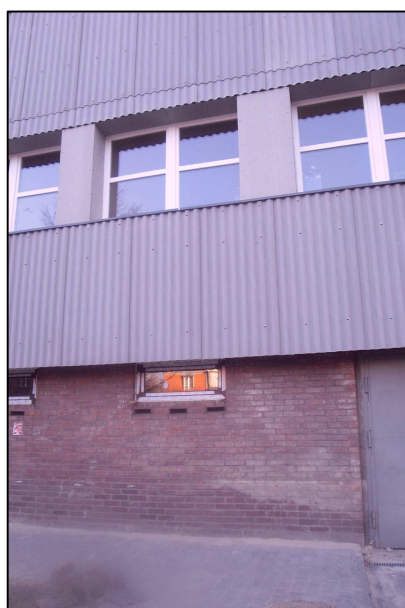
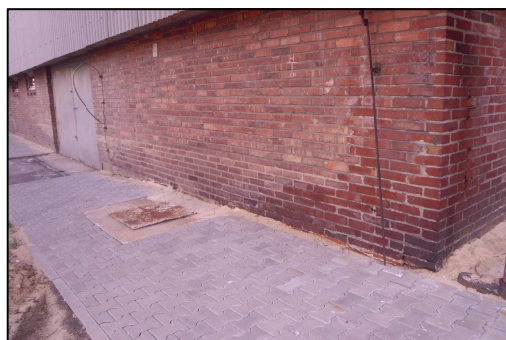
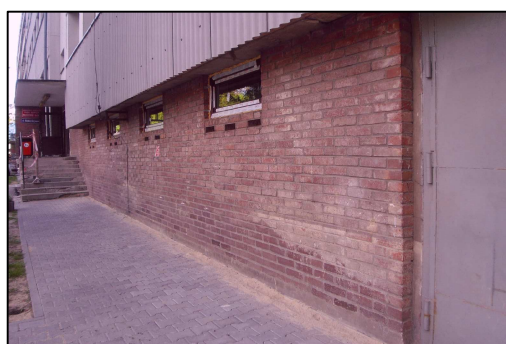
DESCRIPTION: Damp in most of the facade of the building, at the bottom. observed deterioration of elements, efflorescences and coatings

- Very porous wall material
- Too much water in the subsoil because of ground water table
- Saturation field rainwater
- Water facilities breakage or deteriorated (pathology 4)

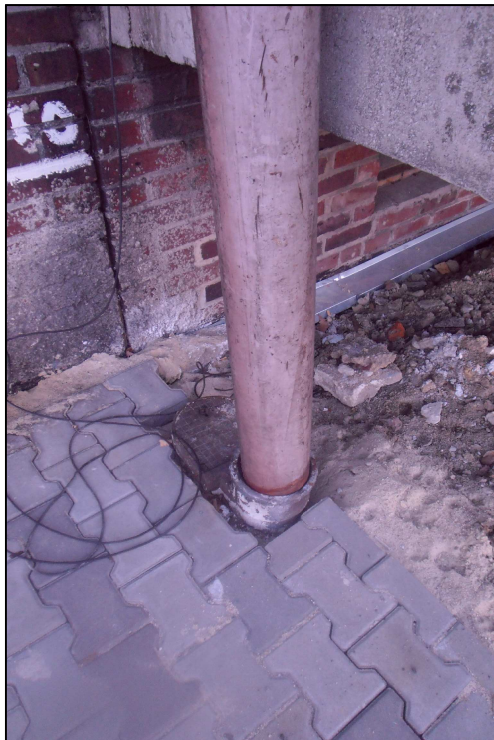
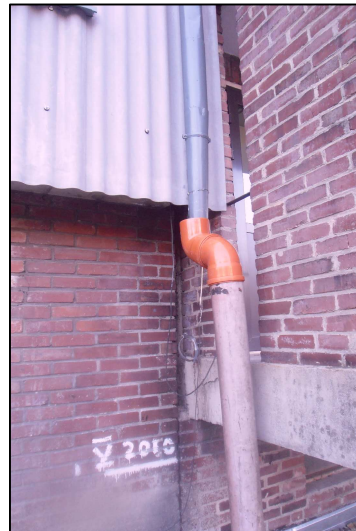
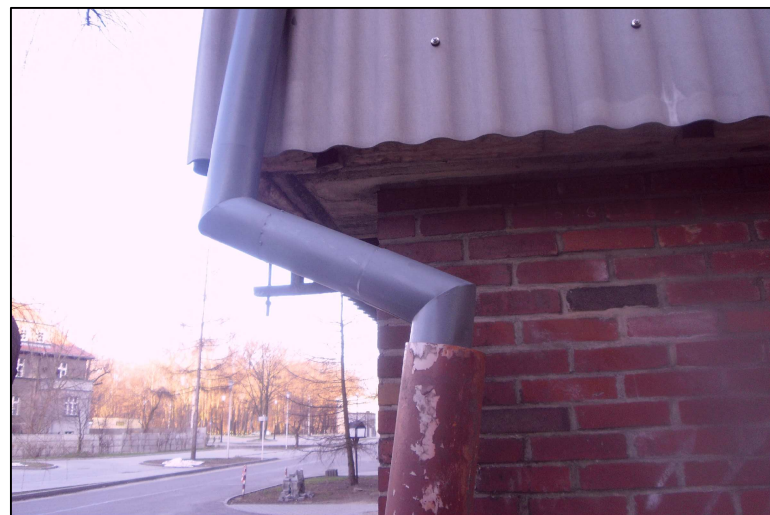
DESCRIPTION: Poor execution of water pipes. Pipes are poorly subject, and are oxidized. The connetions are not suitable. When there are heavy rains the water don't run through the pipes. The water fall directly to the ground.

- Poor design of the pipes
- there is slack between the splices of the pipes

Change all downpipes and replace the entire system

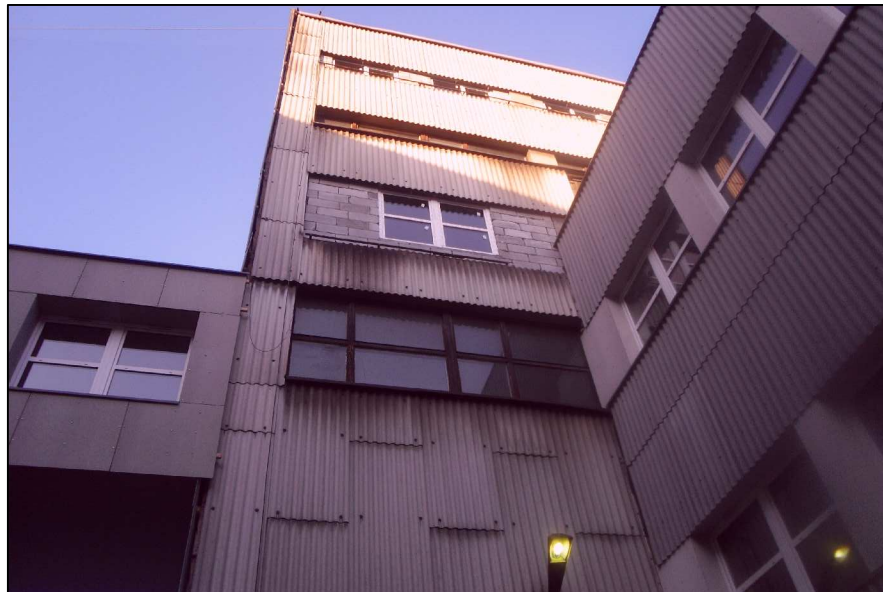
DESCRIPTION: With step the years cement fibre corrugated plates have been deteriorated, leaving the interior discovered. Also all the facade does not comply with the thermal conditions. Global warming.

Breakage facade

Given that the facade finished with fibre corrugated plates and with smooth plates bolted does not meet regulations regarding thermal transmittance and is generally in very poor condition. The recommendation would be to change the entire facade increased insulation rockwool and complying with:

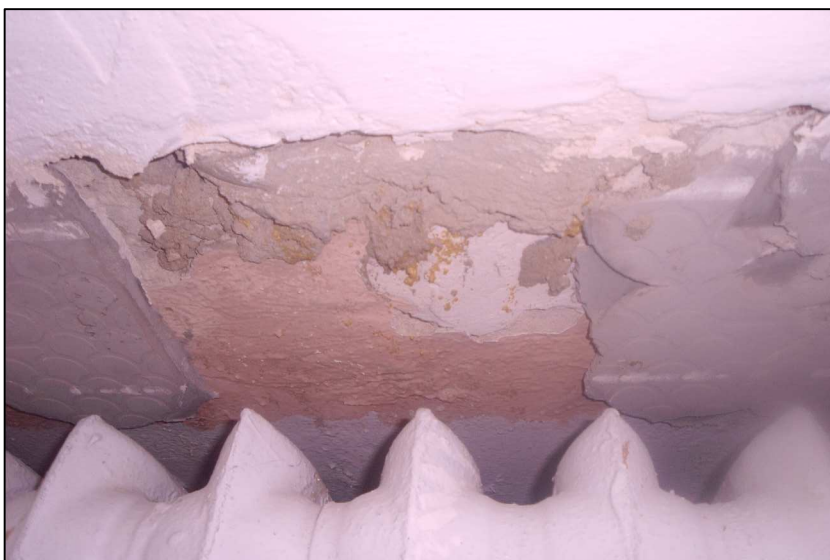
DESCRIPTION: Some tiles have fallen and others are bulging. The pathology is in a wet area of the building

- Moisture
- Poor quality plaster
- Tile placement without prior wetting
- Insufficient plaster layer
- Exposure to high temperatures because there are close to a radiator

1. The steps to intervene successfully on this pathology are:
 - Removing the tiles bulging
 - Remove the layer of plaster
 - Clean the surface
 - Applying plaster of good quality
 - Placement the tiles wetting

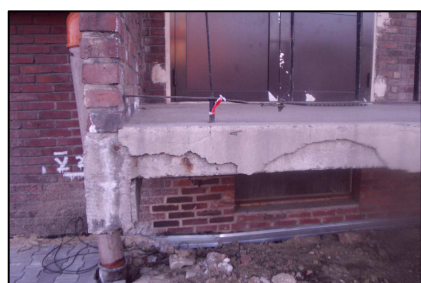
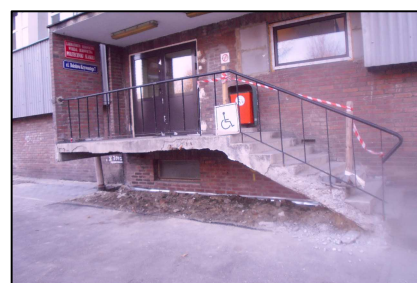
DESCRIPTION: Stairs deteriorated by weatherproof. Observe detachment of concrete remaining sight and rusty armour

- Missing armor coating
- Lack of maintenance of concrete
- Corrosion of reinforcements
- Concrete surface without treatment. Observed pilling and oxidized armor in sight
- Abruption of concrete (coating)
- Insufficient vibrated concrete which has produced voids and detachments
- Elevated foot traffic
- Impact on the steps
- Use low strength concrete.

1. The steps to intervene successfully on this pathology are:

- 1- Substrate preparation: for the corrosion steel, clean it with sandblasted
 - 2- Corrosion protection for exposed reinforcement: it comes to apply a dry mortan, comprising high-grade cement, aggregate plus additives, mixed with water. It provides durable protection against corrosion
 - 3- Application of bonding layer: The cementitious Sopro Repadur mortar bonding layer
 - 4- Ensures good adhesion : Apply cementitious, fibre-reinforced. The repair mortar is applied wet-on-wet to the slurry in 1 to 5cm thick coat.
 - 5- Final surface finishing: Sopro Repadur 5 fine PCC concrete filler is used to fill pores and blowholes and to prepare substrate for paint systems or other coatings. The filler may be applied in coats up to 5 mm thick.
- Following post the whole staircase formwork
 - Return to be concreted the areas where lost concrete section

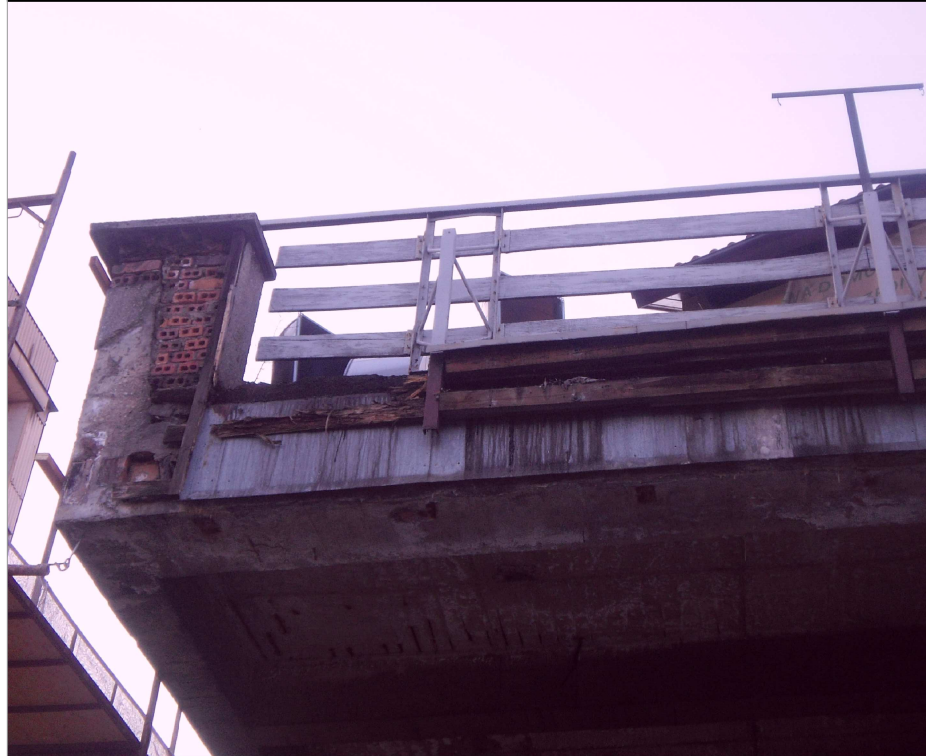
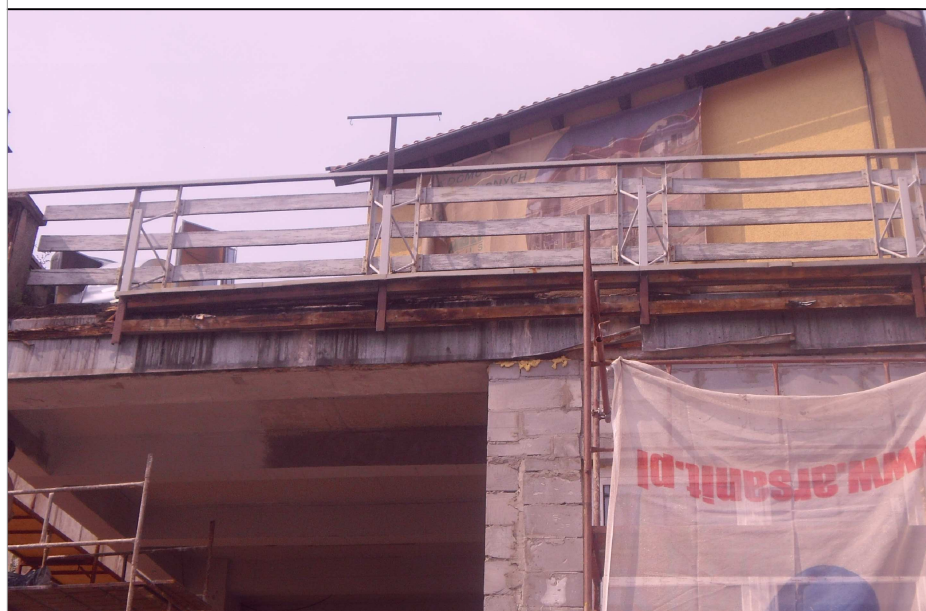
DESCRIPTION: Part of the facade without a coating (cement fibre corrugated plates) . Railings in disrepair, it doesn't comply safety conditions. It is made with painted wood and steel. The steel has oxidized some parts. Cover water flows directly by the facade causing leaks

- Probably the cement fibre corrugated plates has been withdrawn for safety reasons (perhaps was loose)
- On the other hand, the cover hasn't vertical height and don't formed ledge so for this reason the water falls directly from the front facade and producing by filtration humidities

1. The steps to intervene successfully on this pathology are:
 - Remove cement fibre corrugated plates affected and the rockwool.
- * According with the intervention performed in the pathology 5

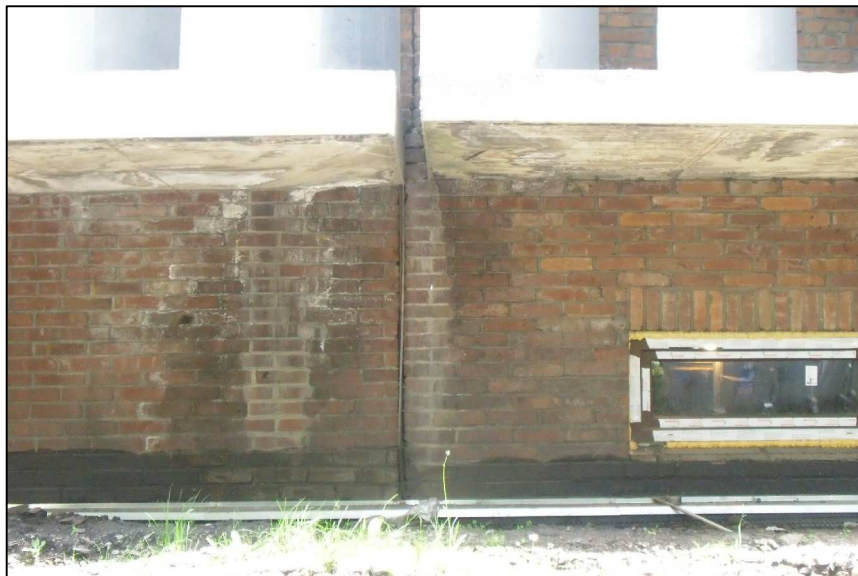
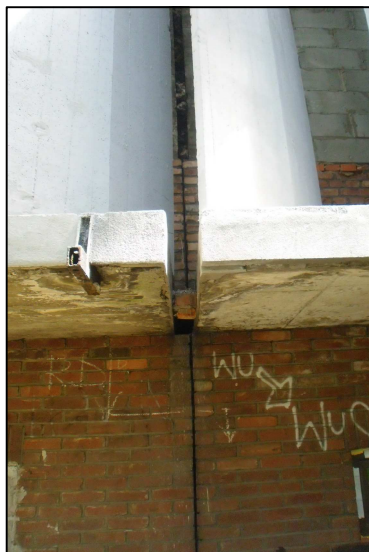
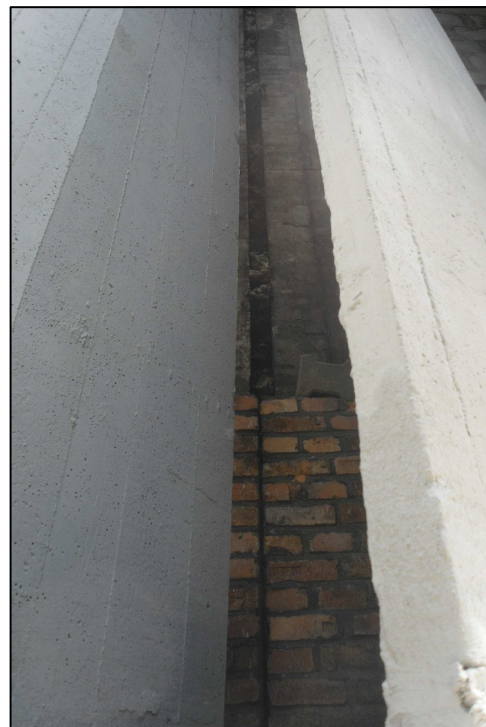
DESCRIPTION: Expansion joint is dirty and has moisture around. The mineral wool also is not constant along its length. It hasn't sealant, so air and moisture can enter into the joint.

- Lack of maintenance and cleaning of the expansion joint
- Meteorological agents

The expansion joint aims to absorb the movements of expansion or contraction due to temperature variations. It should be sealed with elastic fillers that are resistant to mechanical damage and chemical products. It must be impermeable and resistant to atmospheric agents.

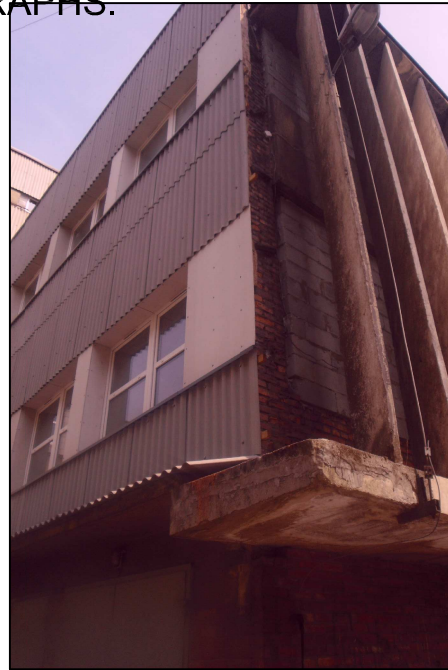
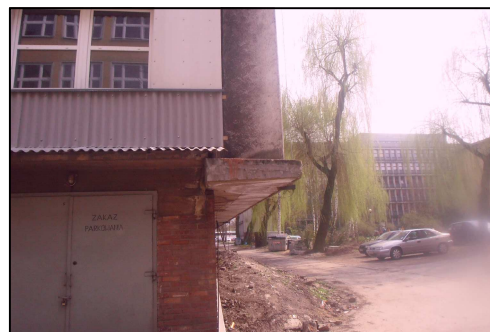
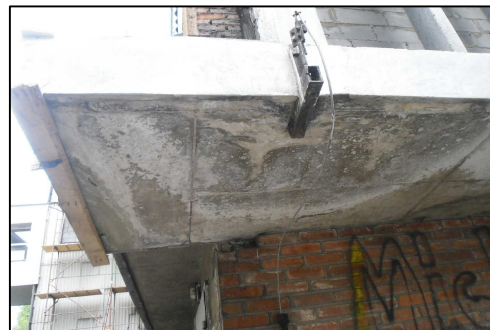
DESCRIPTION: Concrete facade outgoing where there are water stains, chipping, concrete disintegrations even formation of mold on the surface.

- Water stagnates resulting moisture and oxidation.
- No dripcap at the bottom, which causes the water to run directly by the slab
- Concrete surface without treatment. Observed pilling
- Insufficient vibrated concrete which has produced voids and detachments
- Lack of maintenance of concrete
- Slope insufficient outward which causes the water is stagnant

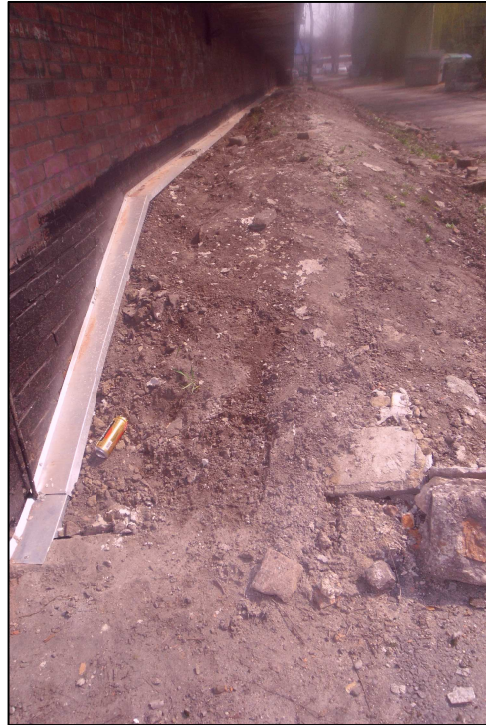
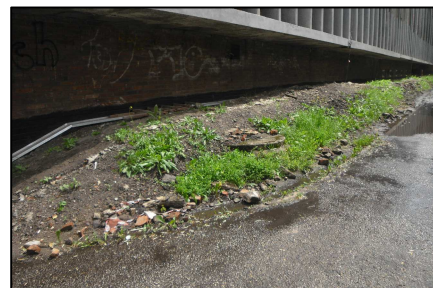
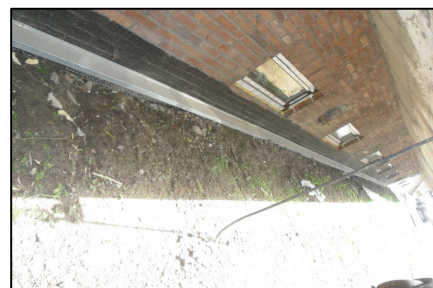
DESCRIPTION: Poor choice of water drainage method. placing a sink for landscaped deck with holes to evacuate water from the perforations in the sump. But when it rains the water is not drained properly and remains in the ground causing it to be wet. That moisture passes into producing more moisture facade.

- Drainage method poorly executed.
- Land obstructing water drainage

1. The steps to intervene successfully on this pathology are:
 - Remove all lands that are observed.
 - Change the drainage method.
 - Place a water collection gutter in the middle of the street with a slope to evacuate the water and it doesn't touch the front of the building

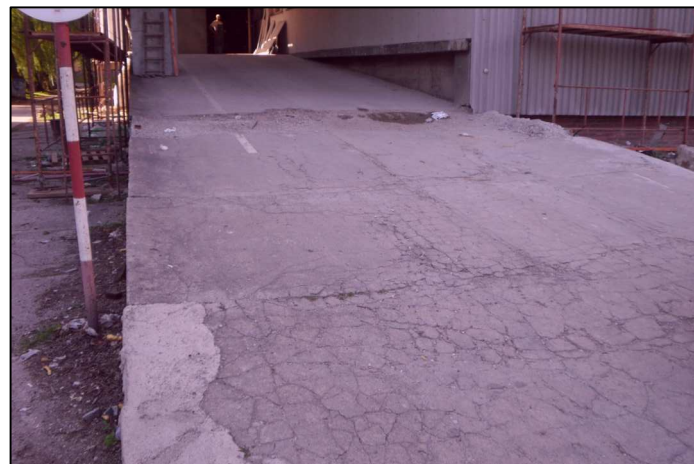
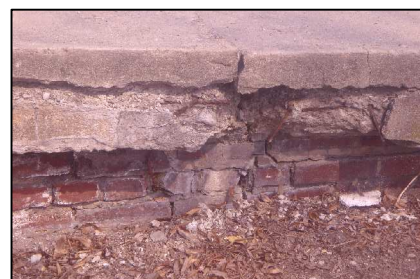
DESCRIPTION: There are lack of uniformity in rolling layer and there is a layer slip. It can be observed rust problems, disaggregation of concrete and efflorescences

- The surface wear is produced by mechanical action due to foot traffic, ordinary vehicles, commercial vehicles and the water that carries suspended particles. Observed disaggregation of the concrete
- Small differential settlement
- Lack of maintenance of concrete
- Concrete surface without treatment. Observed pilling and oxidized armor in sight
- Abruption of concrete (coating)
- Insufficient vibrated concrete which has produced voids and detachments
- Use low strength concrete.

The entire length of the ramp there aren't banister. Place it, with a height of 0.90m.

The steps to intervene successfully on this pathology are similar to the intervention of the pathology 7:

- 1- Substrate preparation: for the corrosion steel, clean it with sandblasted
 - 2- Corrosion protection for exposed reinforcement: it comes to apply a dry mortar, comprising high-grade cement, aggregate plus additives, mixed with water. It provides durable protection against corrosion

- 3- Application of bonding layer: The cementitious Sopro Repadur mortar bonding layer
 - 4- Ensures good adhesion : Apply cementitious, fibre-reinforced. The repair mortar is applied wet-on-wet to the slurry in 1 to 5cm thick coat.

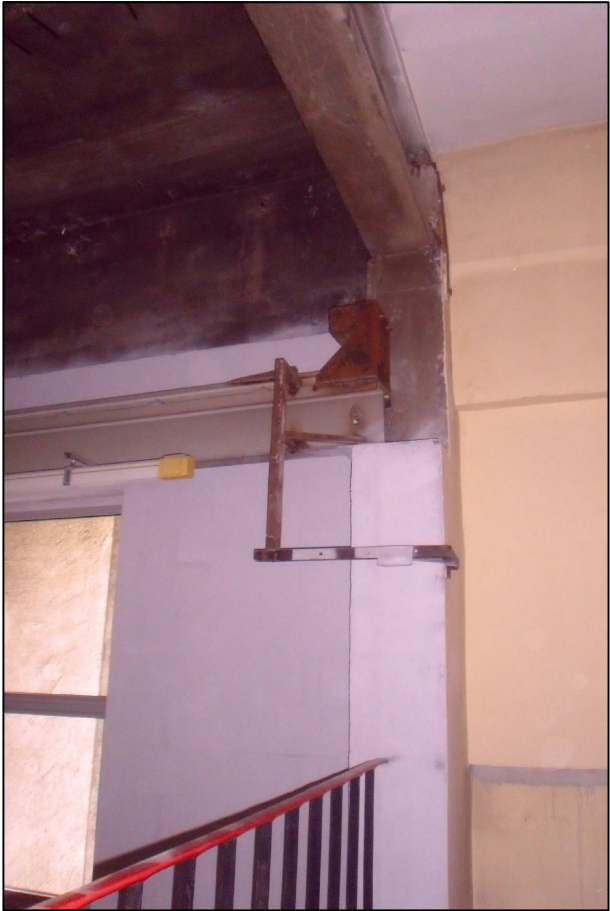
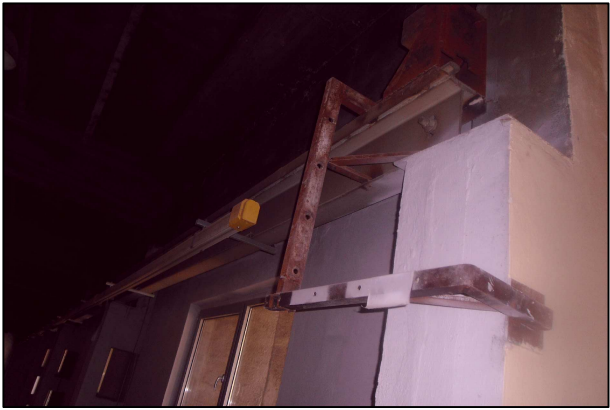
DESCRIPTION: Metal profiles that are inside the building, are oxidized.

- It isn't made galvanized steel
- Because of the moisture

- The steps to intervene successfully on this pathology are:
 - Perform a cleaning of the profiles by sandblasting and following do a quick drying
 - profile must be free of dust, dirt, oil, grease, oxide or other contaminants
 - passivation of the whole area: after performing cleaning steel, give a coat of epoxy to facilitate bonding with the repair material and protect the steel.
 - Protection: Cover the elements with anticorrosive coating

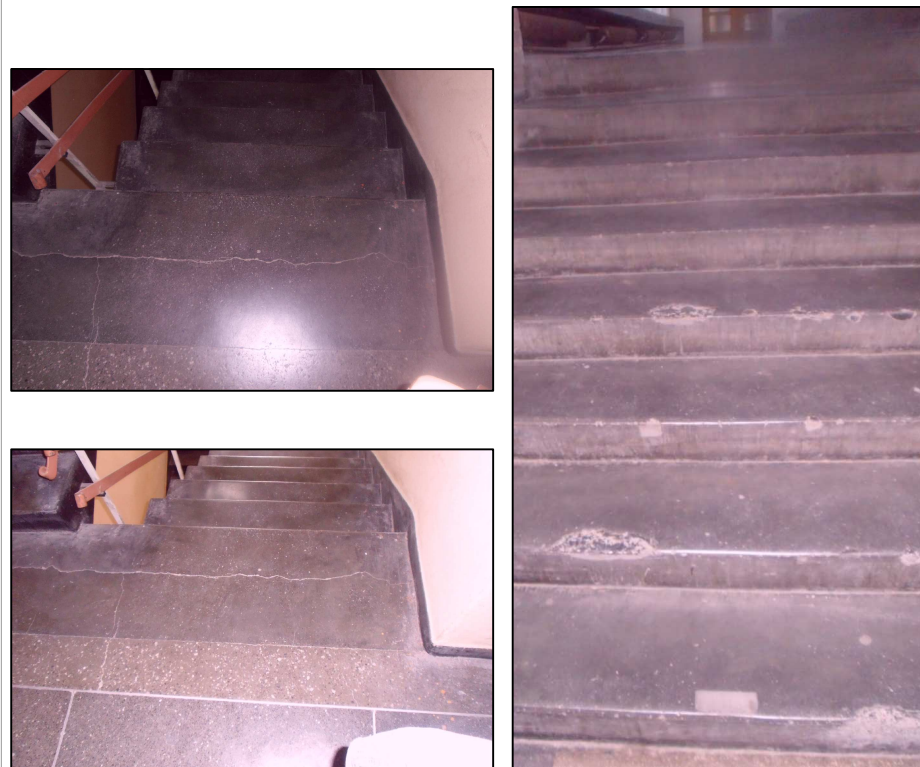
DESCRIPTION: Fissures are observed at the beginning of the stairs.

Also breakage of parts of the steps

- Breakage of the steps may be due to high pedestrian traffic or hard hits to the stairs
- Horizontal fissure on the stairs due to poor execution of the ladder. Maybe because of insufficient splicing of reinforcements of the slab with the ladder

- The fissure of the stairs, still is not a crack

- The breakage of steps only causes aesthetic problems:

- Application of bonding layer: The cementitious Sopro Repadur mortar bonding layer
- Ensures good adhesion : Apply cementitious, fibre-reinforced. The repair mortar is applied wet-on-wet to the slurry in 1 to 5cm thick coat.
- Final surface finishing: Sopro Repadur 5 fine PCC concrete filler is used to fill pores and blowholes.

Recommended observe the crack for a given time and if it increases the thickness or depth and it would be a crack. We will have to take action

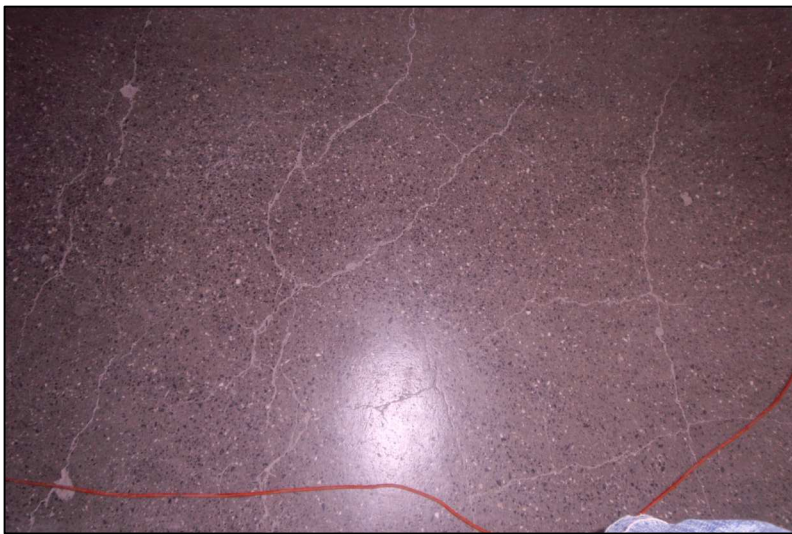
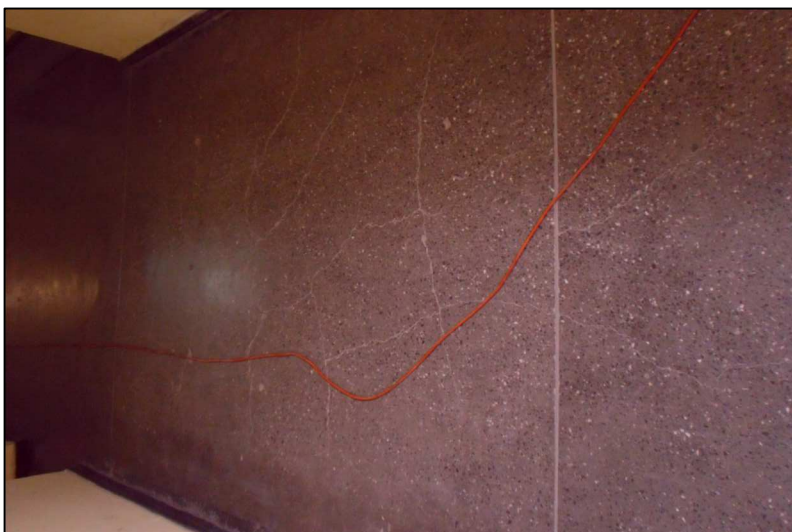
DESCRIPTION: Observed fissures and cracks in different directions of the pavement. Terrazzo is positioned "in site" It isn't made up of tiles of a given size. They are unspecified dimensions plates with joints therebetween

- Absence of dosing mortar 1:6 that makes sharing mortar in order to distribute pressures and level the ground
- Joints insufficient or excessive plate dimensions
- Weakness of the flooring material.
- Errors in adherence with the support.
- Insufficient flexural strength of the tiles (not to be less than 150kp/cm²)
- Lack of continuity and strength of the layer.
- Uneven distribution layer.
- Mechanical erosions produced by the friction of use, since the pavement is in an area of passage and very busy.
- Linear cracks caused by tensile stresses to shrink the pavement.

At the moment is not very serious pathologies, but if the cracks increase the best solution would be the removal of all the affected flooring and replace it by taking various precautions:

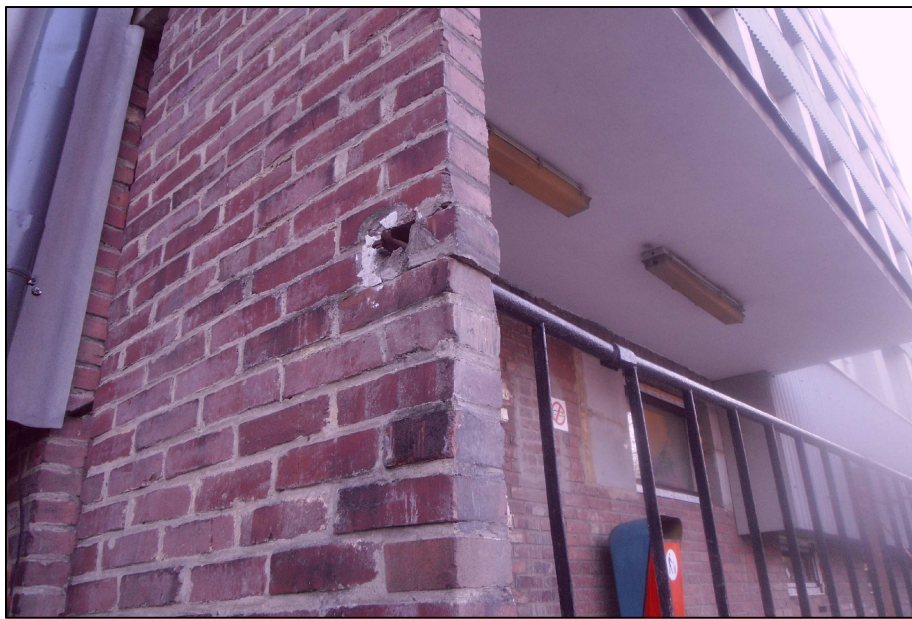
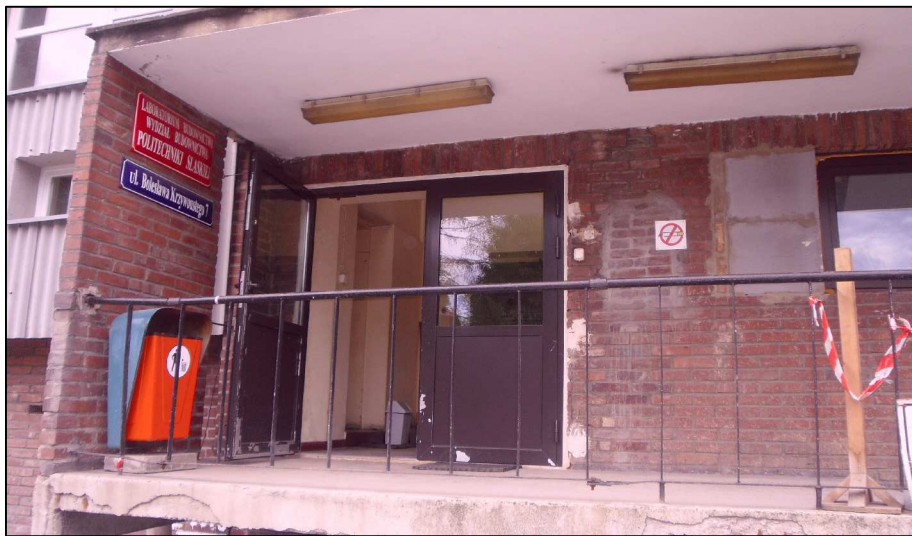
DESCRIPTION: Outer wall made of brick 7. Insufficient wall thickness and the anchoring of the banister has perforated the brick and leaving a completely portion of a brick

- Placement of a brick thick inadequate

1. The steps to intervene successfully on this pathology are:
 - Withdraw the banister and one of this option:
 - 1- Perform the anchoring banister in a different way and repair the broken brick
 - 2- Increase the width of the wall. realizing it again with thicker brick

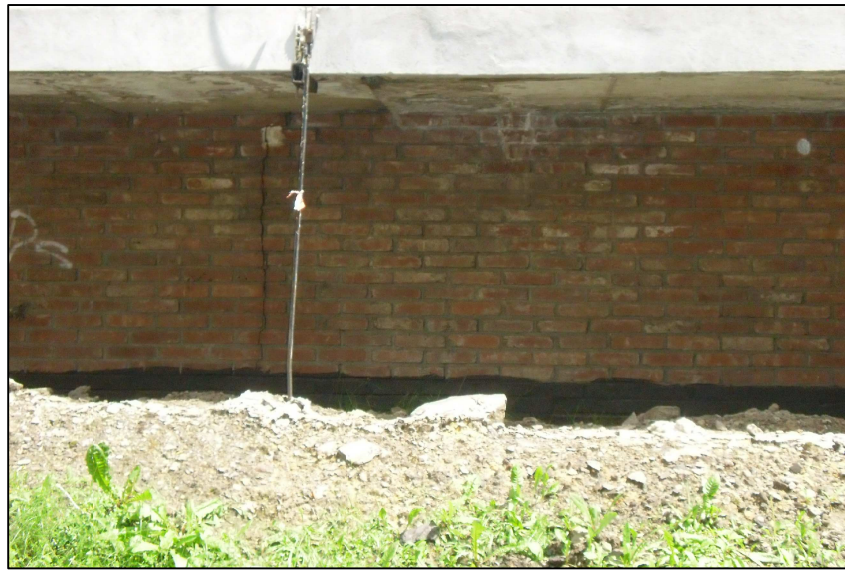
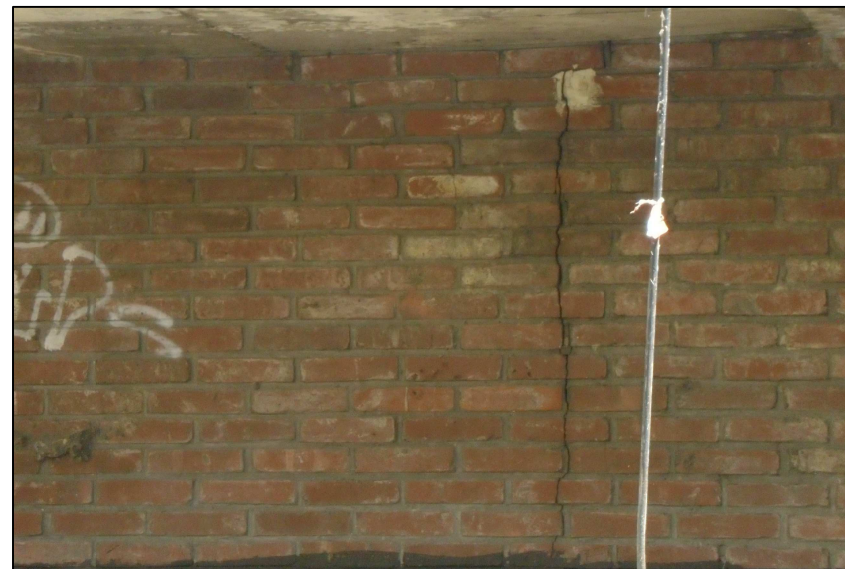
DESCRIPTION: Observed vertical crack in the exposed brick in the bottom of the façade

- Overloads. Unexpected overloads or higher than expected.
- Differential settlement of the foundation or ground. Minimal drop in level of a portion of the work as a consequence of compression of the material used or the area where support stabilization
- Lack of adhesion between brick and mortar
- By lack of wetting of the brick in its placement
- Vertical thrust

To the following repair consider the crack has not affected to the structure beyond repair. Then we have to know if this crack is stable or not.:

- 1-Place testimonials to detect if the crack is stable or not. Once satisfied that the crack is stabilized proceed to put together the two parts of the façade improving continuity.
- 2 - Clean up and peel the crack by escarpment and hammer. Following removed the stones have been broken.
- 3- Observe the size of the crack:
 - If the crack is not big: Fill a mortar without retractions slightly expansive.
 - If the crack is large: stone is placed(same type as the façade) filling with non-shrink mortar.
- 4- Finally plaister the affected area in the time to proceed to coating of all the exterior walls.

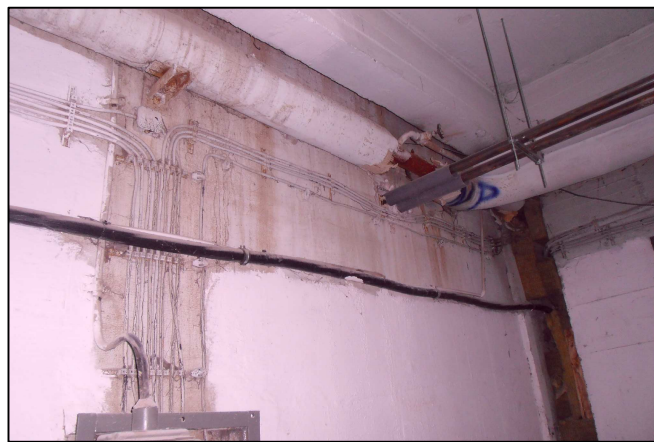
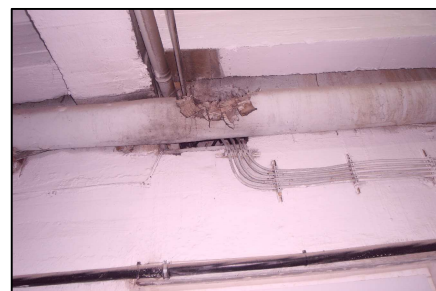
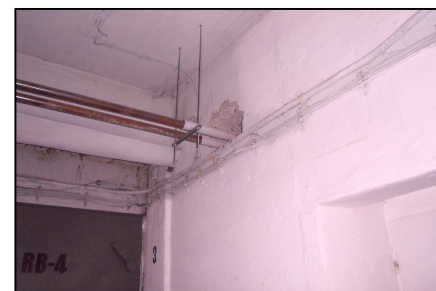
Basement

DESCRIPTION: On the ground floor partitions where it runs the facilities, moisture and stains are observed on the wall. The tubes that protect installations are damaged and broken. Even ducts there are sections that haven't protection. The installations clamps are rusted. On the fourth floor It can be observed a similar problem as the pipe is exposed unprotected one hand.

- Indoor humidity
- Leaks in water pipes
- Lack of care and maintenance
- protection tubes are unsuitable materials

1. The steps to intervene successfully on this pathology are:
 - Check the operation of the facilities is correct by testing, to see that the stains don't come from a leak.
 - Remove the damaged parts, as well as protection tubes and clamps rusted
 - Cleaning the surface of the wall
 - Replacing tubes pipes protection of a suitable material must be insulating.

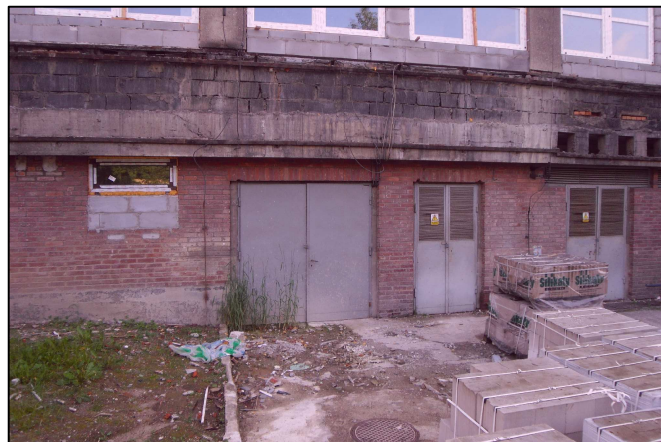
DESCRIPTION: Exit doors of the garage and technology rooms are steel. Through them excessive heating is produced, they don't present any type of insulation.

- The doors do not have insulation.
