Serrano Cruz, JR.; Tormos Martínez, BV.; Gargar, KL.; Bouffaud, F. (2013). Study of the Effects on Turbocharger Performance Generated by the Presence of Foreign Objects at the Compressor Intake. *Experimental Techniques*. 37(2):30-40. doi:10.1111/j.1747-1567.2011.00795.x.

# Study of the effects on Turbocharger performance generated by the presence of foreign objects at the compressor intake

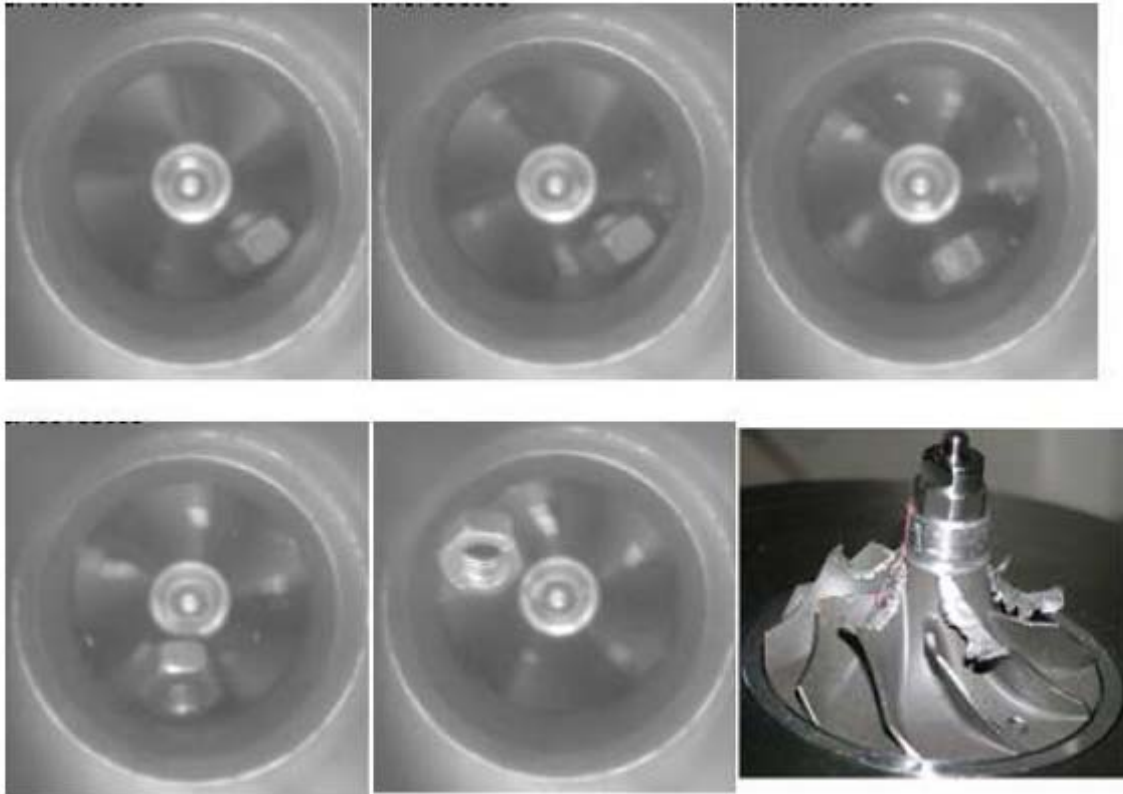
Figure 12

The high speed camera helped to understand the effects of the foreign objects ingestion. Some snap shots are reproduced on figures 12 (nut) and 13 (ice cube). The repetitive hits of the nut over the compressor wheel lead to a progressive severe damage of the blades. The inspection of the compressor disassembled confirmed the video recorded. On figure 13, the snap shots witness the destruction of the ice cube, rather than the milling of the compressor wheel. The final condition of the compressor wheel does not show any appreciable damage.

**Figure 12.** Sequence of frames during the nut introduction and final condition of the compressor wheel (turbocharger #13).

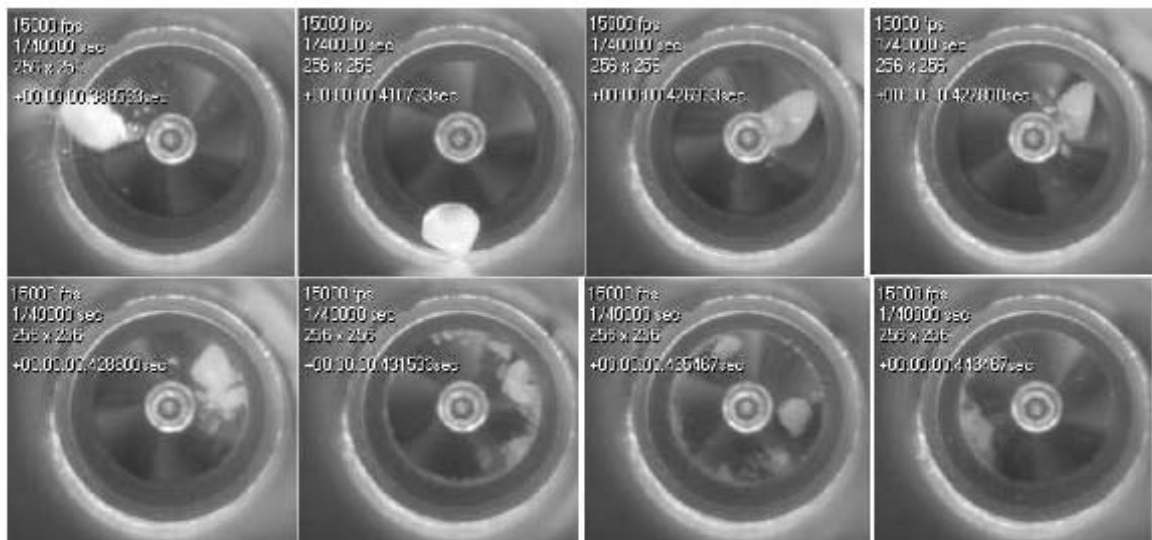
Figure 13

**Figure 13.** Sequence of frames during the ice cube introduction.

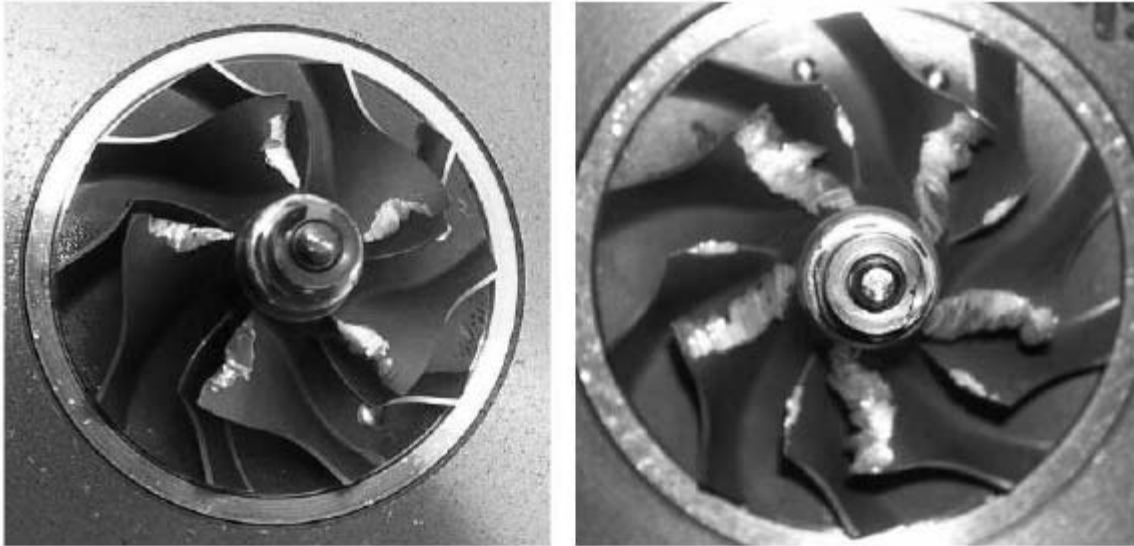
Figure 14

The nuts tests were stopped before swallowing the nuts because the wheels were already clearly damaged. It's impossible and pointless to assess how long the test should last to swallow the nut. It's just obvious that the longer the nuts mills the wheel, and the faster the wheel speeds, the more severe is the damage as shown on figure 14.

**Figure 14.** Comparative damages after nut introduction with different testing time. Left: turbocharger #29, tested at 50 krpm. Right: turbocharger #13, tested at 150 krpm.

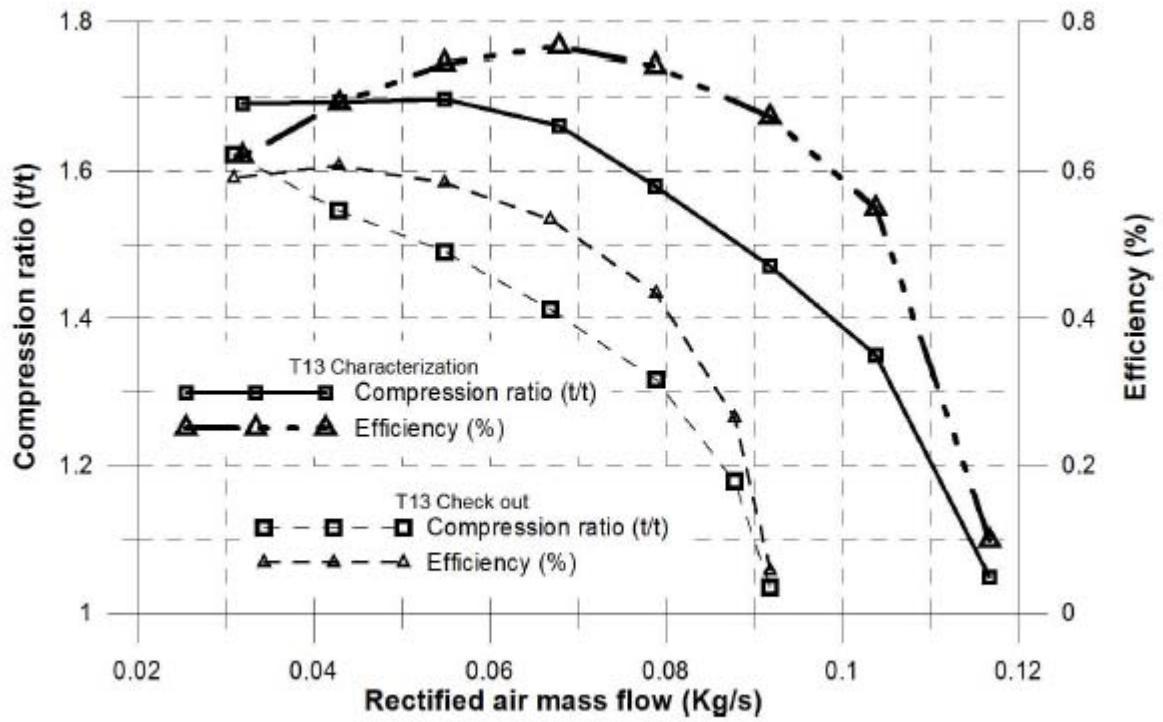
Individual check-out results had been compared the corresponding characterization tests. The nuts led to the most severe damages. Figure 15 present the results obtained for the turbocharger T13. An important deviation from characterization may be observed. It was necessary to disassemble the compressor housing to remove the nut before measuring the thermodynamics parameters again.

**Figure 15.** Results for compressor efficiency and compression ratio in a turbocharger damaged with nut.

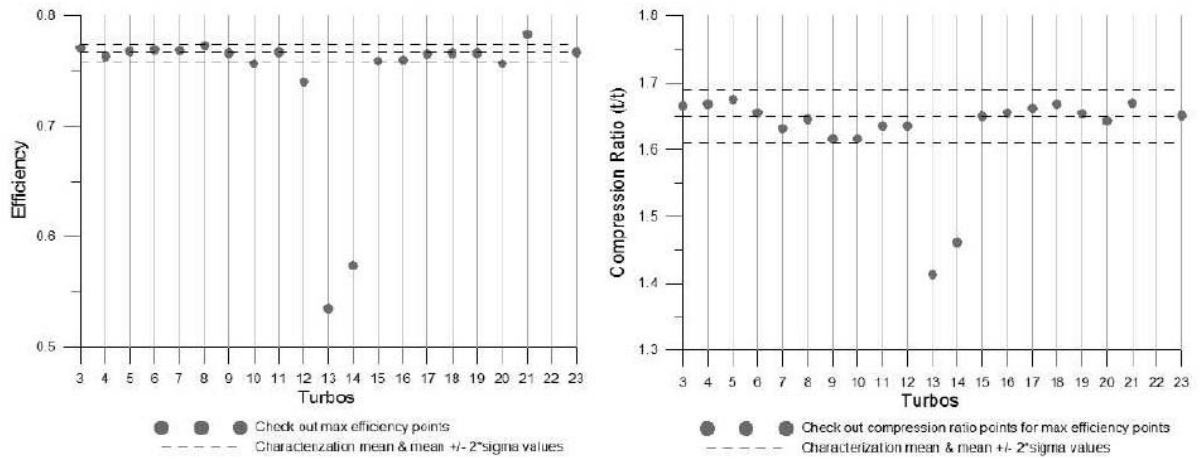
Figure 16

For a selected air mass flow (here 0.068 kg/s corresponding to the maximum efficiency), the graphs presented on figure 16 summarize the measurements of all the compressor performances after swallowing foreign objects. Dot lines represent the characterization performances ( $\text{mean} \pm 2\sigma$ ), so it is easy to identify which tests that led to significant damages.

As can be observed on graphs presented on figure 16, the nut tests show performances significantly out of the statistical boundaries defined by the normal conditions

**Figure 16.** Values obtained for compressor efficiency (left) and compression ratio (right) in the check out tests at 0.068 kg/s air mass flow for the distance 30 mm..

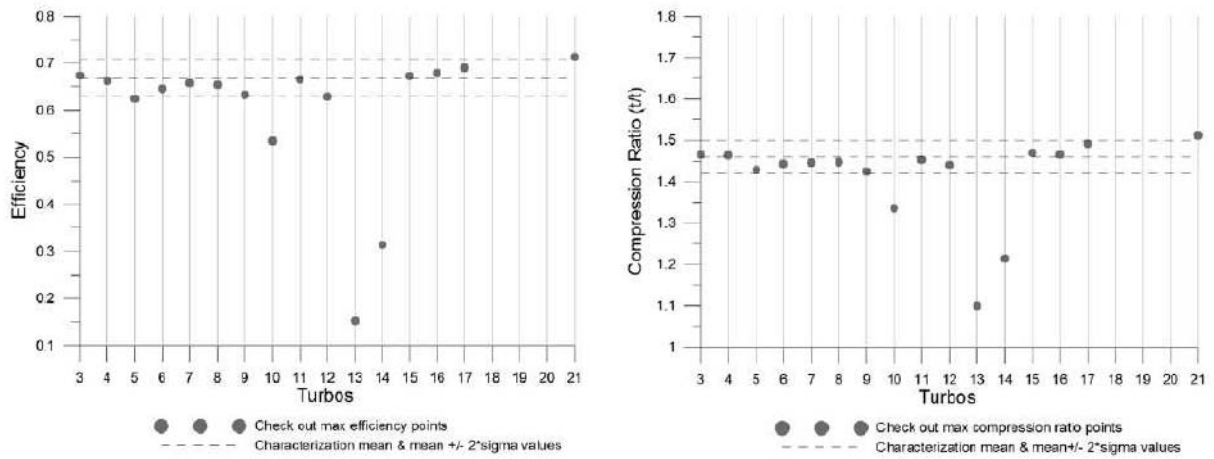
Figure 17

As can be observed on graphs presented on figure 17, obtained for a higher value of air mass flow (0.09 kg/s), not only nuts presents abnormal behavior with T10 (plastic) clearly out of statistical boundaries and tests for T5 (paper), T9 (plastic) and T21 (ice cube) presenting values on the edge of limits. This situation can lead to conclude that up to medium mass flow (0.07 kg/s in our case) the wheel has to be seriously damaged to detect any effect on the compression performances. Thus only hard foreign objects like nuts significantly impact the performances. Looking at higher flow rates (above 0.09 kg/s for this case) allows detecting smaller damages.

**Figure 17.** Values obtained for compressor efficiency (left) and compression ratio (right) in the check out tests for 0.09 kg/s air mass flow for the distance of 30 mm.

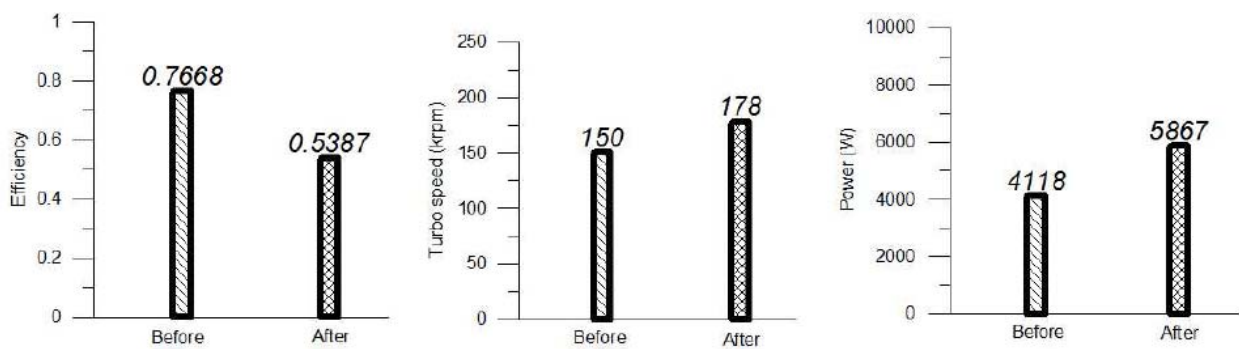
Figure 18

A test was done using a turbo damaged by a nut. The energy required to recover a given air mass flow and compression ratio corresponding to the original maximum efficiency point was computed as shown on figure 18.

The damaged turbocharger had to run about 30krpm faster and requested about 1800 Watts additional to reach the same compression characteristics.

The efficiency dropped down by 23%, and about 40% of additional work was required to recover the original compression characteristics.

**Figure 18.** Comparative data obtained from the analysis for recuperation of lost energy.
