A Peculiar Spanish Timber Floor, the “*Revoltón*”: a Diagnostic Example at the “Palacio del Marqués de Benicarló”

Abstract. The paper deals with the application of the Italian method for assessing on-site and diagnosing timber elements to a distinctive Spanish type of horizontal structure called “*revoltón*” i.e. jack arch floor. As in Spain does not exist a specific regulation for the on-site diagnosis of timber elements, this analysis was performed according to the Italian standard UNI 11119. Due to the peculiar features of the jack arch floor some modifications were applied to the method.

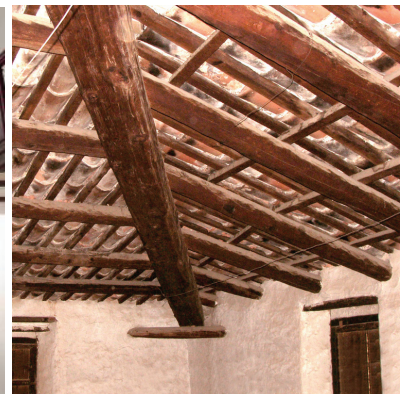
Fig. 3. Roof structure

With reference to the proper roof structure, its features are obviously less varied than floors: the inclination is approximately 12-15° (21-27%) and the main joists have rectangular sections with their base slightly greater than height, around 35 x 30 cm, and a maximum length of 870 cm. The rafters

that lay on top of the main joists have a diameter that varies between 15 and 21 cm, and the longest is 560 cm long. The structure is completed by a sequence of battens on top of the rafters that bear directly the weight of the roof tiles with no layer interposed. (Fig. 3)

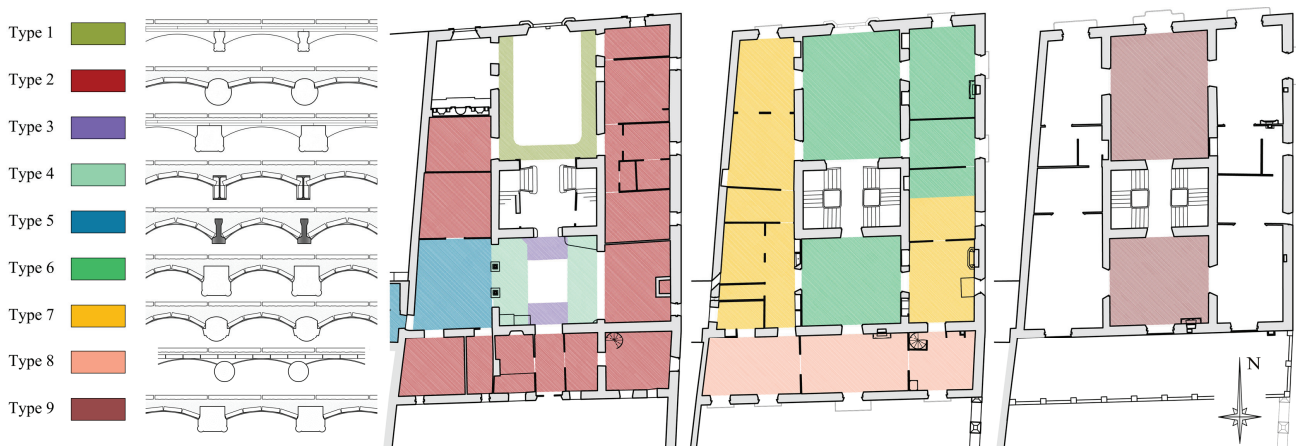
Fig. 4. Types of horizontal structures in the Palace: ground, first and second floor

Type of Floors in the Palace. Despite the numerous possible variations of the jack arch floor structures, in the Marqueses Palace it was possible to recognize seven traditional types and two new ones used as substitution (Fig. 4).

On ground floor most of the horizontal structures are Type 2 floor. The joists are round with a diameter between 17 and 21 cm and a maximum length of 520 cm. Type 2 floor has the typical timbrel vault made of bricks with a span of approximately 47-55 cm.

Type 1 and Type 3 floors have a double layer of boards lying on top of the cantilever beams, beneath them there are thin vaults made of conglomerate. The main difference between the two types is the beam section. In the first case the timber elements have a section of approximately 9 x 15 cm with a maximum length of 105 cm. In the second case the base of the joists vary between 20 and 21 cm with a length of 140 cm. Both these joists have two bow-tell mouldings along the whole length and a span of 56-60 cm.

On the first floor there are three types of structures with three different types of joists sections. Type 6 joists have a rectangular section which base varies between 19 and 22 cm with two bow-tell mouldings. They have a maximum length of 705 cm on top of the main hall and a span of 47-50 cm. Type 7 joists have a diameter of 16 - 20.5 cm with a maximum length of 570 cm and a span of 47-48 cm. The section has also two longitudinal cuts as decoration. The third type, Type 8, in the southern part of the floor, are simply round with the diameter between 13.5 and 16.5 cm, a maximum length of 430 cm and a span of 37-39 cm. This latter structure is different from the others because, while the vaults are made of conglomerate, there are one or two horizontal layers of bricks on top.

On the second floor, only two structures were visible because the rest were hidden behind a false ceiling. These two ceilings correspond to Type 9 and have a section of 22 cm, a maximum length of 700 cm and a span of 43 and 49 cm.

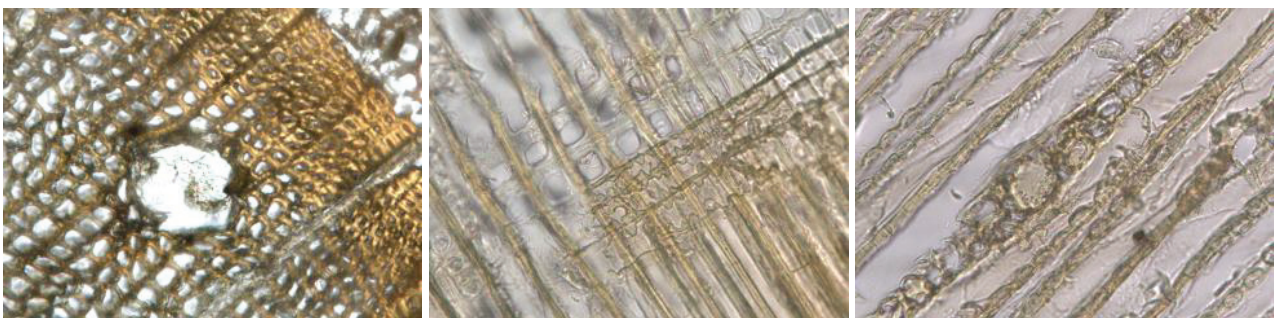
Fig. 5. Cross, radial and tangent section of a wood sample

In addition, 24 samples were collected to identify the timber used in the structure. Each sample had its cross, radial, and tangential section analysed through an optical microscope. It was found that all samples were *Pinus nigra* Arnold (Fig. 5.).

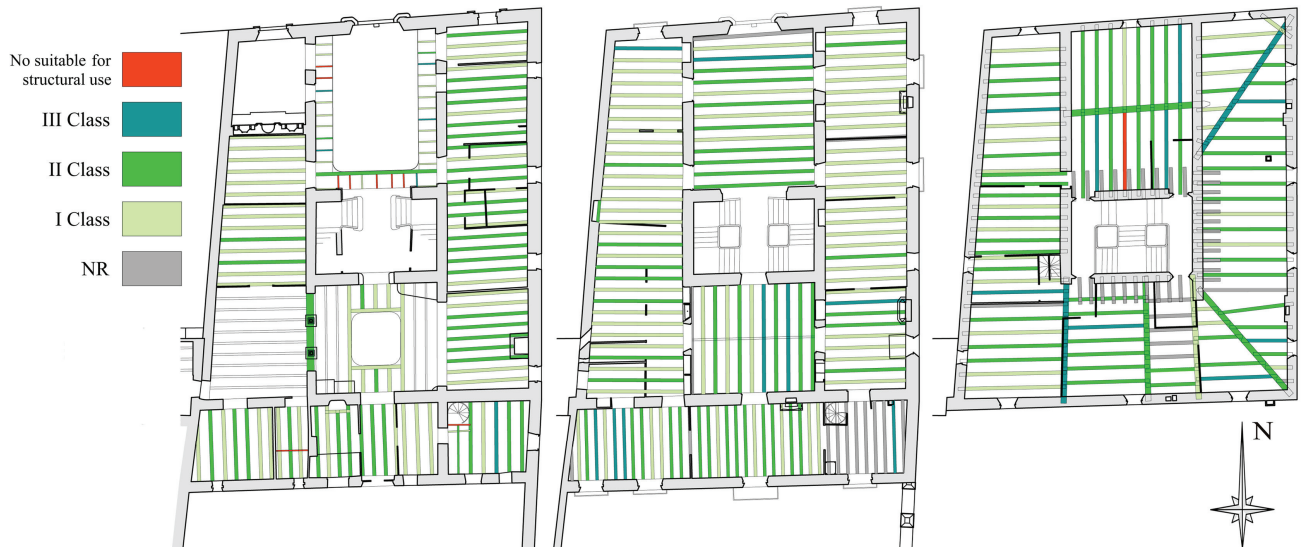
Fig. 6. Grading of single timber elements: ground floor, first floor and roof

Grading. (Fig. 6) The majority of the ground floor joists had a good quality and belong to classes 1 and 2. The only problematic area was the balcony above the hall where some of them, especially on the south side, were not suitable for structural use. This was due to the fact that the section of these joists was very small. This will require a comprehensive intervention on the whole balcony structure.

On the first floor most of the joists in eastern and western rooms were classified as class 1, whereas in the south and middle area the quality was lower. On this floor, the south-east corner joists were not classified because of the bad condition in which they were found, condition that will possibly drive to the replacement of the entire structure.

The grading of the roof revealed a general worse quality of the joists compared to other levels, even if there was only one element not suitable for structural use. While the joists had bigger sections,

especially the main ones, their knots were very big, up to 11 and 8 cm. Finally all the joists holding the upper passage were non-accessible and therefore not classified, but they were clearly heavily damaged by biotic decay.

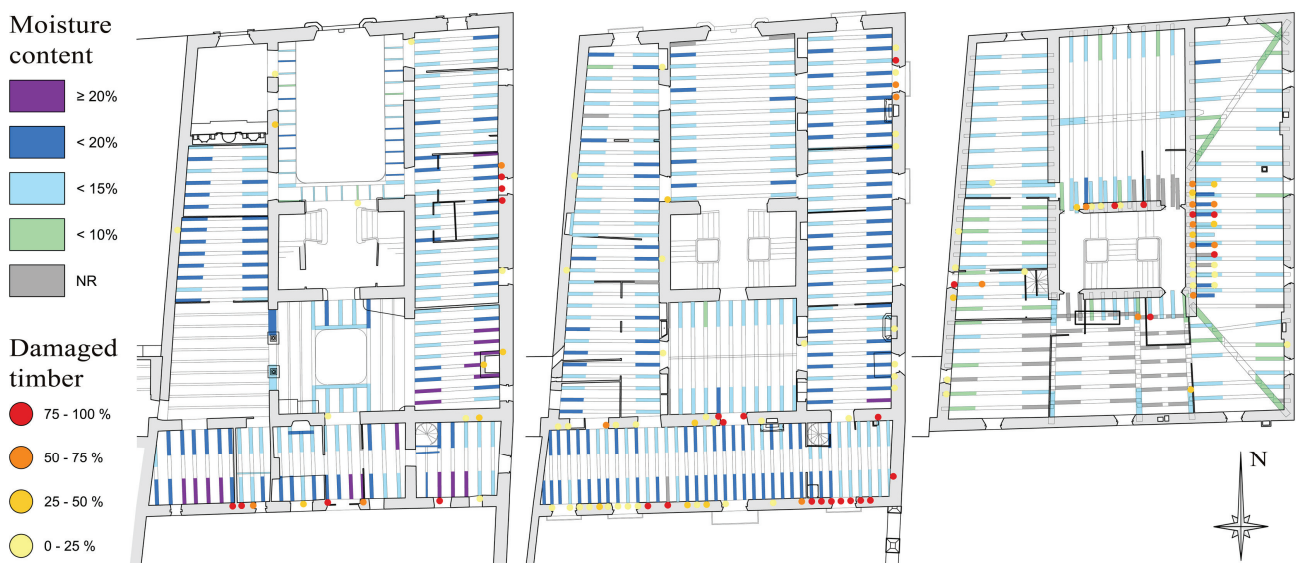
Fig. 7. Moisture content and damage in joists ends: ground floor, first floor and roof

Moisture Content. (Fig. 7) The overall distribution of moisture showed a decreasing percentage in the higher levels of the building. The number of joists showing around 20% m.c. was quite significant on the ground floor while on the roof most of the elements had less than 10% or 15% m.c..

Moisture was the biggest problem on the ground floor because, due to capillary action, walls were transformed in collectors of water. The west area of the floor had a high content of moisture, even though not higher than 20%, due to the absence of any window that caused a lack of aeration. The most humid areas were the portions of timber in the south-east room on top of the well and near the south wall toward the garden, especially corresponding to the presence of the balconies on the first floor.

On the first floor virtually all of the joists had less than 20% humidity. Nevertheless the wettest areas were still the ones in contact with the south and east perimeter wall. The causes might be the infiltration of rainwater from the balconies above and from the large terrace on the second floor. A review of the layer of superficial waterproofing of the terrace and checking its inclination is needed before any future intervention.

In the roof structure a high level of moisture was measured exclusively in some joists that were holding the upper passage because of some rainwater infiltration. All the other elements were dry because the area was extremely aerated due to the openings without closure.

Degradation of the Joists Ends. (Fig. 7) On the ground floor, the decay in the heads of the beams was quite localized and punctual. One of the main concentrations of damaged spots was visible in the eastern wall and could be caused by currently evaporated moisture: so now degradation is no longer active. On the other hand, the relation between the presence of moisture and rotting of the wood was evident in the joists that rest on top of the south east well. The most important damaged area was the southern walls where, as in the previous case, the damaged points corresponded to areas of higher humidity due to the presence of balconies in the upper floor.

On the first floor the problem was concentrated in the southeast corner along with the whole southern part of the palace. The combined action of rot and termites was detected and galleries built by those insects along walls were seen. Despite the danger meant by these insects, no animal was found alive.

On the roof the degradation was concentrated in the joists holding the upper passage; virtually all east and north joists were affected by such degradation. These problems were very deep and sharp and will require redesigning and rebuilding the entire structure of the passage.

More specifically, an intervention directed to the reduction of moisture due to capillary action in the walls of the ground floor will be necessary and the waterproofness of balconies and southern terrace needs to be checked and re-established. In any case, the southern area of ground and first floor will need a radical renovation.
