**FINAL
PROJECT
2013-2014**

**“THERMAL COMFORT IN A
HISTORIC BUILDING IN FRANEKER”**

**Jesús Pizá Martín
409481 Group 59**

Graduation Placement at NoorderRuimte

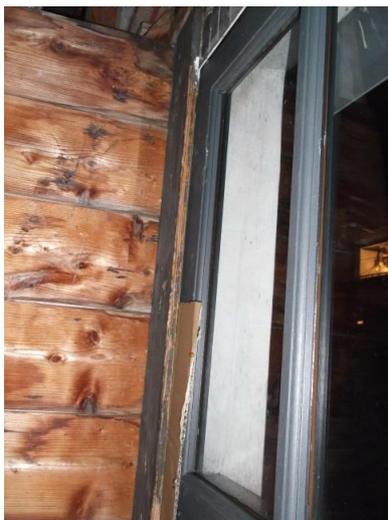
It is also important to mention that there are 2 small windows, one on each side of the attic, on the main front and the back. Here we can see that there have been some problems of air leaks trying to be solved with small peaces of cardboard.

Image 4.4.-4- Air leaks attic window

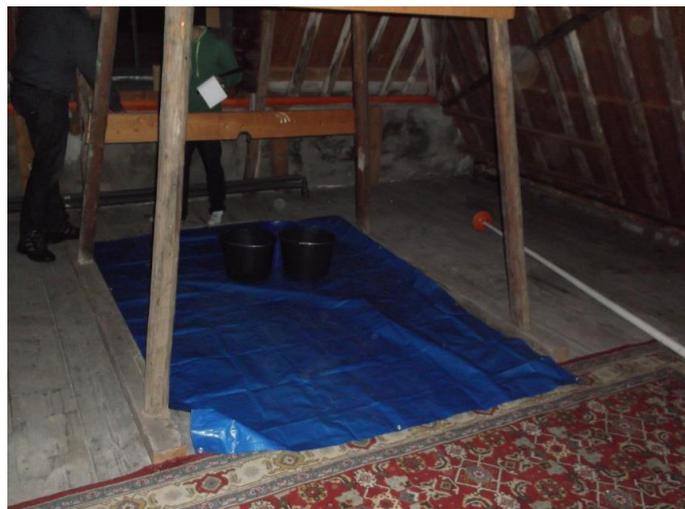
Image 4.4.-5 Water filtrations on the attic

In addition to this finding, we also discovered filtration water filtration problems that are quite typical to find in old covers, as they are always exposed to the weather outside and to a more aggressive environment that can damage the constructive elements.

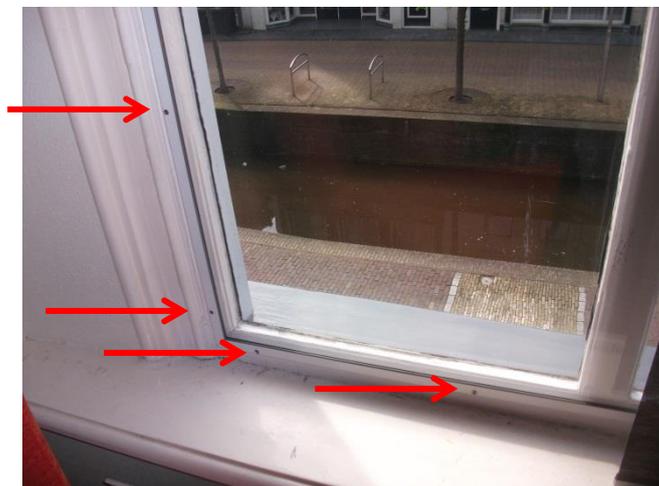
Moreover, there is one element that creates uncertainty of which year it was installed and it is very important because it is the cause of some of the problems that are present in the building and it is an extra glass installed on the wooden frame from the existing windows.

Imagen 4.6-1 Anchorage of the extra glass layer on a window

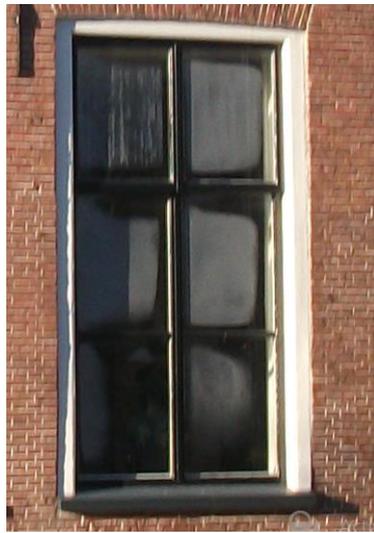
In the main facade of the house, I have to mention that these condensations appear the most at the highest part of the windows on the same floor. That is because the temperature difference above is higher than at that of the lower parts of the windows, producing more condensation, as we can see in the image below:

Image.9.1.1-1- Surface condensations on one window from the main facade of the ground floor.

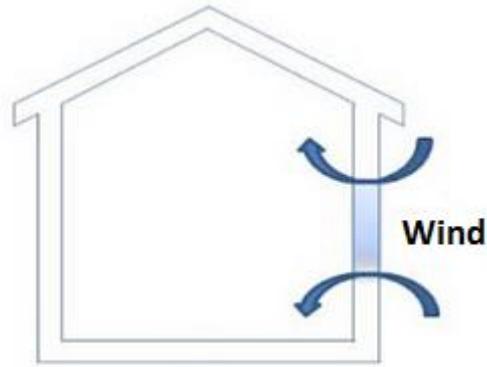
- At the junction of different materials
- At the junction of the woodwork with facade cladding

Image 9.1.0.2 -1 Air leaks ways

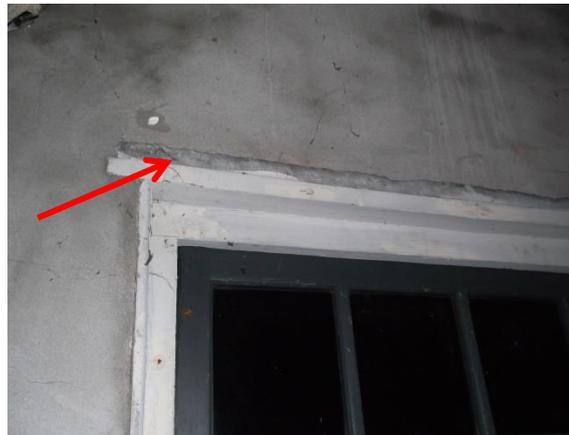
9.1.2-2 Different solutions applied to the air leaks: paperboard and insulation (attic of the building)

The window G of the attic has air leaks too , as it is possible to see in picture 9.1.2-2, but as we will check in the point 10, the attic is cold (there is not insulation on the roof) and is not in use, therefore air leaks in the attic do not modify the comfort conditions for the family living in the building. That is why on the plane 13, the air leaks of window G have not been drawn.

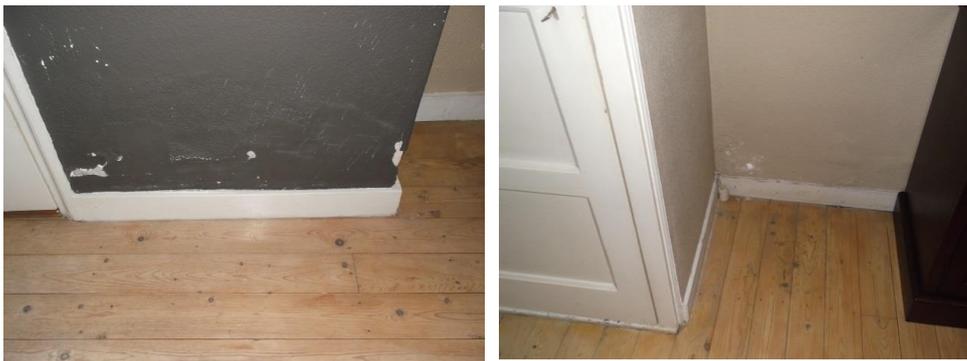
This type of humidity is produced generally on the walls of the ground floors and basements by capillarity. The consequence is the rise of moisture from the soil onto the walls. The water rises through the pores of the materials used o the walls and eventually evapourates to the atmosphere, deteriorating the walls, increasing the vapour in the air and favoring condensations. We will analyse the walls of the living room on the ground floor with the aid of a thermal camera (in point 10) to see if the capillary moisture continues affecting the building or if it was in the past and now we can see only the consequences of it.

Image 9.2.1 Humidity capillary at the living room

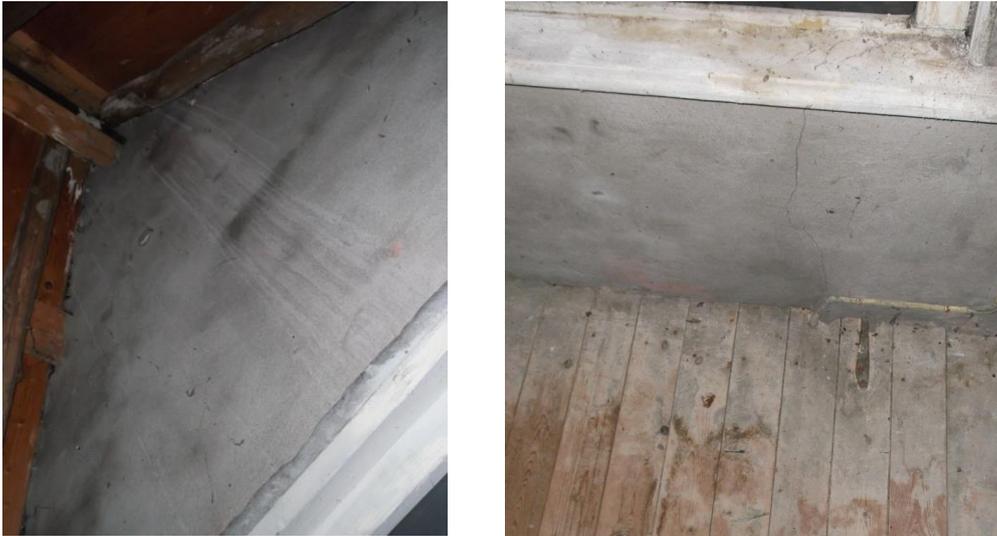
which the water has been travelling from the highest part of the wall until the wooden ground.

Image 9.2.2.-1 Moisture leaks at the attic

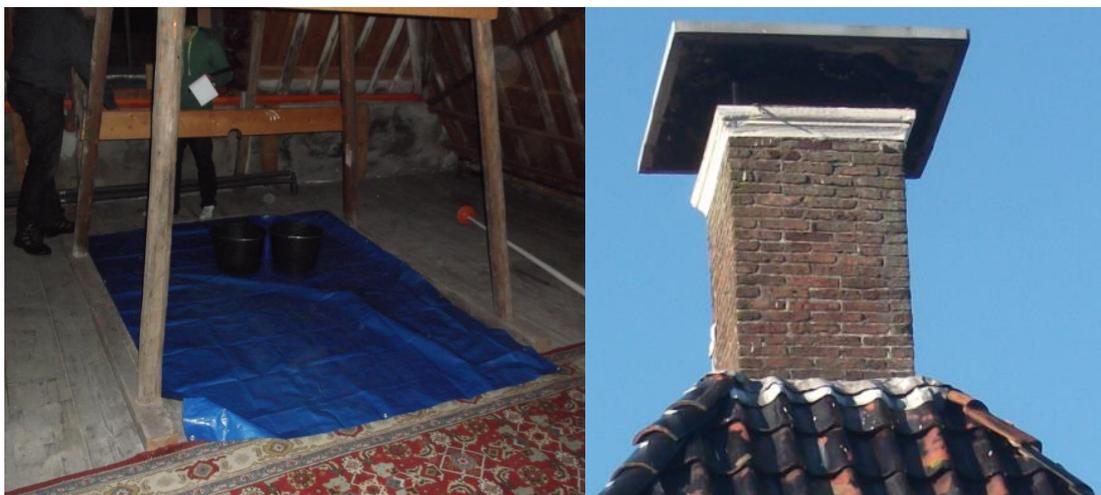
Also mention that there are rain water infiltrations in the centre of the attic, just below where the fireplace is located. Most likely it was produced by a deterioration or improper performance of the waterproofing union of the chimney with the roof.

Image 9.2.2.-2 Water filtrations behind the chimney

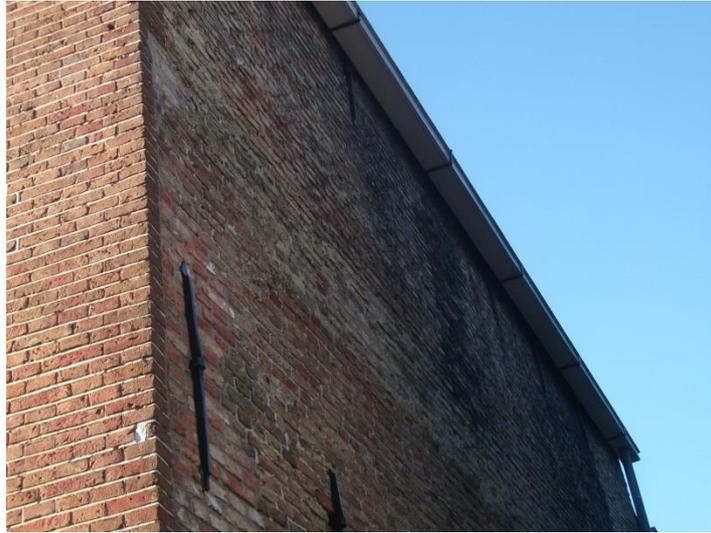
Other part of the building affected by rain water is the side facade. It was probably produced by the ruptured or inexistent gutter that collected rainwater which was spilled all over the wall causing black spots that characterize the humidity. In this particular case, the channel has been repaired so the cause of the problem has been resolved.

Image 9.2.2.-5 Moisture spots at the east facade

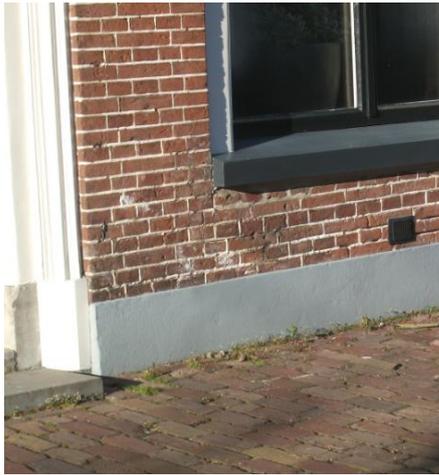
Image 9.2.2.-3 Efflorescence on the main facade

The modification of the sill would be a way to prevent water from flowing through the wall, and this would make a small sample to sill, as in the image I have placed on the right (image 9.2.2-4), so that when the water reaches that part it will fall to the ground and will not reach the wall surface.

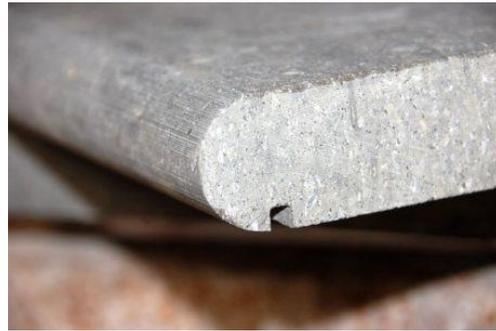
Image 9.2.2.-4 Notch should have outgoing to keep out the water

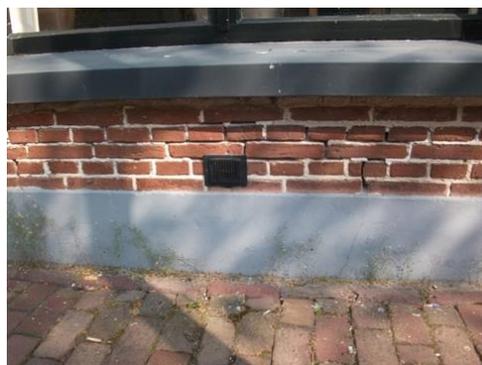
There are cracks in the lowest part of the main façade. This problem will be analysed too in the point 10 using the thermal camera to know if it has a bad consequences, but one wall with crack has more possibilities to have heat losses and air leaks thought the gaps between the cracks. They could have been produced by the water that flows on the flashings of the windows.

Imagen 9.2.3-1Crakcs of the main facade

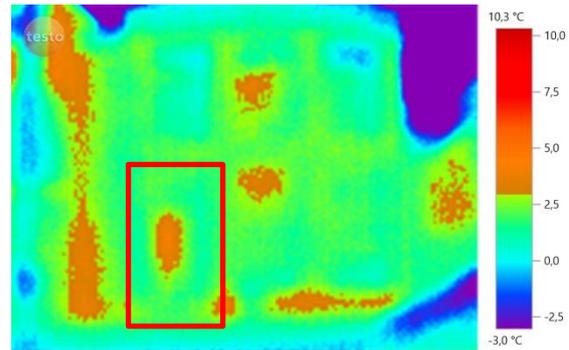
At the image we can see that there are heat losses on the share of the door, but not at the top of the door glass where that extra glass layer mentioned before had been installed. This proves that it somehow prevents the air leaks at this part of the house.

Image 10.2.1-2. Heat losses Main door

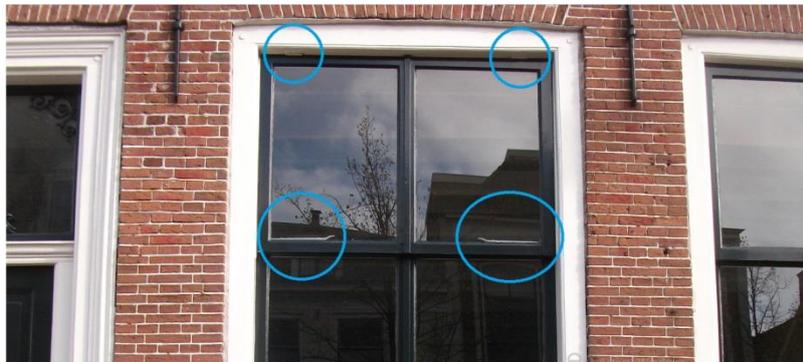
At the highest part of the window there is not that extra glass layer, that is why we can see heat losses at that part of the thermal picture (10.2.2-1). The hot air from the inside goes out because the opening system of the window does not close properly.

Image 10.2.2-3 Opening system of the window B

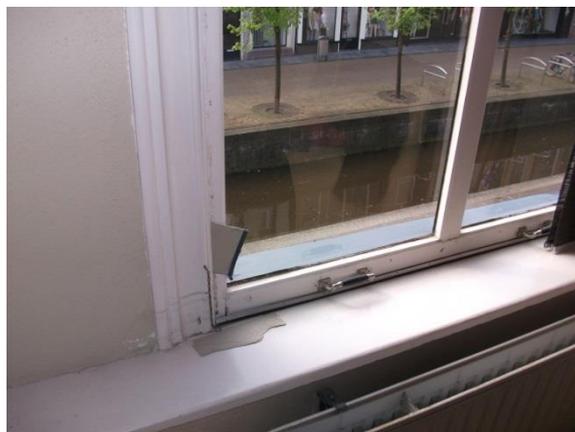
Image 10.2.4-3 “guillotine” opening system and papers to reduce air leaks.

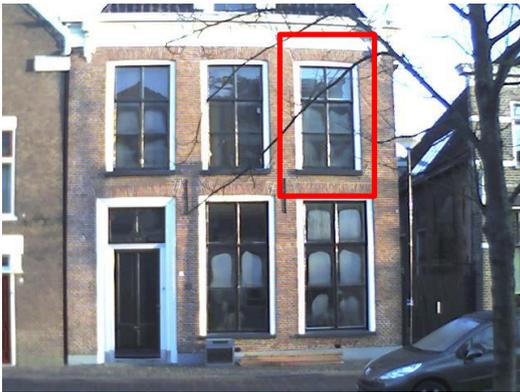
The extra glass is covering all the surface of the window preventing the ventilation on the surface and accumulating the humidity in the air chamber of the window, removing the air leaks but producing the condensation of the vapour on all the surface of the window.

Image 10.2.4-4 Condensation on all the window

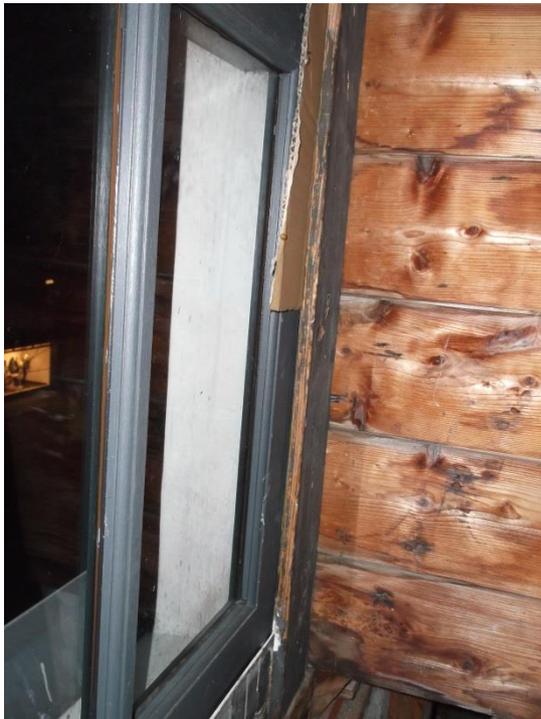
The thermal camera does not detect air leaks because there are not a temperature differences, however we know that at that part of the building there are heat losses by convection as the owner has proceeded to put pieces of papers on the window to prevent the air leaks at the joints.

Image 10.2.5-1 Papers in the joints of the window

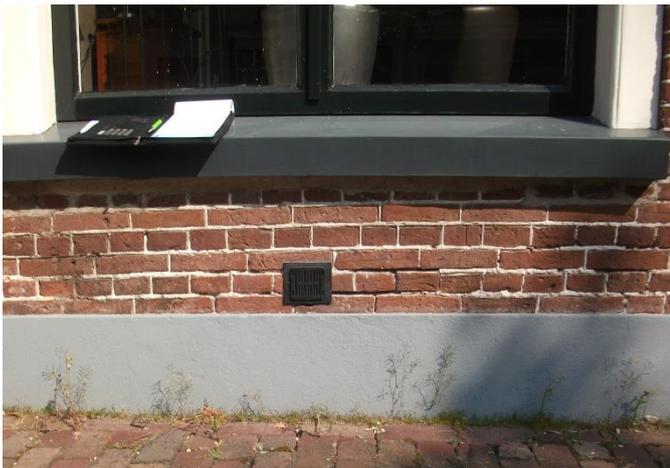
Image 10.2.6-3 Cracks window B

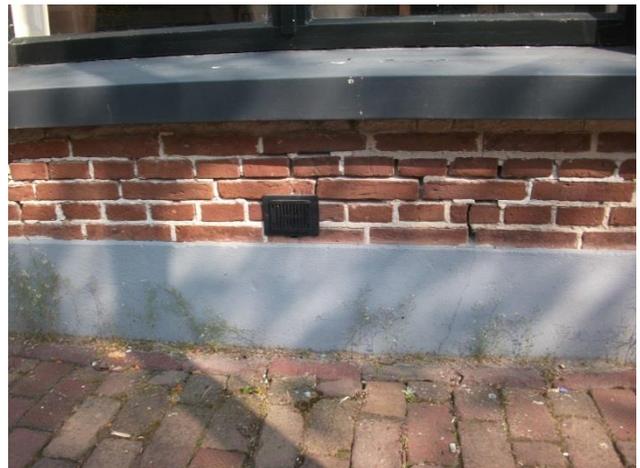
Image 10.2.6-4 Cracks window C

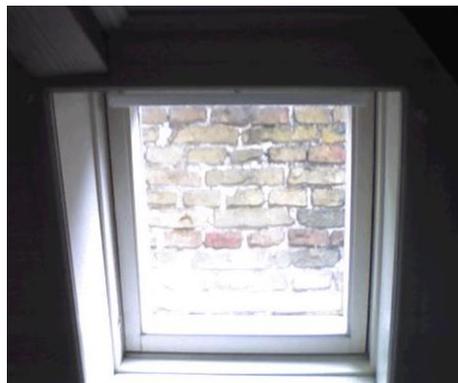
Image 10.3.2-2 Window T First floor (Double glass)

That means that the window is not working properly and if we want to solve this specific problem the only solution is for that window to be replaced by a new one.

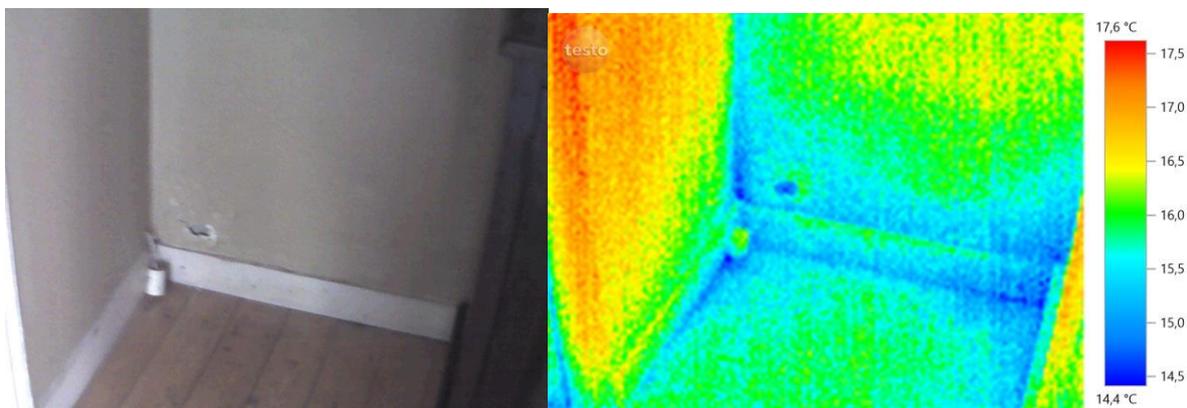
That is what is happening at the capillary humidities of the living room at the ground floor as we can see at the picture 11.2.1-1 below.

Image 11.2.1-1 Capillary humidities of the ground floor

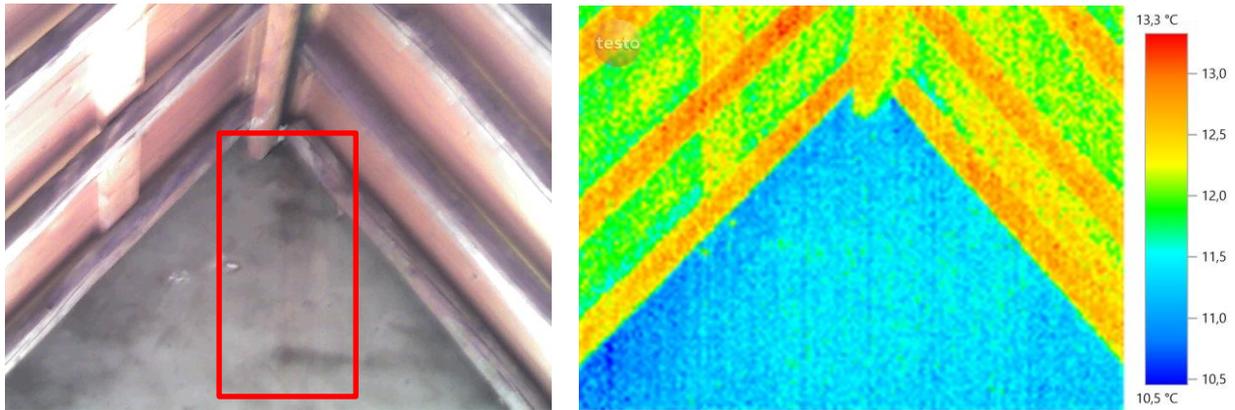
There were also humidities spots at the attic produced by the filtration of rainwater. As we can see in the picture, there is no temperature difference on the wall because it is completely dry. That means that there are not problems of humidities in this part of the house and it will be not necessary do any intervention to repair them.

11.2.2-1 Moisture spots at the attic. Normal and thermal picture

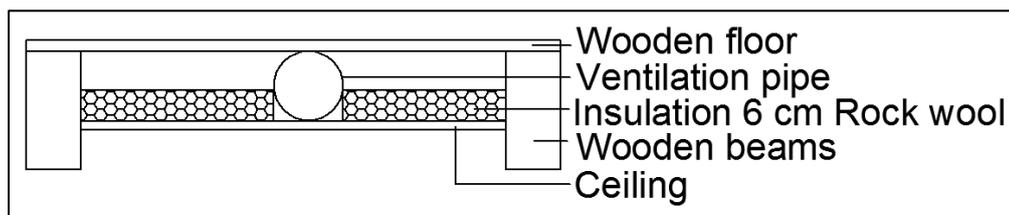
However, according to the documents of the restoration in 1985, there are not any drawings of the way that the pipes follow through the building. Most probably the pipes follow the wooden beams direction and are hidden between the ceiling and the wooden floor like we can see in the detail below. There are not enough information to know where there are the vertical ventilation pipes. (plane 12).

Image 12.2-6 Detail of the pipes between the ceiling and the wooden floor from the next level
