Preservation criteria applied to the case study of a 19th century fortress

C. Mileto, F. Vegas, V. Cristini & J. R. Ruiz-Checa
Universitat Politècnica de València, Spain

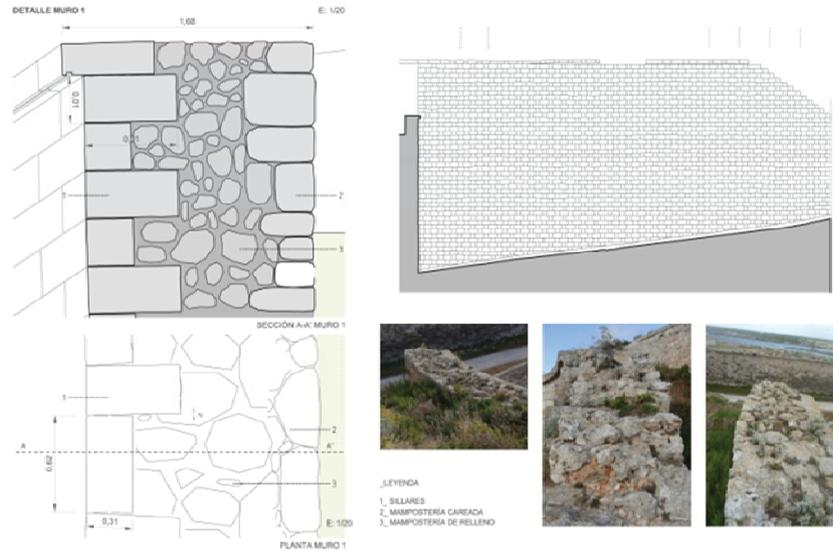
Historically, what is known as Recess 5 consisted in a pincers-shaped defensive element with a redoubt at the incoming angle (Figure 2). The straight retaining wall of the pincers connecting the outgoing angle of the Princess Tower and the Recess 5 stretched for a length of 390 m, closing the landward defence [3]. This series of works — consisting of the straight section, the Recess 5 and its redoubt — began in 1850 and would carry on until 1860, and integrate a perfect example of a polygonal landward defence, in keeping with the fortification theories of the time [4, 5].

Figure 2: Constructive details, Recess 5 (authors).

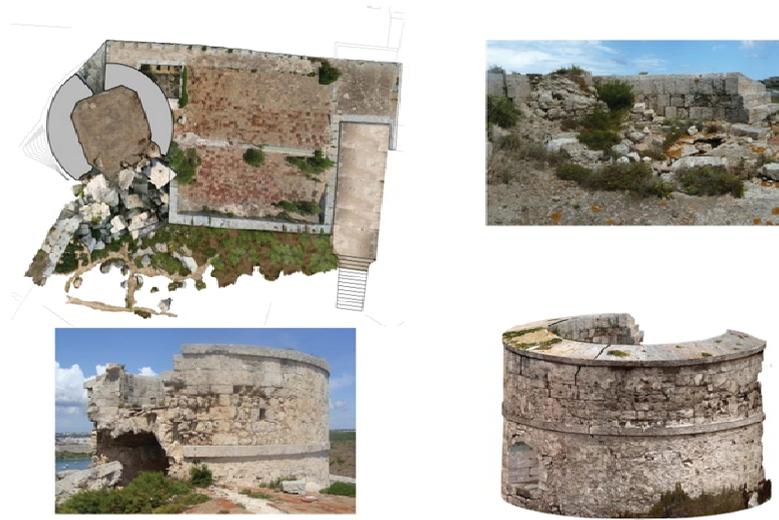
Figure 3: The Princess Tower, details (authors).

On the other hand, prior to the intervention, the Princess Tower presented a delicate state of preservation, being partially demolished on the inside due to an explosion caused by a lightning strike in 1958, when it was used as a gunpowder magazine. Neither the access nor the tower's stairway were preserved, but the embrasure facing north (towards the sea) remained standing. The tower had a circular plan and a slightly truncated cone-shaped morphology, with an upper radius of 5.06 m and a maximum height of 8.26 m, with a total floor area of 80.41 m². Its morphological characteristics were completed by the presence of a barbette on the upper rampart, usually for two or three heavy guns (32- and 36-pounder bronze naval cannons with rotating carriage). Its base was reinforced to resist ground attacks, and the door was risen above the ground level, covered by a vertical fire provided by a simple machicolation above it. The tower base typically housed warehouses and water tanks. The first level, vaulted and artillery-proof, featured loopholes and vertical vents.

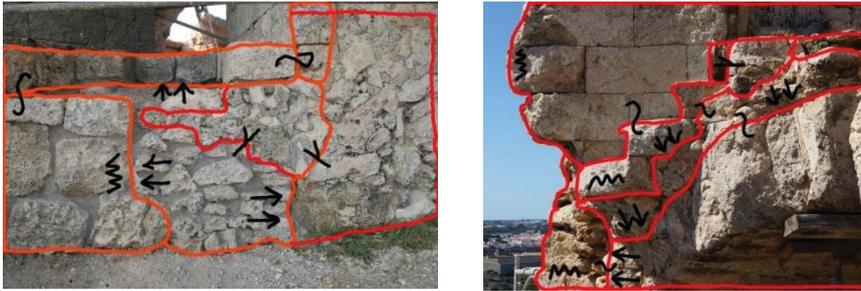
Figure 4: The Princess Tower, stratigraphic details (authors).

The third period corresponds to the construction and addition of the guard-house, possibly in the late nineteenth century (Figure 4). In this case, the structure is built with autonomous and different construction techniques from those employed for the tower: regular blocks of reduced size and lime mortar with dense aggregate of metamorphic origin [7].

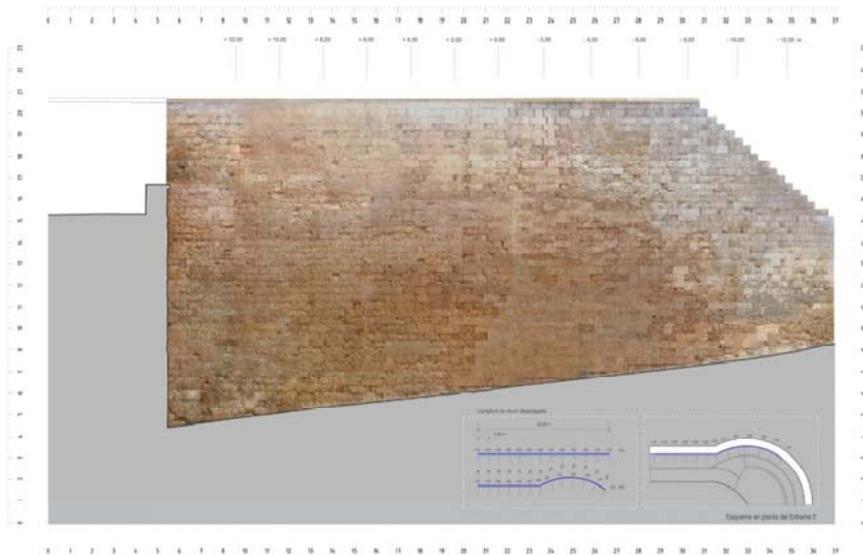
The Recess 5, being a section of the defensive wall of the fortress which acts as a retaining wall, was in a terrible condition, due to earth pressures. The section under study had a length of 30 m and a height of 15.07 m at the highest point. Prior to the intervention, the Recess 5 showed significant degradation, erosion and pulverization of many of the blocks of stone that formed the retaining wall. In addition to this, the entire wall was visibly collapsed; even some of the capstones were missing.

Figure 5: Recess 5 after the intervention (authors).

As for the Recess 5, the needs expressed in general terms have focused on the conservation of the wall and to ensure the safety of visitors. For this reason, it has been necessary to undertake a structural consolidation of the affected wall, with the protection and repair of the crown, the consolidation of deteriorating stone, the attenuation of the phenomena of degradation, the elimination of the causes of moisture, and the resolution or contrast of the earth pressure forces (Figure 5).

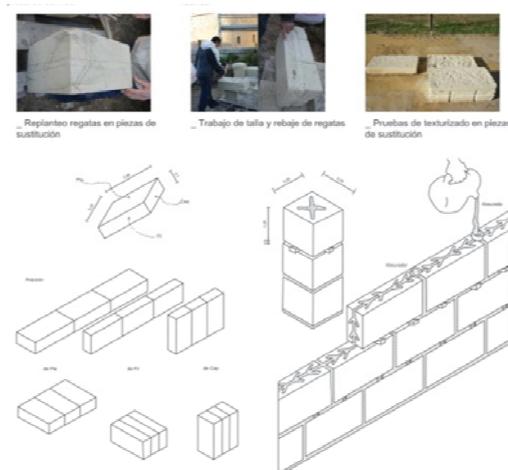
Figure 6: Technical process of 'abeurada' in Recess 5 (authors).

The presence of channels is also clear evidence of the use of the traditional ‘abeurada’ technique, frequently employed throughout the fortress. Such technique is based on creating a network of grooves on the hidden side of the pieces, thus facilitating the entry of lime whitewash (Figure 6). Small exterior sealing joints (with ‘bastard’ lime and plaster mortar) are created to prevent the leakage of the grout through the exterior joints. With this technique we proceeded to the replacement of nearly 500 pieces of the whole structure, whose finish has been carefully treated, using water-sandblasting calibrated to different levels of erosion depending on the final destination of each piece [8].

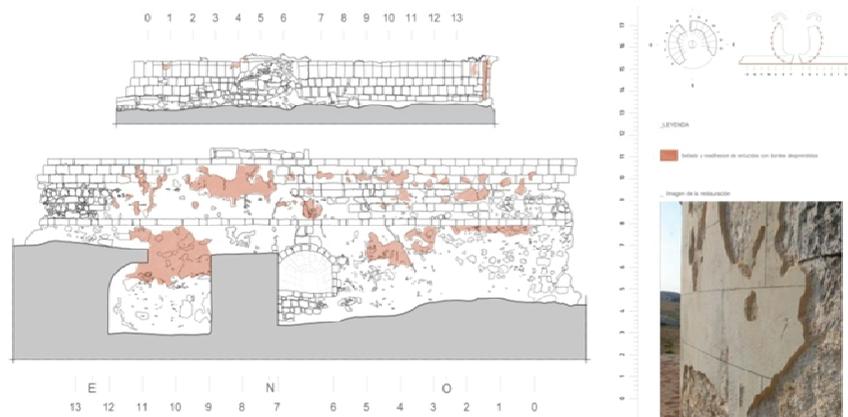
Figure 7: Details of mortars consolidation, The Princess tower (authors).

The uneven and cracked state of the tower’s roof required levelling it and ensuring water evacuation through a bed of lightweight concrete made with arlite and subsequently a base slab of natural hydraulic lime mortar. On the other hand, it is important to identify the restoration work that has focused on the exterior cladding and the roof of the guard-house. Intervention on these elements included selective cleaning, micro-sealing, consolidation of loose mortars, filling gaps, general harmonization and consolidation (Figure 7).
