Grid structures in Wenchuan Earthquake

Abstract

Keywords: grid structure; Wenchuan earthquake; earthquake resistance

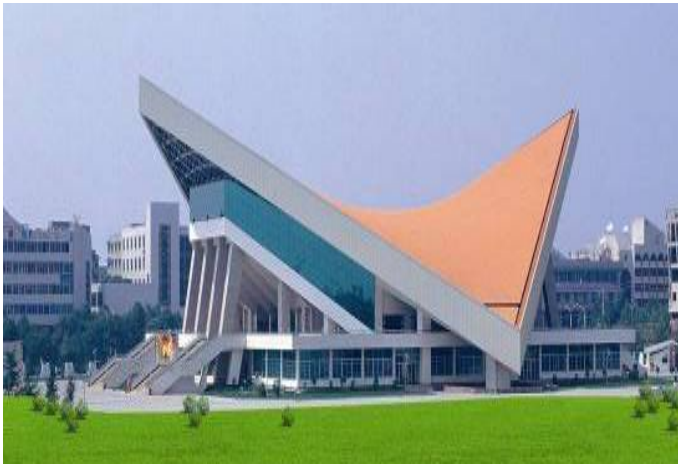
Figure 1: Deyang Gym with a hyperbolic saddle roof; grid shell used here with welding connection; no damages to the main structure, only ceiling damaged and infilling walls cracked partially

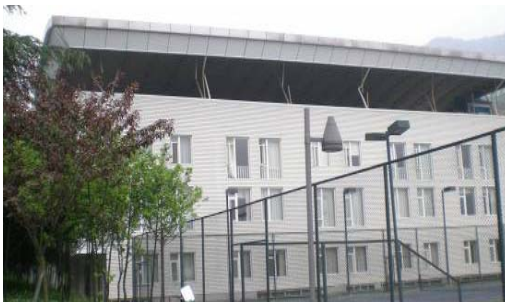
Figure 2-a: A grid shell in Dujiangyan

Fig. 2-a~g show a damaged grid shell in Dujiangyan. We can find some members close to supporters are buckled under pressure or yielded under tension. The earthquake resistance intensity of Dujiangyan is 7 and so earthquake effects can be ignored in this city according to stipulations of Chinese code. But in Wenchuan earthquake, the earthquake intensity

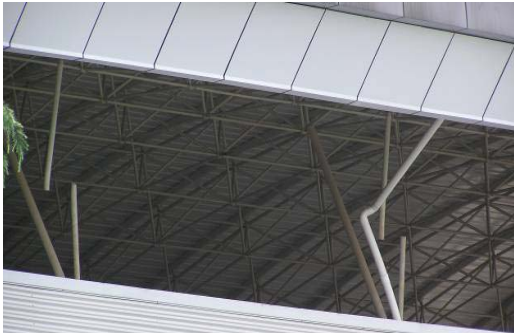
reached 8 or 9, members close to supporter beard higher forces than designer had estimated, so many of them buckled under compression or yielded under tension forces (Figure 2-c, 2-d, 2-f). Failure can also be observed on connectors (Figure 2-e). Although some members failed, the whole structure survived in the earthquake because of its good integrity and redistribution of internal forces (undetermined structures).

Figure 2-c: (↑) member failed under tension forces

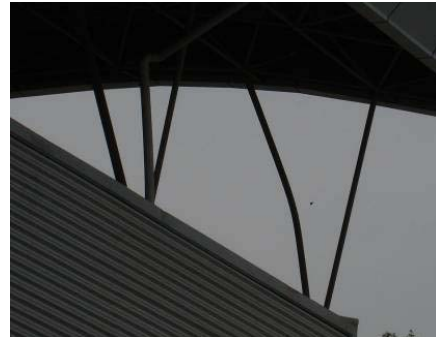
Figure 2-d: (→) member failed under tension forces

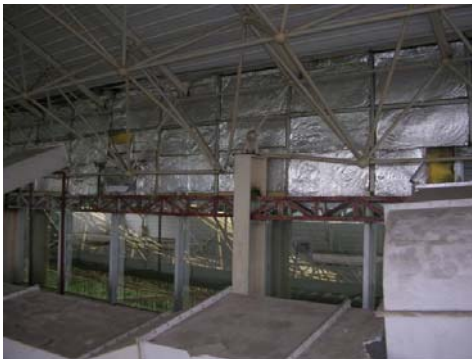
Figure 2-e: (↑) Failure between members and connectors

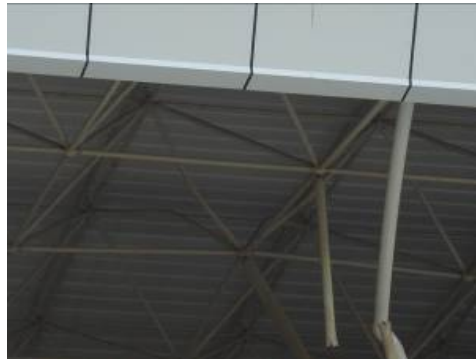
Figure 2-f: (→) members close to supporters buckled under compression

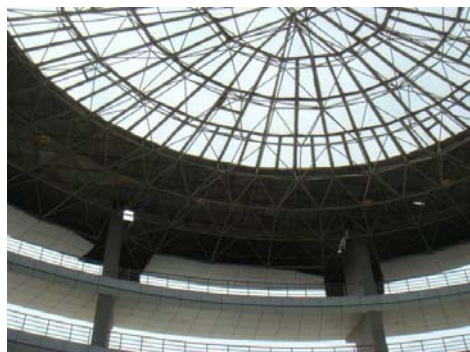
Figure 3-a~c show a grid shell in city Mianyang. This bolted grid shell was supported on cantilever columns. When earthquake happened, displacement on top of the columns exceeded design limit and caused some members connected to supporters failed or buckled.

Figure 3-a A grid shell in Mianyang

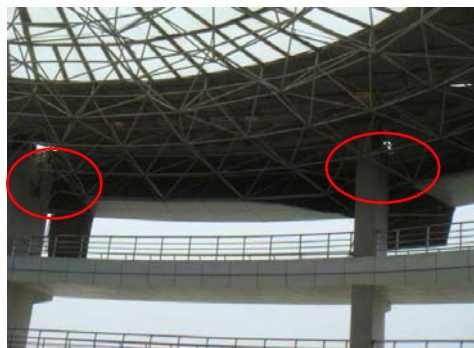
Figure 3-b struts close to supporters failed

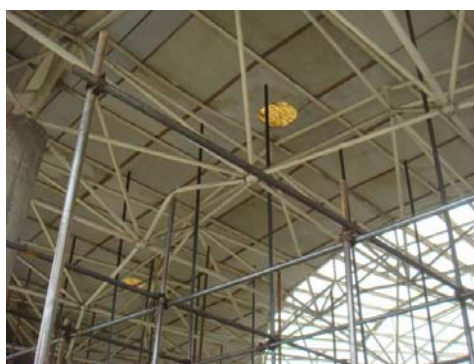
Figure 3-c some members buckled under compression

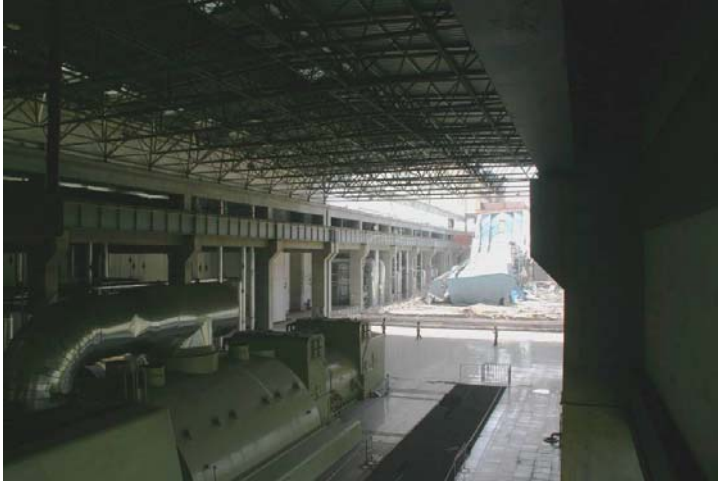
Figure 4-a~c show the damages to a grid shell of a factory in Jiangyou city. The factory spans 28 meters, with 12 meters of column spacing, and has two stories. The first floor is constructed by reinforced concrete slabs; the roof is the combination of lattice shell and concrete slabs. The shell has a skylight shelf along the longitudinal direction. The shell and the lower concrete structures were divided, along the longitudinal direction, into two sectors by the seismic joint: one sector collapsed, the other was only with some small damages. The reason is there is a big hole by side of the constructional joint at the collapsed sector.

Figure 4-a the mechanical factory in Jiangyou, half collapsed

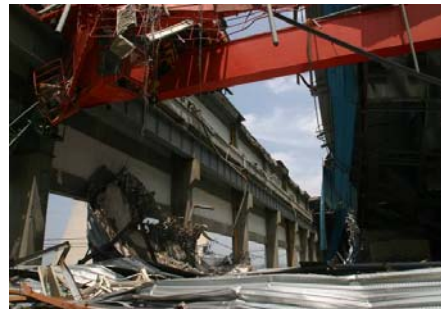
Figure 4-c collapsed sector-Integral collapse

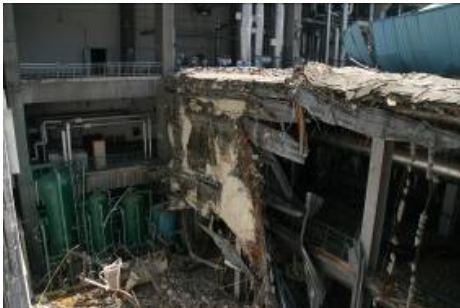
Figure 4-d~e shows collapse of concrete roof plate

Figure 43-d concrete plates as roof covering

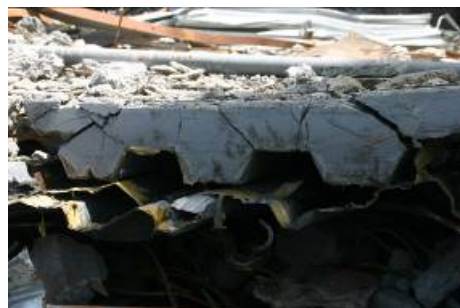
Figure 4-e concrete plates fell

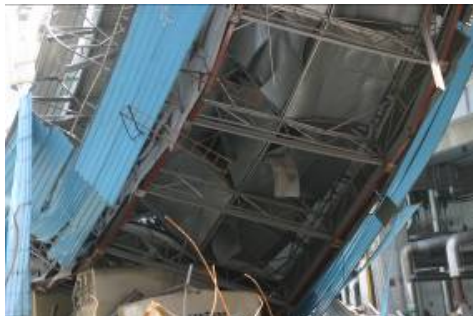
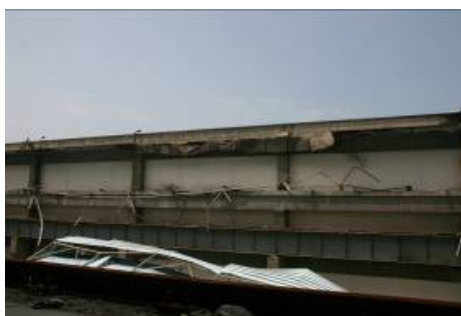
Figure 4-f: (↑) Louver collapsed at the middle part
Figure 4-g: (→) Supporters and the connected members (1)

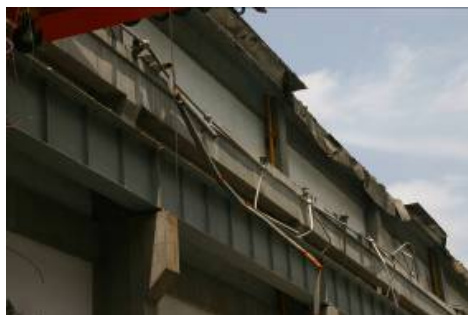
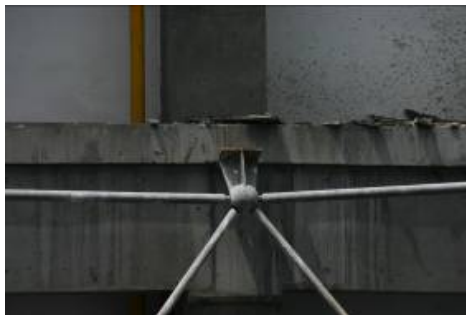
Figure 4-h: (↑) Supporters and the connected members (2)
Figure 4-j: (→) Supporters and the connected members (3)

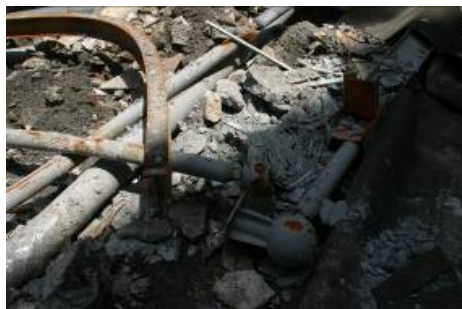
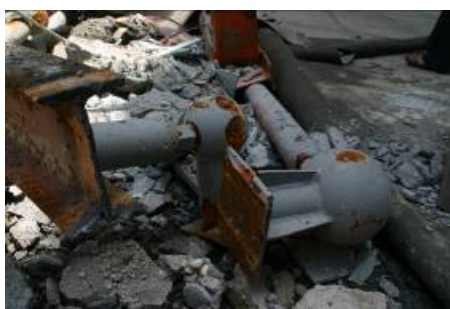
Figure 4-k: (↑) members and nodes fell down on the ground (1)
Figure 4-m: (→) members and nodes fell down on the ground (2)

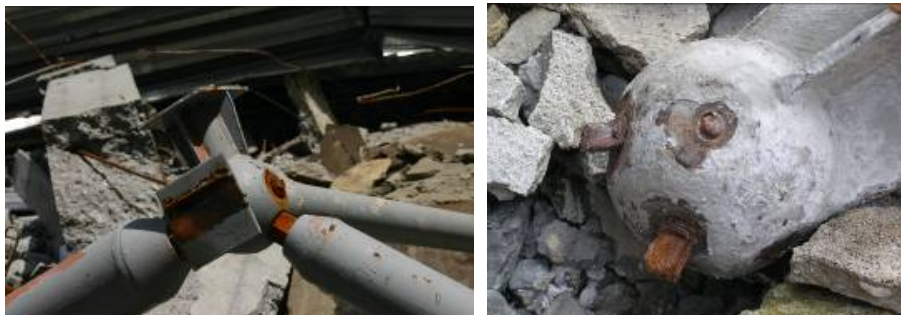
Figure 4-n: (↑) failed connectors, bolts on the nodes rusted and snapped (1)

Figure 4-o: (→) failed connectors, bolts at the nodes rusted and snapped (2)

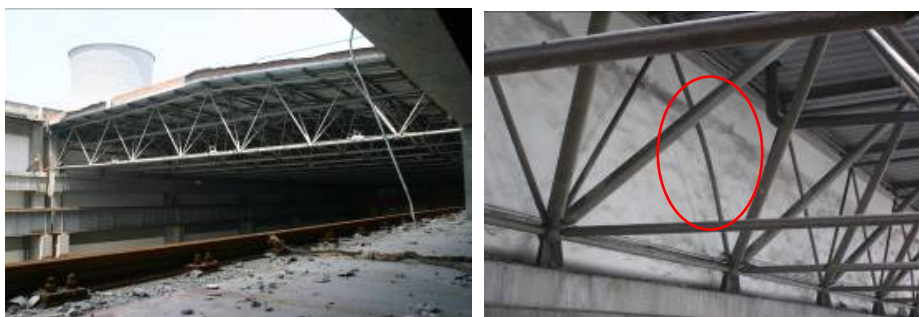
Figure 4-q: (→) neighbored grid shell; a few members buckled
