López Patiño, MG.; Adam Martínez, JM.; Verdejo Gimeno, P.; Milani, G. (2017). Causes of damage to industrial brick masonry chimneys. *Engineering Failure Analysis*. 74:188-201.
doi:10.1016/j.engfailanal.2017.01.014

Causes of damage to industrial brick masonry chimneys

Keywords: *Industrial chimney; Masonry; Damage; Failure; Brick; Classification*

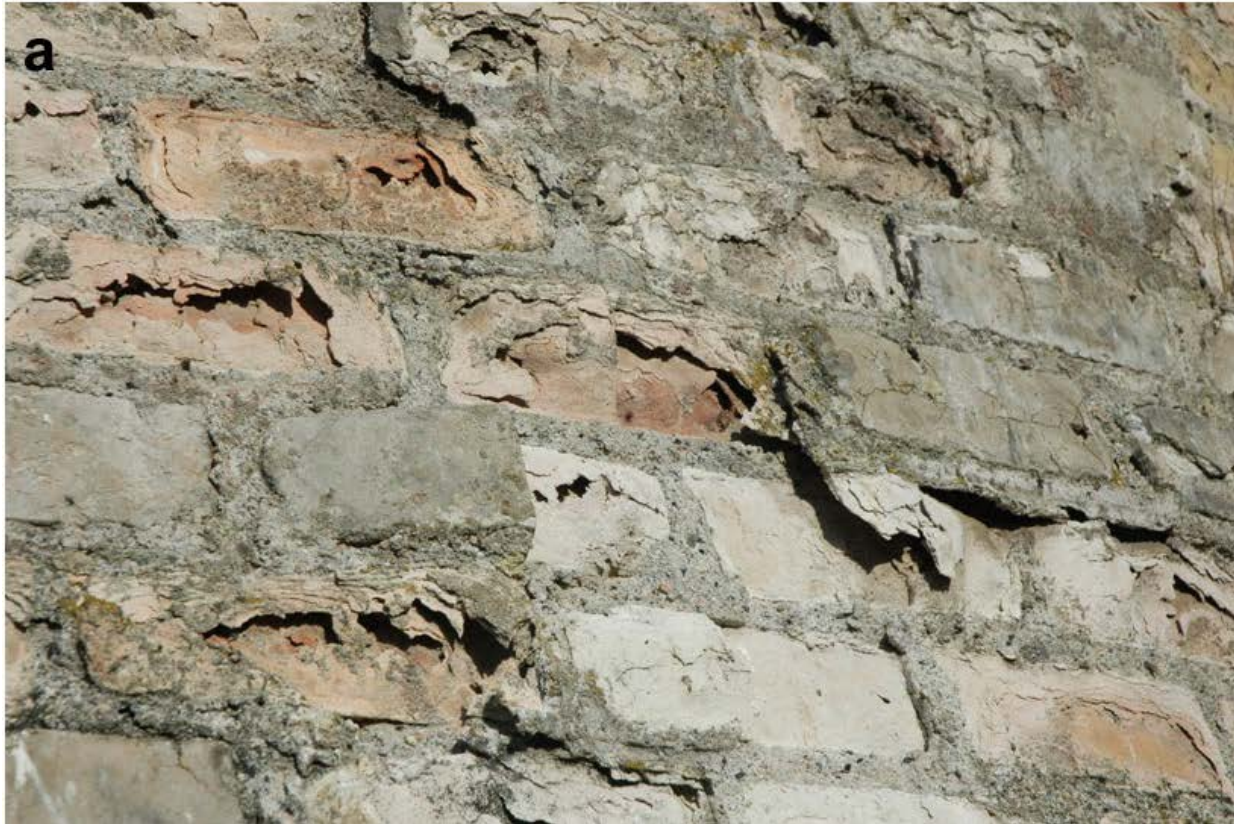
In the inspections carried out, damage was found due to spalling or flaking of the bricks (see Fig.3a), in which they appear to break up into layers or flakes. This type of damage can in time evolve into the complete disintegration of the bricks.

Fig. 3. Damage to bricks: a) Flaking bricks in a chimney in Peñarroya-Pueblonuevo (Spain); b) Efflorescence in a chimney in Daroca (Spain).

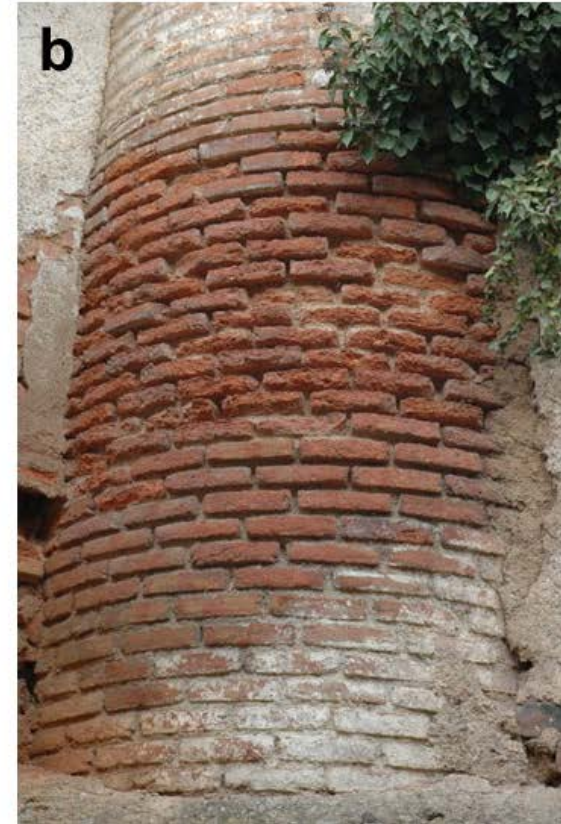
Efflorescence was the most common type of damage observed during the inspections (see Fig.3b). This is in the form of whitish stains that are due to the crystallisation of the soluble salts on the surface that mainly appear on the chimney base, into which moisture seeps from the ground by means of capillary action.

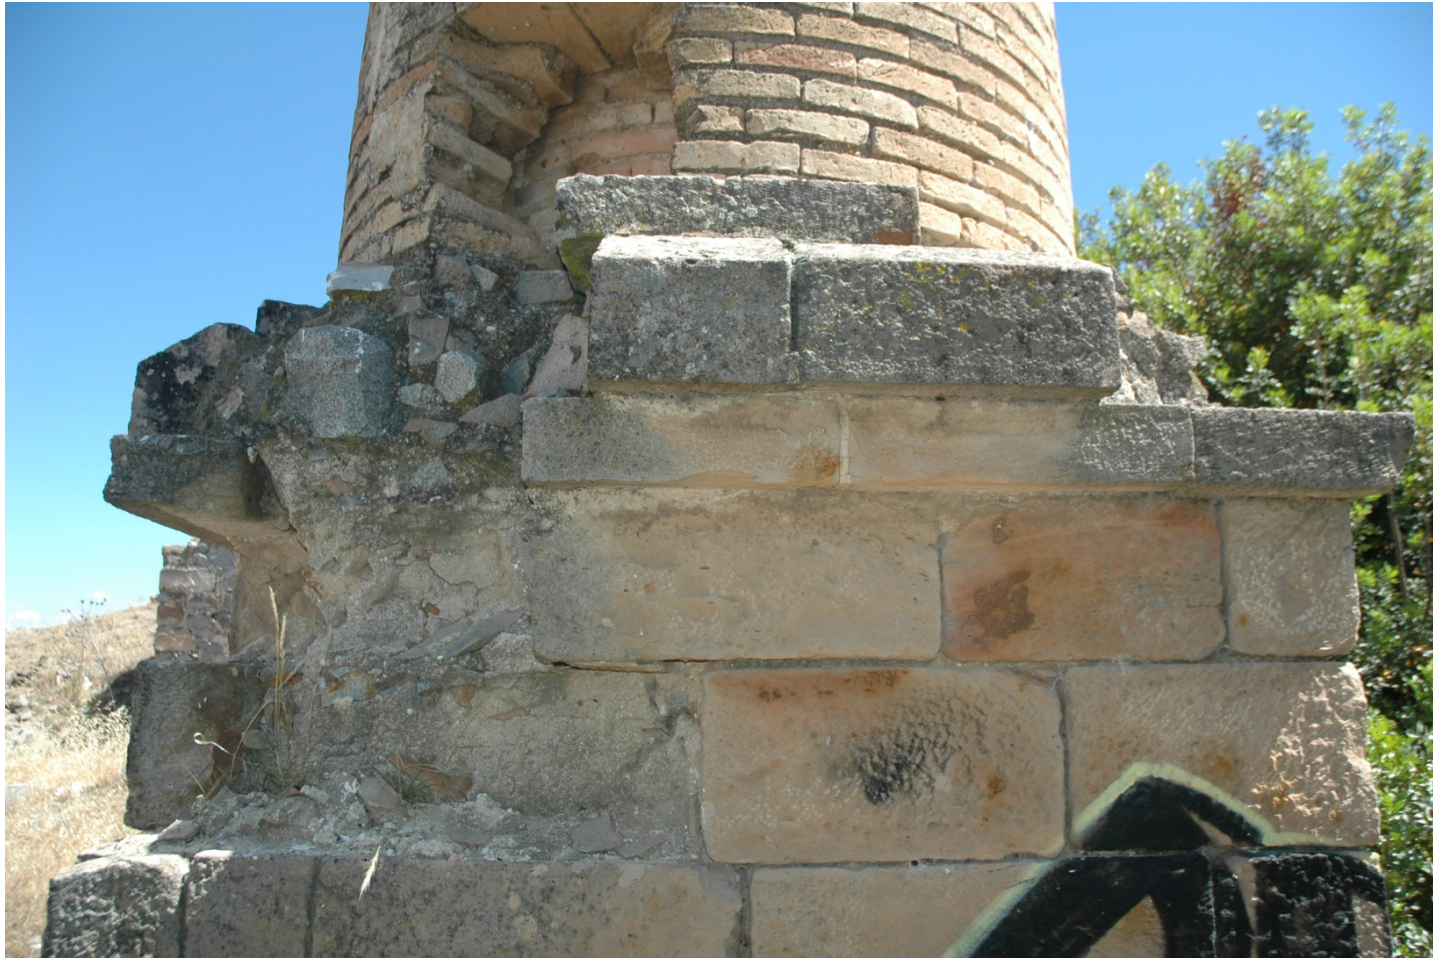
In some cases, stone was used to construct the chimney base and this was often from the countryside close to where the chimney was built. The type of stone and its physical and mechanical characteristics determine its durability. After inspecting the 538 chimneys in the study, the most common problem found in the stone used for the bases was erosion due to environmental agents. Fig. 4 shows the case of a chimney with a base badly affected by erosion.

Fig. 4. Damaged stonework in the base of a chimney in Linares (Spain).

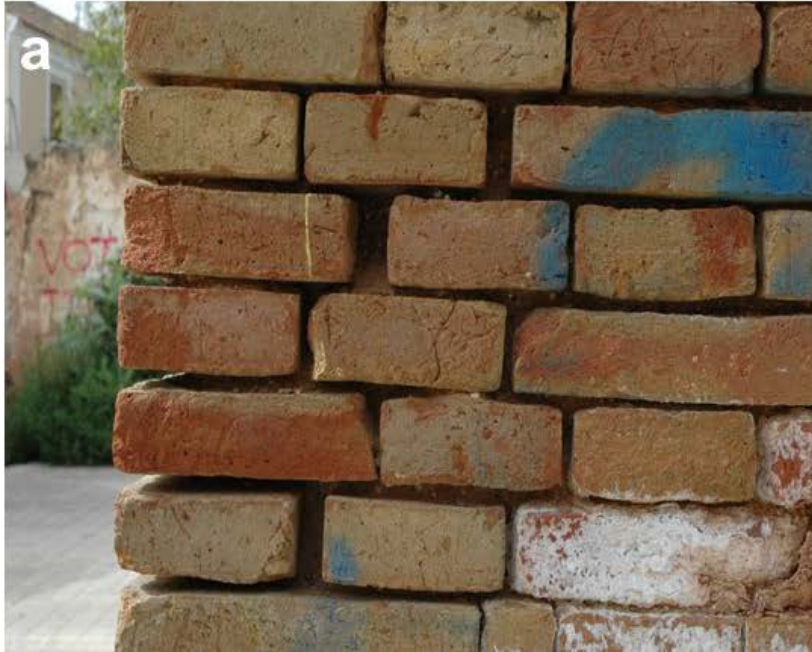
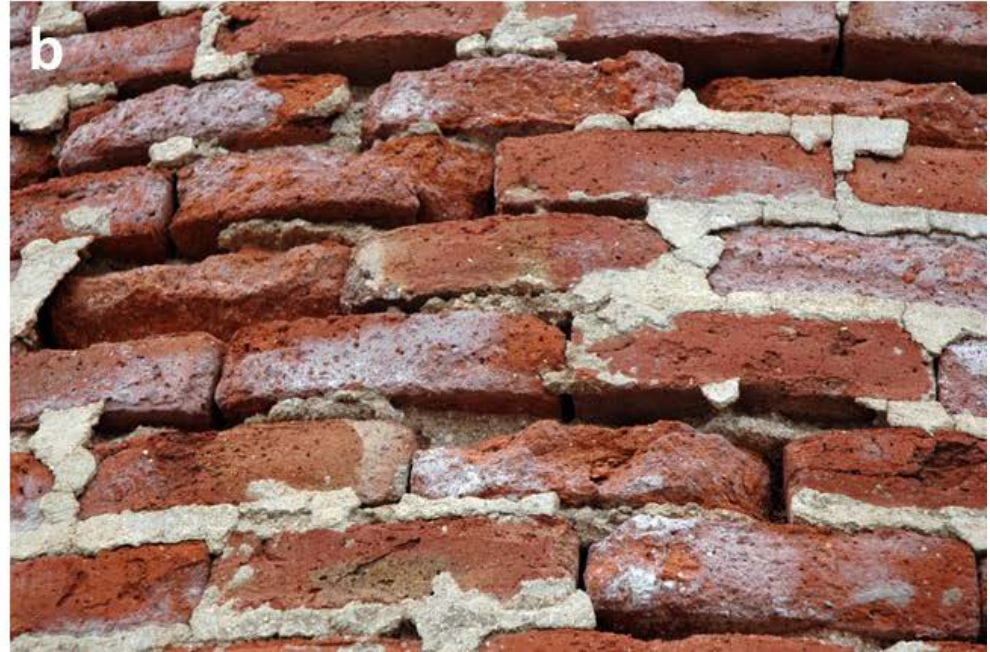
A large number of studies have dealt with how mortar in masonry structures can be damaged, and Lourenço et al. [37] provide an excellent classification, which can also be applied to chimneys. In the inspections of 538 chimneys, mortar was often found to have disappeared between the bricks, usually due to the degradation of the mortar itself or to defective workmanship. The worst cases were found to occur in mortar containing coarse aggregate, due to the reduced aggregate-binder specific contact surface, while in other cases the degradation was due to the lack of a binder. Cases of chimneys in which the mortar has disappeared from between the bricks can be seen in Fig. 5. It should be emphasised that such cases require immediate action since the resistance of the brickwork has been seriously reduced.

Fig. 5. Deterioration and missing mortar. Chimneys in: a) Manzanares (Spain); b) Cinco Casas (Spain).

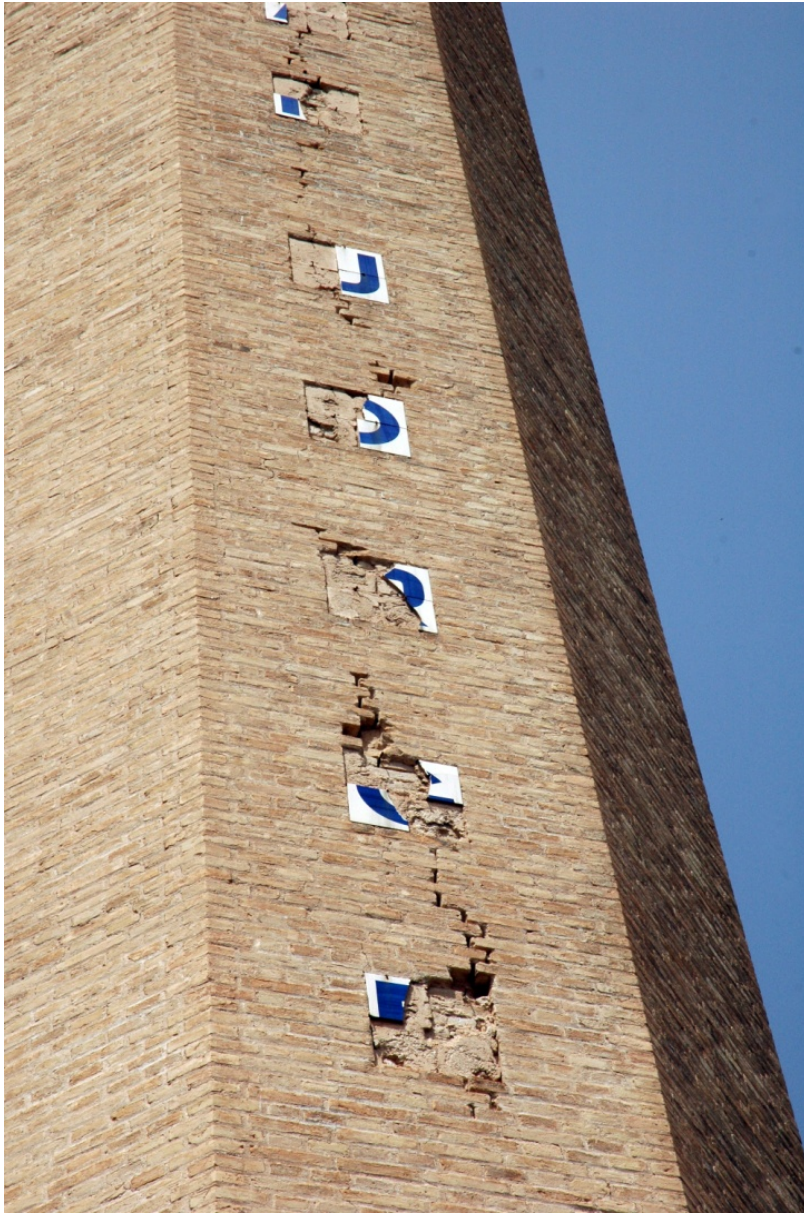
Ceramic elements, which are mostly tiles, were often used to decorate chimneys, usually in the form of a ring around the stack or in a broken vertical line. The main problem with tiles is their tendency to come away from the surface, particularly if they are attached directly to the masonry and not in specially prepared cavities. Cracks often appear in tiles due to their expansion and contraction under changes of temperature. Fig. 6 shows a chimney with a large number of missing and broken tiles.

Fig. 6. Damaged decorative tiles in a chimney in Xàtiva (Spain).

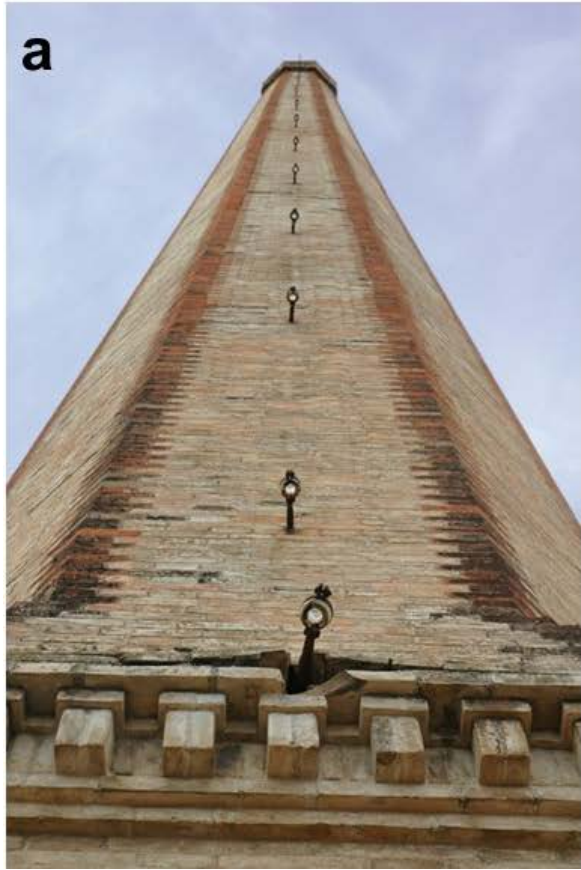
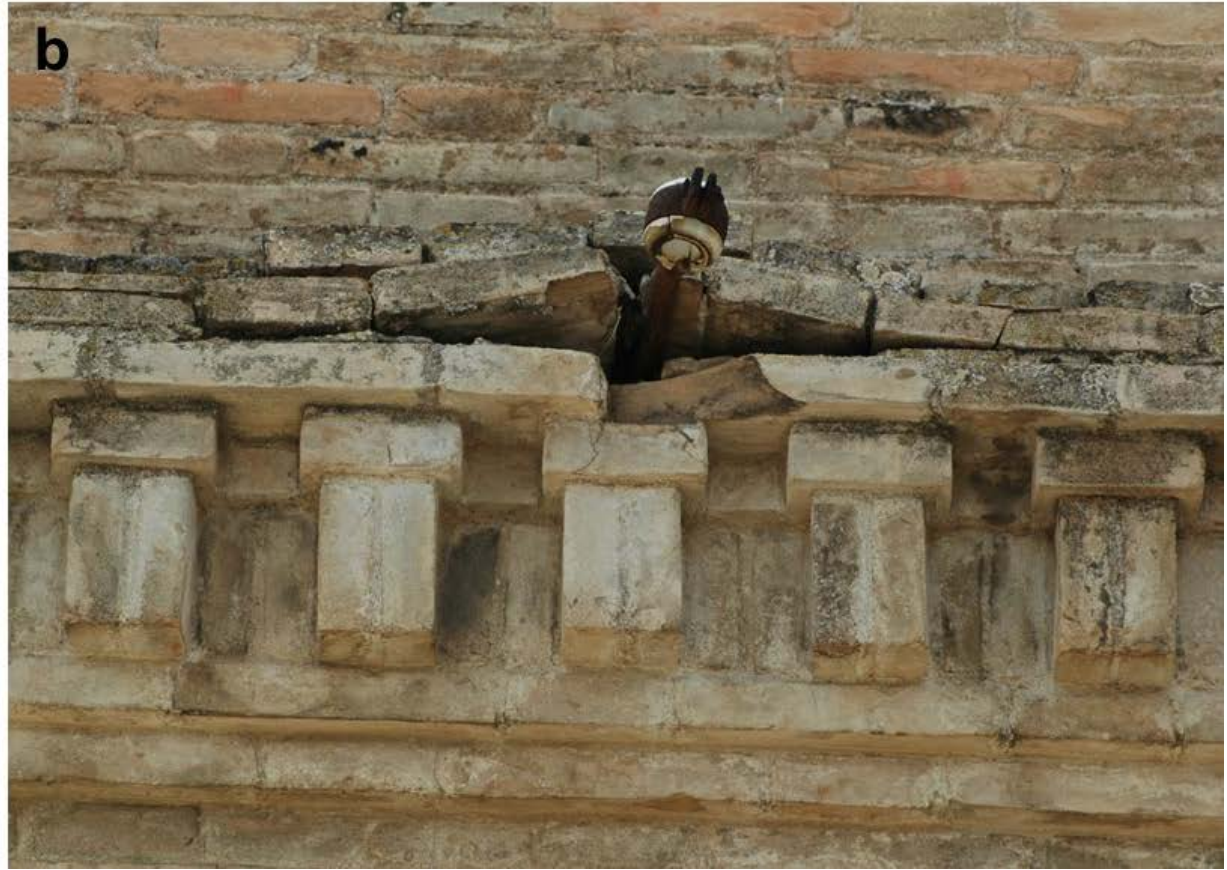
These elements are mostly affected by corrosion, which can damage the masonry itself, as has been pointed out by Lopes et al. [20]. When these elements undergo oxidation they increase in volume and create forces at the points in the masonry to which they are fixed. Fig. 7 shows a case of insulation elements that have corroded on a chimney and caused cracks in the bricks. Metal components can also create aesthetic problems due to the corrosion stains left by the rain running down the surface.

Fig. 7. Damage caused by corrosion of metal components in a chimney in Gandía (Valencia): a) General view; b) Close-up.

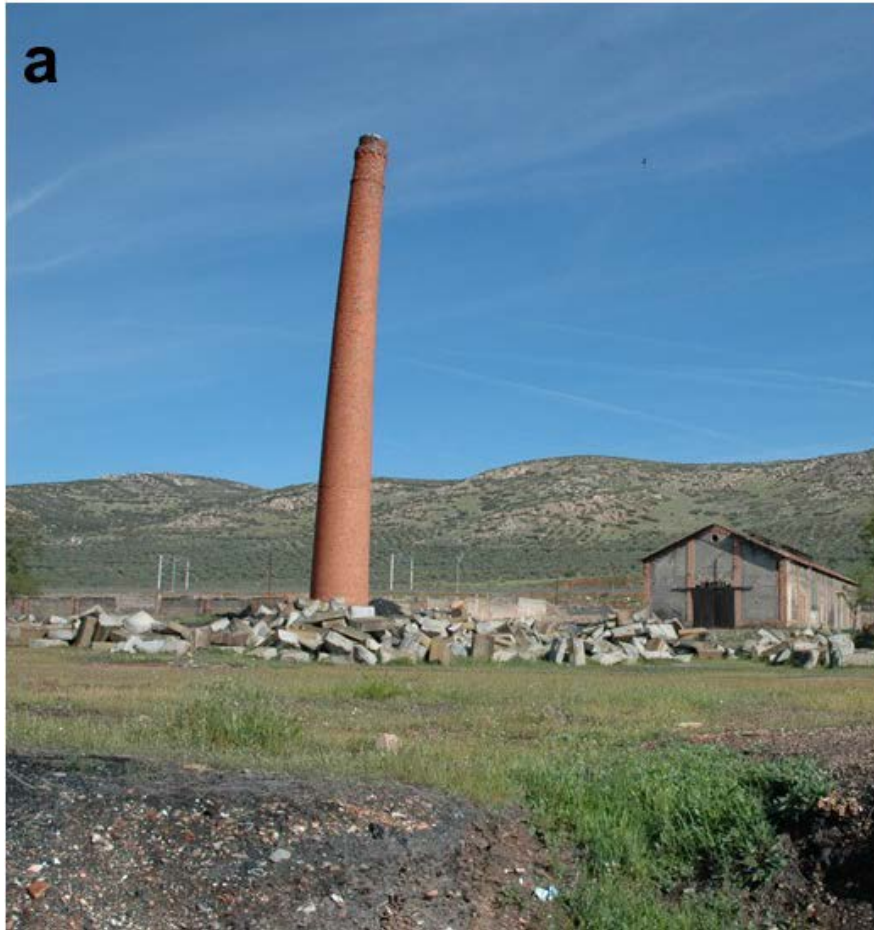
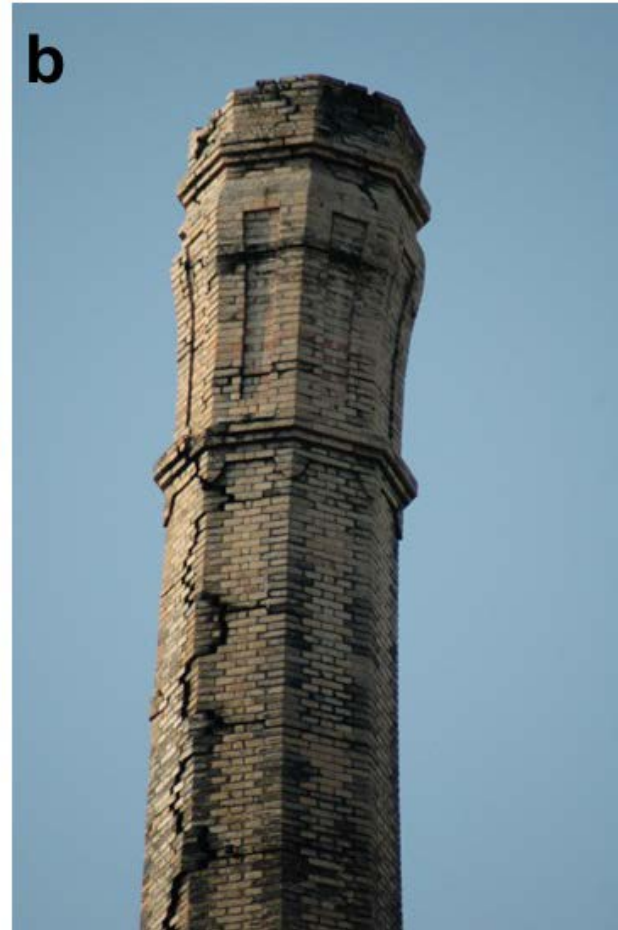
Pallarés et al. [25] have shown that prevailing winds can induce permanent displacement of the top sections of chimneys and that this effect could be due to differences in mortar drying on different sides of the chimney. They cite the example of the city of Oliva (Spain), where most of the chimneys lean in the same direction. Ivorra et al. [28] maintain that the prevailing winds can cause permanent deformation due to creep in the masonry and give as an example the case of a chimney in Agost (Spain), the upper third of which has been deformed by the force of the wind. According to Pallarés et al. [25] and Ivorra et al. [28], the force applied by the prevailing winds affects the upper section of the stack, where the wind is strongest and chimney stiffness is weakest, and permanent deformation may be the result. In cases in which the crown is significantly displaced, serious cracks may appear in the windward side of the stack. Fig. 8a shows a chimney with a considerably deformed crown, and in Fig. 8b another chimney can be seen in which severe deformation caused cracking and a large cavity in both stack and crown.

Fig. 8. Displacements caused by prevailing winds: a) Chimney in Puertollano (Spain); b) Chimney in Oliva (Spain) with large openings in stack and crown.

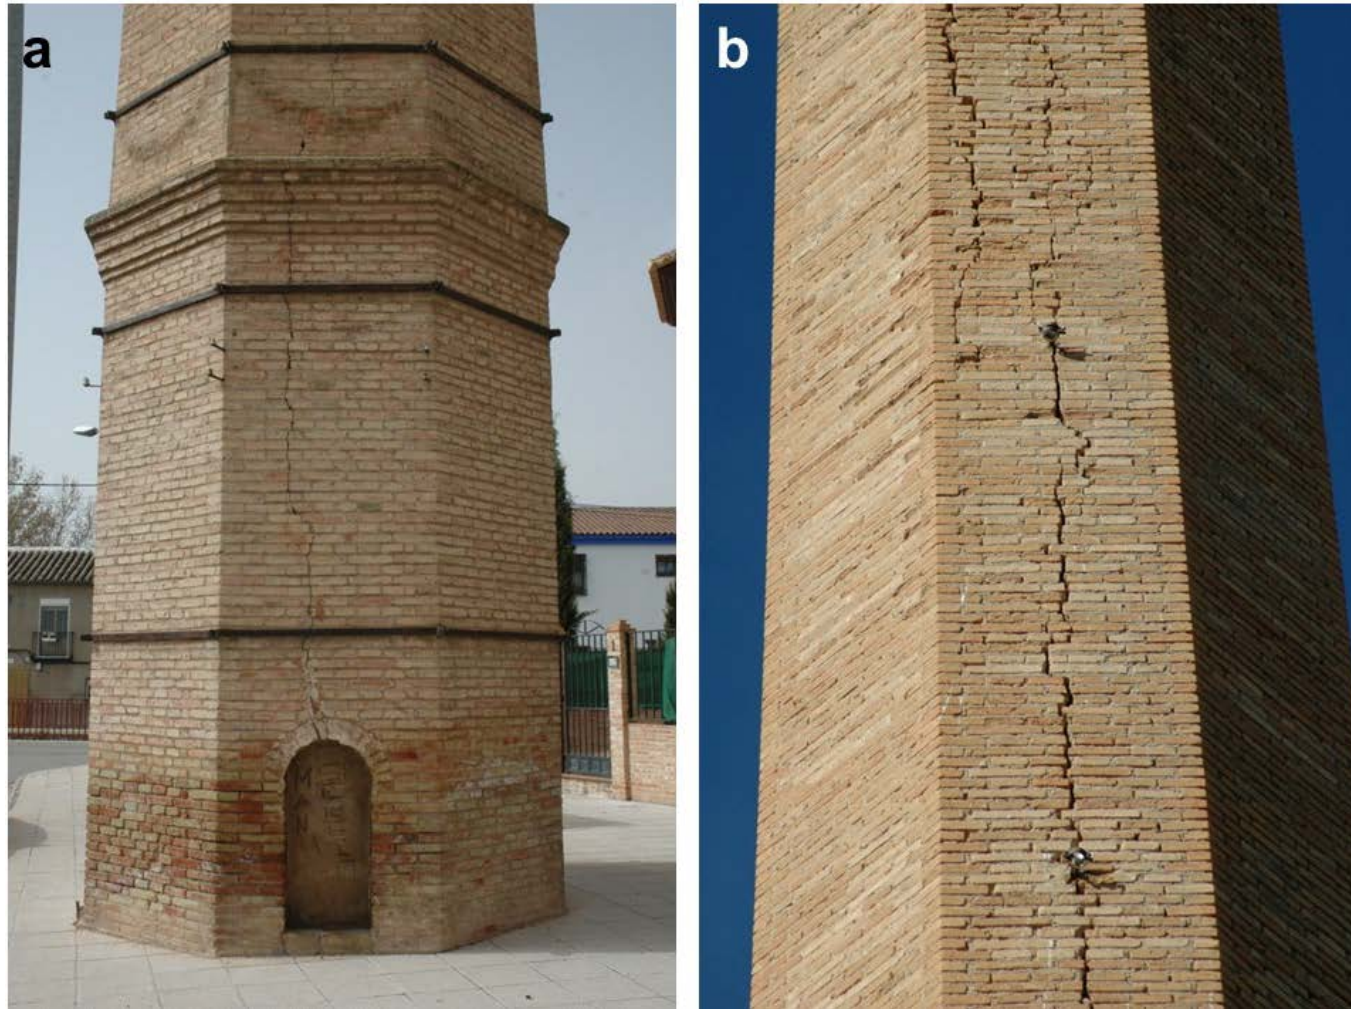
Cracks attributable to temperature variations usually appear near the base, which is close to the furnace, and are concentrated in the weakest part of the stack. Fig. 9a shows an example of a chimney with its base cracked by temperature variations and Fig. 9b shows another situation in which cracks are found in the zones of the lightning conductor insulation. Both the cracks in the base and the holes made in the masonry to fix the insulation generate a series of singular zones in which the stresses derived from the temperature variations are concentrated.

Fig. 9. Damage in the form of cracks due to temperature variations and gradients: a) Chimney in Ciudad Real (Spain); b) Chimney in Sueca (Spain).

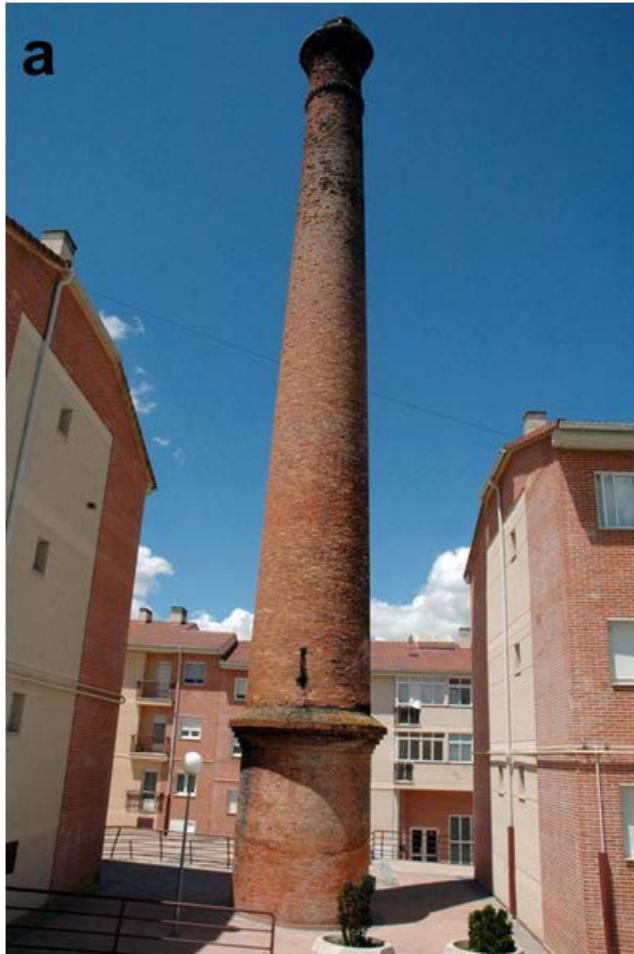
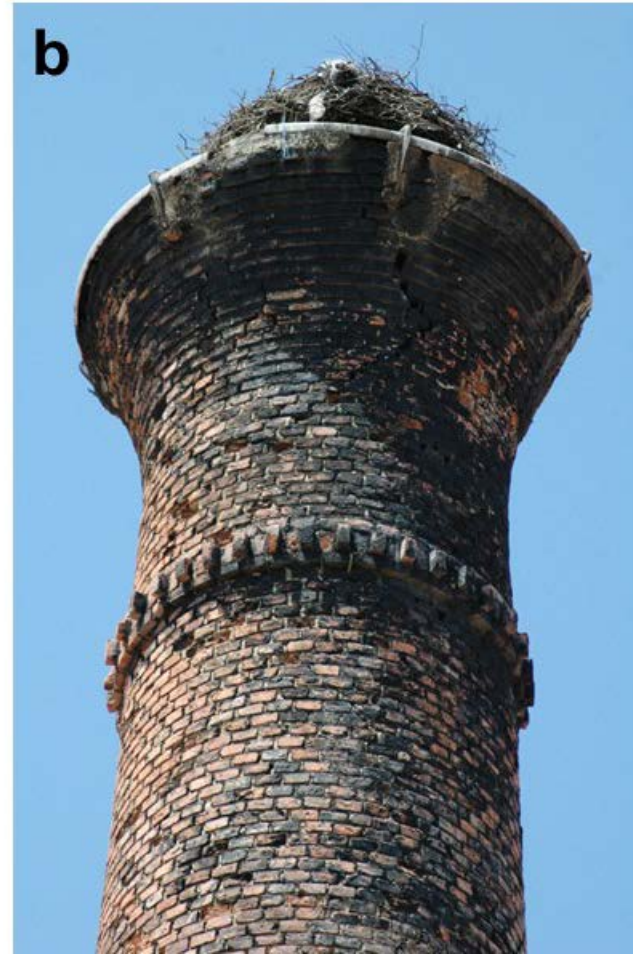
The use of a chimney to exhaust smoke often causes dark stains to appear near the crown on the downwind side. Even though this type of damage does not represent a risk to its structural stability, it can be considered to be an aesthetic problem. Fig. 10 shows a newly constructed chimney in an urban area, where the aesthetic problem represented by the stains is not acceptable. It is therefore advisable to clean any smoke-stained zones, especially when the chimney has a symbolic or aesthetic value.

Fig. 10. Smoke stains on the upper section of a chimney in Segovia (Spain): a) General view; b) Detail of crown.

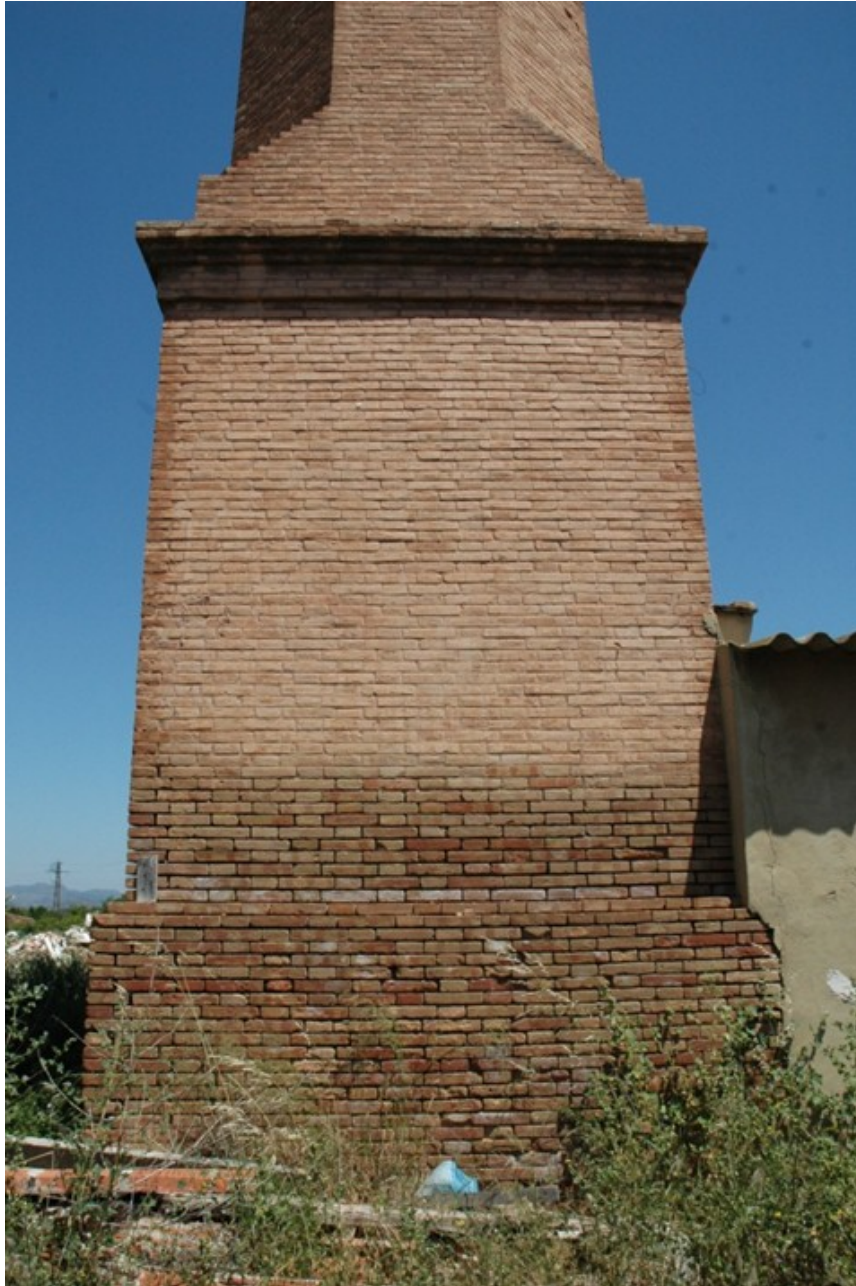
In the inspections carried out in the course of the present study, many cases were found of chimneys with evident symptoms of damp (see Fig. 11), one of which is the discoloration of the masonry in the affected zone. Moisture in a chimney can basically cause the degradation of the bricks, stone, mortar or metal elements, all of which contribute to reducing the chimney's resistance to the forces to which it may be subjected.

Fig. 11. Damp stains on the base of a chimney in Alfara del Patriarca (Spain).

To avoid this problem, when chimneys are being restored it is therefore necessary to use appropriate techniques to ensure moisture cannot reach the structure from the ground.

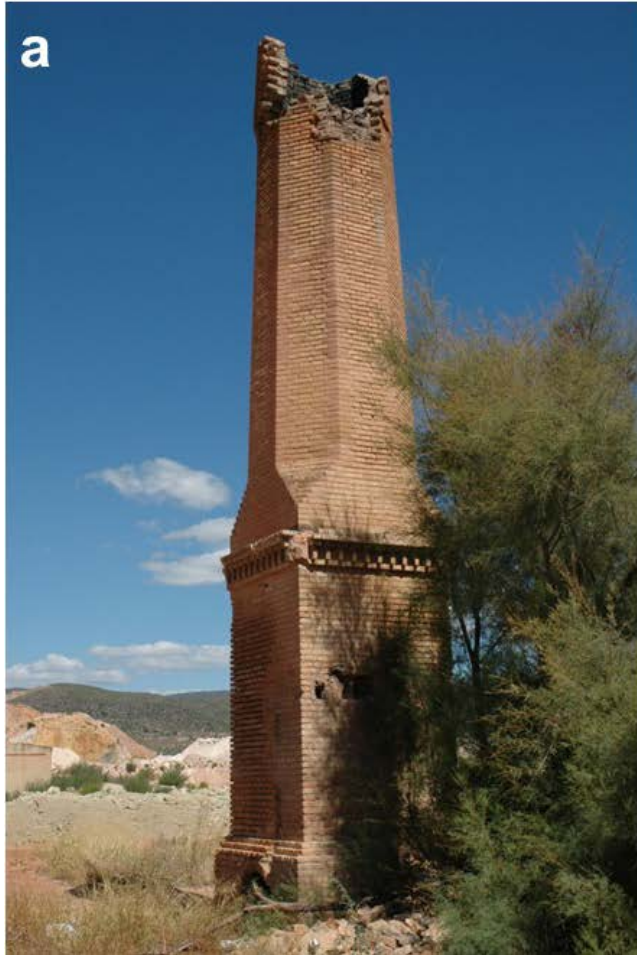
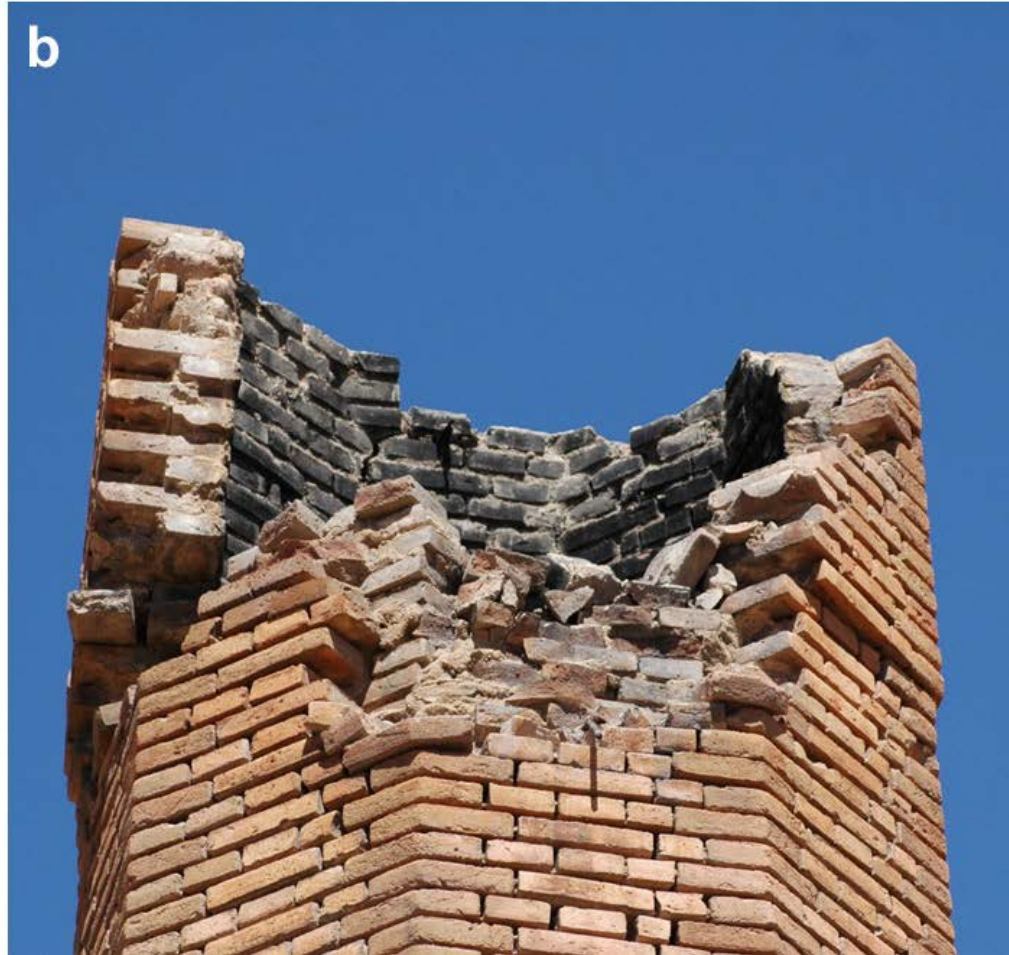
Aoki [19] found that chimneys in Tokoname (Japan) had suffered severe damage from typhoons. In Villar del Arzobispo (Spain) a chimney collapsed in 2007 due to wind gusts of over 130 kph (see Fig.12). As can be seen in the Fig. 12, most of the stack and crown collapsed and the remaining section shows signs of having been twisted by the high wind forces.

Fig. 12. Chimney in Villar del Arzobispo (Spain), part of which collapsed due to strong wind gusts: a) General view; b) Close-up.

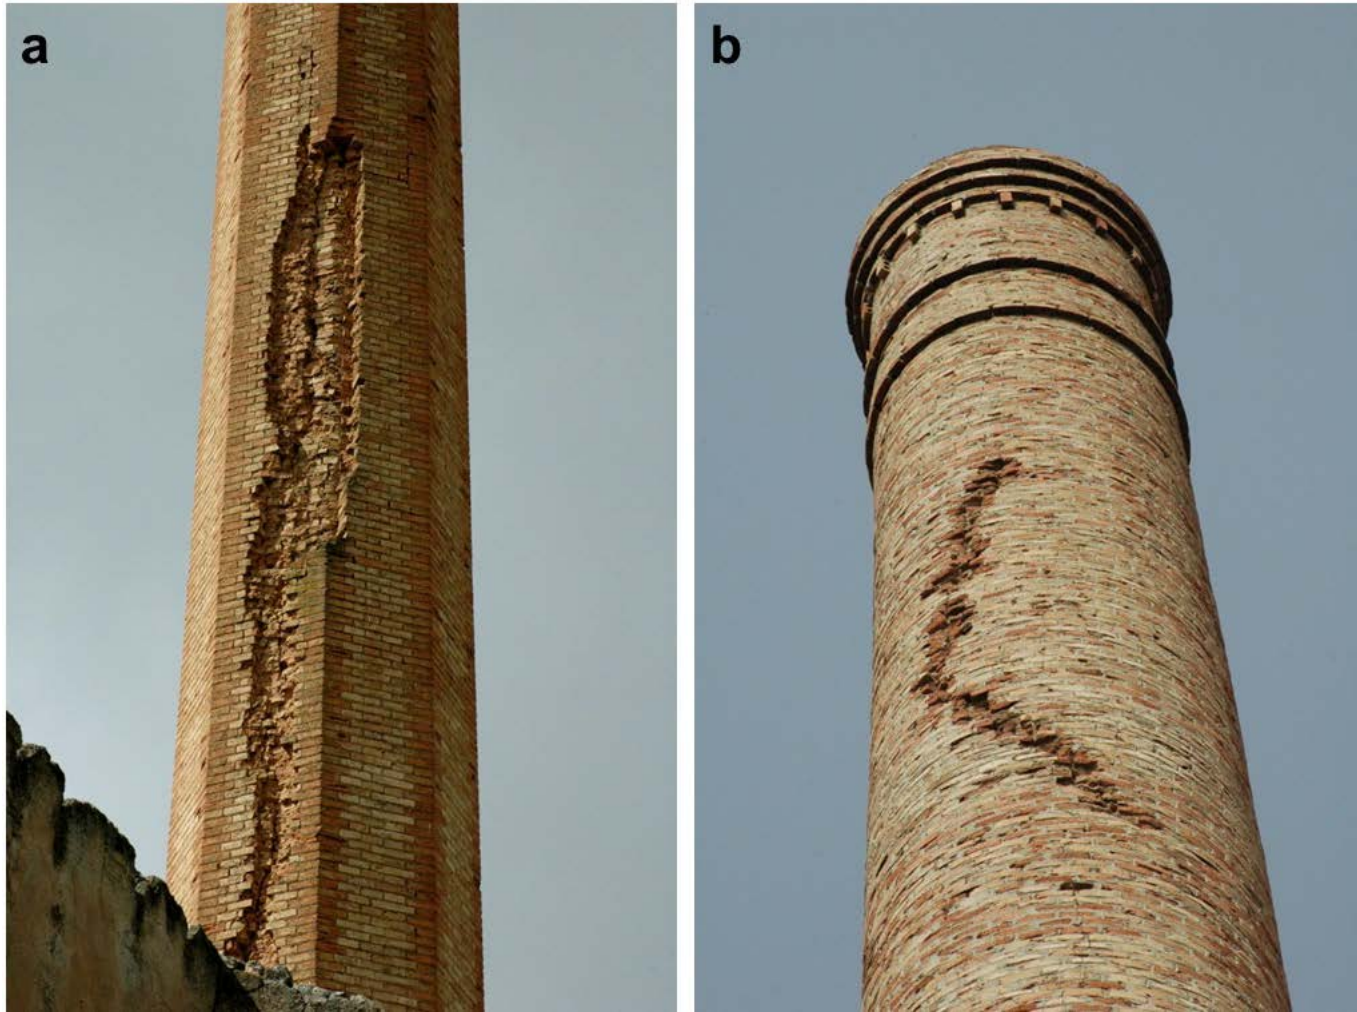
Fig. 13. Damage caused by lightning strikes. Chimneys in: a) Casas de Ves (Spain); b) Daimiel (Spain).

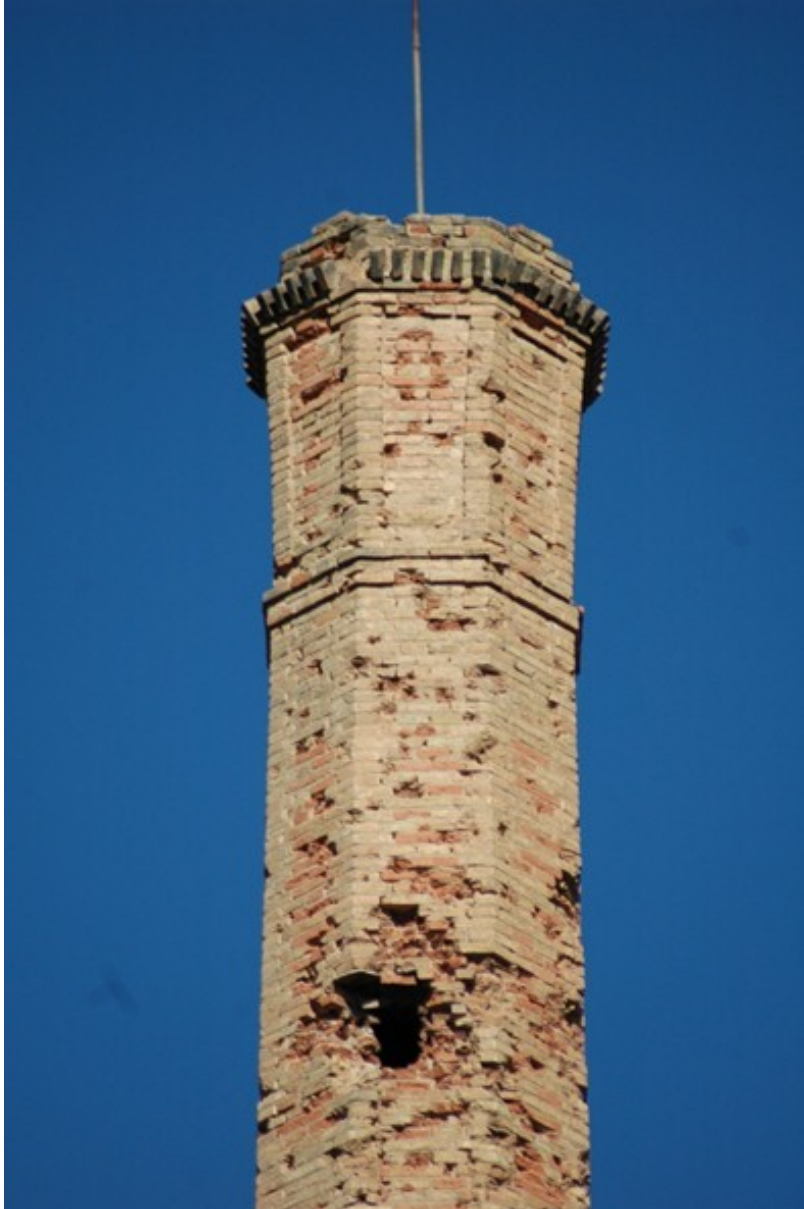
Fig. 14 shows the effects of shell fire on a chimney in Teruel (Spain). There is a large hole in the upper section and the masonry has been badly damaged by shrapnel. In situations such as that shown in Fig. 14 the chimney is seriously weakened and there is an imminent risk of collapse.

Fig. 14. Chimney in Teruel (Spain) damaged by artillery shells.

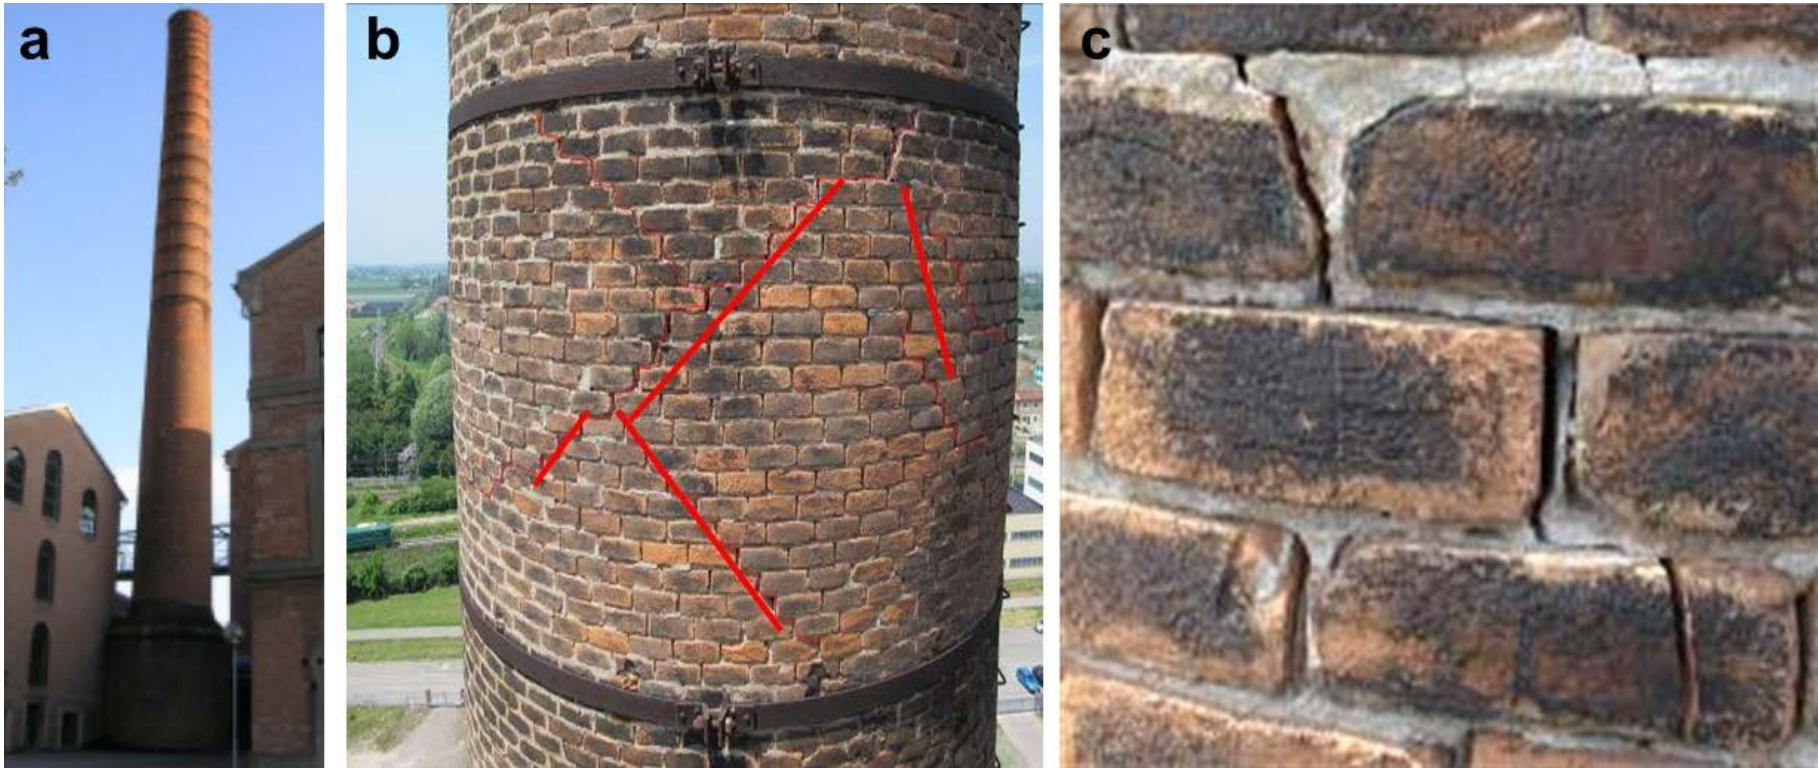
Fig. 15. Chimney in Ferrara (Italy) after the Emilia Romagna earthquake (2012): a) General view; b) Diagonal cracks; c) Close-up.

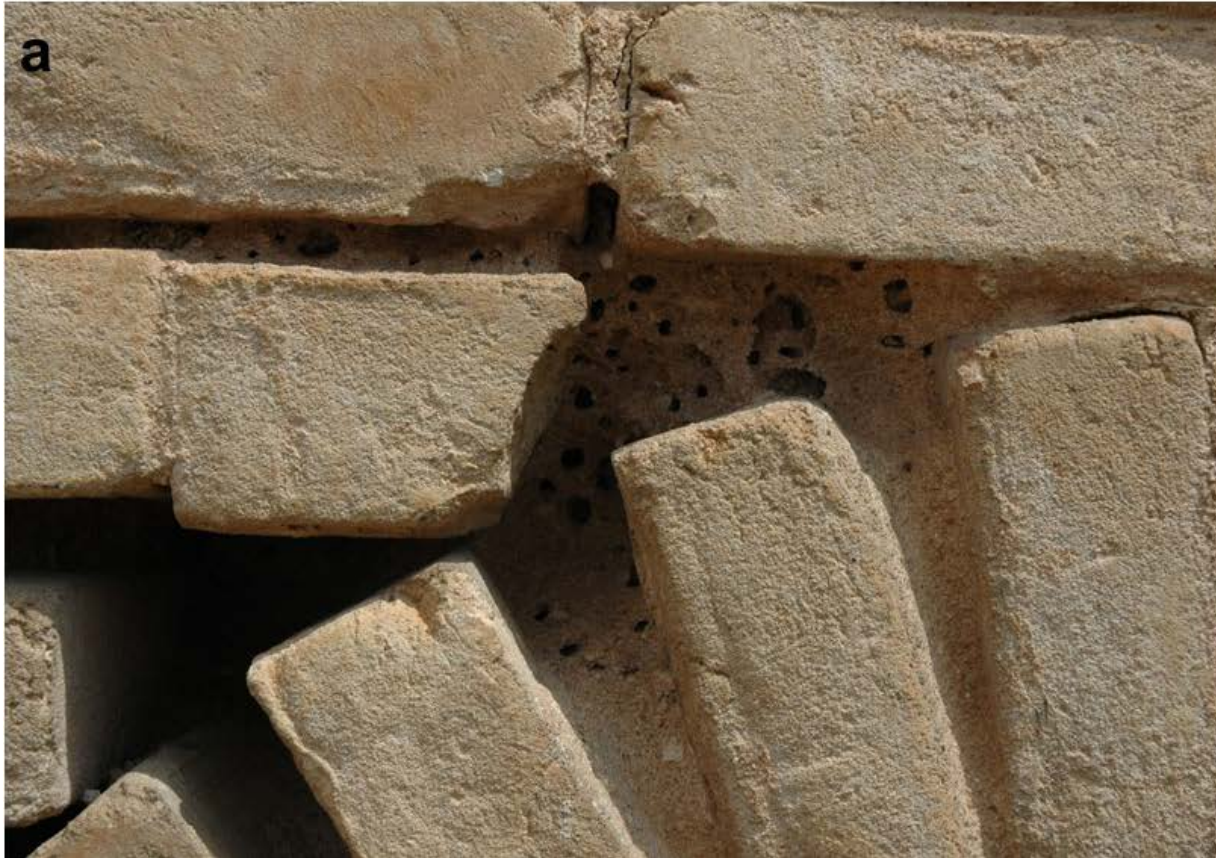
This section enumerates and describes the damage caused by living organisms to industrial brick chimneys, which is mainly due to the action of: insects, animals, vegetation, fungi, lichens, but most of all by human beings. Insects can form colonies in chimneys, as they find mortar a suitable place for making nests. The mortar is weakened by the presence of holes, as shown in Fig. 16a, which in turn reduces the chimney's resistance.

Fig. 16. a) Chimney in Catarroja (Spain) with mortar affected by the presence of insects; b) Chimney in Puertollano (Spain) weighed down by a large storks' nest in the crown.

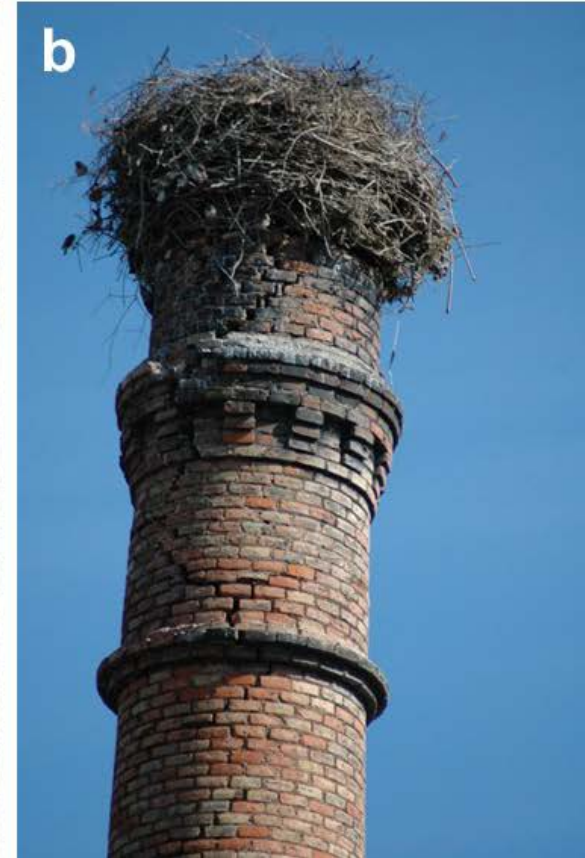
Birds are the animals that cause most damage to chimneys. Bird droppings contain nitric acid and phosphoric acid, which reacts with bricks and mortar with deleterious effects. Large birds such as storks can also cause structural damage by building their large nests in the crowns (see Fig. 16b).

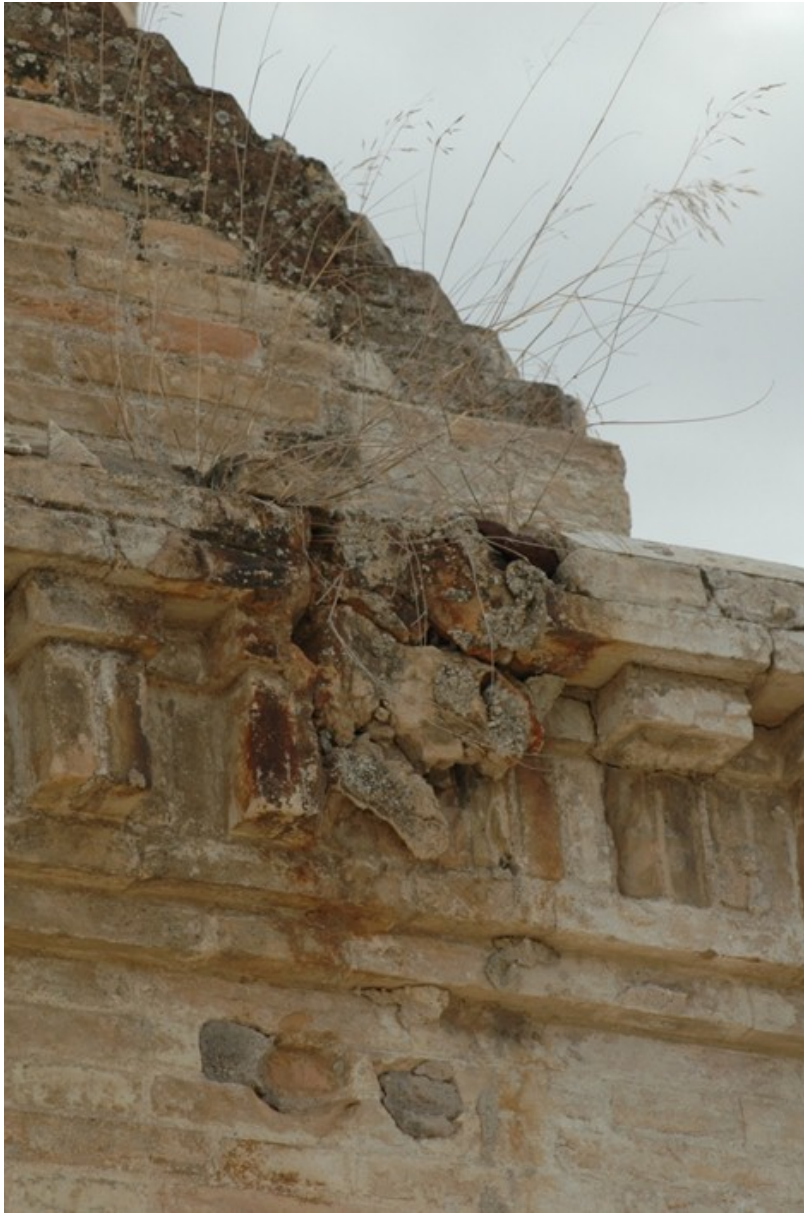
Fig. 17. Damage caused by growth of plants in the base of a chimney in Gandía (Spain).

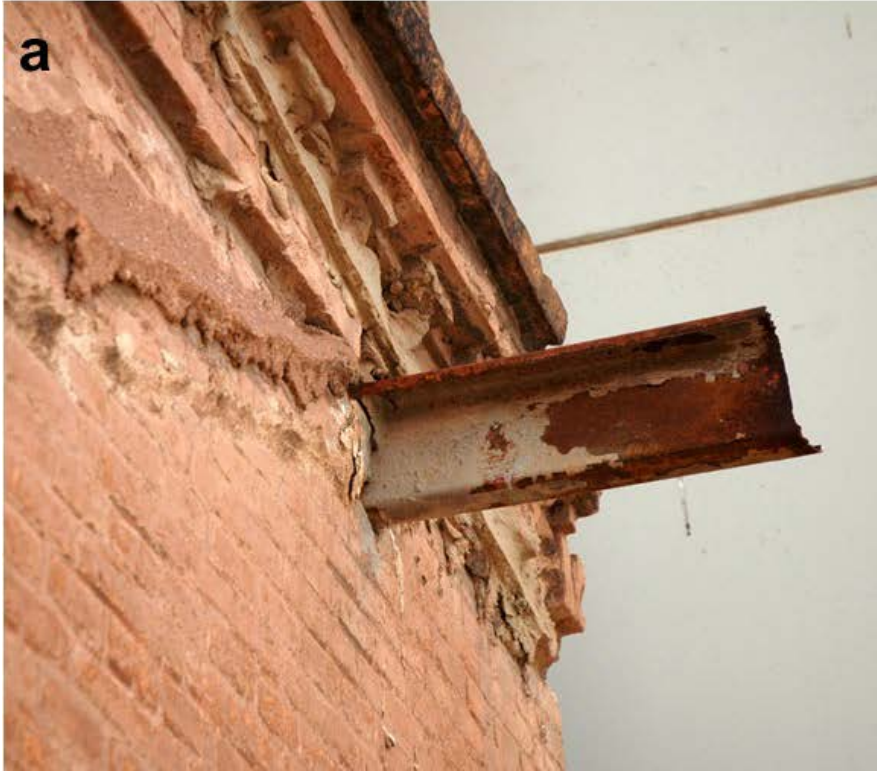
Diverse types of damage can be caused by human actions. Some of these may have taken place while the chimney was actually in use as part of a factory. It was quite a frequent practice to support certain elements such as roofs and ceilings against the chimney, and devices such as electric cables and pulleys were often attached to them. When the factory was demolished, these elements added when it was in operation either remained or were eliminated, leaving cavities, remnants of mortar or areas that had suffered damage by having to support heavy components. In Fig. 18a, the remains of a factory roof can be seen attached to the side of a chimney.

Fig. 18. a) Damage due to having to previously support an auxiliary structure in Foios (Spain); b) Grafitti on a chimney in Villaluenga (Spain).
