López Patiño, MG.; Adam Martínez, JM.; Verdejo Gimeno, P.; Milani, G. (2017). Causes of damage to industrial brick masonry chimneys. *Engineering Failure Analysis*. 74:188-201.
doi:10.1016/j.engfailanal.2017.01.014

Causes of damage to industrial brick masonry chimneys

Keywords: *Industrial chimney; Masonry; Damage; Failure; Brick; Classification*

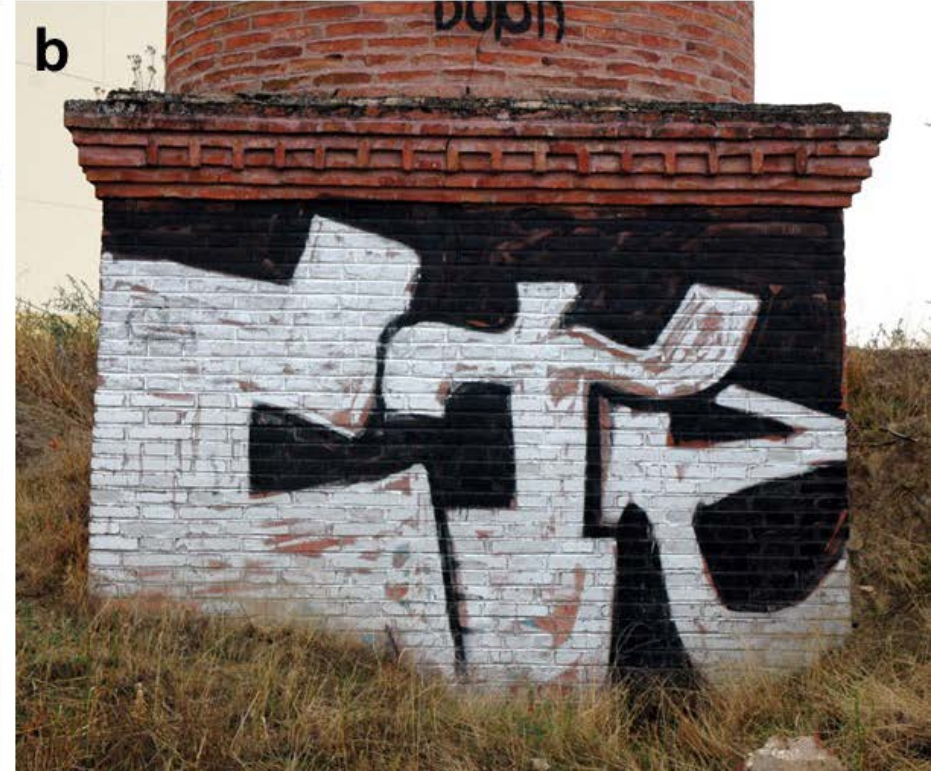
Vandalism is also to blame for a common and highly visible type of damage: graffiti. Although these do not represent a threat to the chimney's stability, the aesthetic damage they cause should be borne in mind, as they do influence the value of the chimney as part of the national heritage (see Fig.18b).
