# Investigation and Monitoring of Sinkhole Subsidence and Collapse: Additional Data on the Case Study in Alcalá de Ebro (Zaragoza, Spain)

**Abstract:** Alcalá de Ebro is located 35 km northwest of the city of Zaragoza, on the right bank of the Ebro River at the outlet of a ravine (Juan Gastón) towards the river, with a catchment area of more than 230 km<sup>2</sup>. Over time, urbanisation and agricultural development have eliminated the last stretch of the drainage channel, and these water inputs have been channelled underground, filtering through the ground. This section of the Ebro Valley rests on a marly tertiary substratum, which promotes dissolution-subbing processes that can lead to sinkholes. The ground tends to sink gradually or suddenly collapse. Many studies have been carried out to understand not only the origin of the phenomenon but also its geometry and the area affected by it in the town of Alcalá de Ebro. In this sense, it has been possible to model an area around the main access road, where numerous collapsing sinkholes have been found, blocking the road and affecting houses. It also affects the embankment that protects the town from the floods of the river Ebro.

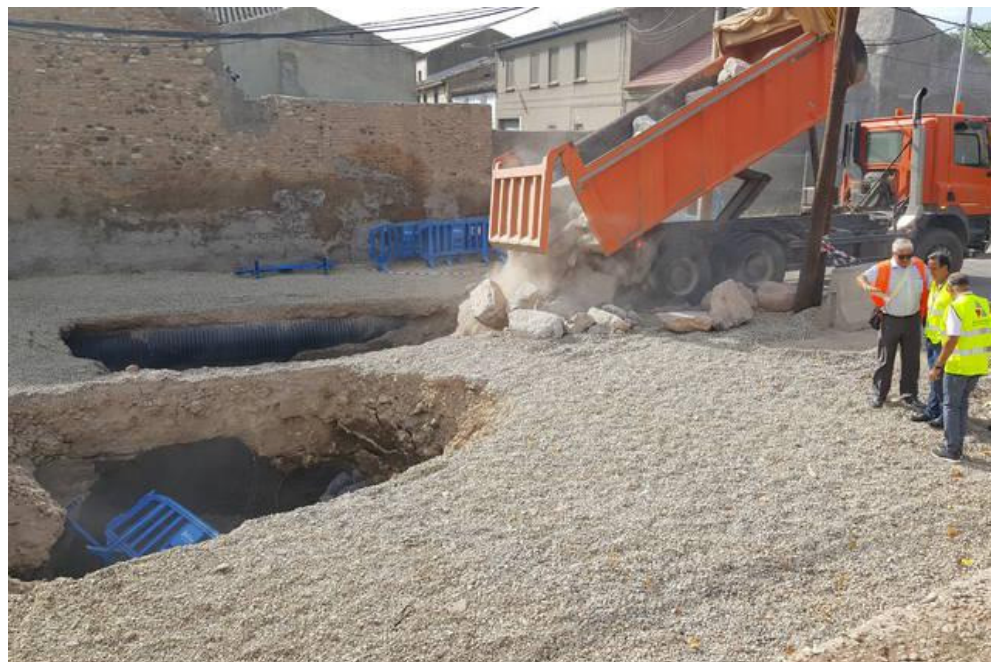
**Figure 2.** View of collapsing sinkholes that appeared next to C. de la Estación Street in August 2016.

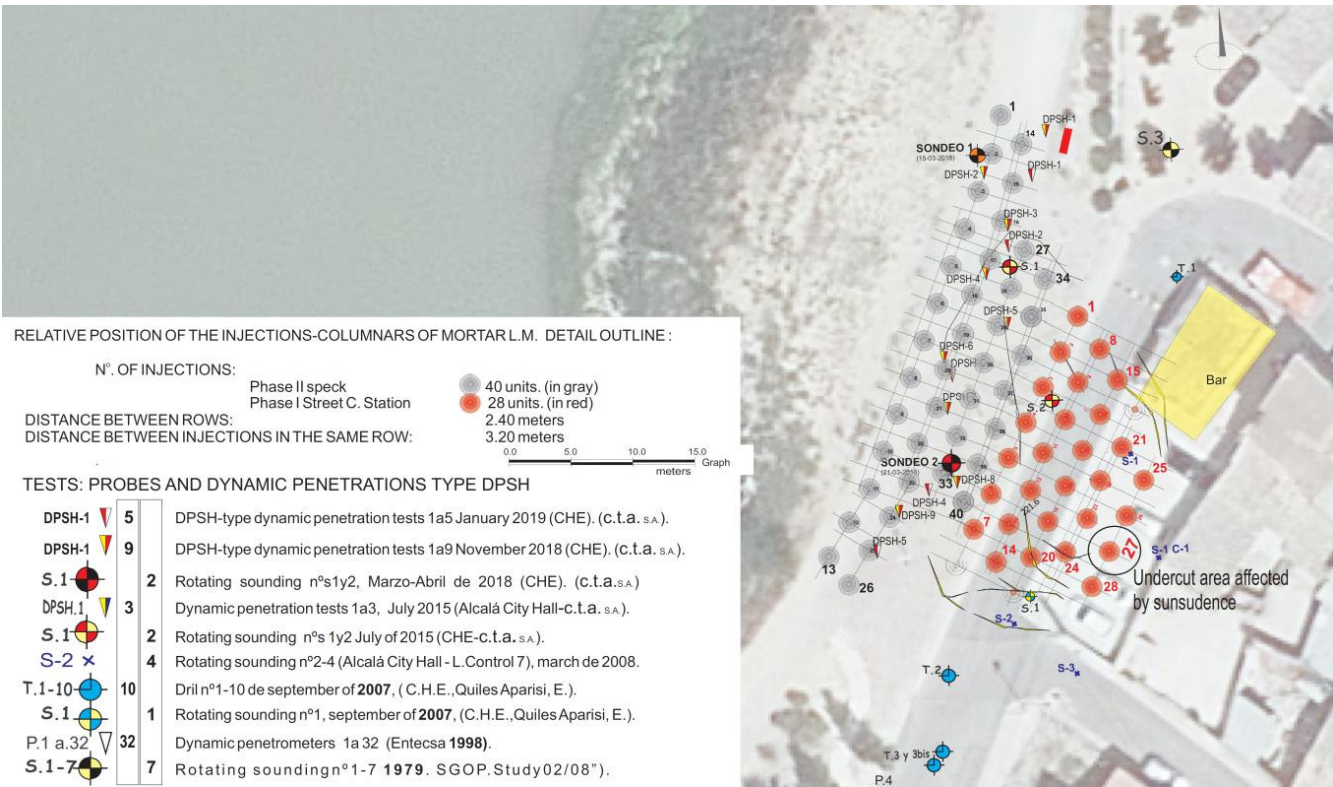
**Figure 5.** Low-mobility mortar injections and high tensile strength geogrids execution: Low mobility mortar Injections layout (in red, injections conducted in December 2016; in grey, injections were conducted in December 2018). The only injection that failed (no. 27) is noted; modified from [2].

The only one that failed, in the farthest column towards the village, was injection no. 27 (see Figures 5 and 9), which was apparently made on an old well filled with all kinds of waste. The problem is shown in the graph.

During the injection process, the volume and pressure achieved at each stage of the manoeuvre (relative depth) are shown. The distribution of these columns is presented in Figure 5. Figure 6 shows the monitor showing the number of injections (24), the relative depth (at −20 m), and the total volume injected (373.2 L), with the pressures reaching up to 20.4 bar.

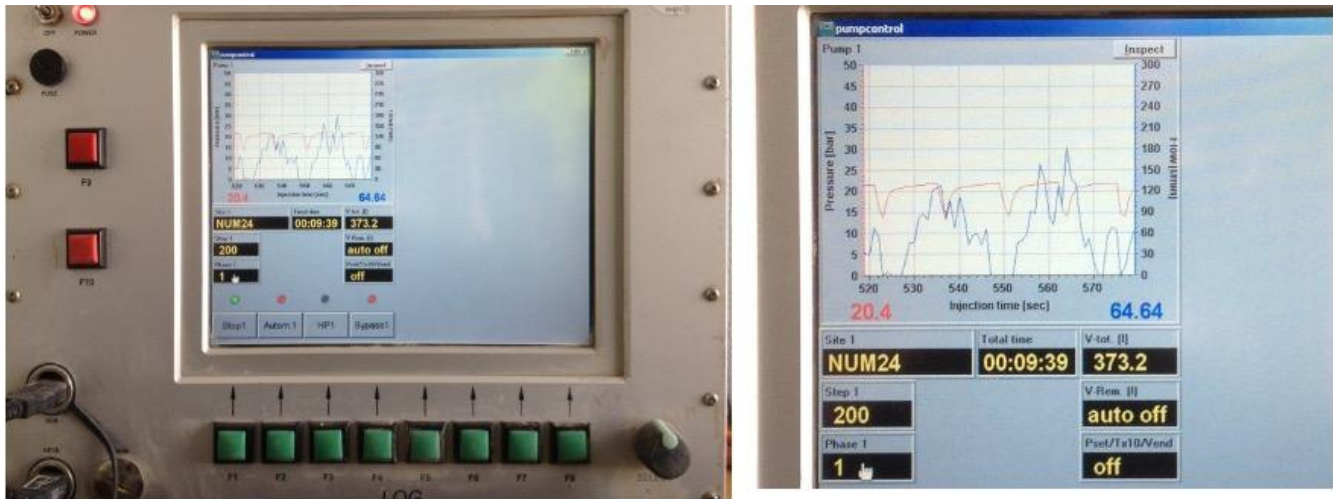
**Figure 6.** Injection control equipment. The graphs show the mortar admissions (blue line) and injection pressures (red line) during the execution of mortar Column no. 24 at a depth of 20 m. The time of execution (9'39'') and the volume injected (373.2 L) are also shown. The location of this column is shown in Figure 5.

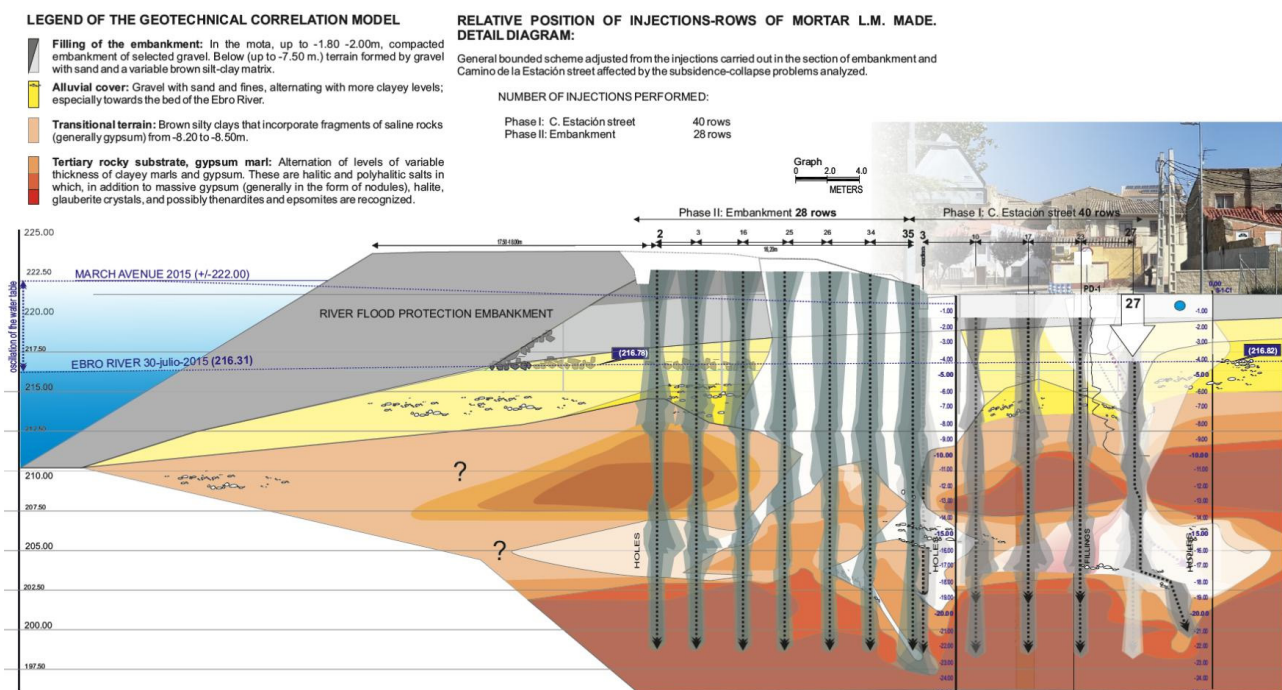
**Figure 9.** Position of mortar columns L.M. in the geological–geotechnical profile carried out. The only injection that failed (no. 27) is noted. Figures 3, 10 and 11 show their location. Graphical representation of the lateral expansion of the mortar in the columns is a reasonable assumption based on the properties of this type of mortar, which are characterised by “low mobility” and the injected ground. They contain plasticisers and tend not to flow away from the point of application.

Figure 9 shows the position and relative dimensions of the injections carried out on the geological–geotechnical profile obtained by correlation of surveys and geophysical prospecting techniques. In practically all cases, the solid ground was reached and at least 2–3 m were embedded.

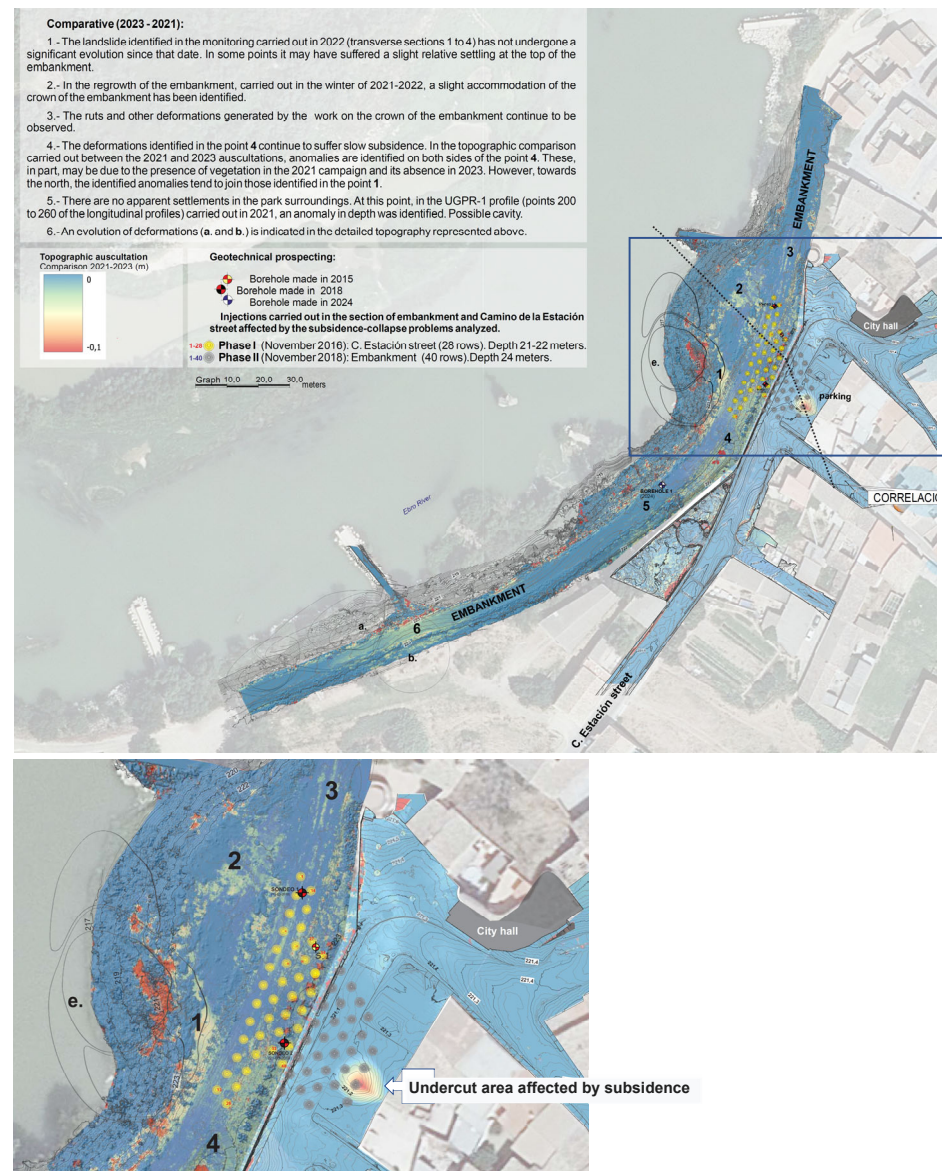
- During the 2022 monitoring, a small landslide was detected at the top of the embankment (cross sections 1 to 4, Figure 11). In some places, it may have experienced a slight relative subsidence at the top of the embankment. However, it has not changed significantly since then.
- During the winter of 2021–2022, the embankment was raised as a preventive measure against the Ebro River. At that time, a slight accretion of the crown of the embankment was noted.
- The ruts and other deformations caused by the work on the crown of the embankment continue to be observed.
- The deformations identified in the staircase continue to suffer from slow subsidence. The topographic comparison between the 2021 and 2023 surveys (Figure 11) shows

anomalies on both sides of the staircase. These may in part be due to the presence of vegetation in the 2021 campaign and its absence in 2023. However, towards the north, between PPKK 90 and 100, the anomalies identified tend to merge with those identified in point 1, corresponding to the slip.

- There are no obvious seats in the park area. At this point in the UGPR-1 profile (points 200 to 260 of the longitudinal profiles), an anomaly at greater depths has been identified. There is a possible cavity.
- An evolution of deformations is identified in a. and b. (Figure 12), which are indicated in the detailed topography shown in Figure 11 and which were also recorded by [7].

**Figure 11.** Topographic comparison between the data obtained on 22 November 2021 and 5 November 2023, with the RTC360 laser scanner. (**Top figure**) General situation plan. (**Bottom figure**) Detail of the area in which consolidation measures were carried out using L.M. mortar injections.

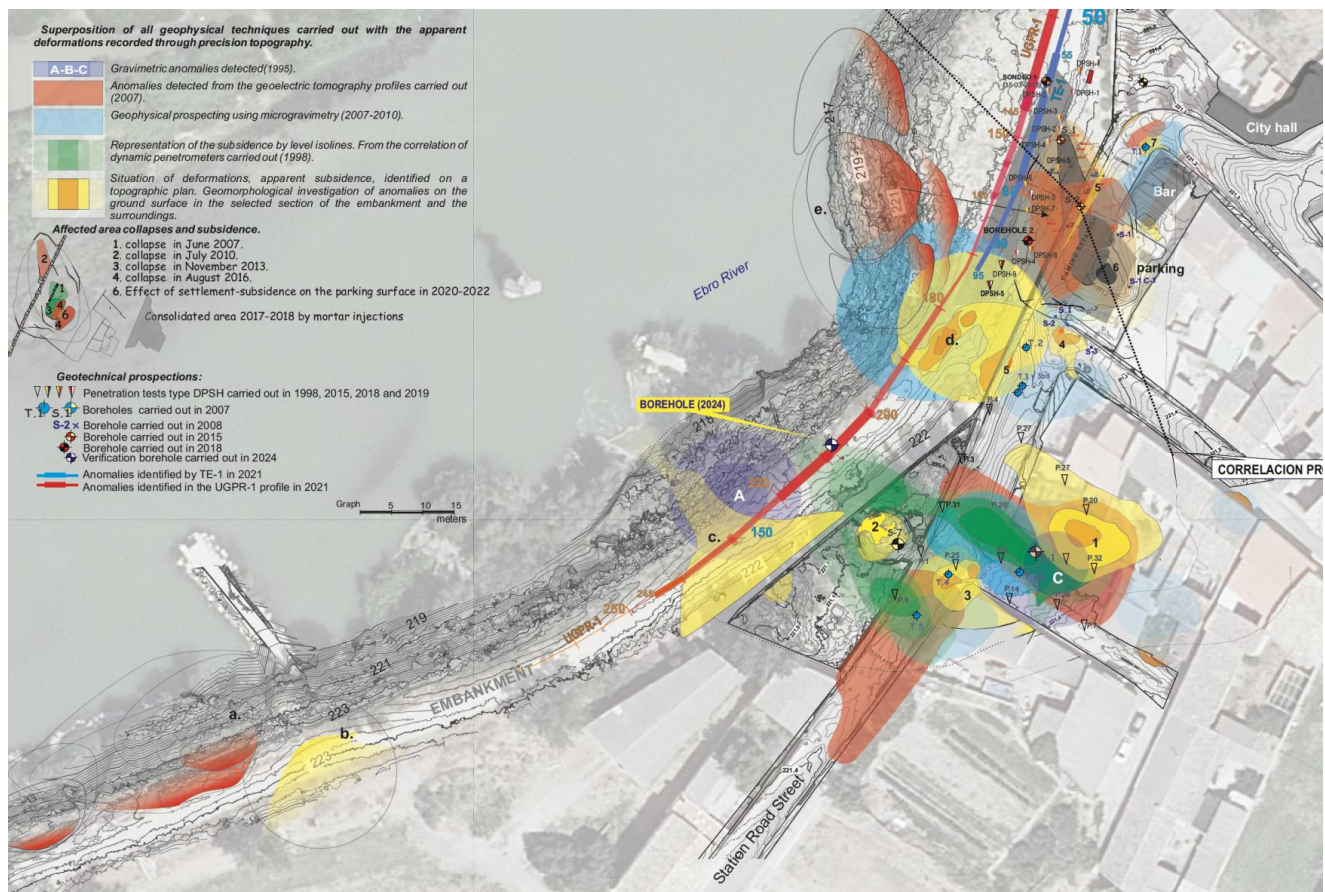
**Figure 12.** Zoning obtained with the anomalies observed in the detailed topography carried out and the different geophysical prospecting campaigns.

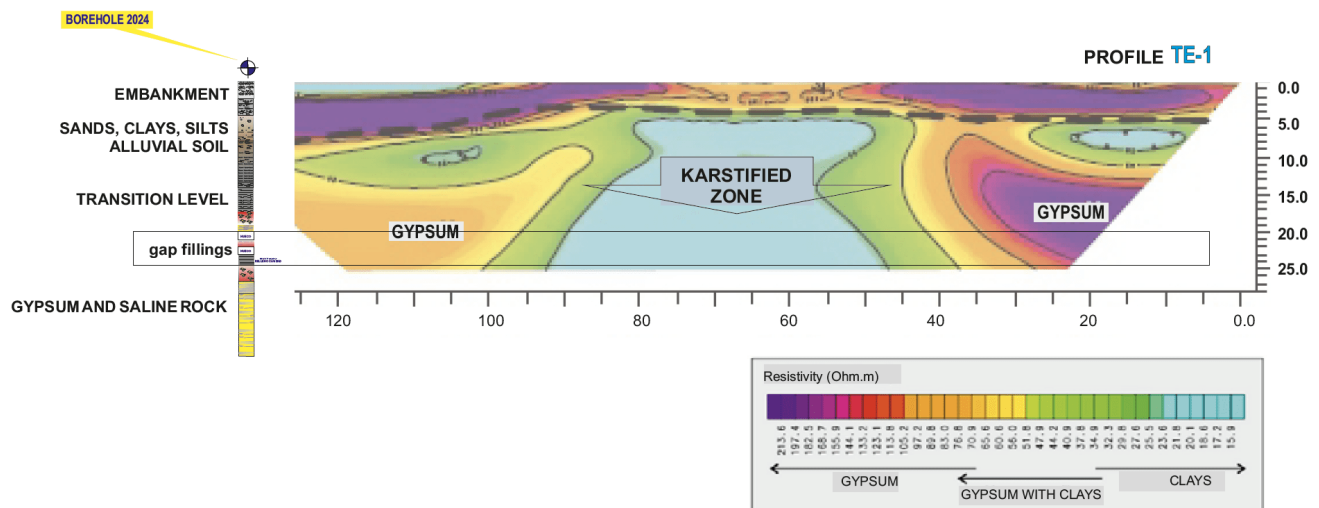
Its most obvious manifestation is between 120 and 220 m from a depth of 35 m, but it is interesting to note that the anomaly extends to more shallow levels towards the north, corresponding to the anomaly defined by the electrical tomography measurements, as can be seen from the results of both measurements (Figure 13).

**Figure 13.** TE 1 electrical tomography profile. Profile localization is shown in Figure 9.

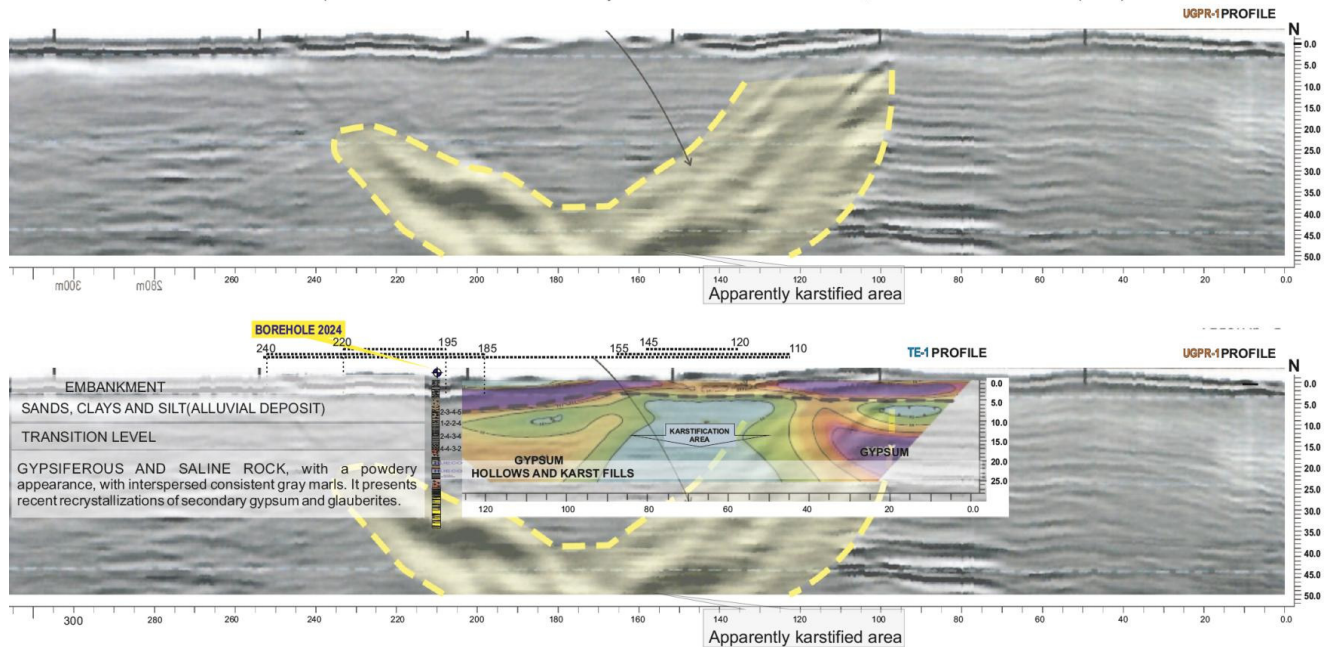
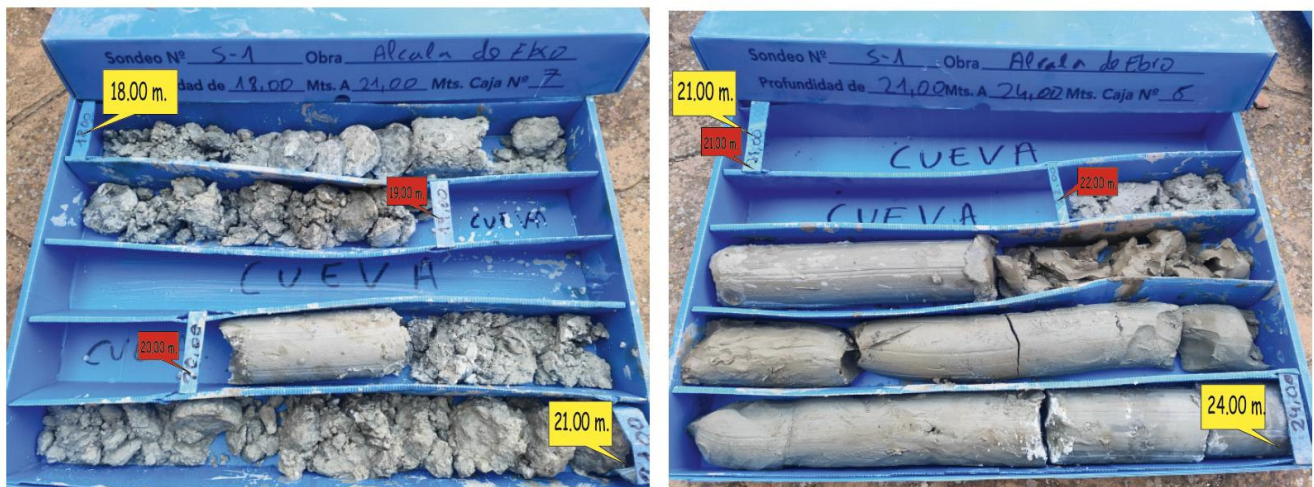
The TE1 electrical tomography profile correlates with the UGPR-1 section measured along the Ebro River protection embankment (Figure 14). This georadar profile also shows the existence of an anomalous zone with considerable lateral extent and depth. It is reasonable to interpret this anomaly as being because of a strongly karstified or altered area of the subsoil, since there is no evidence of possible interference in the georadar records by elements on the ground.

Its most obvious manifestation is observed between 100–165 m and 180–245 m. The first section, especially in its central part (between 129 and 145 m), clearly coincides with the anomalies recorded in the electrical tomography survey. The projection of the disturbance can even be seen towards the surface. In the same sense, it coincides with the projection towards the river (to the north) of the area where subsidence has been recorded in recent years on Station path and the parking area.

**Figure 14.** Combination of electrical tomography in 3D mode and the UltraGPR type georadar (top images) and the appearance of the materials obtained in the S1 survey (bottom images).

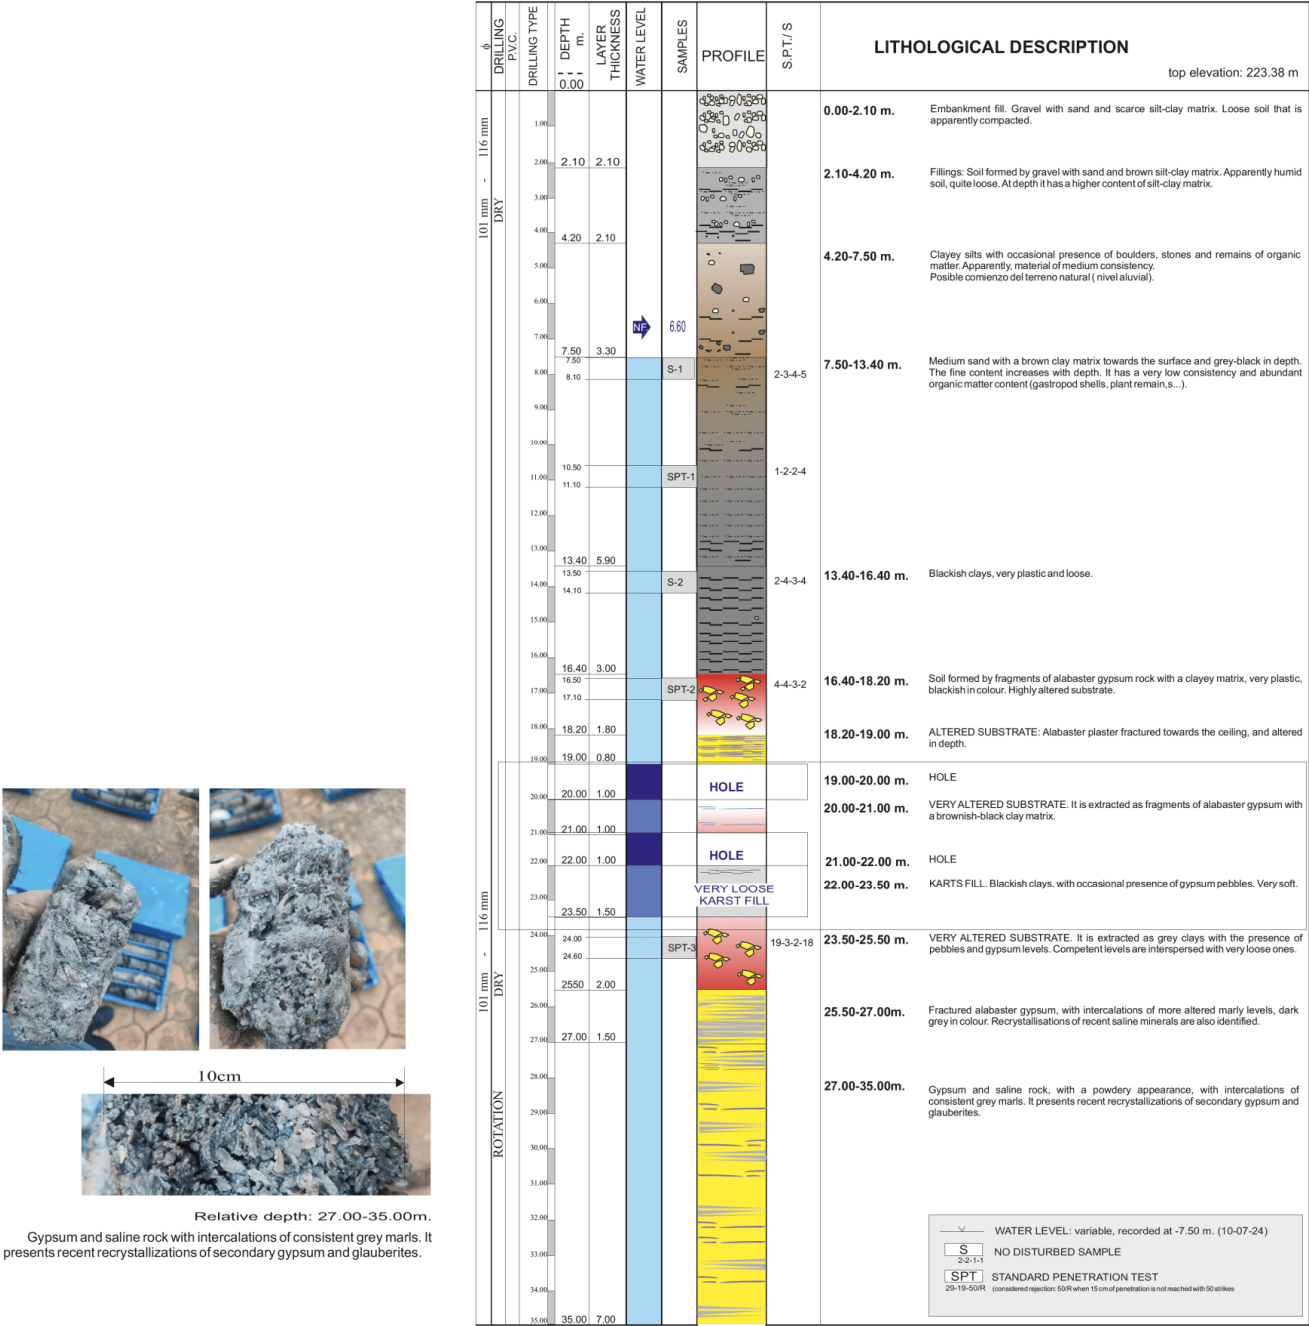
**Figure 15.** Rotation survey with continuous core extraction located in an area with apparent anomalies recorded through geophysical prospecting. The borehole is shown in Figure 12, which confirms the data from the geophysical surveys carried out.

In this case, the S-1 survey (2024) identified a sinkhole between 19.00 and 20.00 m deep and between −21.00 and −22.00 m deep, with a clay fill between −22.00 and −23.50 m deep. Practically on the same topographic level, the S-7 survey carried out by the SGOP in 1979 identified a gap of 80 cm (between −17.30 and −18.10 m), below which, according to our understanding, the excavations would have filled the cavity.

At present, no significant subsidence problems have been observed in the embankment and its immediate surroundings, despite the voids identified at depth in the 2024 S-1 survey, especially considering that the ground is very loose up to  $-18.20$  m and that a hole was identified at  $-19.00$  m. It is possible that if this apparent dissolution–undermining process continues, it could be reflected on the surface in the form of slow subsidence (sinkhole) or, less likely, collapse.

For this reason, to effectively detect and, if necessary, anticipate any subsidence or collapse issues affecting the embankment, it is recommended that at least a topographical survey of the ditch and its immediate surroundings be conducted.
