## Masonry Walls Restoration and Urban Regeneration in the Clock Tower of Monóvar (Alicante, Spain)

V. Fernández-Mora<sup>1,\*</sup>, E. Moya Soriano<sup>2</sup>, C. Boigues<sup>3</sup>

### Abstract

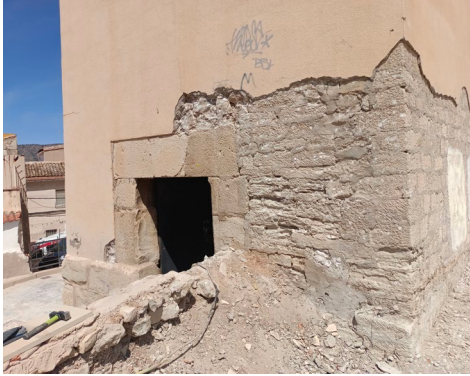
Fig. 3 – *Masonry wall's composition.*

The structure consists of a masonry base with varying quality materials. The lower sections use well-cut ashlar, transitioning to irregular masonry and eventually rubble masonry of poor quality bound with low-quality lime mortar (Fig. 3). Cornices and decorative elements were made of soft, easily eroded sandstone. Inside, a tabicated vaulted staircase spirals around the perimeter in a traditional castellana style. As usual, the walls diminish in size as the tower gets higher. A traditional vault system (*revoltó i bigueta*) was used to build the slabs on the two bell's body floors.

The quality of the masonry walls was deemed as “LOW,” with a Masonry Quality Index (MQI) ranging from 1.12-2.13. The stone and lime mortar wall were not well consolidated and presented several gaps with a size equivalent to that of the used stone.

The flat-jack test results (Table 2) are coherent with the MQI and the rest of the data. High air volume and low horizontal continuity are critical to the wall's cohesion. The results indicate that the building experiences a significant load for its capacity, using 43.95% of it, contrary to the usual 10% capacity usage in other masonry structures.

A lime mortar of a liquid consistency was injected to reinforce the walls. A grid of 50 x 50 cm was drilled in every façade with a hole of 20 mm. By using a low-pressure pump working at 2 atm. of pressure or lower, the mortar was injected from the bottom to the top. The injection continued until the mortar reached out in the wall, either by another drill or a cavity. Several mortar compositions were tried to adjust the mixture to the ideal consistency, adjusting sand granulometry and fluidizing additive. At the end, the mortar used was *Morcem® Cal Inyección Consolidante* from *Grupo Puma*, as it was not possible to use nearby sands.

After performing the injection, the façades have been covered with coloured lime mortar. The mortar has been applied with a layer of continuous thickness despite the irregularities in the masonry. The decorations have been reproduced with the measurements from the previous intervention, and the colour scheme has been chosen based upon typological studies on similar buildings on the zone.

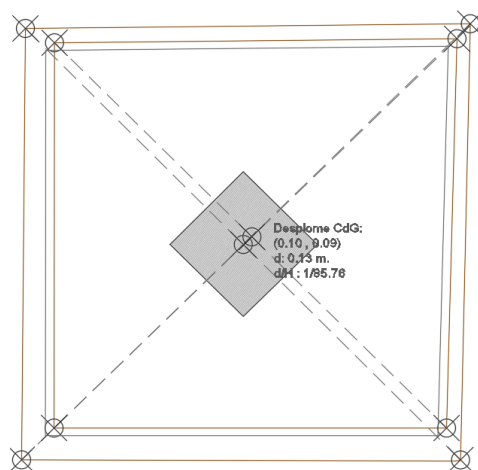
Fig. 5 – Relative displacement of reference points.

Because of the downfall, the center of gravity from both bodies is not aligned. There is 13 cm from one center of gravity to the other with a d/Z ratio of 1/86.7 (Fig. 5).

Despite this displacement and the inclination of the tower both centres of gravity are entirely inside the central core of the tower's section. So, the tower is perfectly stable as the gravitational forces upon it do not create any tensile efforts on its base.

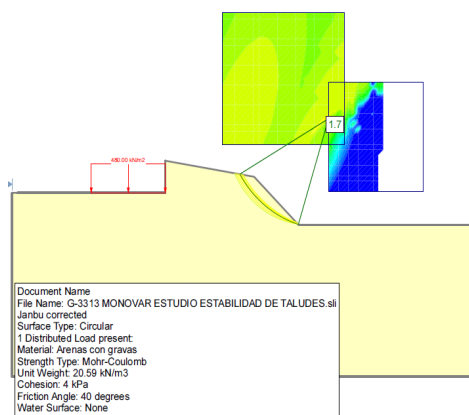
Fig. 7 – Security factor of the slide.

The slide near the tower was caused by the collapse of two nearby houses on Sacristan Street, 23 and 25. The landslide created a 7.5-meter-high terrain scarp. Due to its steep slope and soil composition, the slide is considered unstable (Fig. 7). The security factor is 1.7 in normal conditions, and it is reduced to 1.4 in seismic conditions.

The slide does not currently affect the tower's foundation as the loads under them do not collide with it. Despite this, its instability and atmospheric erosion will affect it in the future. During the time gap between the studies and the execution (11 months), the slide top had neared around 50 cm toward the tower's base.

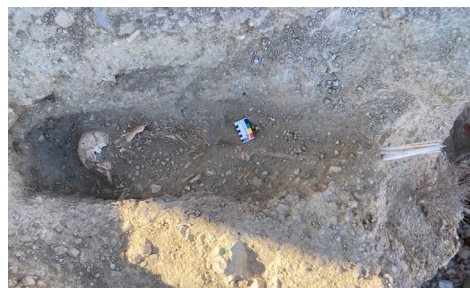
Despite conservation issues, such as insect activity, erosion (Fig. 9) and subsequent uses of the site, two types of tombs have been identified. Excavated directly in the ground, simple graves and graves with a lateral steps/rim can be observed. These graves feature a lateral rim where adobe blocks or stone slabs are placed, adopting a form similar to a shed roof. The orientation of the tombs aligned NE-SW, and the positioning of the bodies—on their right side with their faces directed towards the S-SE—suggest that these burial sites date to the Islamic period, a pattern also observed in nearby *maqâbir* (Jover et al., 2005; Lopez Segui et al., 2005; Olcina et al., 2008). Additionally, no grave goods have been found within the tombs in keeping with Islamic burial practices.

Fig. 9 – *View of tomb 1 showing how erosion has made part of the tomb disappear, the tibia and fibula of the buried individual are suspended in the section of the ground.*
