# Proposal of a Sensorization Methodology for Obtaining a Digital Model: A Case Study on the Dome of the Church of the Pious Schools of Valencia

**Abstract:** The Church of the Pious Schools of Valencia (18th century) has the largest Valencian dome ever constructed, with its 24.5 m span, and it is included among the prestigious great European domes, inspired by the Pantheon and belonging to neoclassicism. Currently, this monument is undergoing a thorough study and restoration process to improve its management, especially to halt its deterioration due to moisture and cracks. An initial study included in the Master Plan (1995) determined that these cracks were caused by thermal effects, but recently, other studies have suggested that these failures originated from the walls. Additionally, environmental impacts and thermal behavior are among the causes, as excessive humidity due to high interior occupancy can cause damage to the dome, which has historic coatings. As a result of this study process, we propose sensorizing the dome of the church in order to enable comprehensive control of the temperature, humidity, and CO<sub>2</sub>, as well as installing accelerometers to monitor the

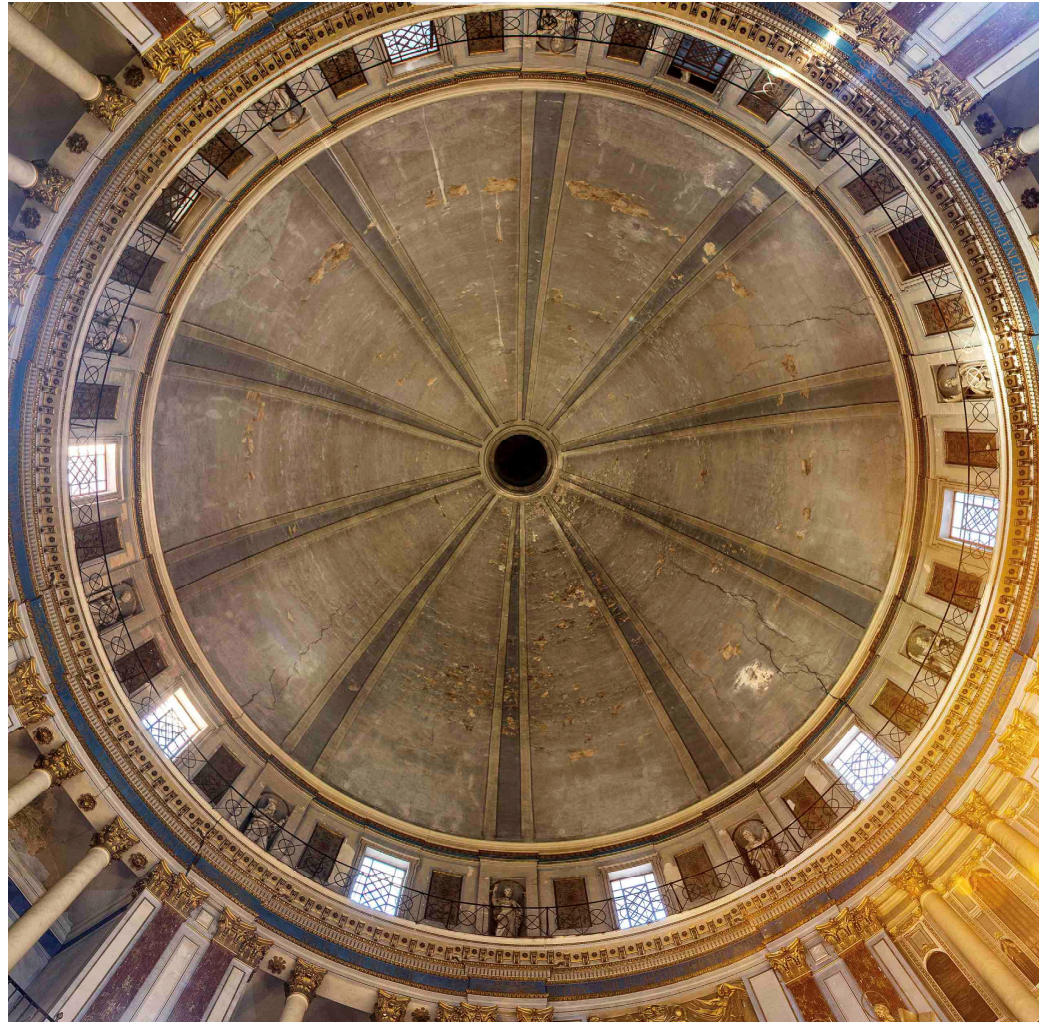
and due to the pathological damage of the dome, Rafael Soler's firm was commissioned to develop the Master Plan in 1993 [21] by analyzing the complex and focusing on the cracks of the dome (Figure 3) and their possible causes.

**Figure 3.** View of the dome and the cracks in four different sectors.

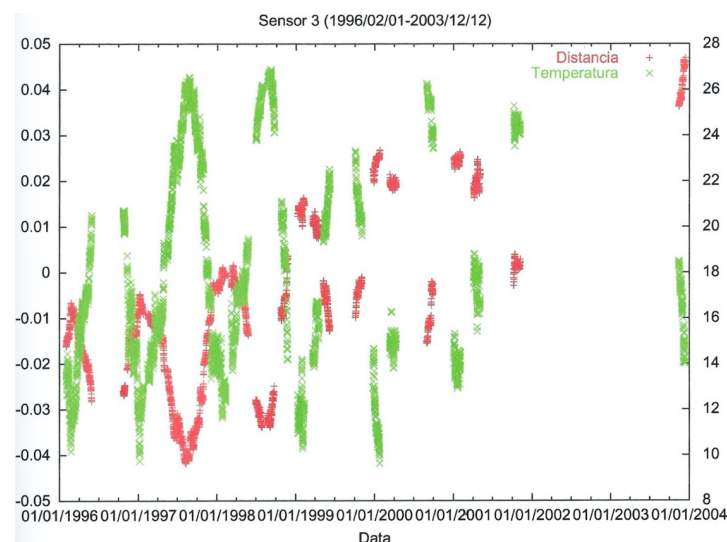
Between 1996 and 2003, architect Rafael Soler's study carried out the sensorization of the dome in order to obtain the relationship between temperature and the movement (opening/closing) of the cracks, similar to what was carried out in the dome of Santa Maria del Fiore [27]. An analysis of the extensive documentation collected, along with the interpretation of the results that recorded the movements of the probes over the analyzed time period, confirmed the inverse correlation between temperature variation and crack opening: as the temperature increases, the crack distance decreases, and vice versa (Figure 4). It is worth noting that in the analysis of these data, a drift was observed, meaning that the crack openings increased over time due to thermal variations.

**Figure 4.** Scheme of the relationship between temperature and crack movement, with red representing movement and green representing temperature; 1996–2003.

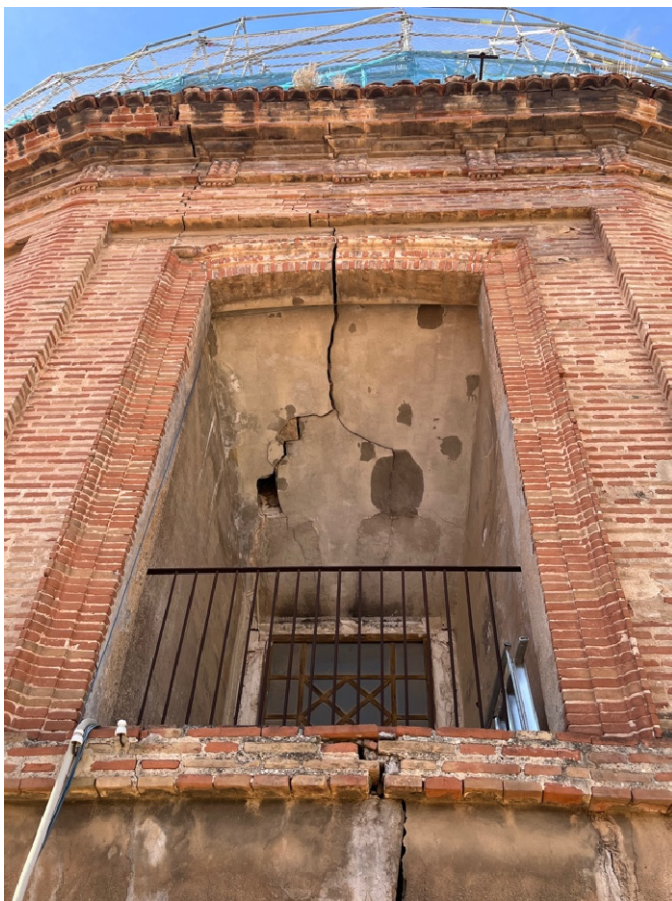
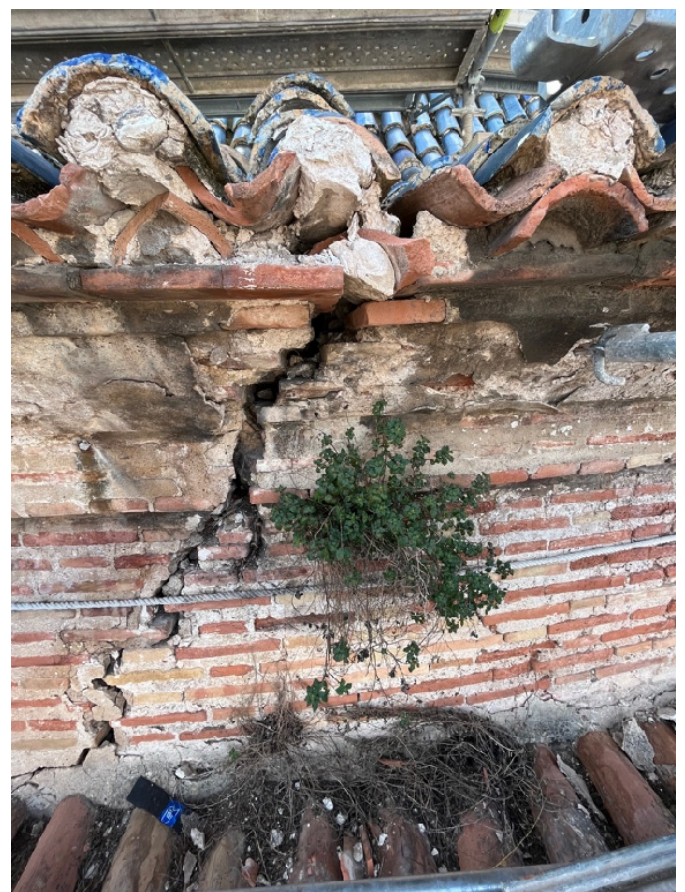
Clearly, the cracks that exist in four out of the ten sectors of the drum, with lintels and jambs of the openings being split and the cracks extending to the upper ring and prior to the start of the dome (Figure 5), as well as the displacement of two ribs in two of the ten sectors, indicate some movement of the materials, and it can be affirmed that the cracks in the dome were not solely caused by thermal inertia. Following these findings, Cortés and Alonso [28] carried out a complete parameterization of the dome and walls to analyze the behavior due to settlements, using the finite-element method (Angle software 2021), and obtained results similar to those existing in the monument, providing an explanation for the cracks (Figure 6).

**Figure 5.** Cracks in the drum and the ring before the dome: (a) cracks in one lintel and vault of one of the four damaged sectors; (b) crack in the ring before the dome in sector G.

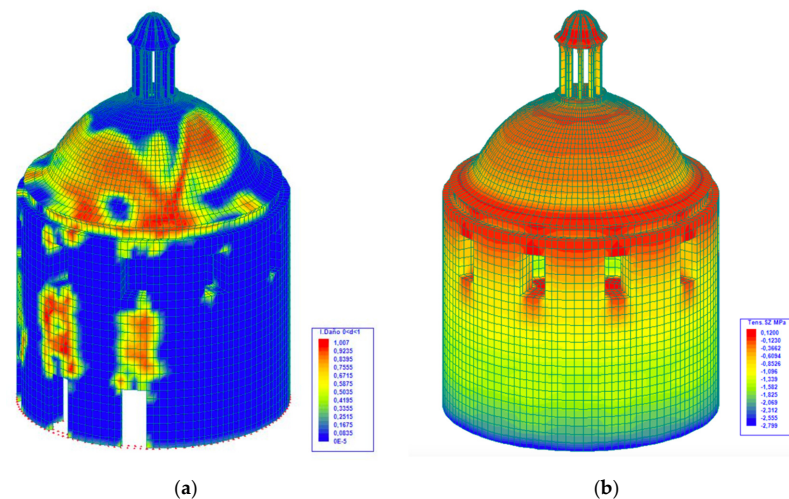
**Figure 6.** Cracks in the drum and the ring before the dome: (a) fissure pattern with the hypothesis of a settlement of the vertical wall; (b) stress state of the dome showing tension at the base of the dome.

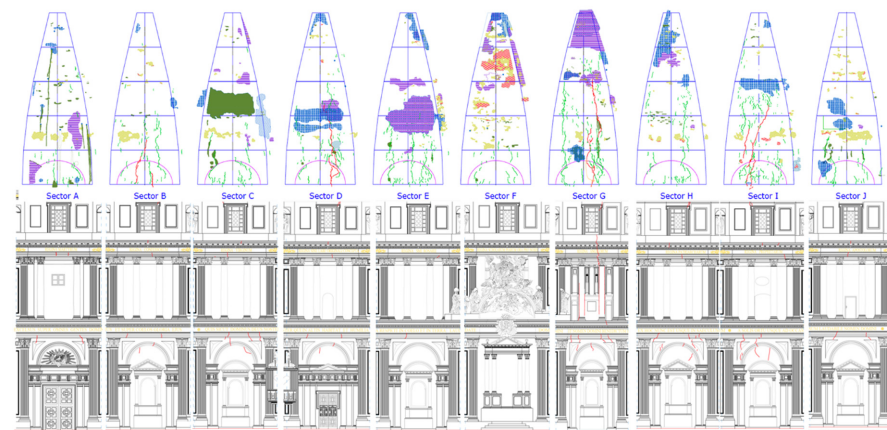
Prior to the restoration, the dome exhibited four large cracks in the calotte that extended from the interior to the exterior, as well as in the drum. Additionally, there was a displacement of two roof tiles, allowing water to leak into the interior. The tile covering was in a very poor state of conservation, with water infiltration causing dampness, salt deposits, and loss of plaster, among other issues. The exterior showed numerous broken tiles, vegetation, missing tiles, and tiles with enamel loss. Furthermore, the lantern had had its openings blocked with a honeycomb brick infill and red waterproof paint.

**Figure 7.** Study of the pathology of the interior, with the observation of damage in the dome derived from moisture and cracks.

Currently, the interior of the dome is undergoing restoration. As an initial step, the cracks in both the interior and exterior of the dome and its drum have been repaired. These cracks followed the meridian direction and were centrally located, extending from the base of the dome to approximately 3/5 of the length of the calotte, about 10.74 m, in four of the ten sectors of the dome (Figure 7). Associated with these cracks, there are numerous other fissures that exclusively pertain to the cracking of the coating.

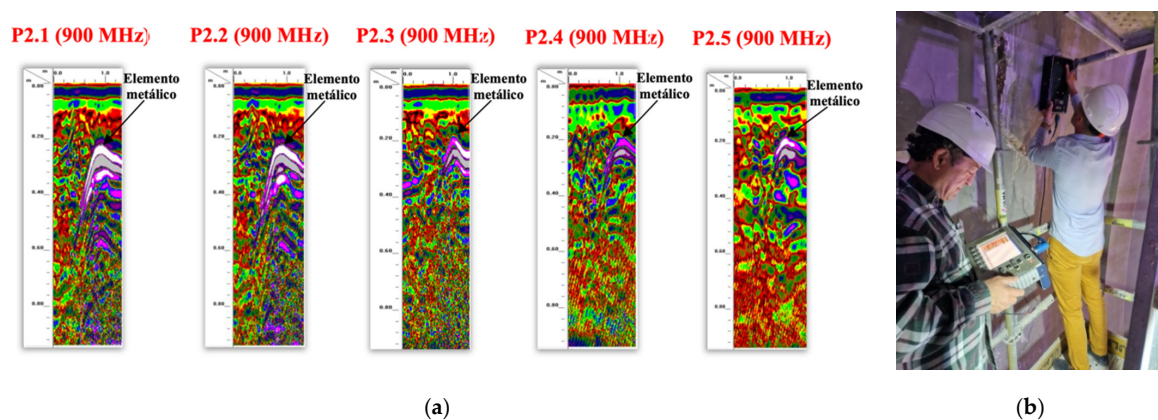
**Figure 8.** Results of the geophysical study using ground-penetrating radar to detect “anomalies” in the dome and an image depicting the progress of the study within the dome: (a) radargrams where anomalies in the waves can be observed; (b) image showing the execution of the geophysical study.

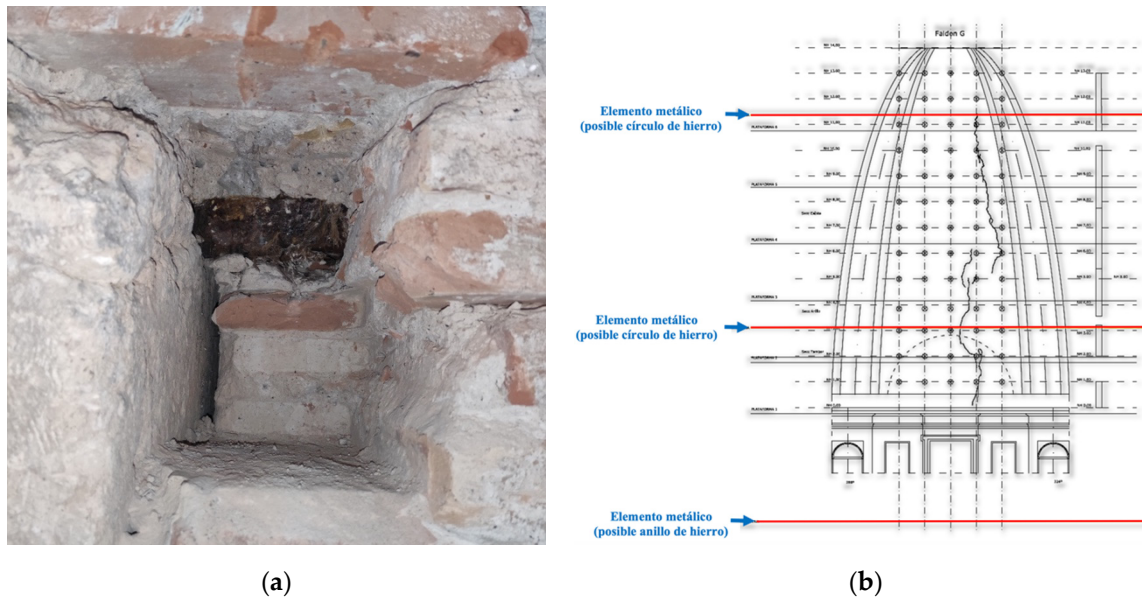
**Figure 9.** With the geophysical study, it became possible to find the iron rings: (a) archaeological window with an iron ring; (b) representation of the grid with the red lines representing iron rings.

In these three sectors of the dome, a total of 31 2D geophysical radar profiles were conducted, and an archaeological window was opened to observe the mentioned ring. This consisted of a 5 cm × 5 cm iron bar covered with braided esparto, embedded in stone blocks approximately every 5 m.

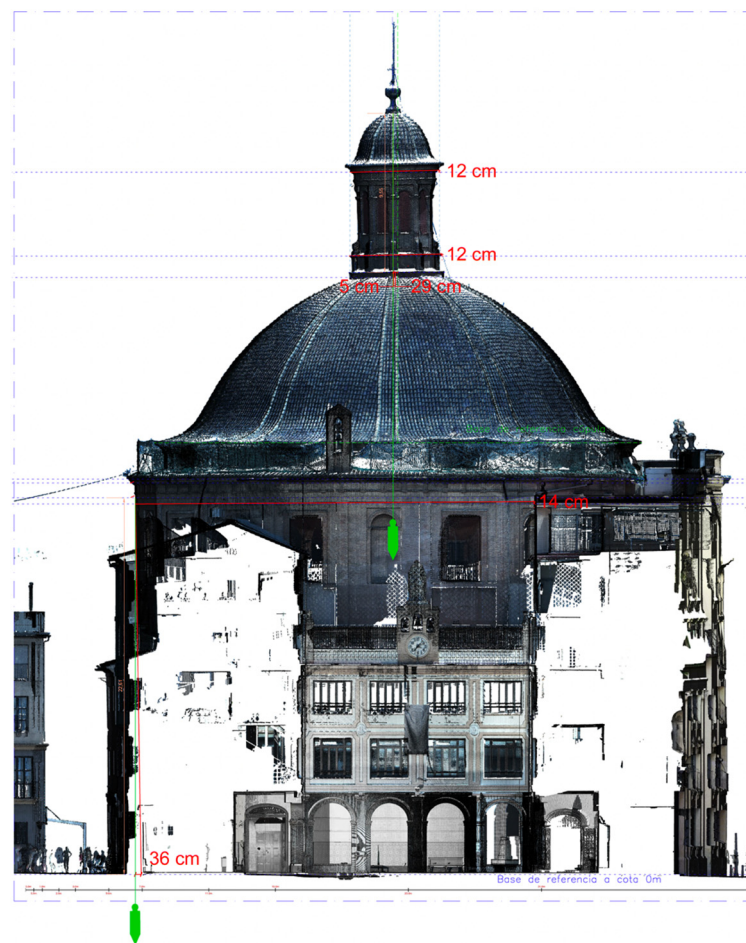
Figure 10. Study of the tilts using orthoimages obtained from 3D laser scanning (TLS).

From the study of collapses, we know that the drum has a deviation of 36 cm from its base, and the horizontal planes in the dome bodies have rotated 14 cm. This study helps us address the disparity in opinions from all previous structural studies and explains the dome's cracks: as the drum deforms and there is a deviation, the ring cracks, and the dome readapts to the new stresses, resulting in cracks in the dome.

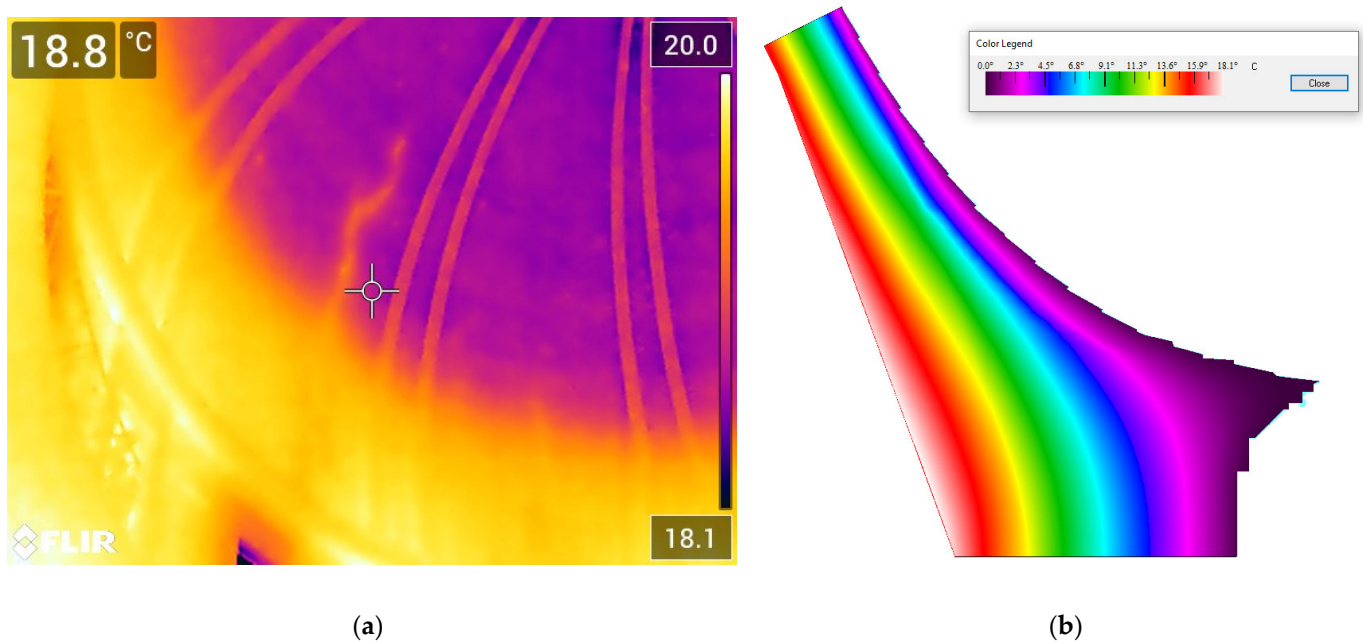
Figure 11. Thermal behavior: (a) image from the thermal camera, where the crack shows a thermal bridge; (b) parameterization of thermal behavior in the Therm 8 software, with an external temperature of 0 °C and an internal temperature of 20 °C.

From the observations with the thermal camera, it was noted that across the dome, from the intrados starting from the drum, the ribs increase their thermal inertia, highlighting thermal bridges caused by the cracks, which have since been repaired and sealed.

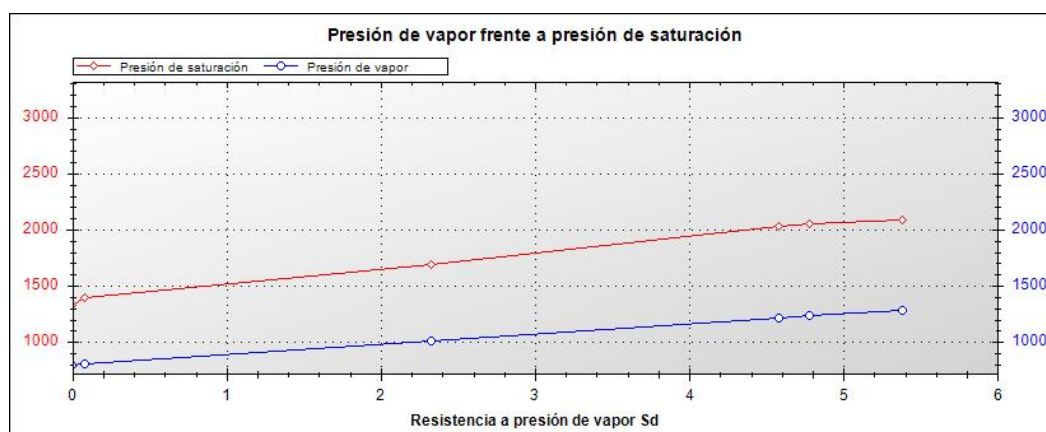
Thanks to its construction arrangement, including a 2 cm thick inner layer of plaster, a 45 cm thick solid brick dome, a layer of lime mortar, and glazed ceramic tiles, a more than satisfactory result was obtained. This is because the saturation pressure is much higher than the vapor pressure, and no condensation occurs or accumulates. The graph shows two parallel lines (Figure 12), indicating the absence of condensation accumulation.

Figure 12. Study of the verification of interstitial and surface condensations of the dome.
