Characterization of damages in buildings after floods in Vega Baja County (Spain) in 2019. The case study of Almoradí municipality

Ricardo Moya Barbera^{a,*}, Begoña Serrano Lanzarote^b, Teresa Escrig^c, Ivan Cabrera-Fausto^d

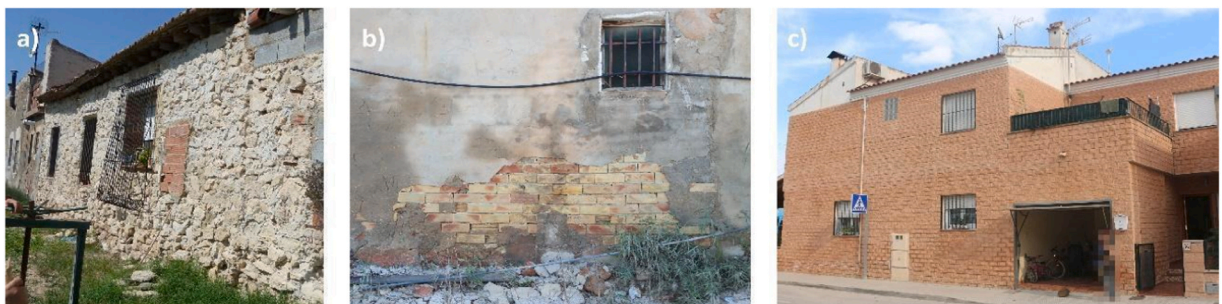
Fig. 5. a) Rubble masonry fabric, b) Brick masonry fabric, c) Concrete block masonry fabric (Image credits: Valencia Institute of Building, IVE).

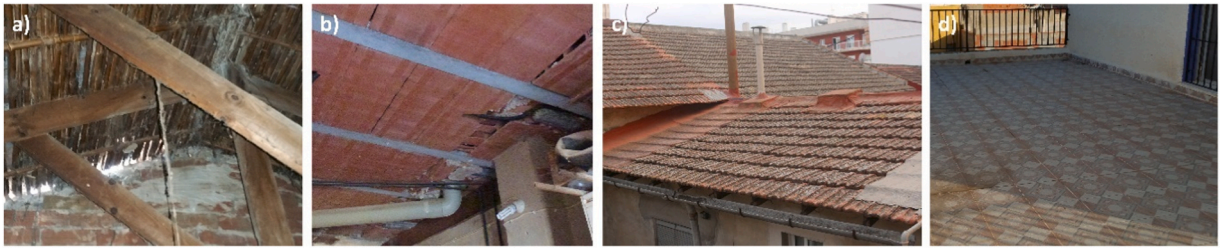
Fig. 6. a) Timber roof truss with "cañizo", b) Slab made of reinforced concrete frames with ceramic vaults, c) Sloping roof with ceramic shingles, d) Flat roof with ceramic tiles (Image credits: Valencia Institute of Building, IVE).
