# Casual-Nuevo Alausí Landslide (Ecuador, March 2023): A Case Study on the Influence of the Anthropogenic Factors

**Abstract:** Landslides in Ecuador are one of the most common deadly events in natural hazards, such as the one on 26 March 2023. A large-scale landslide occurred in Alausí, Chimborazo province, causing 65 fatalities and 10 people to disappear, significant infrastructural damage, and the destruction of six neighborhoods. This study presents a detailed case analysis of the anthropogenic factors that could have contributed to the instability of the affected area. Field investigations and a review of historical, geological, and social information are the basis for analyzing the complex interactions between natural and human-induced conditions. Key anthropogenic contributors identified include unplanned urban expansion, ineffective drainage systems, deforestation, road construction without adequate geotechnical support, and changes in land use, particularly agricultural irrigation and wastewater disposal. These factors increased the area's susceptibility to slope failure, which, combined with intense rainfall and past seismic activity, could have caused the rupture proces

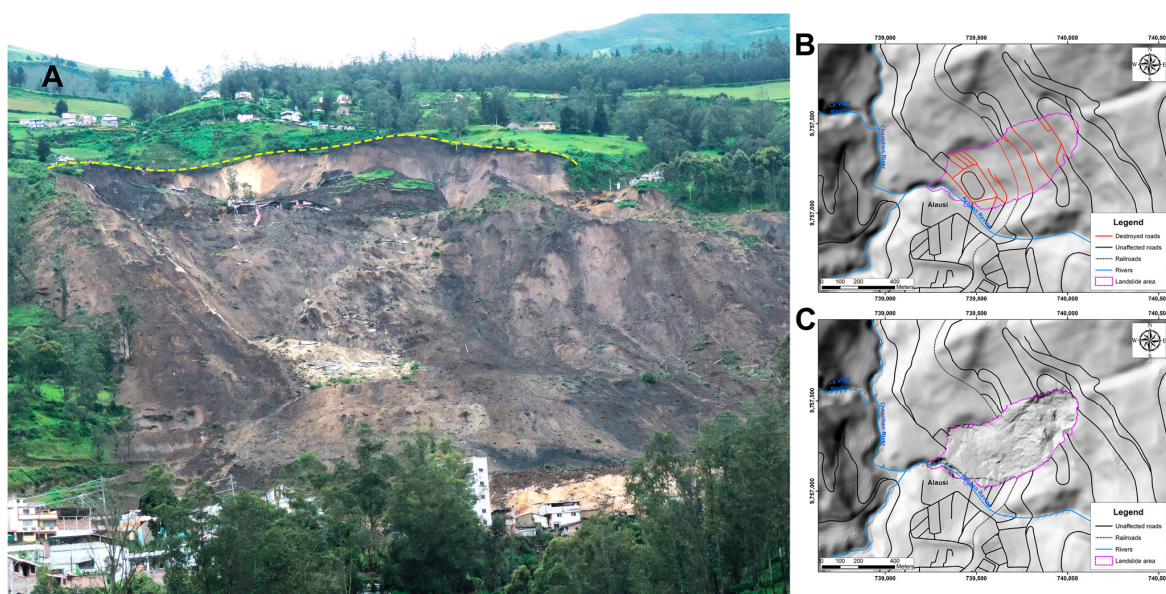
The Alausí landslide occurred on the night of 26 March 2023 (21:13 local time, Sunday) after a slow precursor process that was initiated in December 2022 (Figure 1A) [6,7]. It can be considered a major catastrophic event that devastated over 24 hectares (cut and fill) and caused significant loss of life and infrastructure damage. It had a big size [8], being ~236 m wide, ~300 m long, and 18 m deep on average, which mobilized more than 1.3 million m<sup>3</sup> of materials (volume obtained from the difference in digital elevation models shown in Figure 1B,C). As part of the interpretation of the process, this article examines the interplay between natural and anthropogenic factors. Also, it can be said that this landslide (as a big disaster event) highlights the need to understand human responsibilities in the triggering of landslides and to find which ones have been the probable causes of the initiation of the mass movement.

**Figure 1.** (A) A panoramic view from the west of the 2023 Alausí landslide, one of Ecuador's largest and most mortiferous landslides in recent years (yellow dashed line marks the landslide crown). (B) Digital elevation model (DEM) of the area before the landslide event (2019). (C) DEM showing the changes in elevation at the affected area in 2023 (modified DEM from free data at the Ecuadorian Military Geographic Institute geoportail [9]).

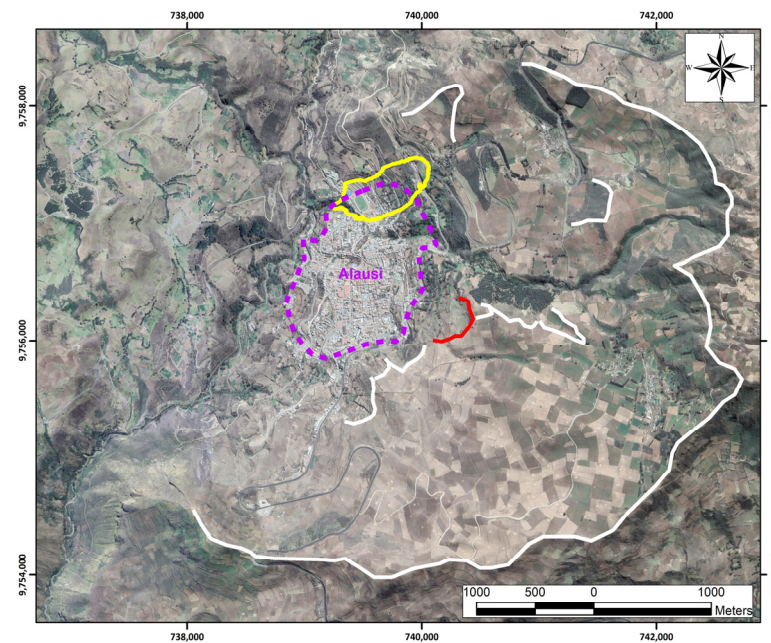
**Figure 3.** A broad aerial view of the Alausí landslide area and its surroundings (the village is at the center of the picture in a dashed purple line, and the landslide is marked in a solid yellow line), showing several scarps (white lines) related to possible ancient mass movements. Also, it includes the Cerro Gampala landslide scarp (in red line). Modified from Google Earth [17].

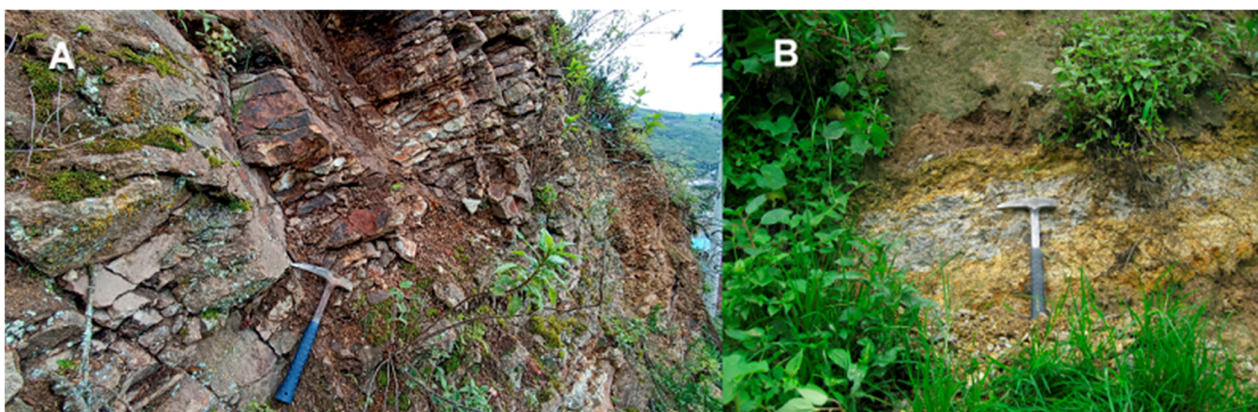
The subvolcanic rocks comprise rhyolites, exposed on the main scarp of the landslide and over the E-35 Road slopes in an area South of the Casual-Nuevo Alausí landslide crown. These rocks exhibit intense hydrothermal alteration, including silicification, kaolinization, and pyritization. X-ray diffraction analysis performed at the FIGEMPA Faculty [7] determined that the rock contained mainly kaolinite and cristobalite to a lesser extent. These rocks could constitute the southern extension of the rhyolitic body reported by Dunkley and Gaibor [16] further north of Alausí. Altered and weathered rocks of whitish and reddish yellow color are exposed in a small outcrop northwest of the coliseum (UTM, WGS 84: 739,410 N, 9,757,428 E), which are highly jointed and whose main families have a N70E/20NW and N20E/40SE orientation (Figure 4A).

**Figure 4.** Altered and weathered rock outcrop located to the northwest of the Alausí Coliseum. A predominant white coloration in the rocks (possibly due to hydrothermal alteration) and a high grade of fractures and discontinuities can be observed (A). Outcrop of four extremely weathered rock layers of reddish-brown color (lower layer), creamy-yellowish layer (layer coinciding with blue hammer handle), light gray layer, and yellowish layer, overlain by consolidated superficial clastic deposit (B).

Also, the studied area has a complex geology in its basement and soil. Tectonic structures fractured the rocks, giving them a high permeability grade [22]. The basement investigation evidenced high degrees of hydrothermal alteration (see Figure 4), which weakened the rock strength and made it easy to mobilize and develop excavation processes by people [23,24]. Additionally, the low permeability of the Cangahua Formation soils (one of the most important overburden materials in the area), coupled with the high-grade slopes, forced the constructors to fill or change the direction of the stream channels, thereby affecting the hydrology.

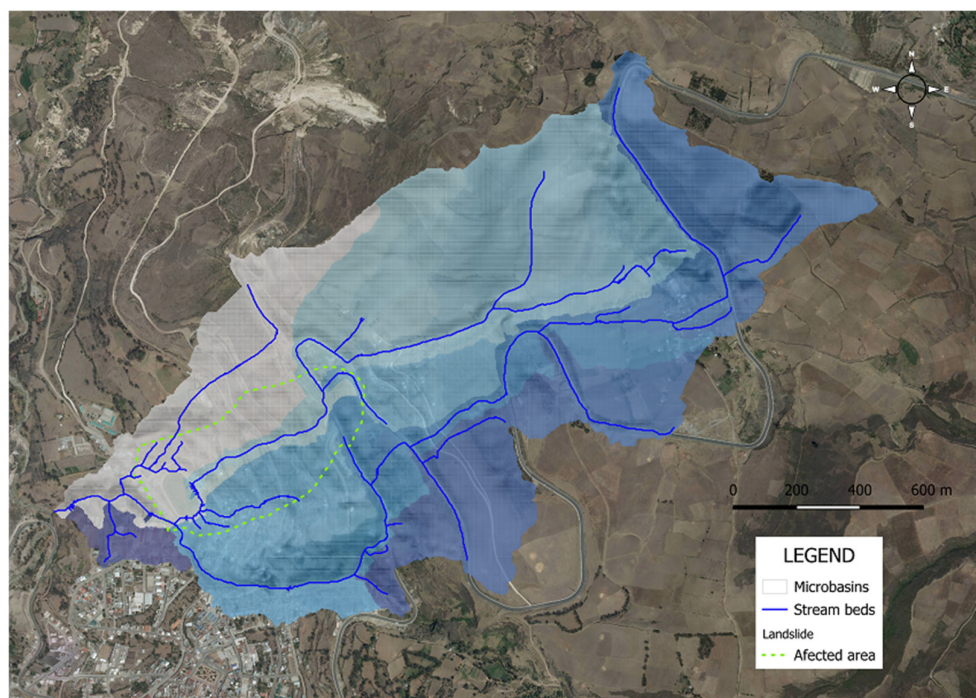
**Figure 5.** Hydrogeological map of the landslide area. The microbasins are delimited from a digital elevation model (DEM) analysis and shown in different blue tones. The stream beds are drawn in dark blue lines, and the landslide-affected area is shown as a dotted green line (modified base map from Google Earth [17]).

The courses of water and the surficial runoff water show evidence of human activities, such as the E-35 Road construction element and the local roads, which interfered with the natural downward water flux trace (just to the northeast of the landslide area, the traces

of the rivers have clear-drawing ways which delineate the ways of the roads). Another observed evidence is the main direction of the water flux, with all microbasins draining towards the landslide zone.

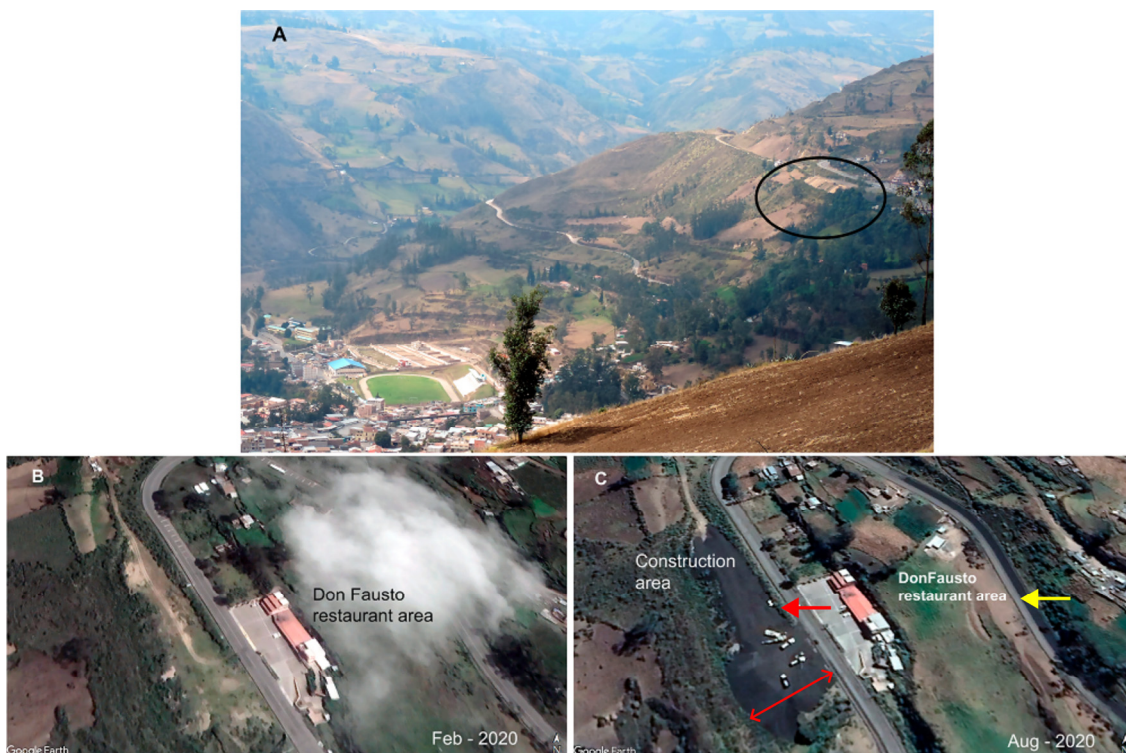
- **2 and 3 November 2022.** After a technical inspection of the Shushilcón-La Elegancia area (southeast of Alausí village), the authors did not identify any abnormal behavior in the geomorphology of the surroundings or on the E-35 Roadway in the area where the head of the landslide was to occur (the Don Fausto restaurant area). Moreover, a material deposit of anthropic origin was identified in front of the mentioned restaurant and close to the E-35 Road (Figure 6A,C). Regarding this fill, it was found that it was for the project construction of the Land Transportation Terminal [28]. The project, located in front of the Don Fausto restaurant, was proposed as a bus stop and tourist viewpoint. It was determined that the structure did not exist in February 2020 (Figure 6B, analyzing Google Earth Pro images), and it appears that the construction started before 29 August 2020 (Figure 6C). The structure had an area of approximately 3250 m<sup>2</sup> and 4800 m<sup>2</sup> at its base with a height of 6 to 10 m. The aforementioned anthropic body had an approximate volume between 47,000 and 79,000 m<sup>3</sup> (78,000 to 130,000 tons in weight considering about 1.65 g/cm<sup>3</sup> of material density). Additionally, another older fill as a flat platform can be identified at the head of the area (east of the restaurant), which can be related to cut-and-fill material from the construction of the E-35 Road in the 1980s (see yellow arrow in Figure 6C).

**Figure 6.** (A) A broad view of the location of the anthropic landfill between the Casual and Nuevo Alausí neighborhoods (black oval). That anthropogenic deposit was located in the head of the area of the landslide (the Don Fausto restaurant is to the right of the oval). The slide materials would cover the football field in the picture’s left corner. (B) On 4 February 2020, it can be noted that no anthropic landfill was in front of the restaurant, as shown in the picture [17]. (C) On 29 August 2020, it can be seen in the image that black landfill was deposited in the area (red arrow) where some earth machinery was working [17]. The yellow arrow shows where the cut-and-fill material was deposited from the E-35 Road construction, and the double arrow line shows a 55 m length.

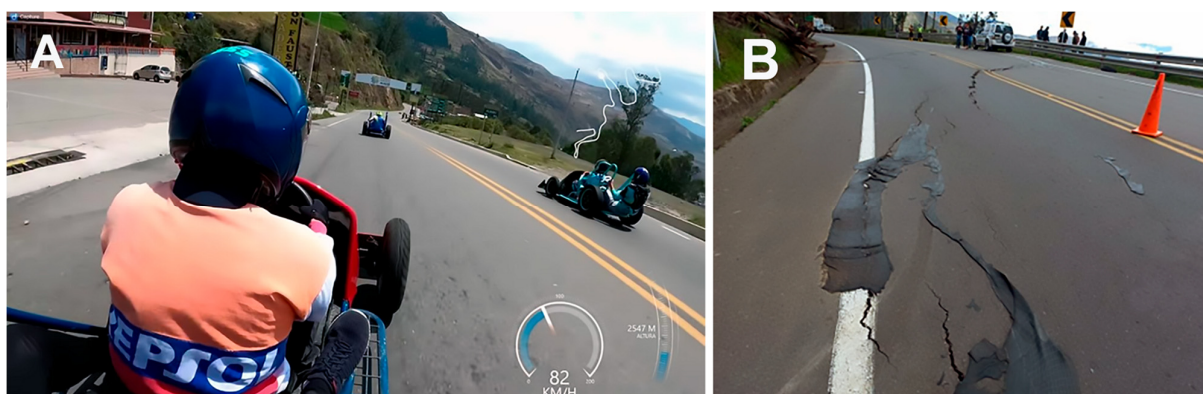
- **12 November 2022.** Extracted from the frames of an amateur video [29], the recording of the route over one vehicle (playing a wooden car competition) could identify that there was no evidence of damage on the E-35 Roadway in the area of the head of the landslide (Figure 7A).

- **February 2023.** On the 8th, a local online news report [32] showed the effects of the increase in cracks and settlement in the E-35 Road (Figure 7B), and on the 19th, the Yellow Alert was established by the Government over a 247-hectare zone [33]. That included the Aypud and Casual communities (no urban areas) and La Esperanza, Control Norte, Nueva Alausí, Pircapamba, and Bua (urban neighborhoods). The exceptional pluviometry that fell over the area this month was that some minor landslides affected the steep slope of the E-35 Road, 100 m down the abovementioned restaurant, and up to 10 m high slope runs through the road (Figure 8A).

**Figure 7.** (A) A picture from video footage shows the pavement condition on the E-35 Road. The race could not have been performed if the road had been cracked (4:25 min frame from a camera over a non-motorized car in front of the Don Fausto restaurant, modified from a video posted by César Zumba [29]). (B) Some cracks developed on the E-35 Road at a close location to the picture in (A) (just at the head of the landslide) on 8 February 2023 (modified from [32]).

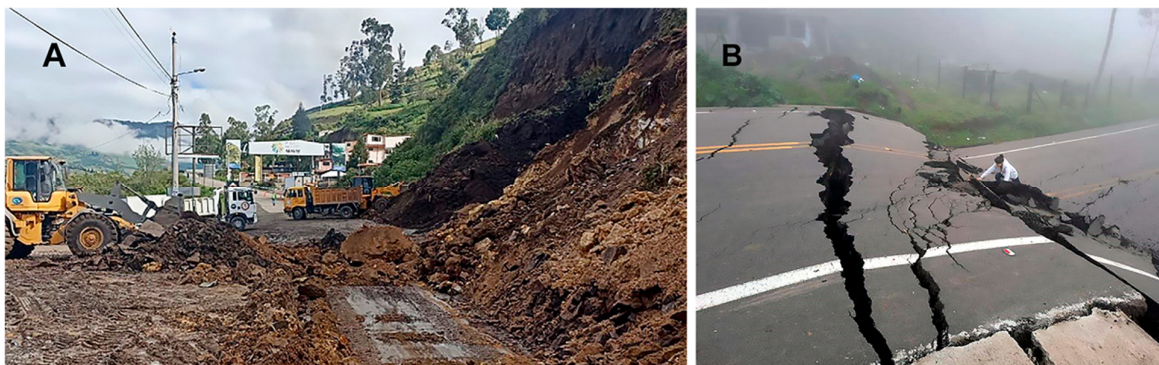
**Figure 8.** (A) Government machinery works to clean and clear debris to open the E-35 Road, South of the Don Fausto restaurant, in the Casual sector, 19 February 2023 [30]. (B) Impressive open cracks and vertical displacement (over four meters) 50 m North of the Don Fausto restaurant. The picture was granted by S. Berrones, a geologist, who took it on 26 March 2023, in the morning, a few hours before the event happened.

Consequently, the water accumulation in soils and rocks, one of the most important factors in landslide processes [59], must not be considered a determining factor when arguing the trigger cause of the landslide rupture, but, of course, it could be a complementary factor in the process (as a long period of rainy days before the start). Also, it is necessary to consider that the rupture process lasted about 4 months (it began to become evident in December 2022) and the Balao earthquake affected it and accelerated the process (see Figure 8B) [6]. That is a future line to investigate and quantify.

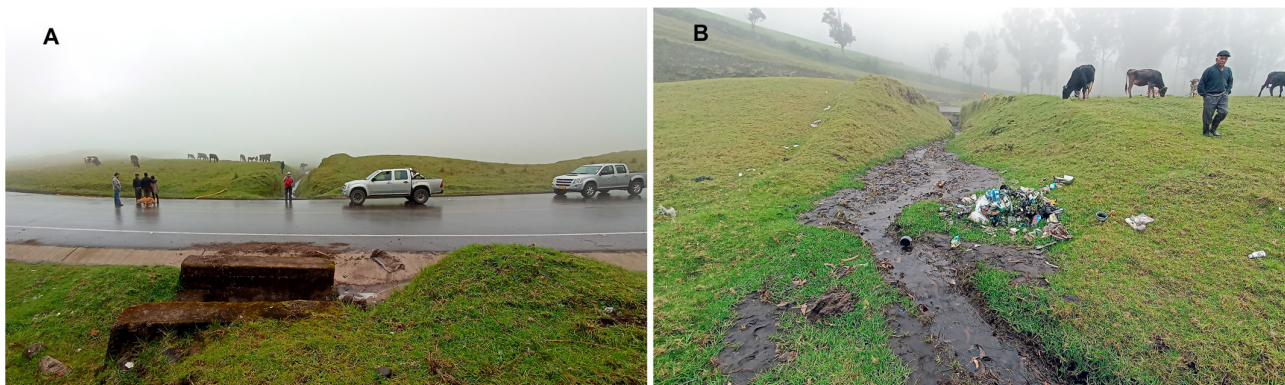
- **Water drainage and runoff direction alteration.** During heavy rainy periods, similar to the days before the landslide event in Alausí, the water can erode constructed and bare-naked slopes, weakening their internal structure (Figure 8A). That is especially important in areas with recurrent or common rainfall periods (including climate change variations) [59,60]. In addition, the lack of adequate drainage (internally in the slope) exacerbates the problem by allowing water to accumulate on slopes, increasing pressure on the soil [12]. It was observed that not only did the road ditches direct the water towards the upper part of the landslide, but the owners and inhabitants also drained that water to points at the top of the landslide (see Figure 9B).

waste products that infiltrate the ground (in the Aypud and Casual neighborhoods, no sewerage system was developed, and they used to throw these products into the surface water streams). Additionally, the lack of garbage management or inappropriate disposal (always illegal or “pirate” throwing) accumulates waste in waterways so that the water carries it away from houses and inhabited areas, which can clog or make some embankments in streams (see Figure 9B). That was evidenced in several places in rural Ecuadorian territory, as indicated in Troncoso et al. [15]. Also, inappropriate agricultural practices, where the remobilization of surficial soil and irrigation water (in high volumes) can also increase the risk [60]. In the Aypud area, it was observed that more than 5 l/s could be unused and sent to streams or over the fields and growing areas.

**Figure 9.** (A) E-35 Road in the Aypud neighborhood area. The road drainage, collecting of water, and redirecting it to the crown of the landslide area can be seen. (B) Anthropogenic alteration of the runoff water through a property down the area of picture A. Garbage and human waste accumulate in the waterways and clog the water flow.
