Lopez-Perez, D.; Antonino-Daviu, J. (2017). Application of infrared thermography to failure detection in industrial induction motors: case stories. IEEE Transactions on Industry Applications. 53(3):1901-1908. doi:10.1109/TIA.2017.2655008

Application of infrared thermography to failure detection in industrial induction motors: case stories

D. Lopez-Perez and J. Antonino-Daviu

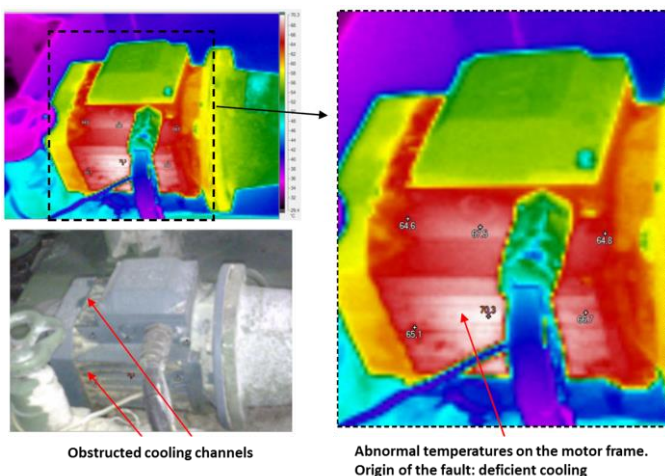
Fig. 3. Infrared inspection of Motor 1: deficient cooling.

This motor was a L.V. machine that was driving a pump for bearing lubrication. The infrared inspection revealed a motor overheating, since the frame temperatures were reaching values above 70°C in some points (Fig. 3). After a more detailed analysis of the motor, it was observed that the cooling air flow was insufficient; the cause was an obstruction of the cooling channels that was produced by product wastes. The cooling channels and fins were properly cleaned and the subsequent infrared inspection revealed an abrupt decrease in motor frame temperatures up to values around 30-40°C with the motor operating under similar conditions as in the first inspection (see Fig. 4). Hence, in this case, infrared thermography enabled to detect the source of the problem.

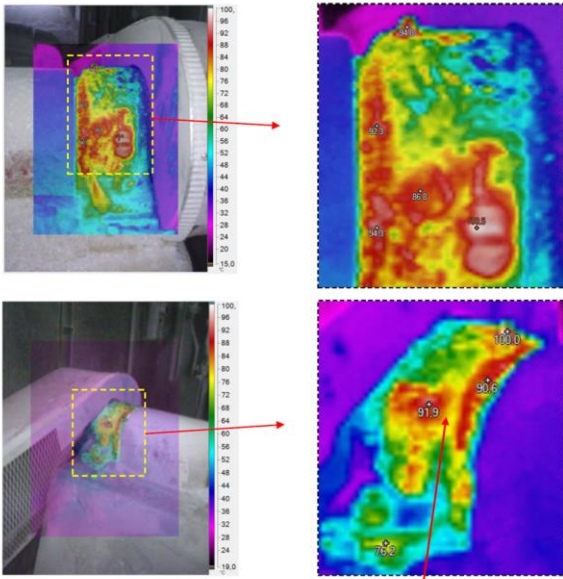
Fig. 5. Infrared inspection of bearing of Motor 2: deficient bearing lubrication.

In this case, the inspected element was a bearing of a motor that was driving a blower. An initial infrared inspection revealed an excessive heating of the bearing. This can be noted in Fig. 5 which shows superficial temperatures above 90°C (and even 100°C) in the bearing region. We can also observe the deposit of product waste over the bearing cage. The bearing was properly cleaned and a new inspection was carried out. However, no significant temperature drop was detected. Therefore, it was finally decided to re-lubricate the bearing. This measure was much more effective, as a new infrared inspection revealed: the temperatures were not higher than 60°C in the bearing region for the motor operating under similar conditions (Fig. 6).

Abnormal temperatures on the bearing region.
Origin of the fault: deficient bearing lubrication.

In order to prevent the occurrence of this type of bearing lubrication problems, the plant engineers proposed not only the use of the infrared technique to detect such anomalies in advance, but they also suggested the lubrication of the bearings by means of ultrasounds; this lubrication method may bring interesting benefits, such as the reduction of the possibility of an inexact lubrication, amongst others. Moreover, the accurate study of this failure enabled to plot a P-F curve associated with bearing faults; this curve shows, for the corresponding fault, the minimum detectable alarm level for each considered technique. This curve is plotted in Fig. 8 and shows how primary bearing defects (wear, indentations, smearing, corrosion...) are best detected via infrared thermography and ultrasounds while vibrations and oil analysis are best suited for the detection of secondary defects.

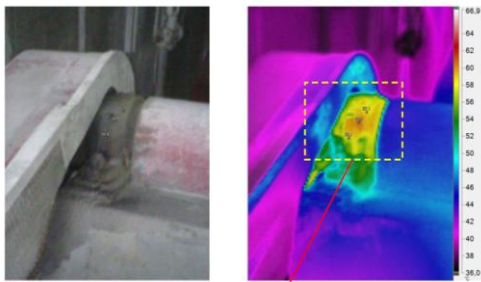
Fig. 6. Infrared inspection of bearing of Motor 2 after re-lubrication.

Much lower temperatures after re-lubrication

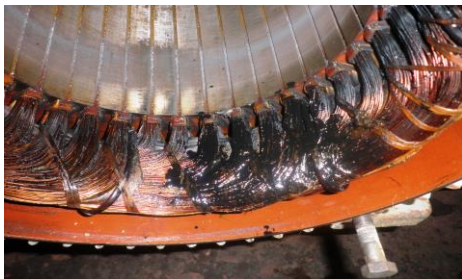
It is important to emphasize that, in the past, this motor had an episode of catastrophic failure caused by problems in the bearings: in 2010, the lack of proper bearing lubrication was not properly detected via vibration analysis; finally, this fact led to the collapse of the bearings and to the damage of the stator insulation (see Fig 7). This is an illustrative case that shows how the infrared thermography may provide very interesting information for the diagnosis in situations where other techniques may fail.

Fig. 7. Insulation damage occurred in 2010 in the same motor due to catastrophic failure of the bearings.

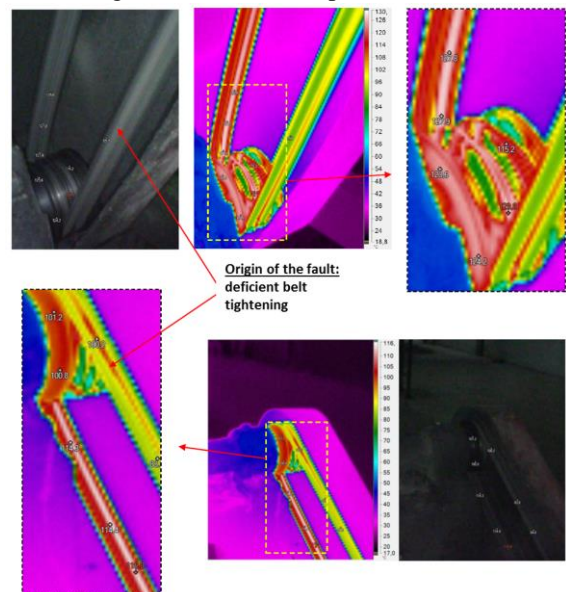
Fig. 9. Infrared inspection of Motor 3: deficient belt tightening.

The inspected motor in this case was an L.V. machine driving a fan for deodorization purposes. Oddly enough, the infrared inspection revealed a very high heat dissipation in the belt transmission system (see Fig. 9), with a maximum temperature of 129.8 °C that was read on the pulley. The deficient tension leads to belt slip on the pulley and increases the heat dissipation due to the friction, which results in decreased efficiency and a reduction of the belt service life.

To solve the problem, the belts were properly tightened and, afterwards, a new inspection was carried out. Fig. 10 shows the new thermal map after the belt tightening that reveals much lower temperatures in the transmission system (30°C in average lower than in the previous case).

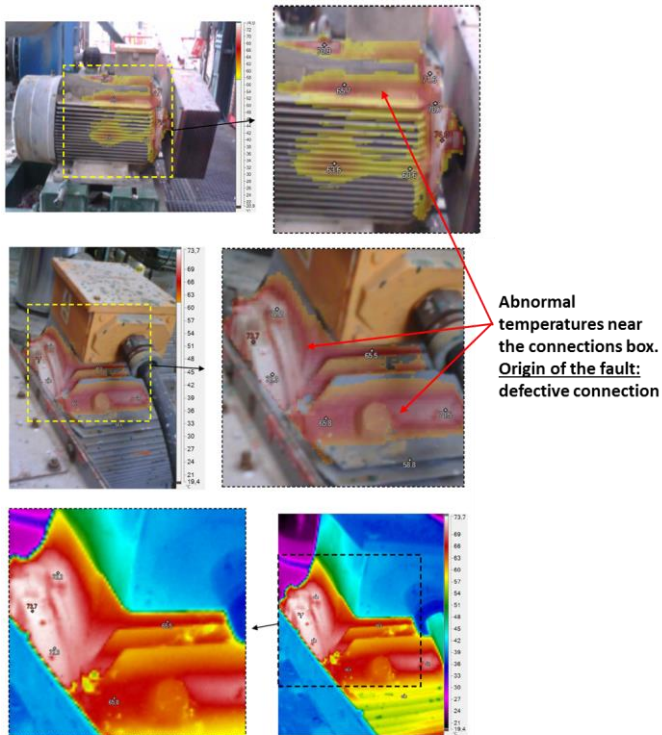
Fig. 11. Infrared inspection of Motor 4: defective connection.

The inspected motor was an L.V. machine driving a blower. The infrared inspection revealed an excessive heat dissipation that was localized in the upper part of the frame, close to the motor terminal connection box, as shown in Fig. 11. The temperatures there reached high values (76.8 °C).

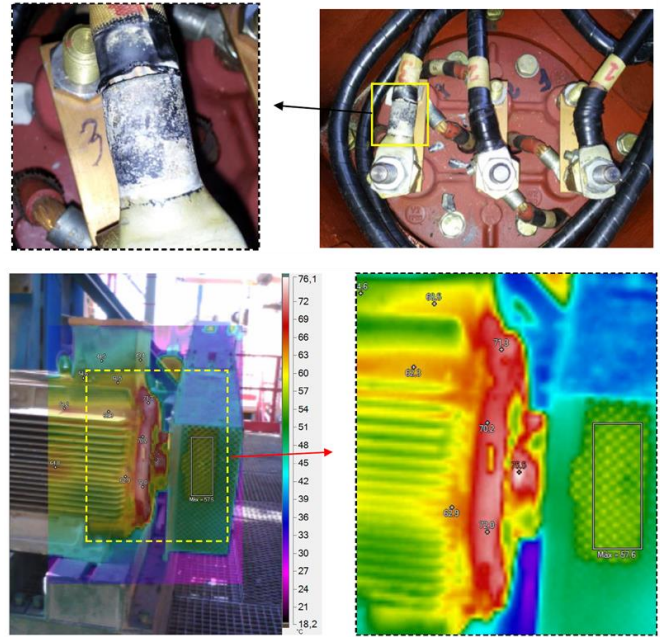
While the motor was switched-off, the winding resistances were measured, obtaining very similar values. The connections were checked and a weak connection was found as well as a partial damage in one of the terminals (Fig. 10, top). After replacement of the terminal and after fixing the connections, the new infrared inspection showed lower temperature values (Fig. 12, bottom).

Fig. 12. Defective connection and terminal in motor connection box (top) and Infrared inspection of Motor 4 after repair (bottom).

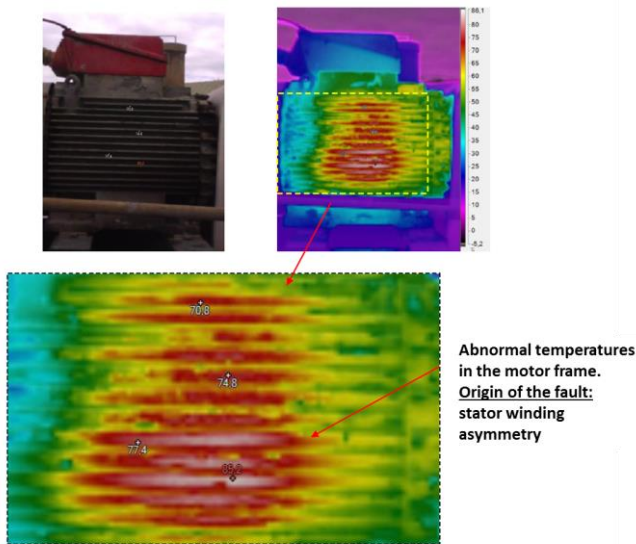
Fig. 13. Infrared inspection of Motor 5: winding asymmetry.

In this case, the considered motor was driving a fan of a cooling tower. The infrared inspection of that motor (Fig. 13) showed a significant heating in the motor frame (85.2 °C in the surface and, probably, above 100 °C inside the motor). No cooling anomalies were found during the inspection. As a first measure, the bearings were re-lubricated and repaired in a workshop but no temperature drop was observed.

Then, the motor terminal box was inspected and only a little temperature difference between connections was found. The winding resistance of each phase was measured with an ohmmeter and the results were very interesting (see Table IV, which compiles the results of the measurements): a significant winding asymmetry was detected between phases, leading to a Max Delta R value of near 9%. This could indicate internal high resistance connections, broken turns or internal shorts. This may be the potential cause of the abnormal heat dissipation. A motor re-winding was finally suggested.
