TRABAJO FIN DE GRADO EN INGENIERÍA EN TECNOLOGÍAS INDUSTRIALES.

ANALYSIS, DIAGNOSIS, AND REDESIGN OF AN INDEXING TABLE INCORPORATED IN A CAMSHAFT PRODUCTION LINE.

AUTHOR: Llac Hernández Llinares.

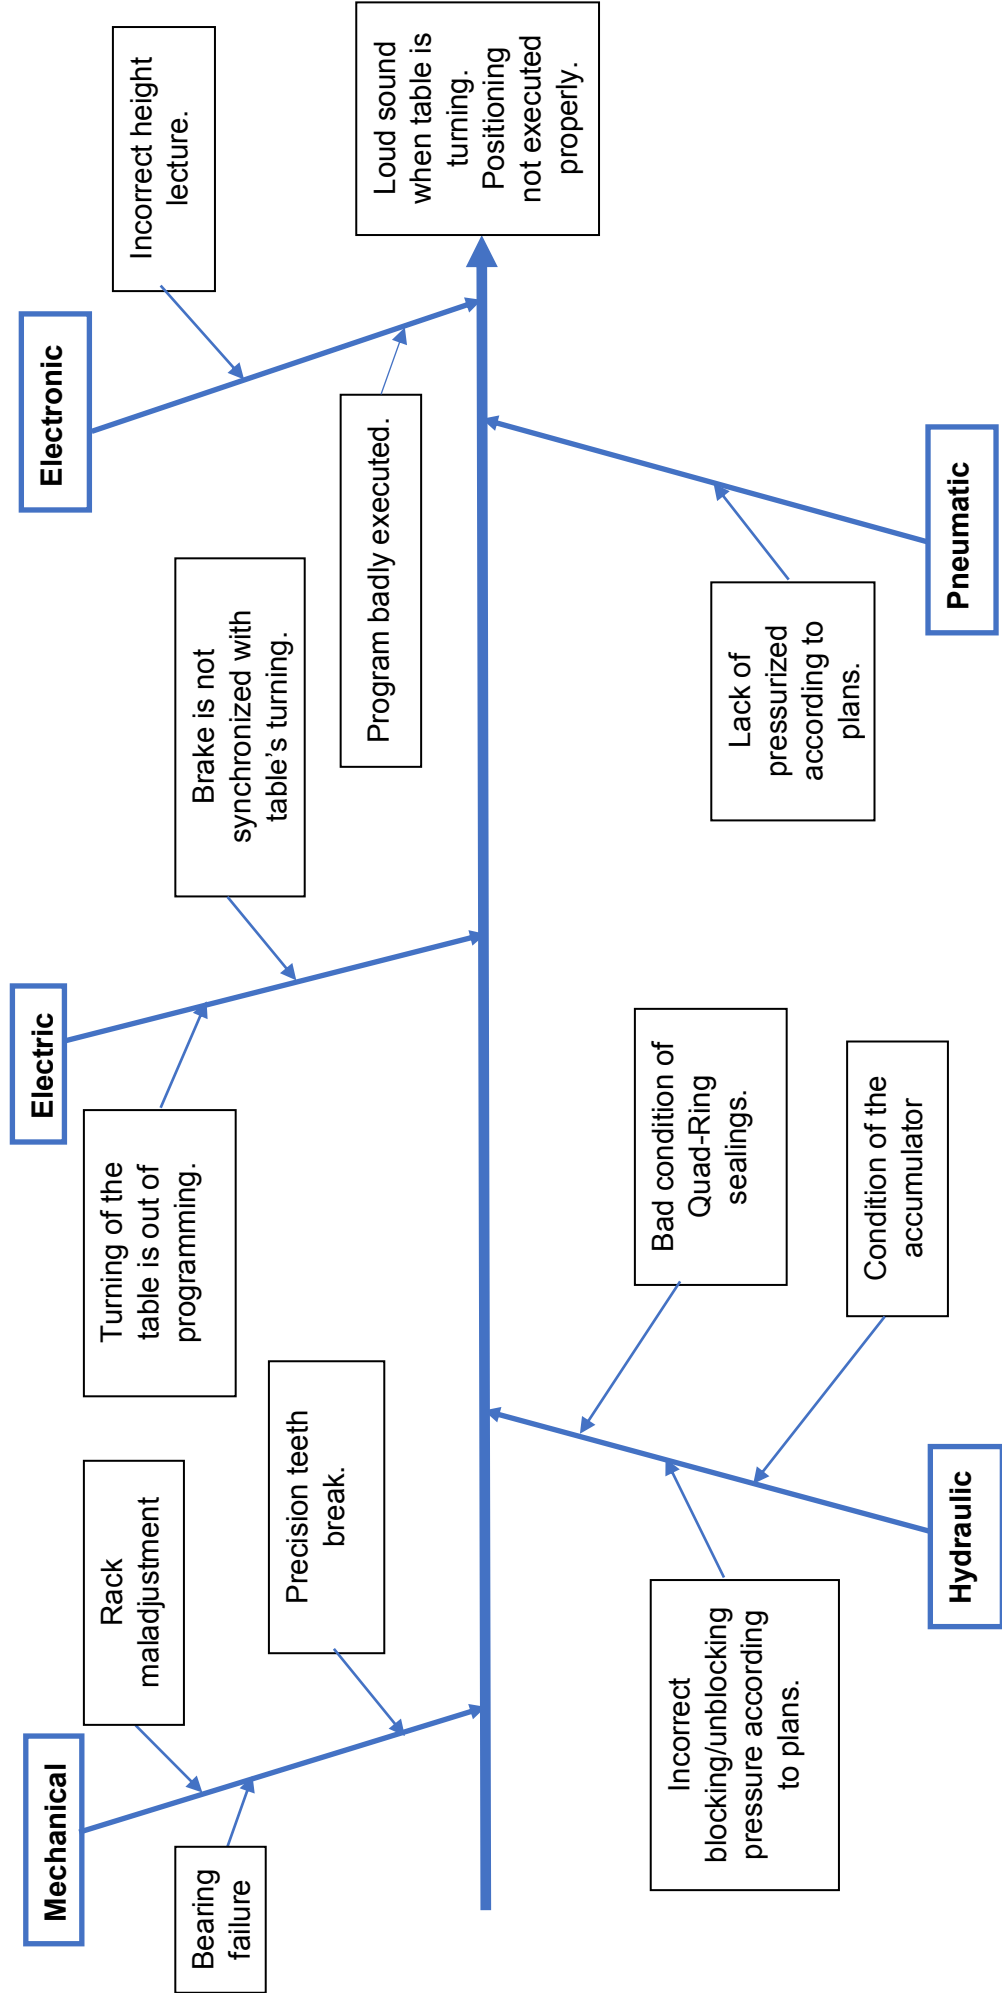
Figure 1: Ishikawa diagram

Before dismounting the table, an Ishikawa was made to determine the possible causes of the loud noise that the indexing table was making [4].

Conclusions after Ishikawa analysis: When opening the table to see what failed, we confirmed that the noise's reason was the broken bearing. Because of the severity of the damage, the spare table needed to be installed in the production line to ensure that production would not suffer a prolonged shutdown.

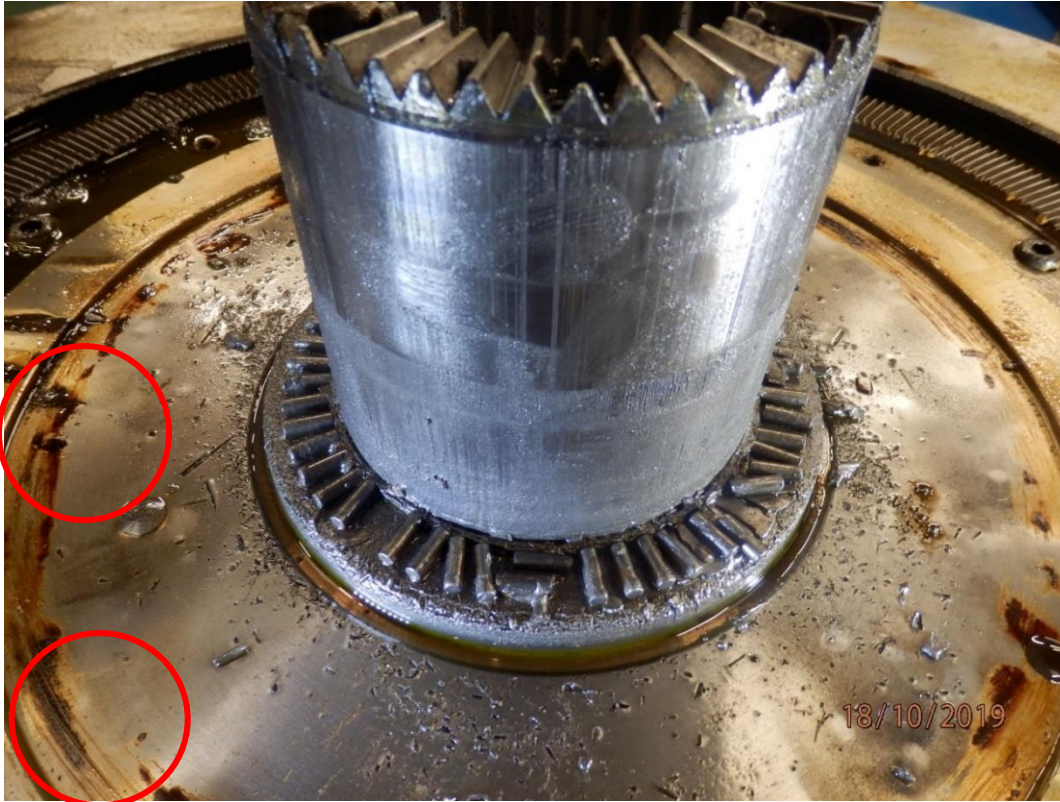
Figure 2: Bearing conditions and temperature marks.

Broken bearing analysis: The needle bearing located between the spindle and the piston was in deplorable conditions. The **cage was destroyed**, unable to guide the rolling elements; the **needles were dispersed around the cavity**; and, there was **no trace of an inferior bearing washer**. Figure 1 helps to understand the condition of the bearing.

Grease analysis: Also, the bearing had a **per life grease that seemed contaminated** due to its viscosity and its bad smell. It looked like the compound was a **mixture of grease and oil**. However, the machine had no leaks while working in the production line. This fact made us think that **possibly, the Quad-ring sealing between the upper hydraulic chamber and the bearing housing failed** (19) (see plan 0), producing the mixture of the hydraulic oil and the grease. This combination could have initiated the wear of the bearing. However, as seen in the Ishikawa, the **sealings were in usable condition**, even more, there was **no need to replace them** when assembling the table again.

Grease condition explanation: Therefore, the only **reason for the bad condition of the grease was the high temperatures** produced by the friction between the bearing shavings and the plate. We arrived at this conclusion when noticing the **temperature marks** that we can see in figure 1. The working temperature range of the grease (Isoflex NCA15) goes from -50°C to 120°C [5]. According to the mentioned marks, it is reasonable to think that the **temperature was higher than the recommended**, producing the degradation of the grease.

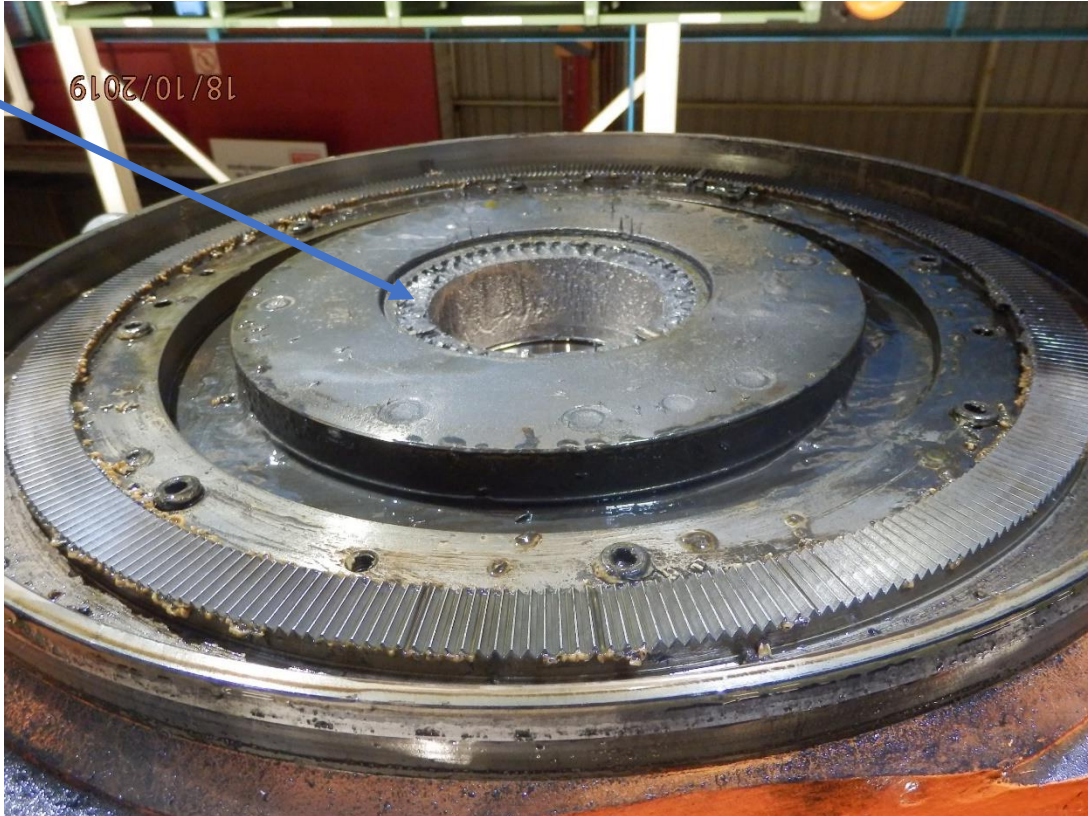
Figure 3: Damaged surfaces.

Piston analysis: If we continue scoping the consequences of the breakdown, figure 2 shows that the rolling elements left **deep marks on the piston**. These marks could mean that the bearing was mounted without an inferior washer. A hypothesis that we already mentioned, as we did **not found an inferior washer when first opening the table**. This assembly implies that **the table was incorrectly mounted, in case that the piston did not have proper heat treatment**.

Parts with damaged surfaces: Also, the breakdown damaged other components of the table; these were **cylinder lid, antifriction sleeves, and spindle**. These were affected by the shavings of the bearing washer and cage that eroded their surfaces.

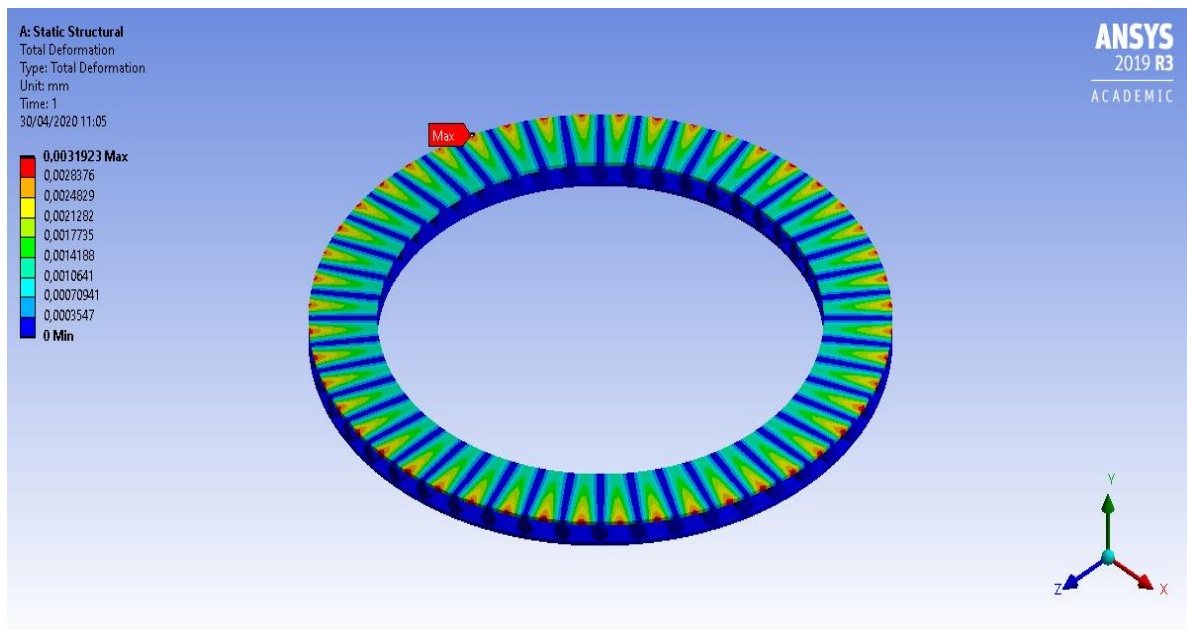
Figure 4: Original bearing deformations.

Deformations: Figure 4 shows the deformation suffered by the bearing when applying the force that corresponds to the weight of the clamping tools, the plate, and machined parts. As we can see, **deformations are small**, with a maximum value of just **3,19µm**. This value seems reasonable according to the applied load and the material; this is EN 1.3505 [9], hard steel used for bearing manufacturing. Also, higher deformations are placed where they are supposed to be, at the superior surface, between needles, where there is no support for it.

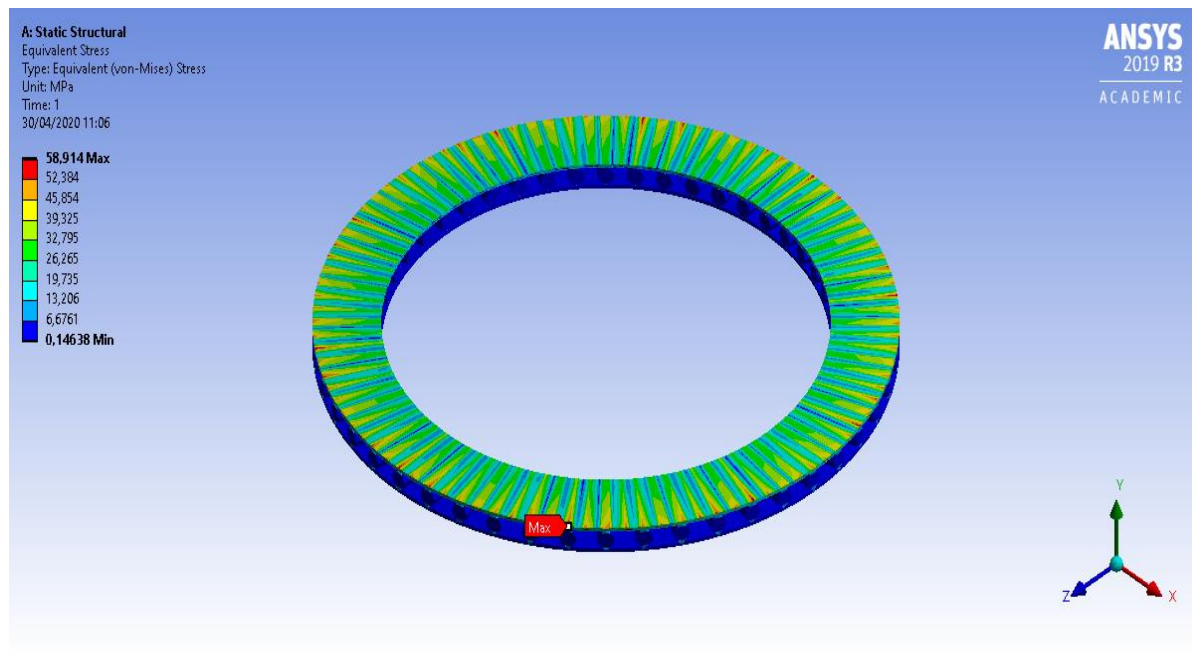
Figure 5: Original bearing stresses.

Stresses: Figure 5 shows the **maximum stresses** that the bearing is handling. With a maximum value of **58,914MPa**. This small stresses that coincide with the **oversized conclusions** of the manufacturer's analysis. Also, maximum stresses are placed in the superior surface, in those zones over the rolling elements, as expected, as the material in these zones is not able to deform to redistribute stress.

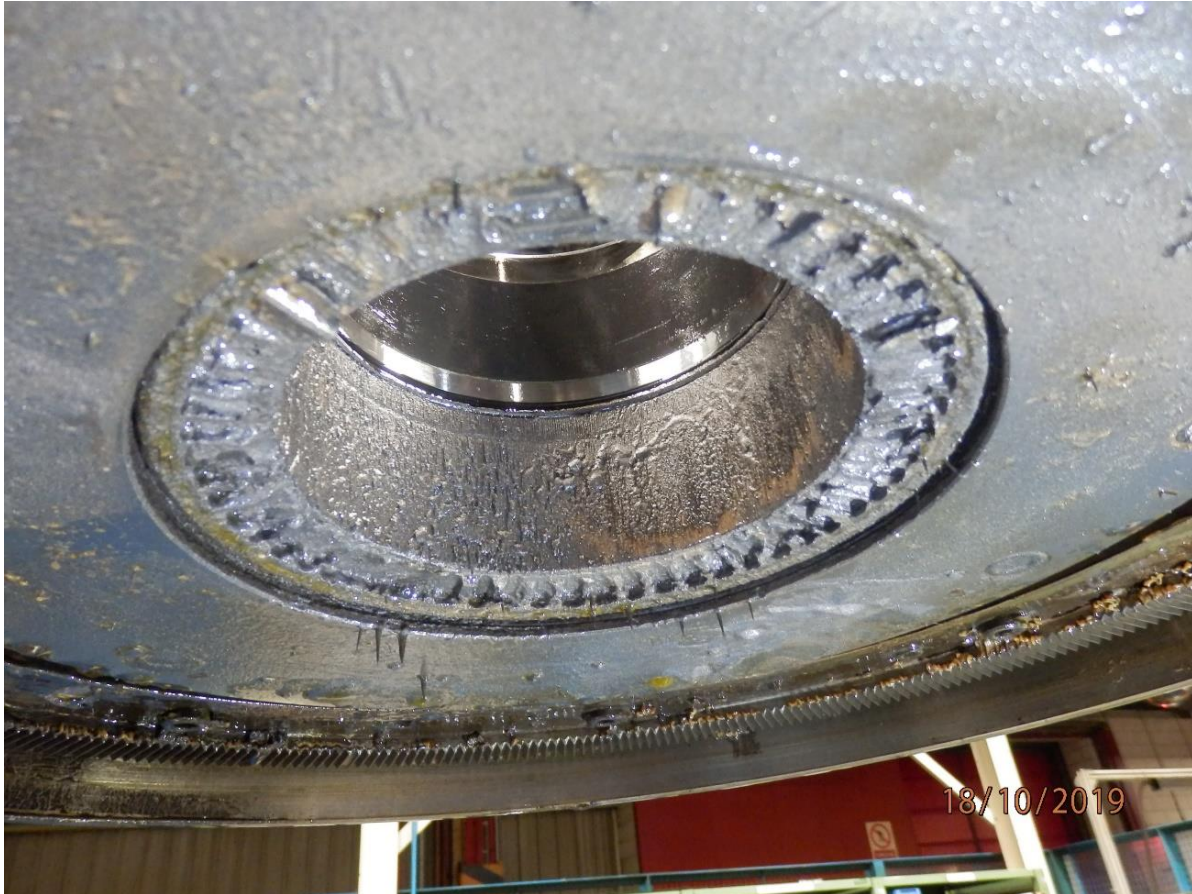
Figure 6: Damage of the piston.

Rugosity check: It was **impossible to measure the Ra** of the piston's surface in contact with the needles, as it was utterly irregular **due to the marks that the rolling elements left** on it. Figure 6 shows that the surface of the piston had severe damage, which did not allow us to identify the real distance between this surface and the top of the piston.

Functioning check: Because **we could not measure the distance between the piston's surface in contact with the rolling elements and the top of the piston, we could not determine the original design of the table.** Therefore, we could not conclude **if there was an impact when lifting or not.** If we knew the depth of the piston's surface where the bearing relies on, we could find out the total height of the bearing-piston package and determine if there was still space between the bearing and the spindle when the table is mounted (see plan 0). We should wait for the information from Fibro. However, **we will assume that there is no impact to continue with this analysis**, as is the most logical option from a designing point of view. We will **also consider that the rugosity was according to Schaeffler.**

Hardness check: Because the other **critical factor was the hardness of the surface**, we measured this on the piston's surface in contact with the needles, with a result of 238HB, which is just **22HRC**. This hardness is much lower than the **minimum required (58HRC)**. It could be that the piston had a superficial heat treatment, but this critical face could have lost it because of its wear. To check this, we made **measurements on all surfaces of the piston**, and the results were similar, with a hardness **average of 20HRC**.

Consequences of the incorrect mounting: The lack of hardness caused that the **rolling elements deformed the piston's surface** due to the stress produced by the weight that the bearing had to support. This deformation made the surface irregular, contributing to an **irregular distribution of the lubrication grease** with the corresponding wear that this implies. Also, **if the surface is irregular, the rolling of the bearing is not uniform**, making the **cage of the rolling elements suffer high stresses**. With each cycle, the deformation increased, multiplying the mentioned stress of the cage, and the incorrect distribution of the grease. These higher solicitations produced the **cage's breaking**, the **shavings from it contaminated the grease** and were distributed around the bearing's housing and the space between the plate and the cylinder lid. As said before, these **shavings produced friction between the lid and the plate, creating the temperature marks found in the plate** and degrading the grease by high temperatures. While this was taking place, the cage continued breaking even at a faster pace, as the lubrication grease had lost its properties, and deformations continued increasing. **These facts explain the loud noise** that the table was making that alerted machine operators.

Once the material and the characteristics of the piston were clear, we concluded that the piston's surface in contact with the rolling elements needed to have **a specific treatment** to ensure the proper functioning of the bearing. This condition took us to analyze the **possible procedures to increase hardness** [12]:

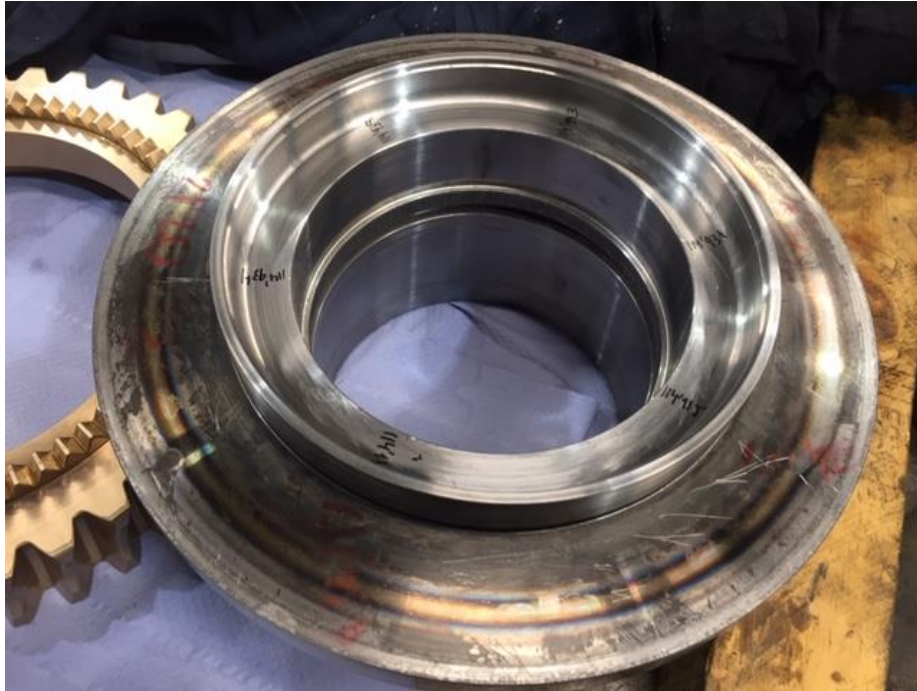
Figure 7: Superior temperature marks.

To conclude this analysis, we must mention that **temperature marks** were found in the piston (figures 7 and 8). These are the result of **the hardening of the EN 1.4057**, not from the possible hardening made by Fibro.

These marks are the **result of an induction hardening process** [12], where two spirals contacted these surfaces of the piston. The use of two spirals is justified by the need to cover the whole piston without using a spiral with an excessive diameter.

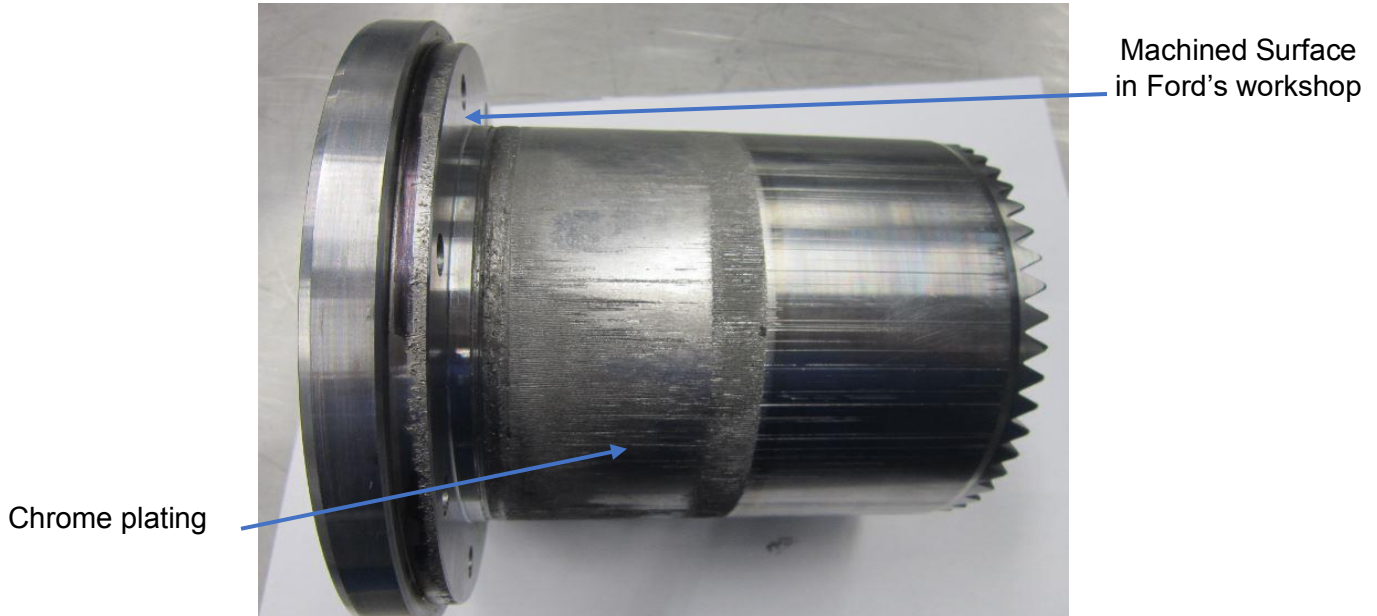
Figure 9: Differences in the spindle damaged surface.

Spindle repair: The spindle had **two damaged surfaces**, the one that is directly in **contact with the superior washer**, and the surface in **contact with the antifriction sleeves**, we can see this damage on this surface in figure 9. We repaired the surface in contact with the washer **in the workshop**, but the **other one had a rugosity of Ra0,1-0,2** that was not possible to achieve with Ford's machines. It was **necessary to send it to an external company to machine it to perform a chrome plating**.

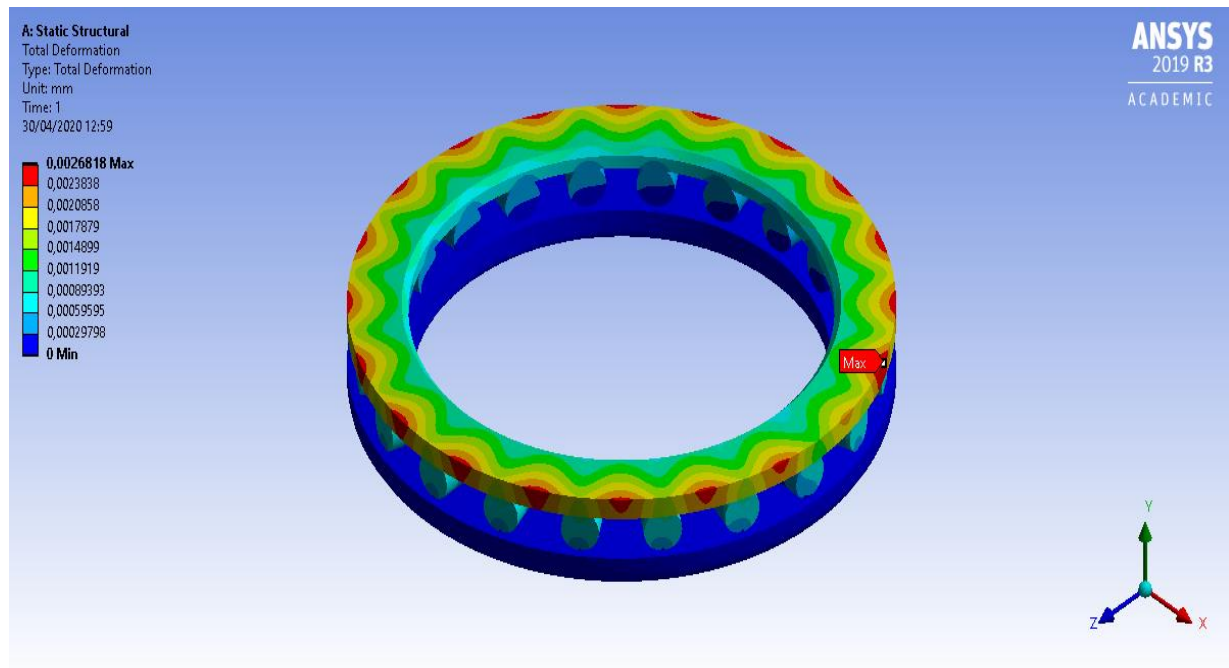
Figure 10: New bearing deformations.

Deformations: Figure 10 shows the **deformation** of the bearing when applying the load. As in the original bearing, the higher deformation values occur in the superior washer, between the rolling elements, with a **maximum value of 2,68µm, smaller than the 3,19µm obtained in the original bearing.**

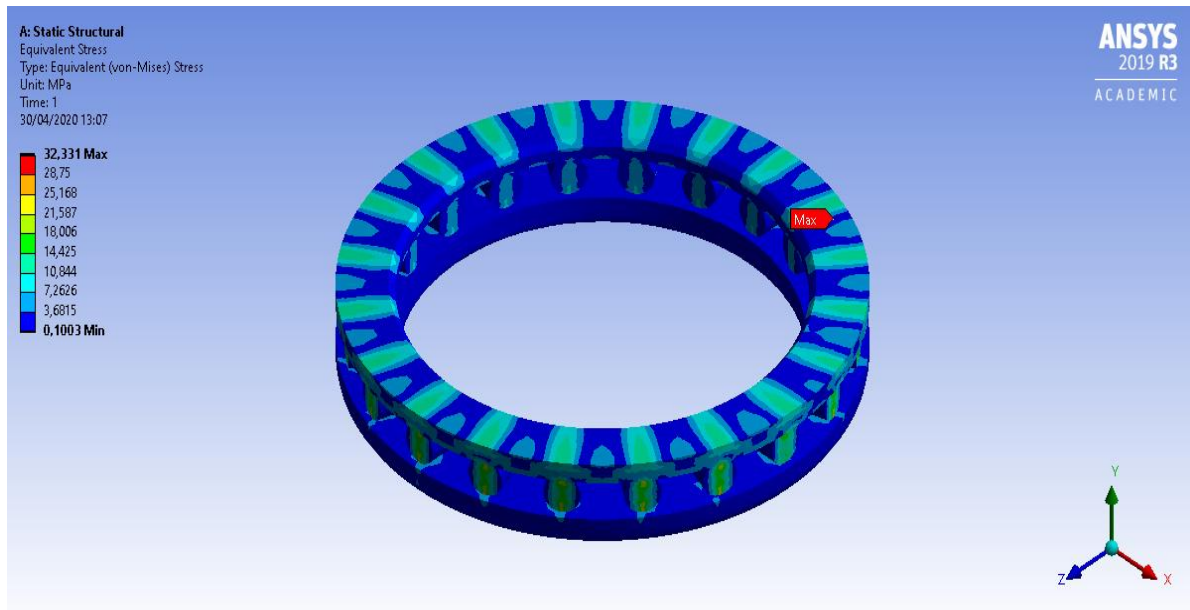
Figure 11: New bearing stresses.

Stresses: Figure 11 shows the **stress** produced in the bearing. Again, the maximum stresses take place in those zones of the superior washer that are over the rolling elements that prevent it from deformation. The **maximum stress value is 32,331MPa, smaller than the 58,114MPa obtained in the original bearing.**
