Daugiabučio gyvenamojo namo Trakų g. 14 Vilniuje rekonstrukcijos projektavimas
Reconstruction planning of the multi-dwelling residential building at Traku str. 14 in Vilnius

FINAL THESIS WORK

VILNIUS, 2013

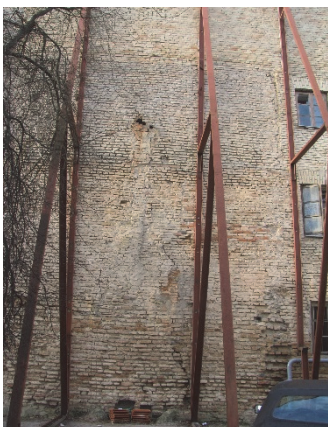
The problem presented to analyse in this section is related with the conditions of the facade walls of the building. According to the plans and the pictures provided is possible to link the problem with the rising damp, the age of the façade brick walls and the lack of maintenance and cleaning for a long period of time. The problem of the age of the façade walls is a kind of unavoidable factor that have been increased by the low maintenance.

Figure 40 . Example of crack in wall

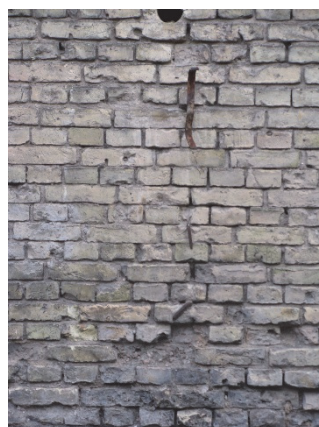
Figure 39 . Example of crack and rests of rusty iron in courtyard wall

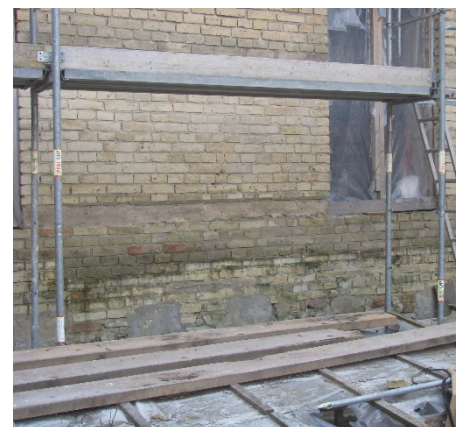
The appearance of certain damp stains in other higher parts of the wall can be related with the poor condition of the wall, the wind-driven rain is another deposition mechanism of moisture if an adequate drainage or other protection is not provided. A graphical example of how works the rising damp is showed in the next draw (Figure 37).

Figure 38 . Example of moisture in courtyard wall

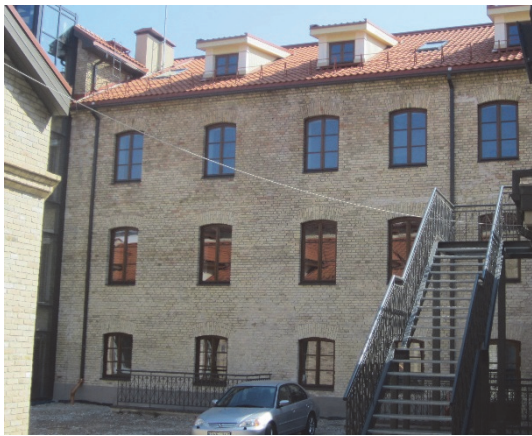
These pictures (Figure 53, Figure 54) taken during the month of May represents the current state of the building where is possible to see the tonality change of the façade and the good state of the repaired masonry.

Figure 53. Courtyard facade, picture after the restoration

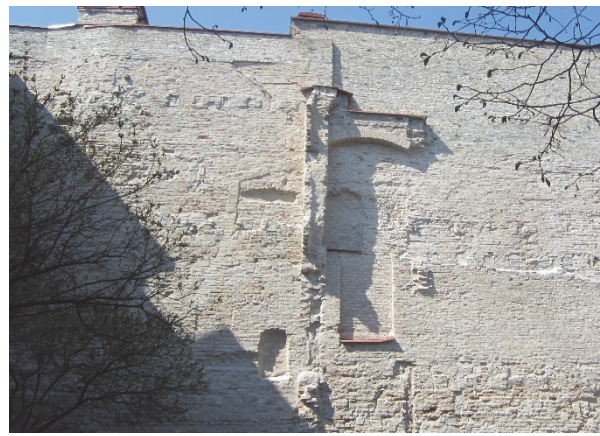
Figure 54. Exterior wall facade, picture after the restoration

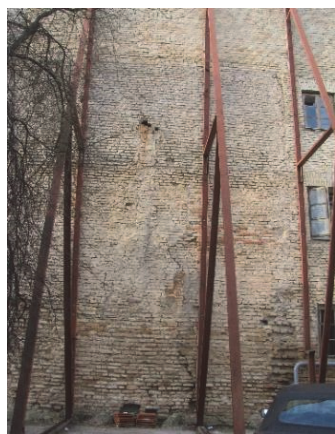
The following pictures (Figure 58, Figure 57) represent clearly the state of the facade found when before the reconstructions works started.

Figure 58. Exterior eastern wing facade before the reconstruction works

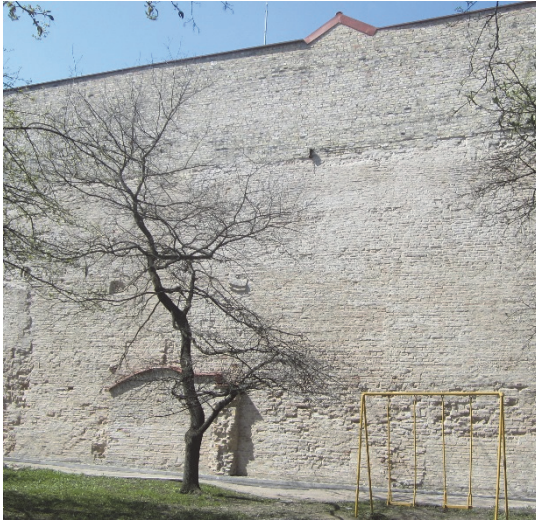
The next pictures (Figure 62, Figure 61) taken during the month of May represents the current state of the building where is possible to see the repaired cracks of the facade

Figure 62. Exterior eastern wing facade after the reconstruction works

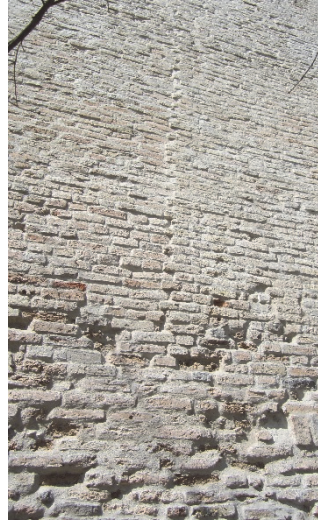
Figure 61. Exterior eastern wing facade after the reconstruction works

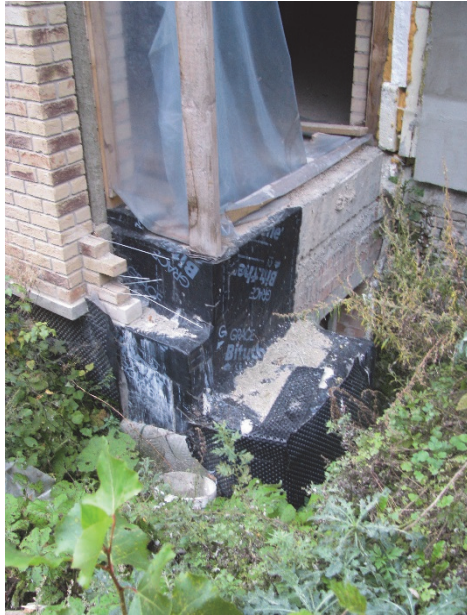
The next pictures (Figure 63, Figure 64) represents the state of the foundation before the start and in the first steps of the installation of the foundation waterproofing.

Figure 63. State of the courtyard walls and foundation during the waterproofing works

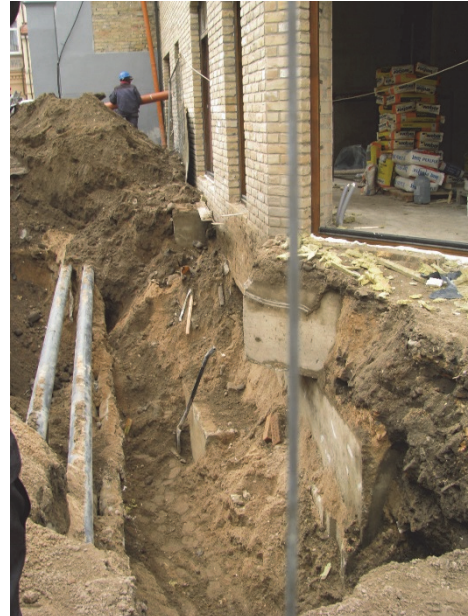
Figure 64. State of the courtyard walls and foundation during the waterproofing works

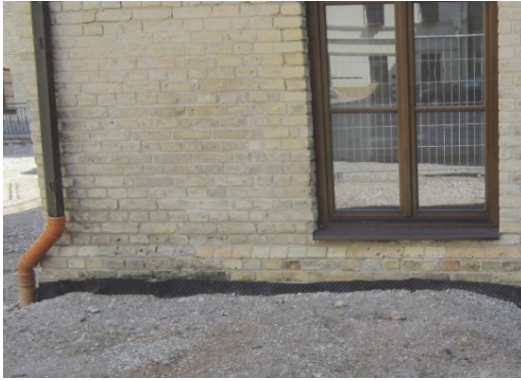
Figure 66. Foundation waterproofing installed after the reconstruction works

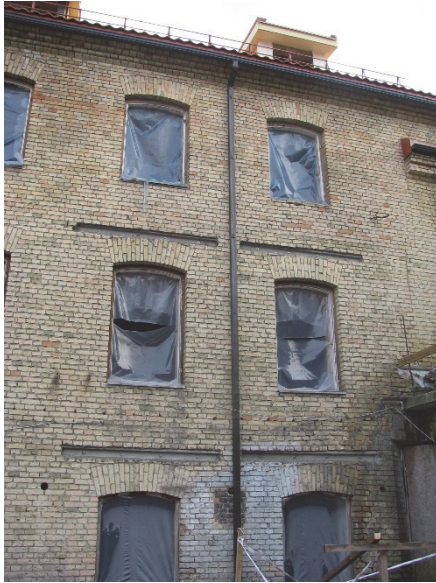
These are pictures of the facade state before the start of the first restoration works (Figure 67, Figure 68), during the first phase, which represents the half process of the lintels restoration.

Figure 67. Facades of courtyard before the reconstruction works. 1st phase replacement of the lintels is done.

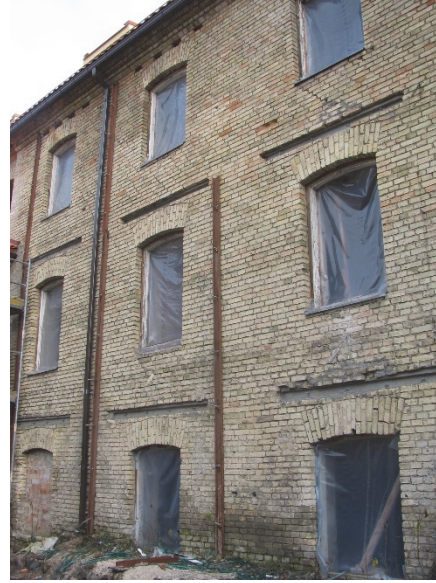
Figure 68. Facades of courtyard before the reconstruction works. 1st phase replacement of the lintels is done.

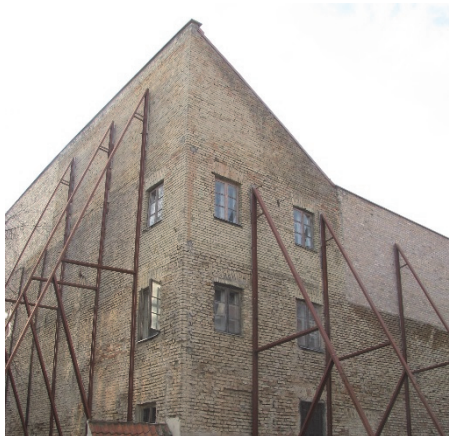
The following pictures were taken after the first reconstruction, when part of the restorations works have been done (Figure 72, Figure 73) and when the reconstruction works finished (Figure 41, 42) where is possible to see the replacement of the masonry bricks and lintels

Figure 72. Exterior facade wall of northern, eastern wing, after first reconstruction

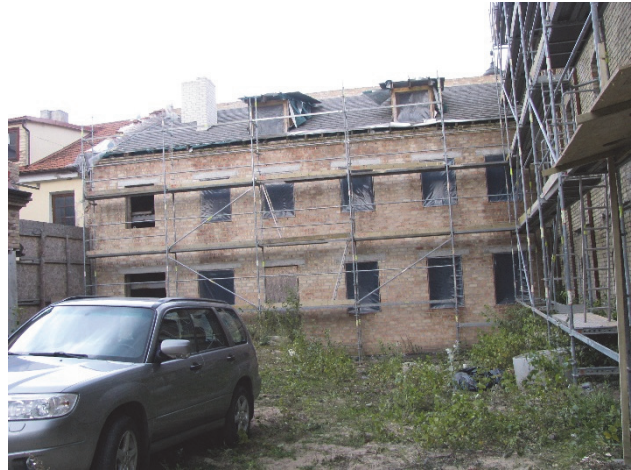
Figure 73. Courtyard facade of northern wing, after first reconstruction

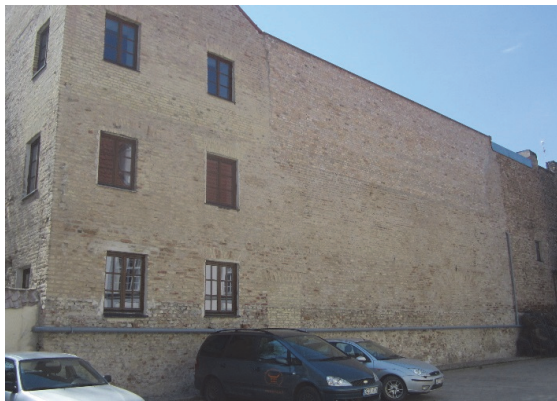
Figure 70. Exterior facade wall of northern, eastern wing after the reconstruction works

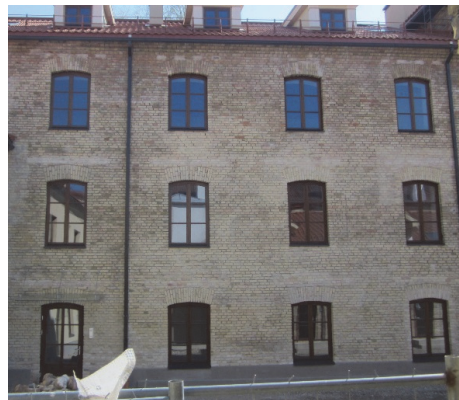
Figure 71. Courtyard facade of eastern wing after the reconstruction works

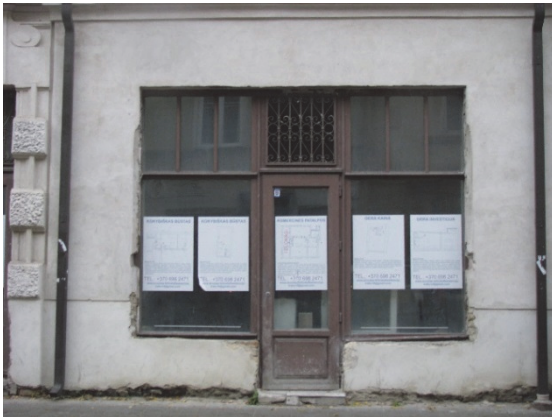
The following picture (Figure 74, Figure 75) and the draw (Figure 76) represent the state of the access of Traku Street before the reconstruction works started and the indication of the new demand for the grille.

Figure 74. State of one of the entrances for public areas of Traku Street before the reconstruction works of the facade started

The solution adopted is to place a gate hinged metal that will be used to protect the glass windows of the main street facade. In the next pictures (Figure 77, Figure 78) is possible to see the replacement of all the doors and windows of this facade as well as the rehabilitation of the sockets and repainting the entire facade.

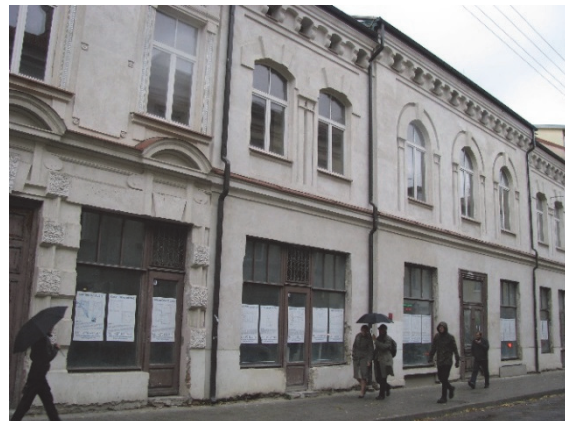
Figure 75. State of the facade and the different access for public areas of Traku Street before the reconstruction works of the facade started

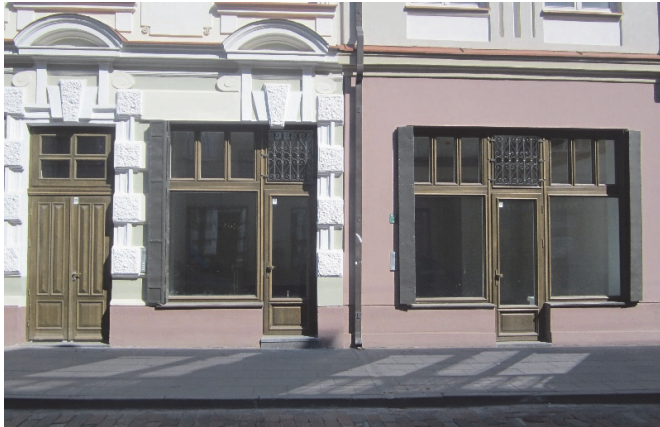
Figure 77. Protection grille installed in Traku Street facade
