SEISMIC PERFORMANCE OF MASONRY RESIDENTIAL BUILDINGS IN LORCA'S CITY CENTRE, AFTER THE 11TH MAY 2011 EARTHQUAKE

Luisa Basset-Salom¹; Arianna Guardiola-Víllora

ABSTRACT

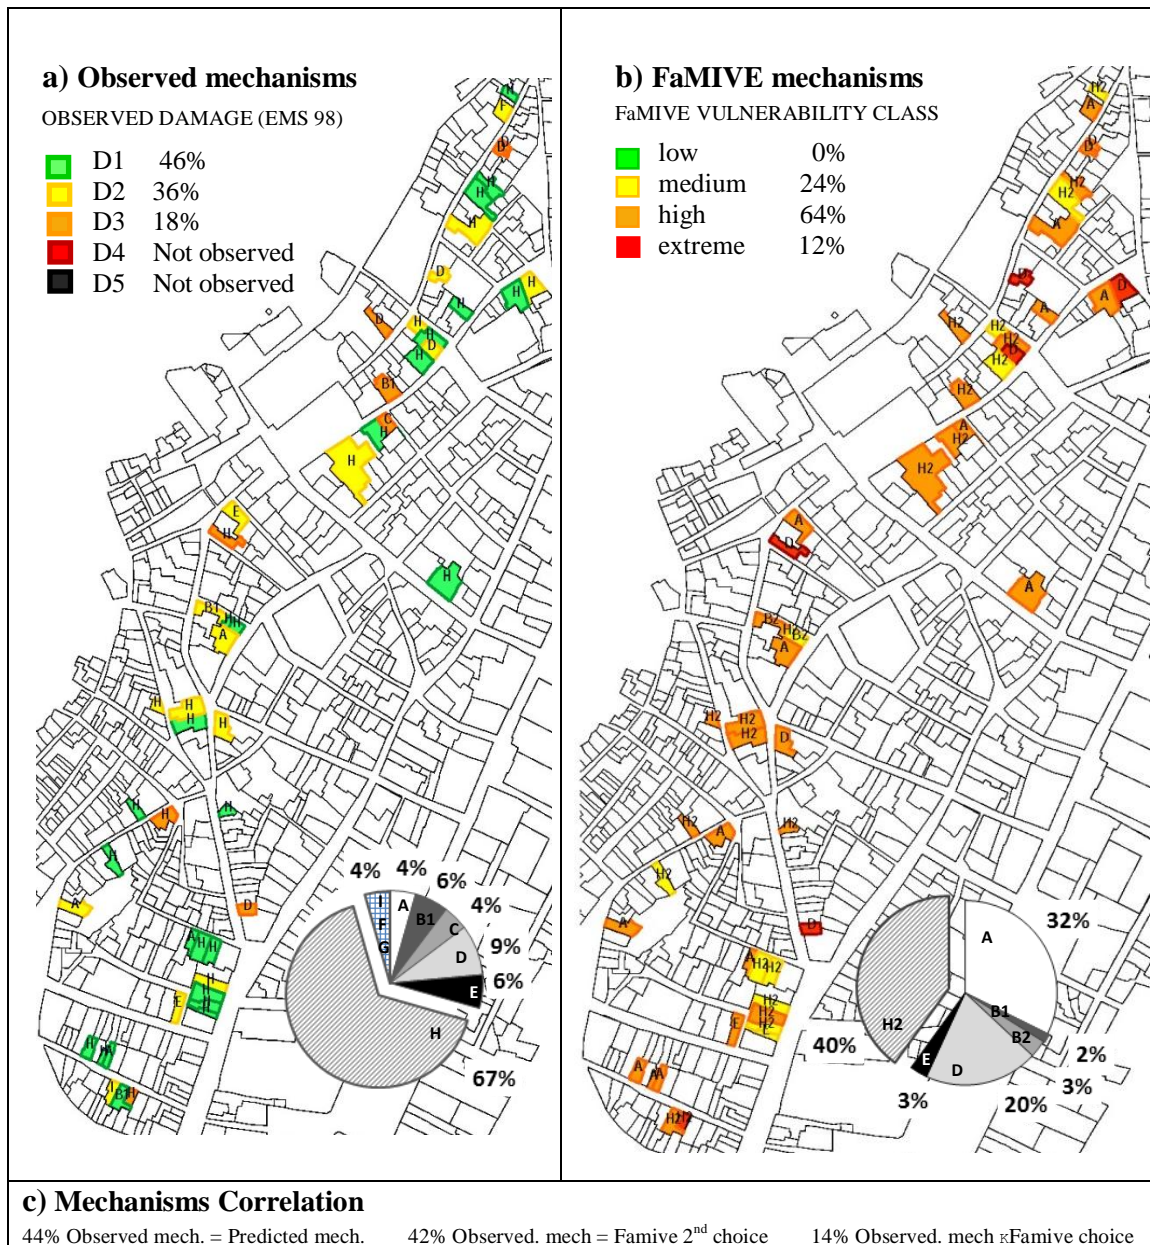
Fig. 16 a) Observed collapse mechanisms and damage levels, **b)** FaMIVE predicted collapse mechanisms and vulnerability classes and **c)** Mechanisms correlation

During the field survey the authors have associated to each façade's crack pattern a representative mechanism among the possible ones (in some cases up to three), being sometimes difficult to identify which is the prevalent, especially for the low and moderate damaged buildings. The observed mechanisms are mapped in figure 16a. In-plane mechanisms, H or H2, have the greatest occurrence (67%), distantly followed by three out-of-plane mechanisms: partial overturning, D (9%), overturning with 1 side wing, B1 (6%) and vertical strip overturning, E (6%).

Taking into account the gathered information of each façade, FaMIVE identifies all the feasible mechanisms, selecting the prevalent one, depending on the collapse load factor and the damage extent, classifying the building into four vulnerability classes (low, medium, high and extreme). It is worth pointing out that, sometimes, this first choice is not the mechanism that might really occur. FaMIVE predicted mechanisms are mapped in figure 16b. FaMIVE has estimated that the majority of the sample buildings will, also, develop an in-plane mechanism, mainly H2, although with a low percentage (40%). Other representative predicted mechanisms are the vertical overturning of the façade, A (32%) and the partial overturning, D (20%).

The correlation has been established not only between the observed mechanism and the first FaMIVE proposed mechanism but also with the second FaMIVE choice: 44% of the observed mechanisms are predicted as the prevalent ones, while 42% correspond to the second choice. Not matching prediction represents only 14% (figure 16c).

The main difference is that the percentage for observed out-of-plane mechanisms (33%) is lower than the corresponding percentage for the predicted ones (60%). As has been proved in previous studies about the seismic performance of similar masonry buildings, when façades are prevented from overturning by efficient connections between orthogonal walls, the most probable collapse mechanisms would be the in-plane ones, however, the façade will fail with an out-of-plane mechanism when there is lack of connection. During the survey, it has been very difficult to establish in some buildings the presence of internal strengthening devices and their efficiency. In absence of accurate information, this uncertainty has been taking into account considering that the walls were poorly connected and assigning a low level of reliability in FaMIVE inspection form. Therefore, differences in the collapse mechanism prediction can be explained by the unnoticed presence of restraining elements that are preventing the occurrence of out-of-plane mechanisms.

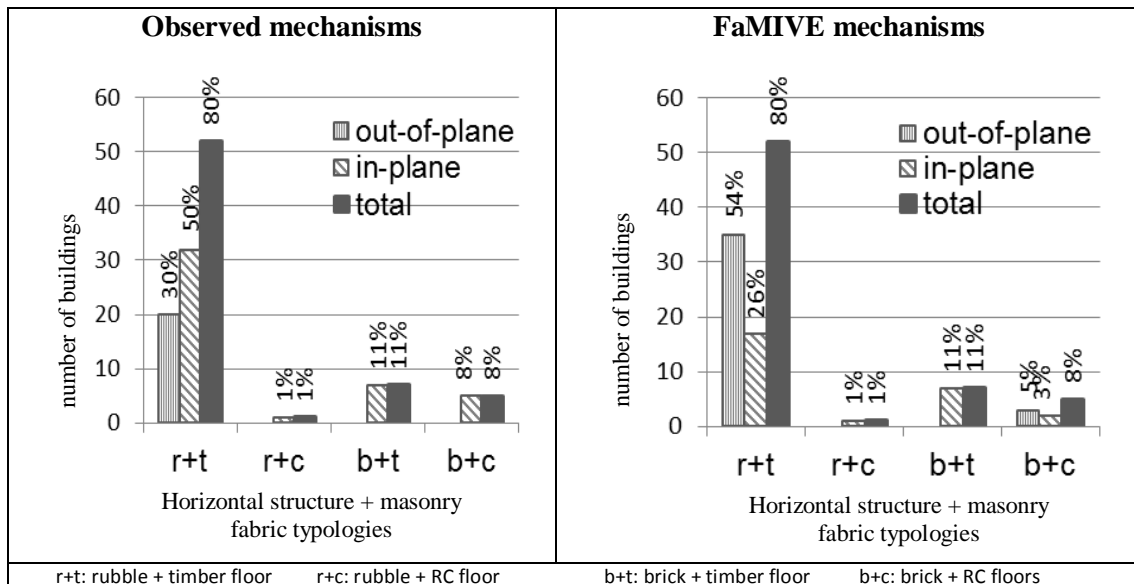
Fig. 17 Observed and calculated mechanisms depending on horizontal structure and masonry fabric typologies

To explain better the differences between FaMIVE predictions and surveyed damage, a comparison has been made depending on the horizontal structure and the masonry fabric typologies (figure 17), showing that differences correspond to rubble masonry walls with timber floors (out-of-plane mechanisms: 30% observed, 54% predicted and in-plane mechanisms: 50% observed, 26% predicted).

Quality, dimensions and construction characteristics of masonry fabric are relevant factors in seismic performance, being rubble masonry walls the most difficult to characterize. The average size of rubble walls units and overlap data have been obtained directly from open cracks in the façades or from demolished nearby buildings or party walls. On the other hand, despite the fact that observed walls were neither uniform nor homogeneous, the same unit sizes and overlap have been considered for all rubble façades.

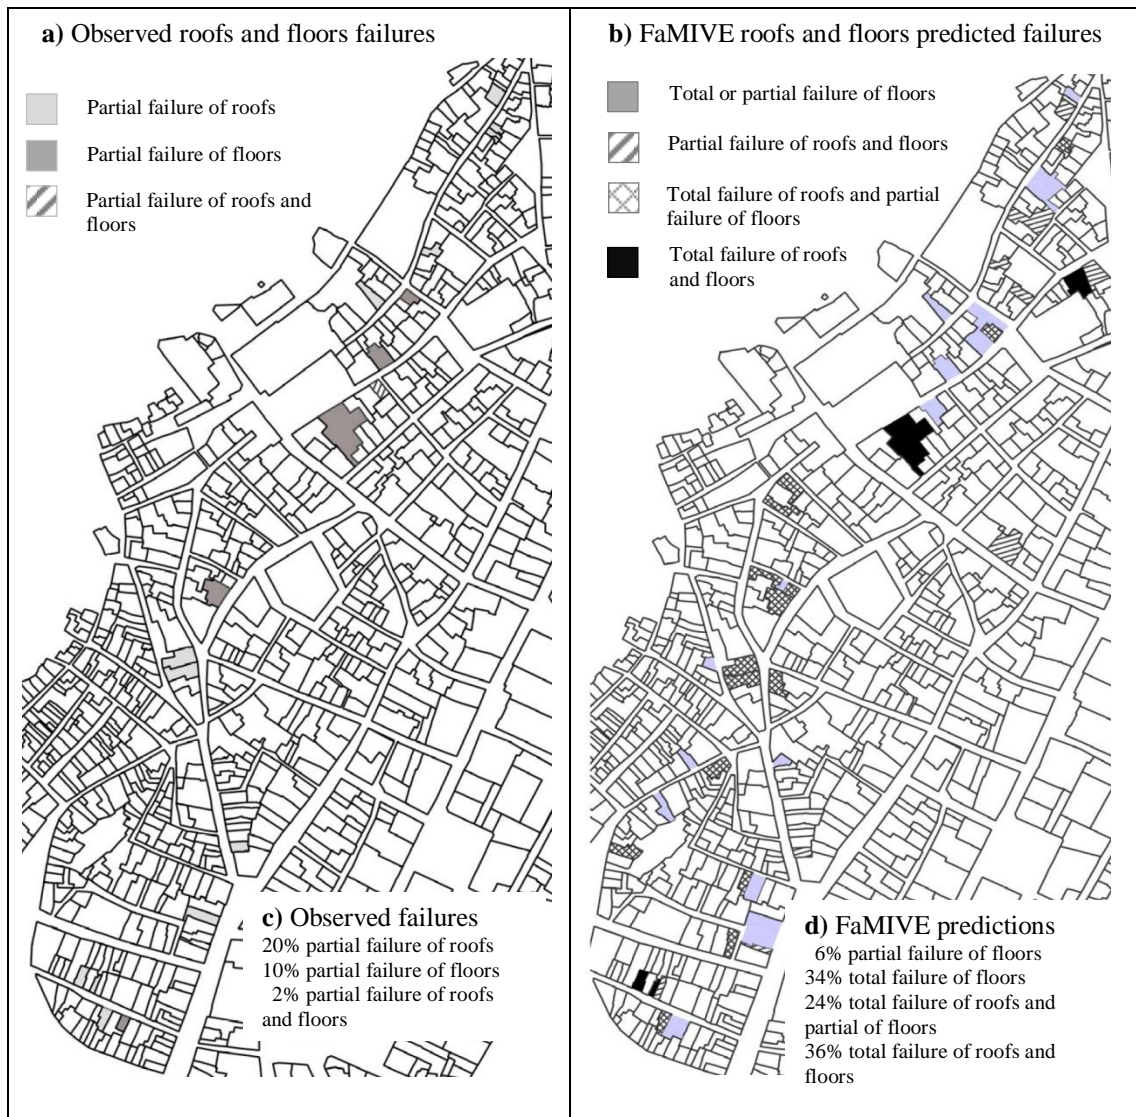
Fig. 18 Observed and predicted roofs and floors failures

Observed or predicted partial or total failure of the roofs and floors are mapped in figure 18a and 18b, respectively. Regarding FaMIVE the percentage of horizontal structures involved in a partial or total failure is clearly higher than the percentage of the observed collapses. As the survey has been generally carried out from the exterior (either for security reasons or due to the absence of inhabitants), data reliability in this specific subject is the lowest one. Therefore the percentage of real collapses might be possibly higher.

A proper maintenance of façades and roofs might avoid building decay resulting in a better seismic performance in accordance with their expected strength, preventing water infiltration and ensuring preservation of wooden elements and strengthening devices conditions.
