# Exposure Factors Influence Stone Deterioration by Crystallization of Soluble Salts

To perform this studio we focus on the stone obtained from the Church of *Santos Juanes* in Valencia. The Church of *Santos Juanes* is situated, within its enclave, in the historic centre of Valencia, in an area delimited by and known as the *Barrio del Mercat* (market neighborhood). The group of dwellings in this quarter, as with many others that form part of the city, are characterized by belonging to, and forming part of, the urban history of the city of Valencia [1].

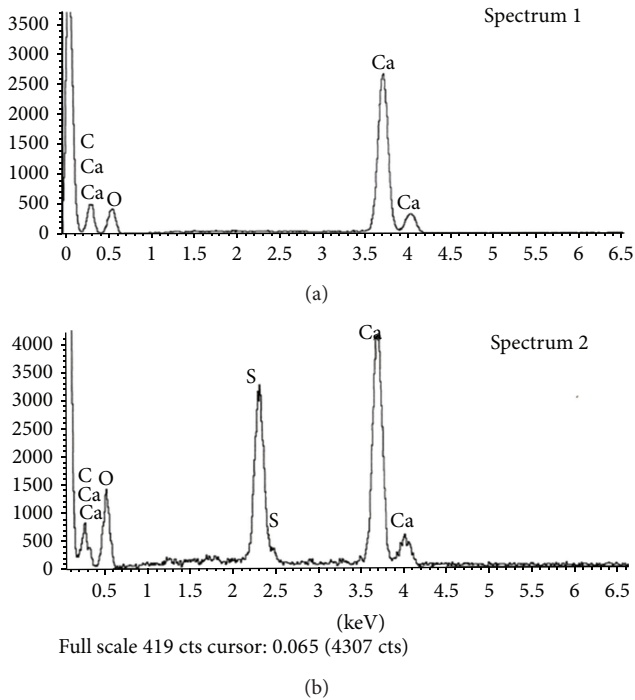
FIGURE 5: X-ray diffraction analysis.

spectroscopy (SEM-EDX) to characterize the salt mixture with surface damage. Analysis of the fresh, altered, and mainly physical-chemical meteorized samples has been compared by X-ray diffraction. Sulfur peak presence has been observed in monument samples. Pb and Na presence in some samples are sporadic anomalies due to samples spatial orientation in front of gas emulsions from combustion and saline seaside environment; an example is shown in Figure 5 and Table 4.

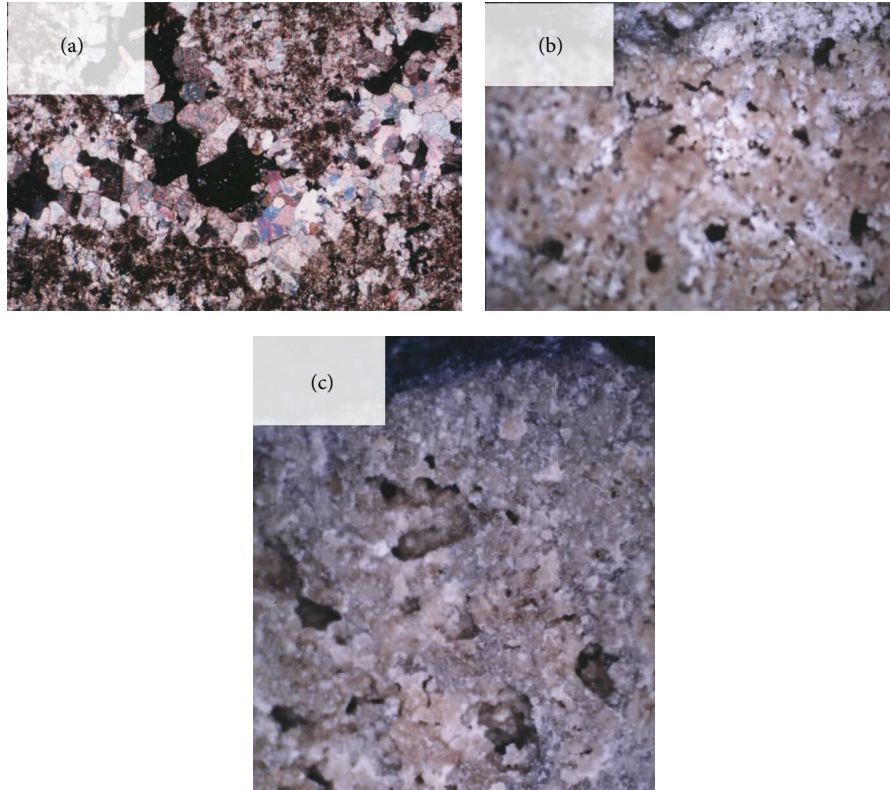
secondary porosity of modic type. This stone is a microgranulated limestone without predetermined structure with a high porosity and large cavities. It has good cementing recrystallization areas where perfect crystals (Figure 6(a)) and little stratification develop. In parts of fresh samples, we can see how the recrystallization is massive, with just cement, giving an aggregate of crystals. The calcite crystals are tabular rhombohedra with perfect faces and growth planes around the pores are observed.

**3.4. Texture of the Material.** The formation of crystals is linked to the texture of the material itself, regarding its morphology, shape, and size of its pores. Therefore, a crystalline structure grows by adding layers of material to the external surface when it is in contact with a solution which carries the necessary material for its growth. When the crystals grow in contact with the surface of the pores, there is always a thin coating of solution due to capillary attraction and absorption. We must take into consideration the fact that a solution can become supersaturated with respect to a crystal under low pressure, the case of crystal growth in large pores, while the same tends to dissolve a crystal that is under high pressure, the case of crystal growth in small pores [13]. For this reason the process is more feasible in material made up of many small pores that feed the growth of crystals in their large pores; these are fewer in number. The stone material under study fits this case. This fact can be seen in the microphotographs taken of the different samples of stone material extracted from the building where we can observe the formation of geodes in the interior of the microspores (Figure 6(a)).

FIGURE 6: (a) View of thin section NP40X. Geologic process or natural process of pore filling by calcium cement. (b) View through a binocular magnifier. Advance of the process of precipitation by formation of salts in a porous mass. (c) Transverse cut from the least affected part (interior zone) to the most affected.

The formation of efflorescence was observed in less exposed areas (Figure 6(b)) and where a balance between the rate of evaporation and the flow of water to the surface existed, the formation of scales was observed.

The thickness of this layer varies depending on the content and nature of the soluble salts, the reach of the water which is directly related to the texture of the material, and the evaporation conditions (Figure 6(c)).

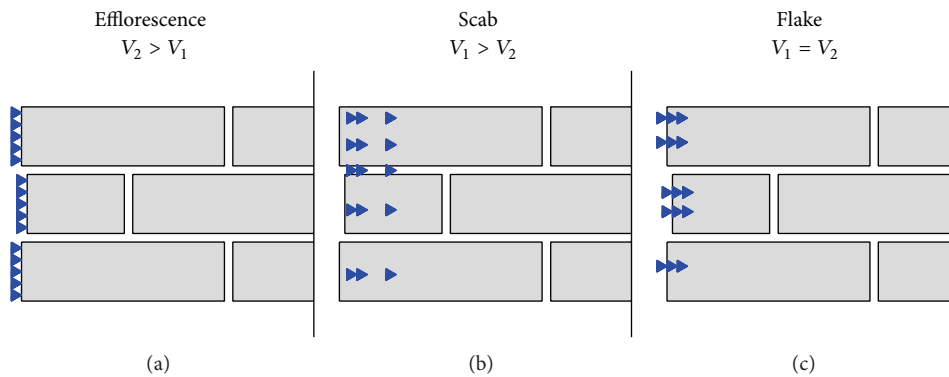
FIGURE 7: Material deterioration morphology produced by the crystallization of salts.

When the stationary state is reached, that is to say, when the rate of diffusion of water vapor from the dry stone surface is dynamically balanced by the rate of capillary migration of the solution from the dry and wet zone, a compact sheet of material, known as scale, is formed on the external surface (Figure 7).

The different morphologies of deterioration originated by the formation of soluble salts were found to be distributed throughout the building depending on its orientation. In facades exposed to greater ventilation and more sun the formation of internal crusts, exfoliation, and ampullae was observed.
