SURVEY OF THE TALLER DELS CANETS, XIX-XX CENTURIES: THE OLD SAN ANTONIO WOODEN CARRIAGE FACTORY, BENEIXAMA (ALICANTE, SPAIN)

The centennial workshop 'San Antonio' hosted the industrial rise of a family business dedicated to the craft of construction of wooden carriages, now disappeared. A business activity that began in 1860 and almost saw the dawn of the 21st century. The complex has not received appropriate maintenance and its roofs threaten ruin, compromising the survival of the manufacturing building, abandoned since its closure. Almost 2,000 square meters of industrial history languish awaiting an urgent intervention. This publication, therefore, is inserted in a trend of revalue enhancement and recovery of the heritage site. This graphic survey has been carried out with the essential purpose of capturing its current state, in order to serve as a basis for a future and necessary restoration. In the absence of the original plans, prior to 1909, this work constitutes the only existing planimetric document of the building. And it is being shown in this article for the first time.

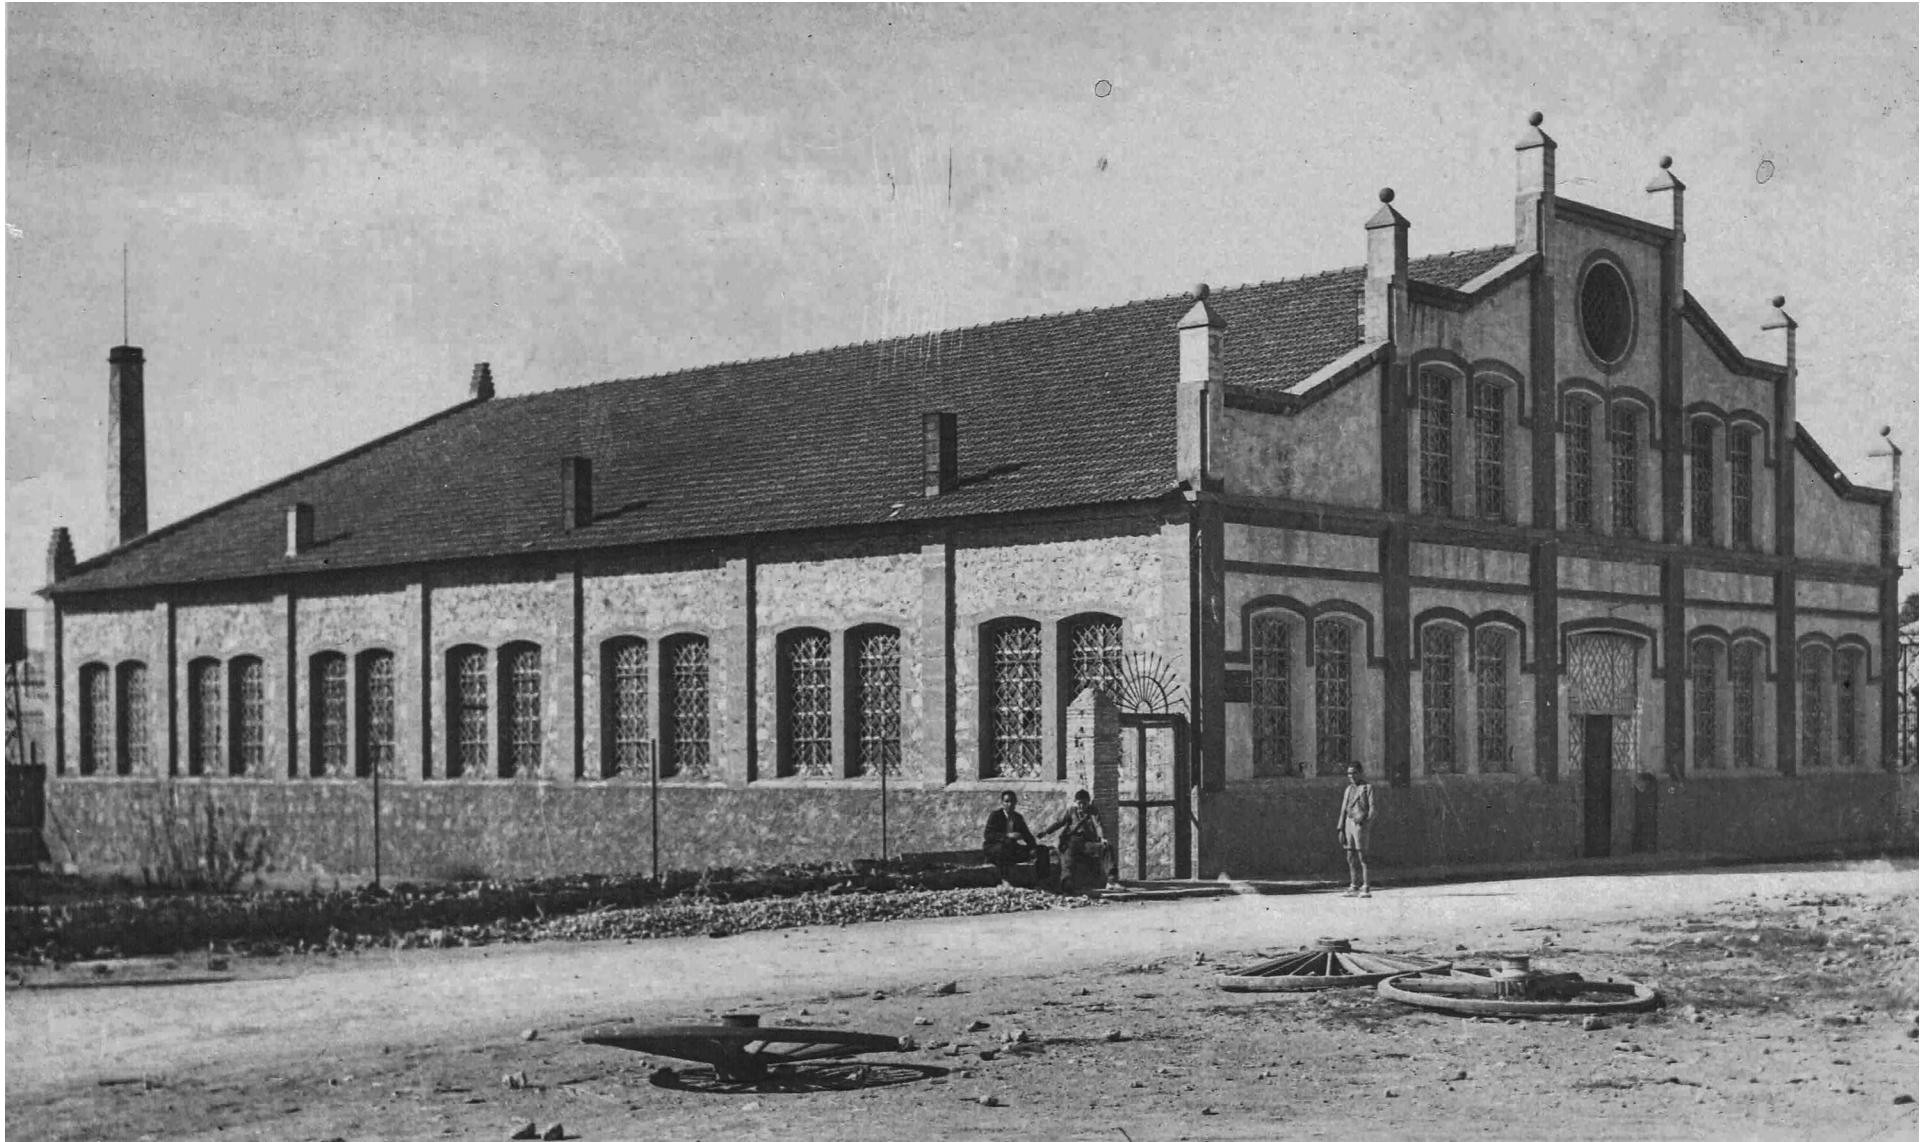
Fig 1. Taller dels Canets (former San Antonio wooden carriage factory), Beneixama (Alicante, Spain), 1930-1940. Historical photograph of the carriage factory before the construction of the outer porch at the east terrain and the attached warehouses. (Stock image courtesy of S. Sanchis, one of the current owners of the Taller dels Canets).

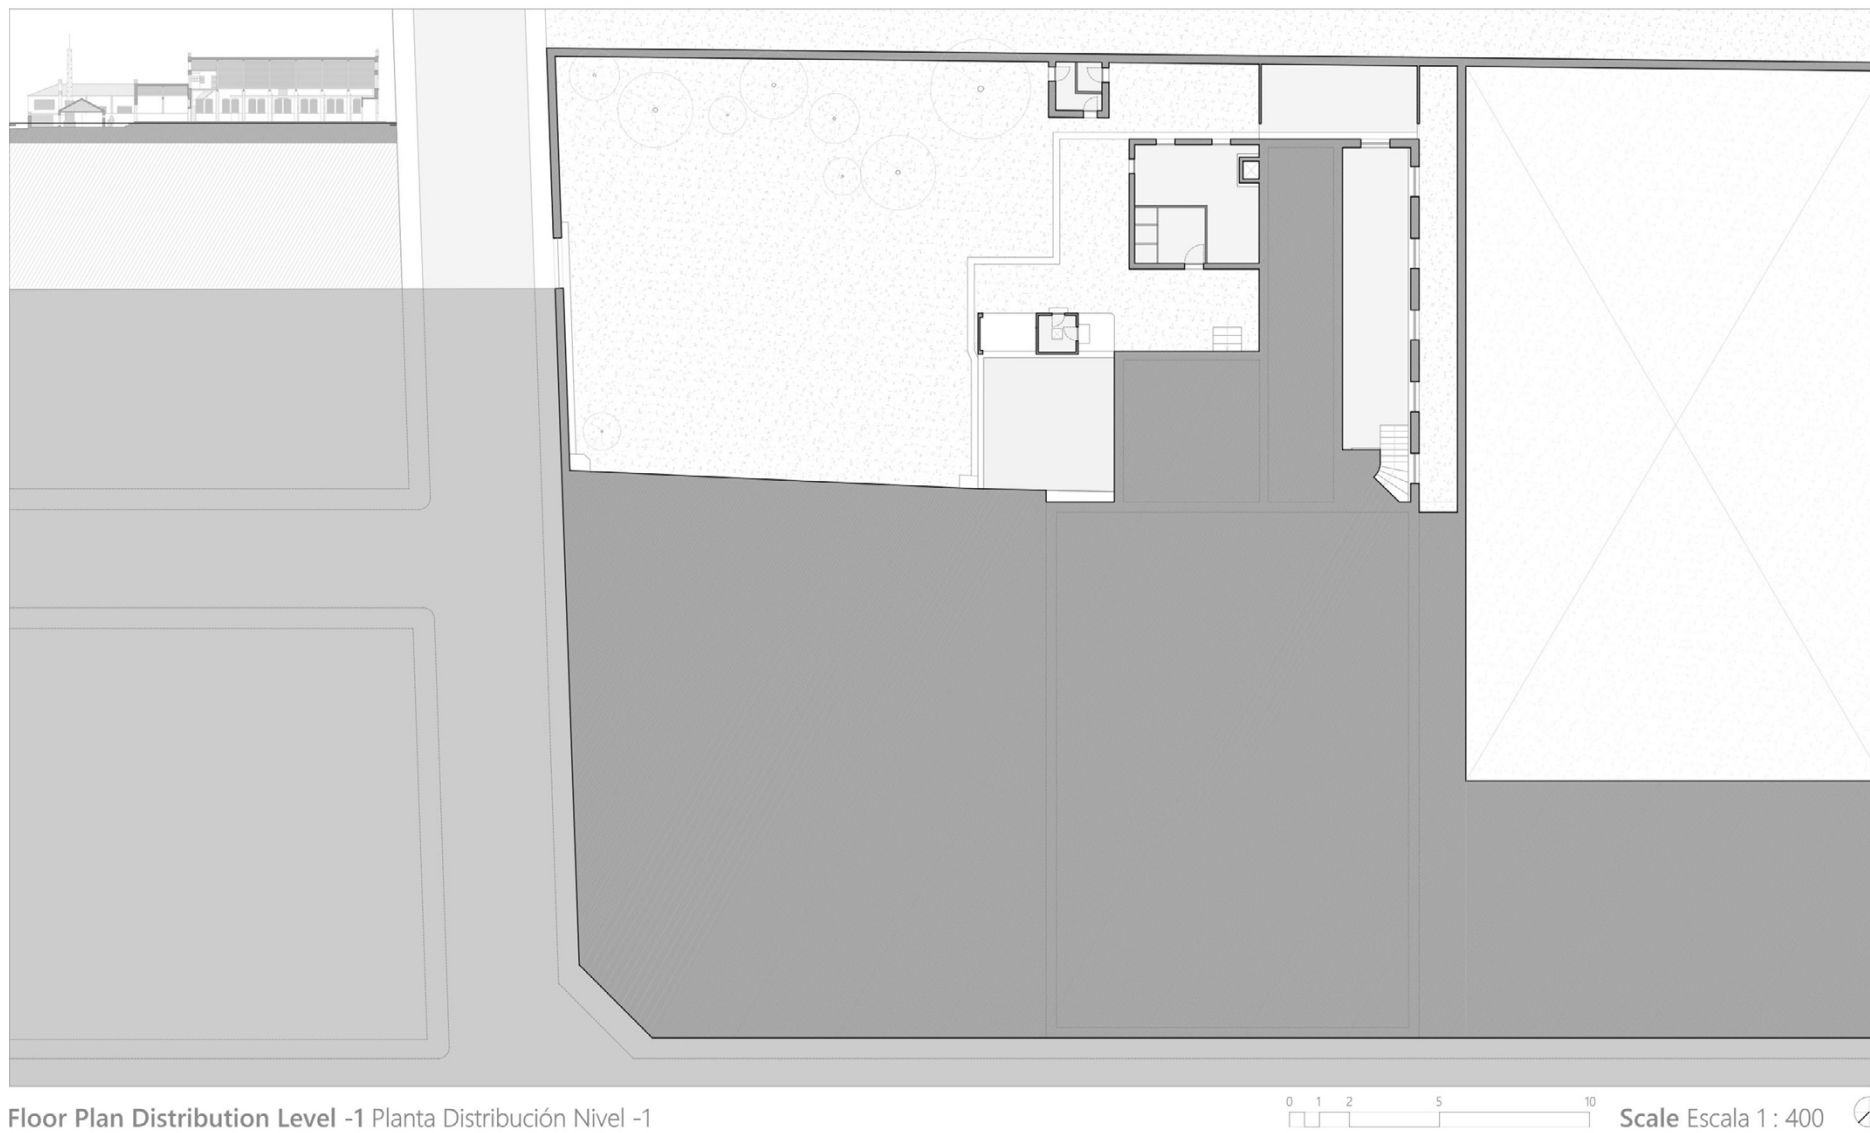
Fig 3. Taller dels Canets (former San Antonio wooden carriage factory), Beneixama (Alicante, Spain), April 2021. Current state drawing of basement floor distribution plant, destined to underground warehouse, boiler, chimney, electric transformer and well. (Ortín Molina, S.; Ortín Molina, M. A., measurements by hand and drawing in AutoCad).

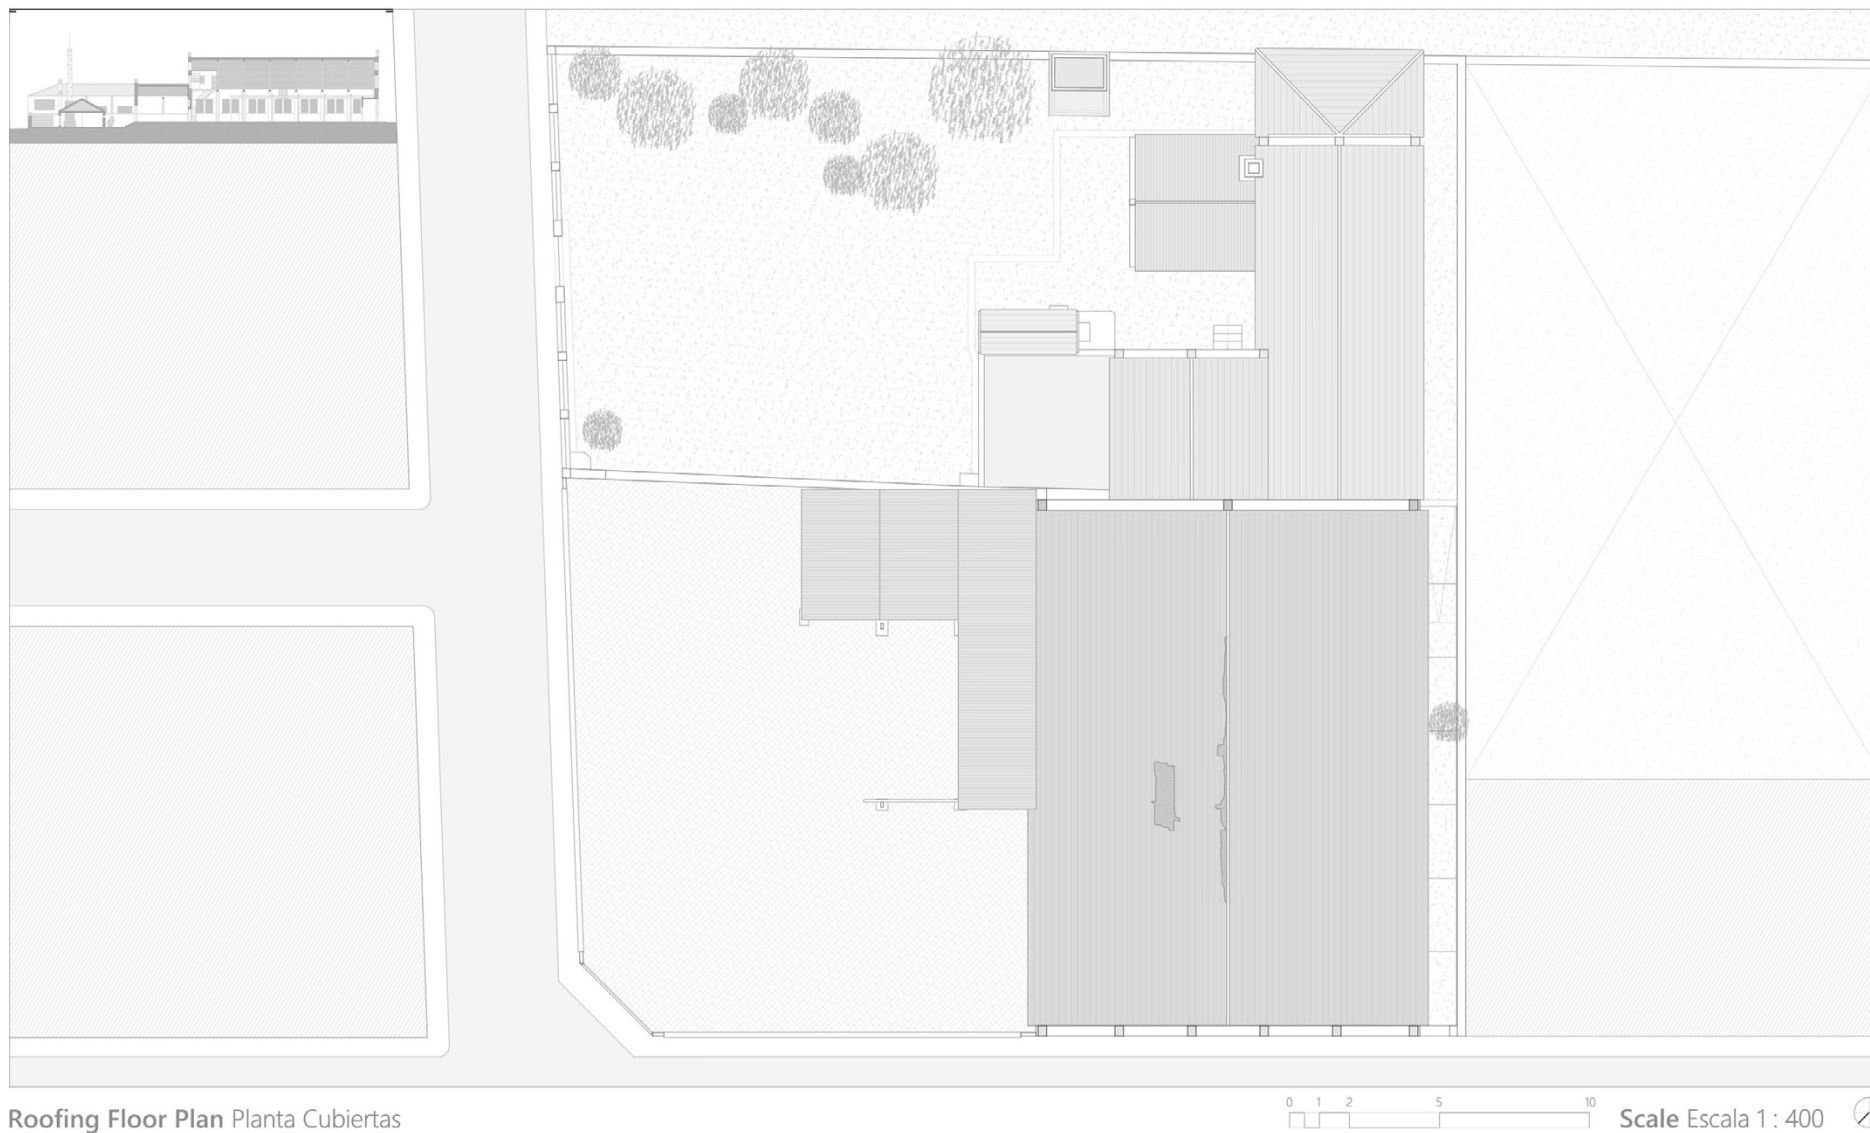
Fig 5. Taller dels Canets (former San Antonio wooden carriage factory), Beneixama (Alicante, Spain), April 2021. Current state drawing of roof plant. The open crack on the east side of the roof can be seen as a result of structural collapse of wooden joists. (Ortin Molina, S.; Ortin Molina, M. A., measurements by hand and drawing in AutoCad).

Sin embargo, la patología más apremiante es la creciente brecha en el faldón Este de la cubierta de la nave principal. Algunas viguetas de madera han sufrido colapsos, y otras muestran una curvatura apreciable que amenaza el ensanchamiento del boquete. Desde fuera, el tejado semeja una enorme malla que flexa en cada vano entre cerchas.

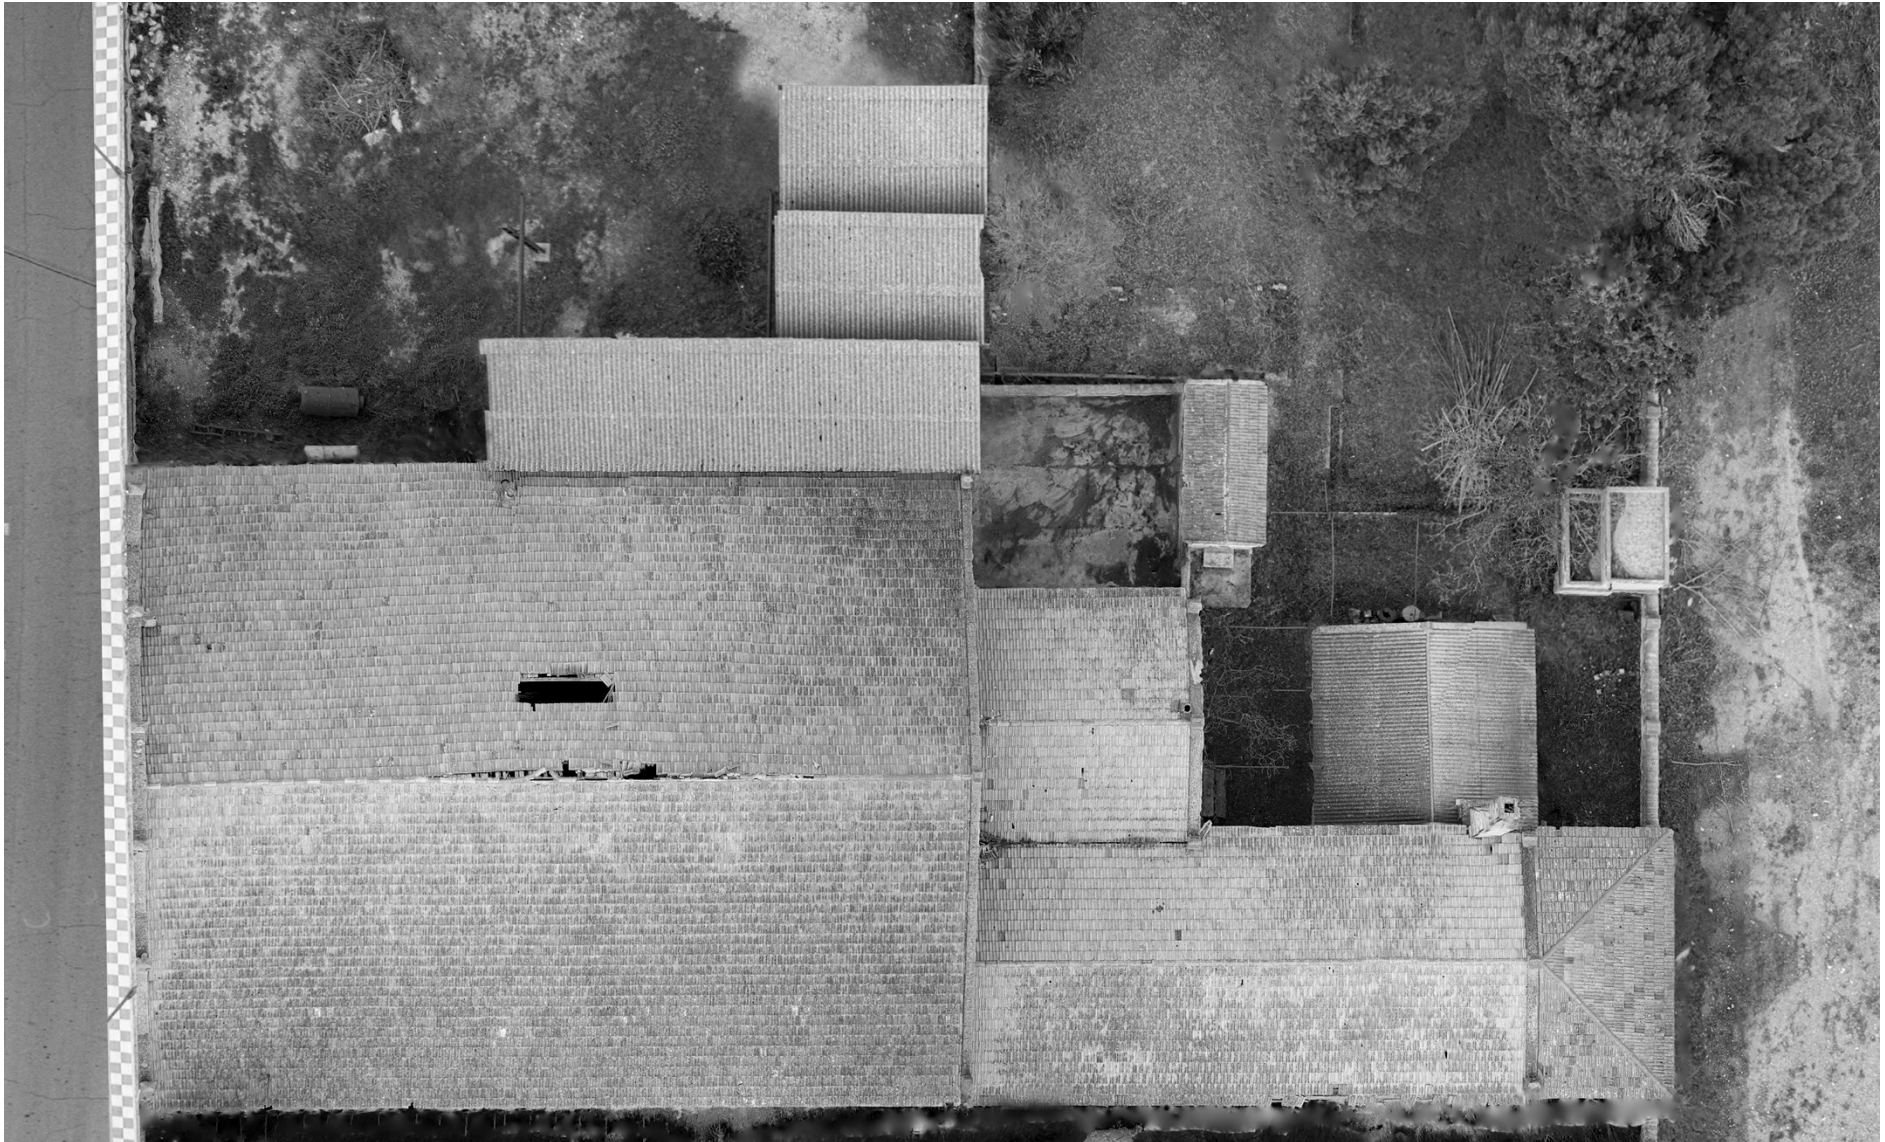
Fig 6. Taller dels Canets (former San Antonio wooden carriage factory), Beneixama (Alicante, Spain), April 2021. Aerial photography taken with drone of the current state of the workshop. The roof is seriously damaged as a result of the last snowfall in 2019. (Courtesy of Martínez Pérez, A. (Arqueojocs); Molina Carbonell, J. (MuixegoDigital)).

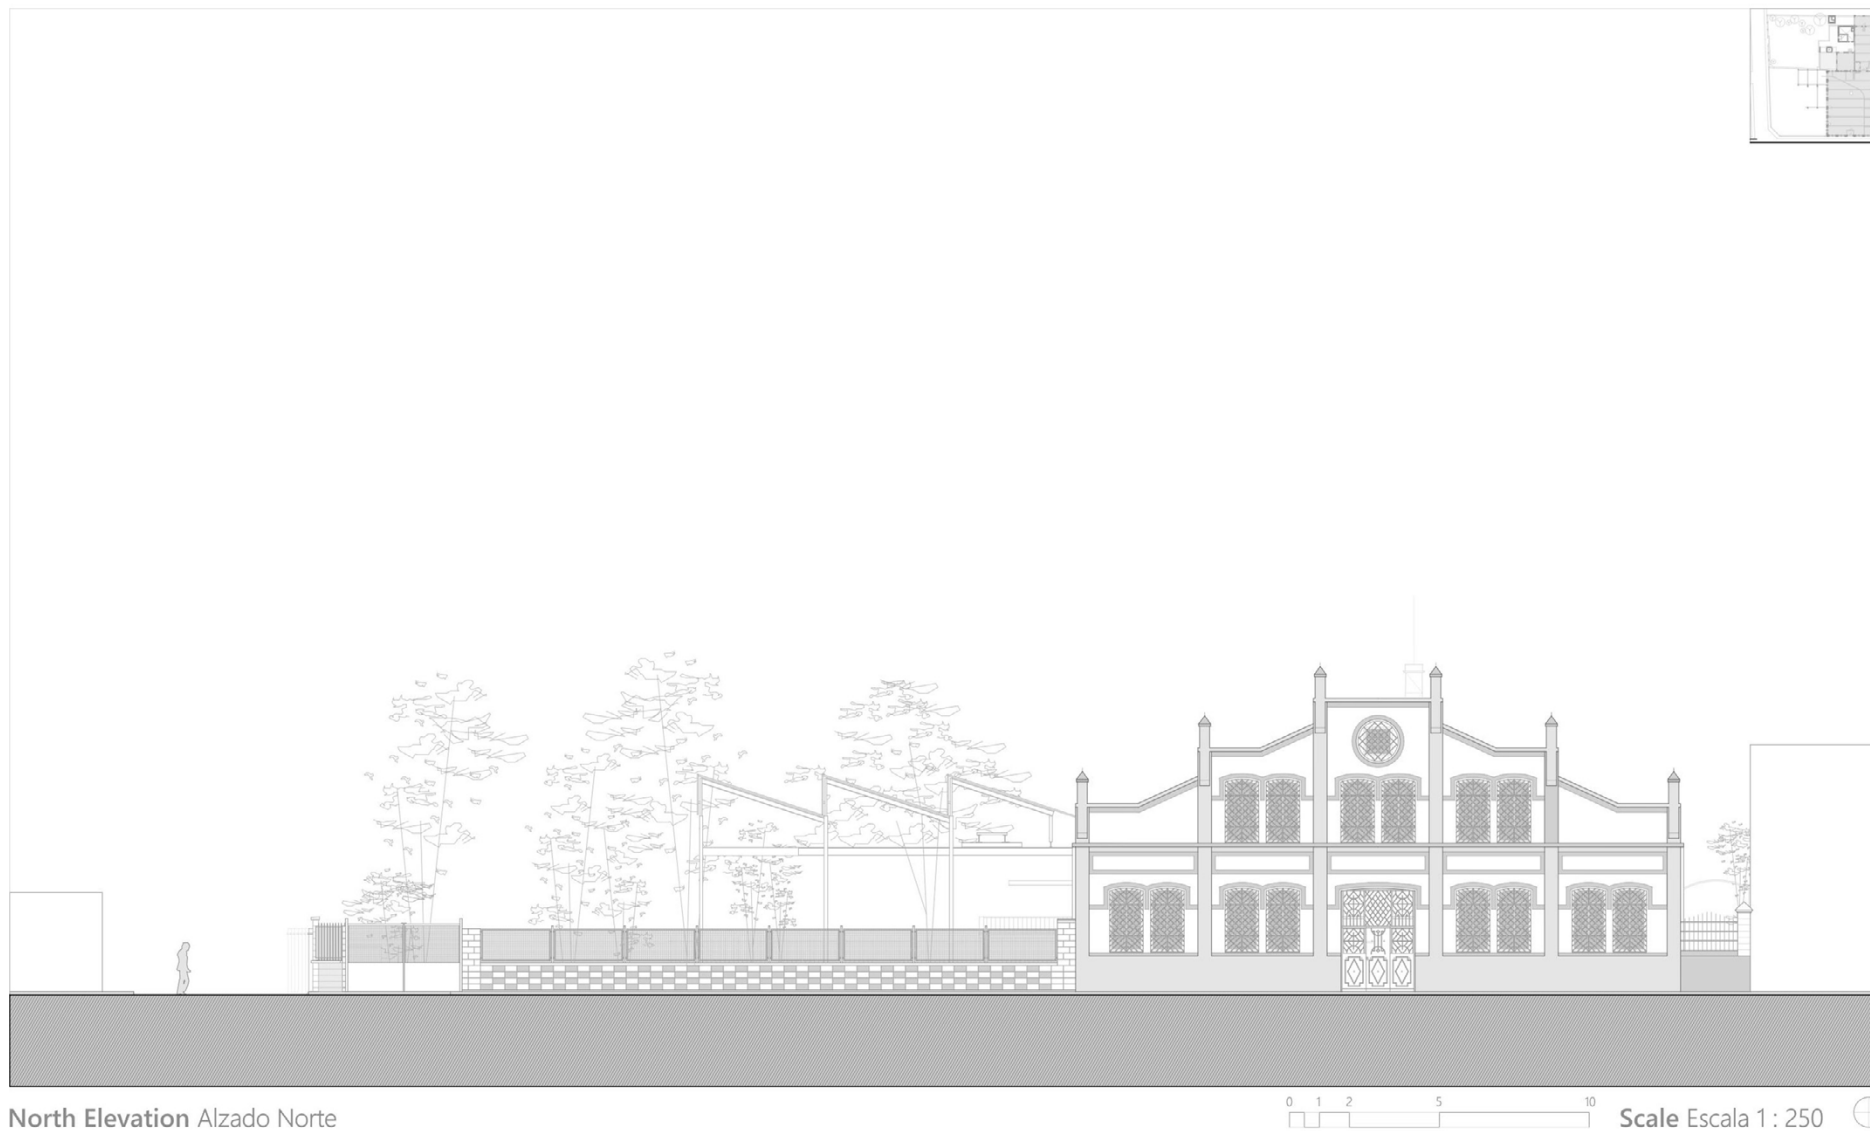
North Elevation Alzado Norte

Fig 7. Taller dels Canets (former San Antonio wooden carriage factory), Beneixama (Alicante, Spain), April 2021. Current state drawing of North elevation. The symmetry of the main façade of the factory contrasts with the horizontality of the exterior fence. (Ortin Molina, S.; Ortin Molina, M. A., measurements by hand and drawing in AutoCad).

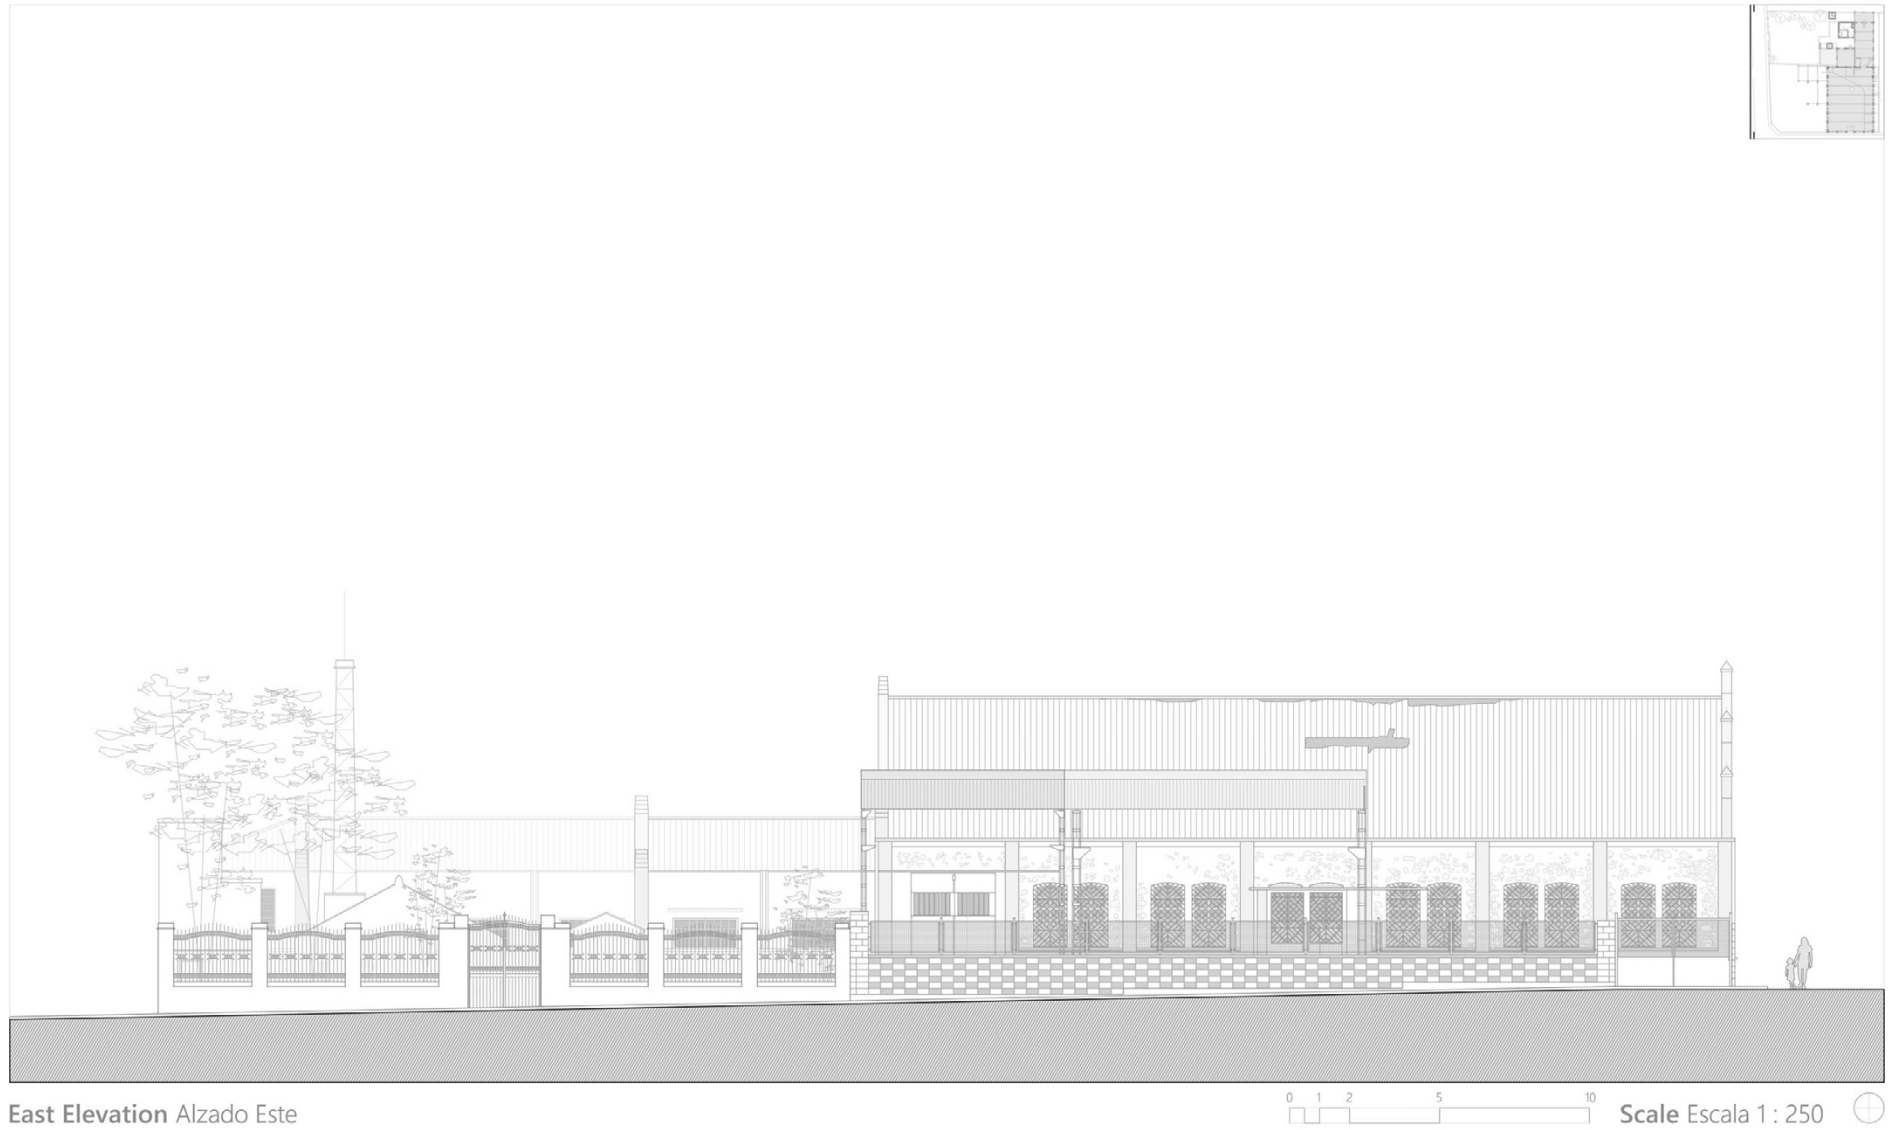
Fig 8. Taller dels Canets (former San Antonio wooden carriage factory), Beneixama (Alicante, Spain), April 2021. Current state drawing of East elevation. The side façade of the factory shows the organic growth of the industrial área, over time and needs. (Ortin Molina, S.; Ortin Molina, M. A., measurements by hand and drawing in AutoCad).

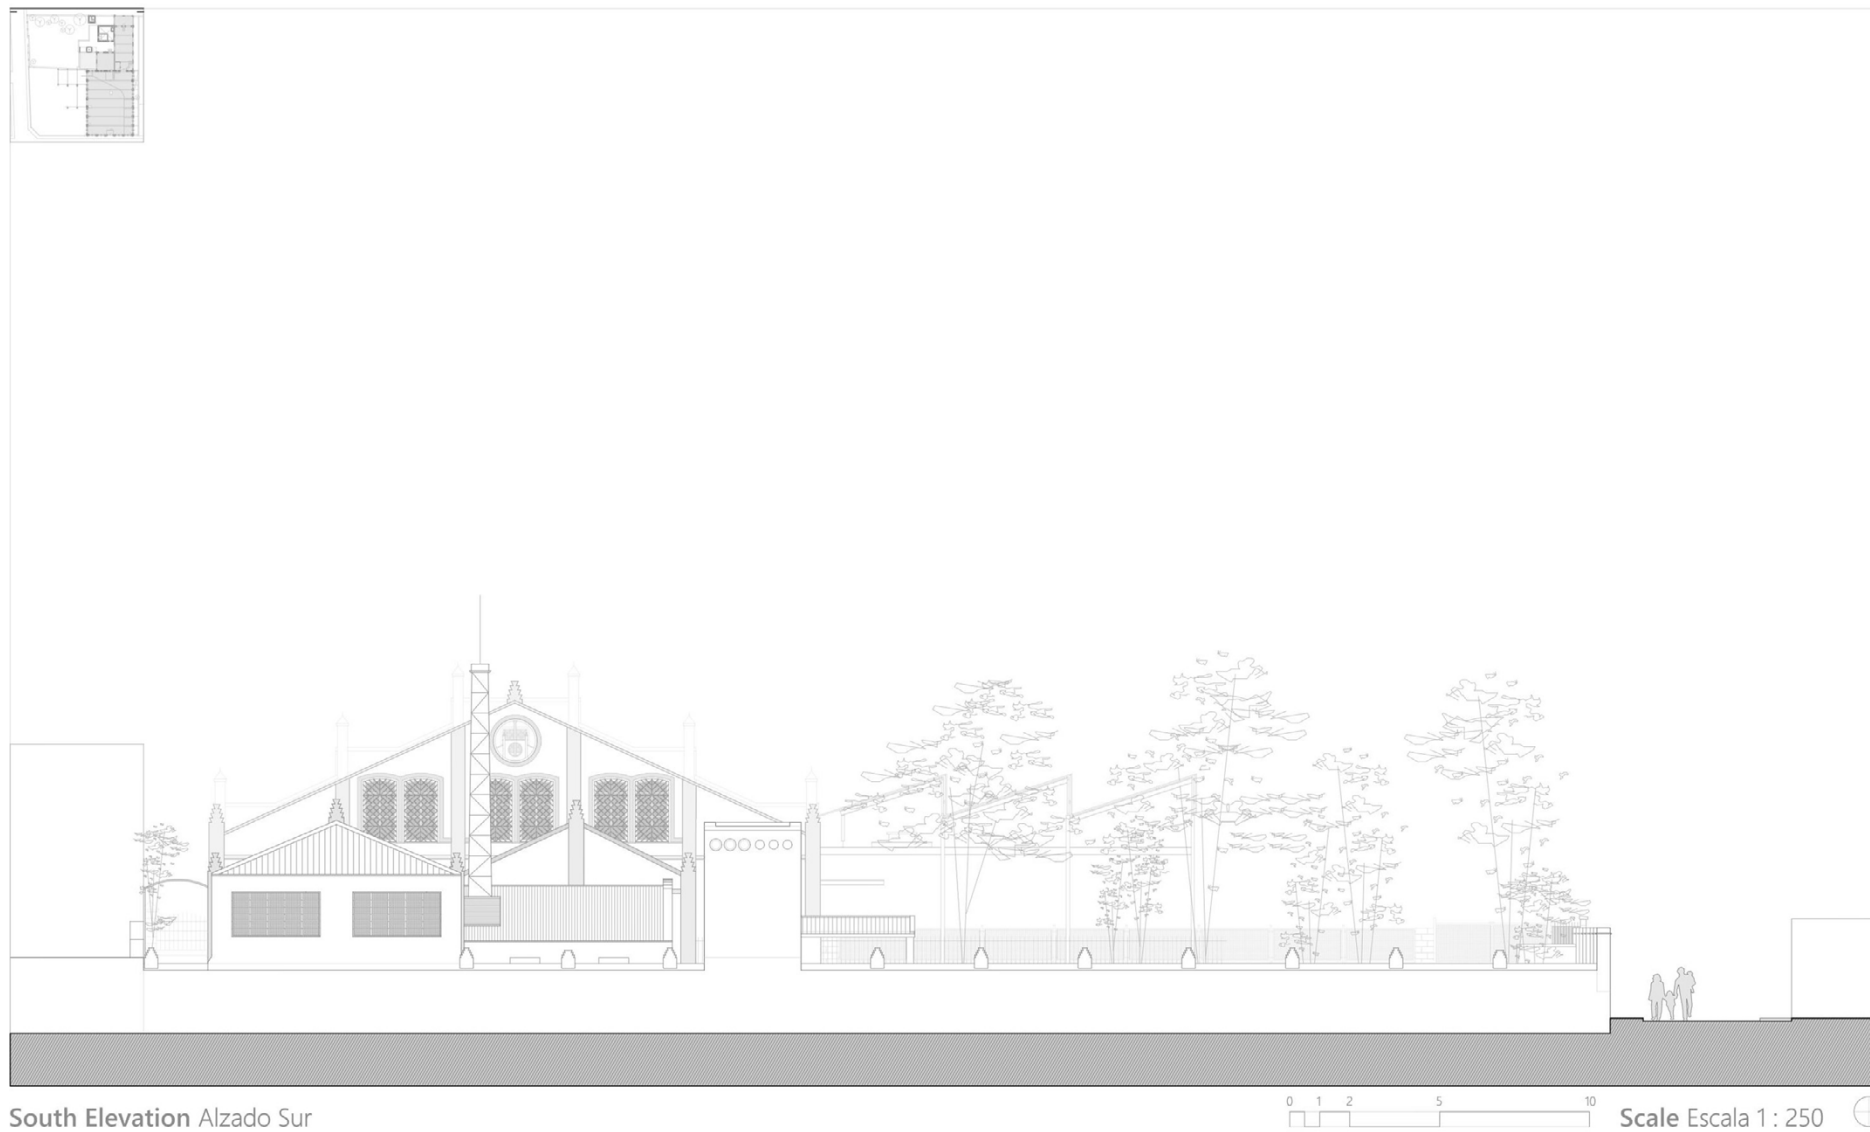
Fig 9. Taller dels Canets (former San Antonio wooden carriage factory), Beneixama (Alicante, Spain), April 2021. Current state drawing of South elevation. The rear façade, more heterogeneous, shows the different volumes of the factory over the long wall. (Ortin Molina, S.; Ortin Molina, M. A., measurements by hand and drawing in AutoCad).

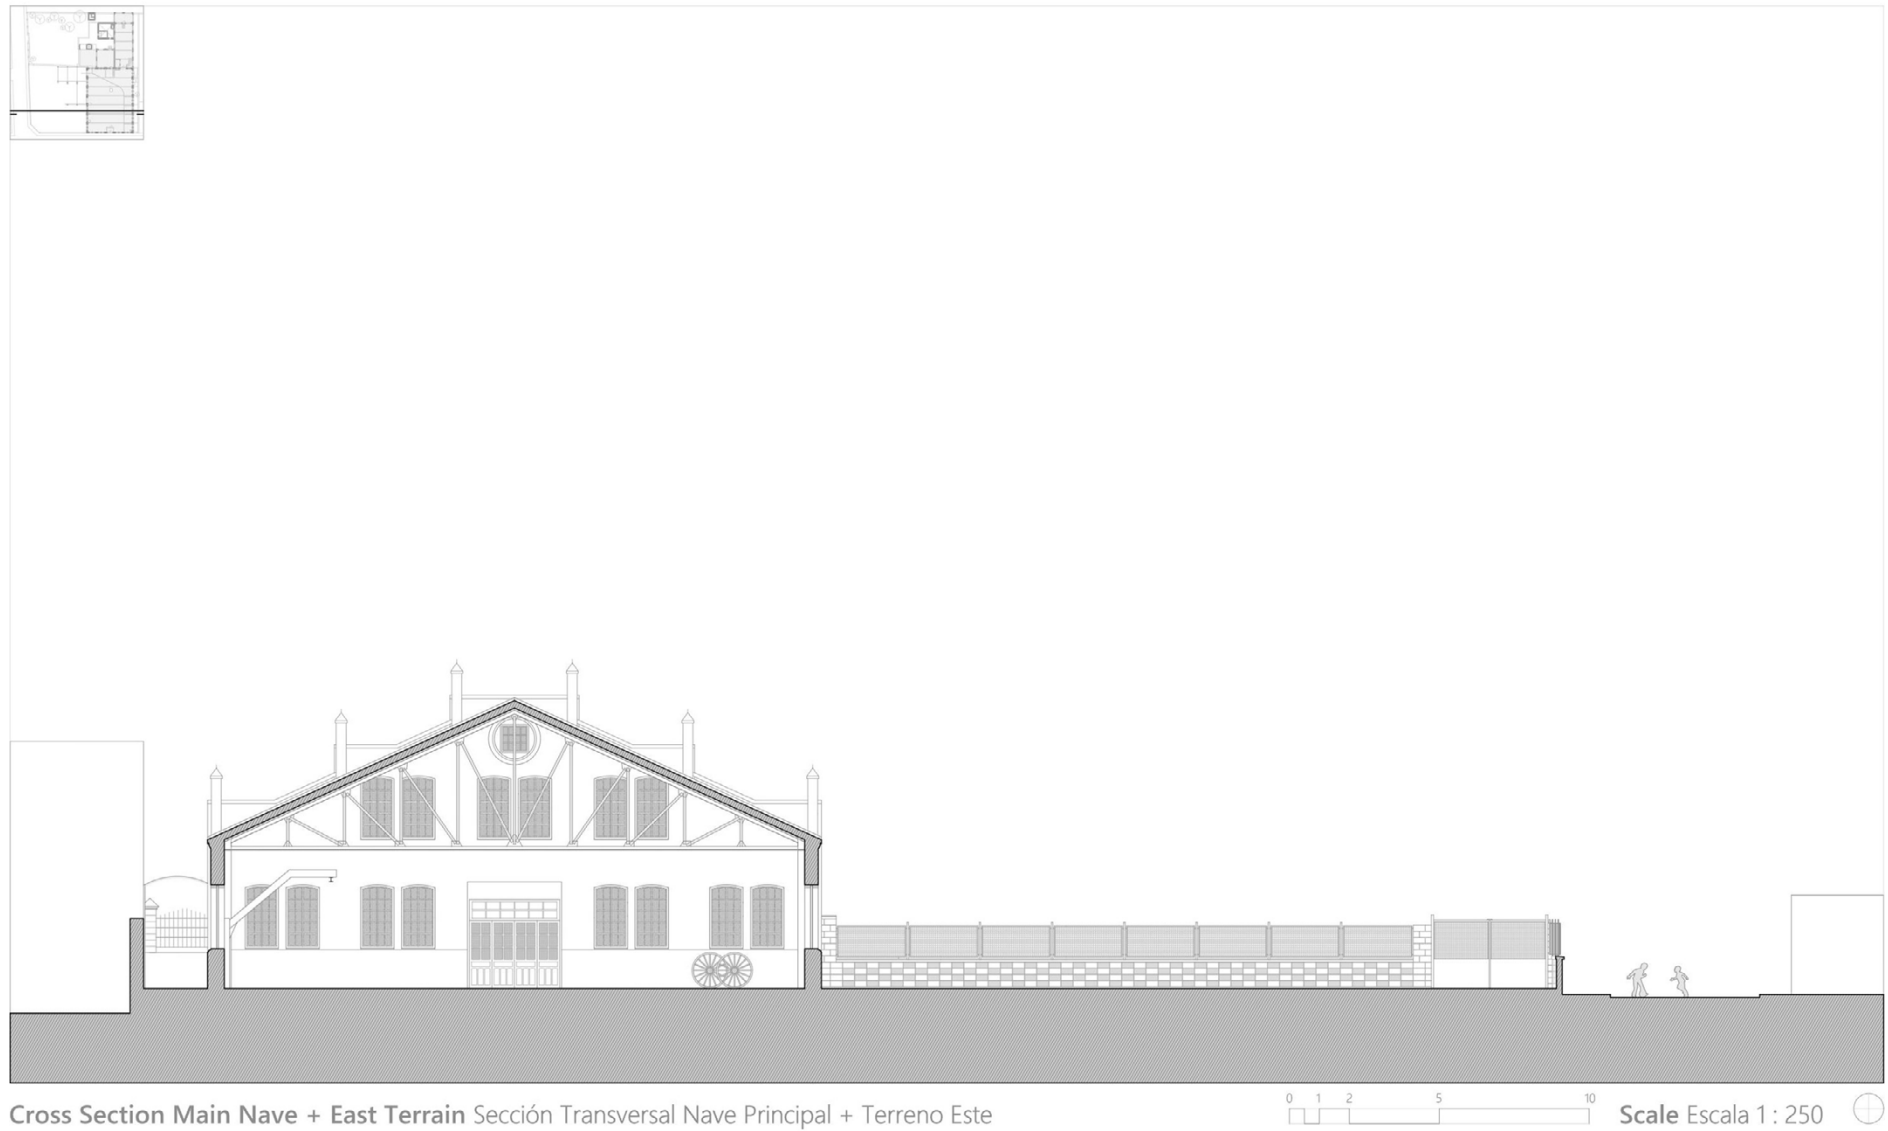
Fig 10. Taller dels Canets (former San Antonio wooden carriage factory), Beneixama (Alicante, Spain), April 2021. Current state drawing of cross section made by the third north span of the main nave. The background fences are shown in their magnitude. (Ortín Molina, S.; Ortín Molina, M. A., measurements by hand and drawing in AutoCad).

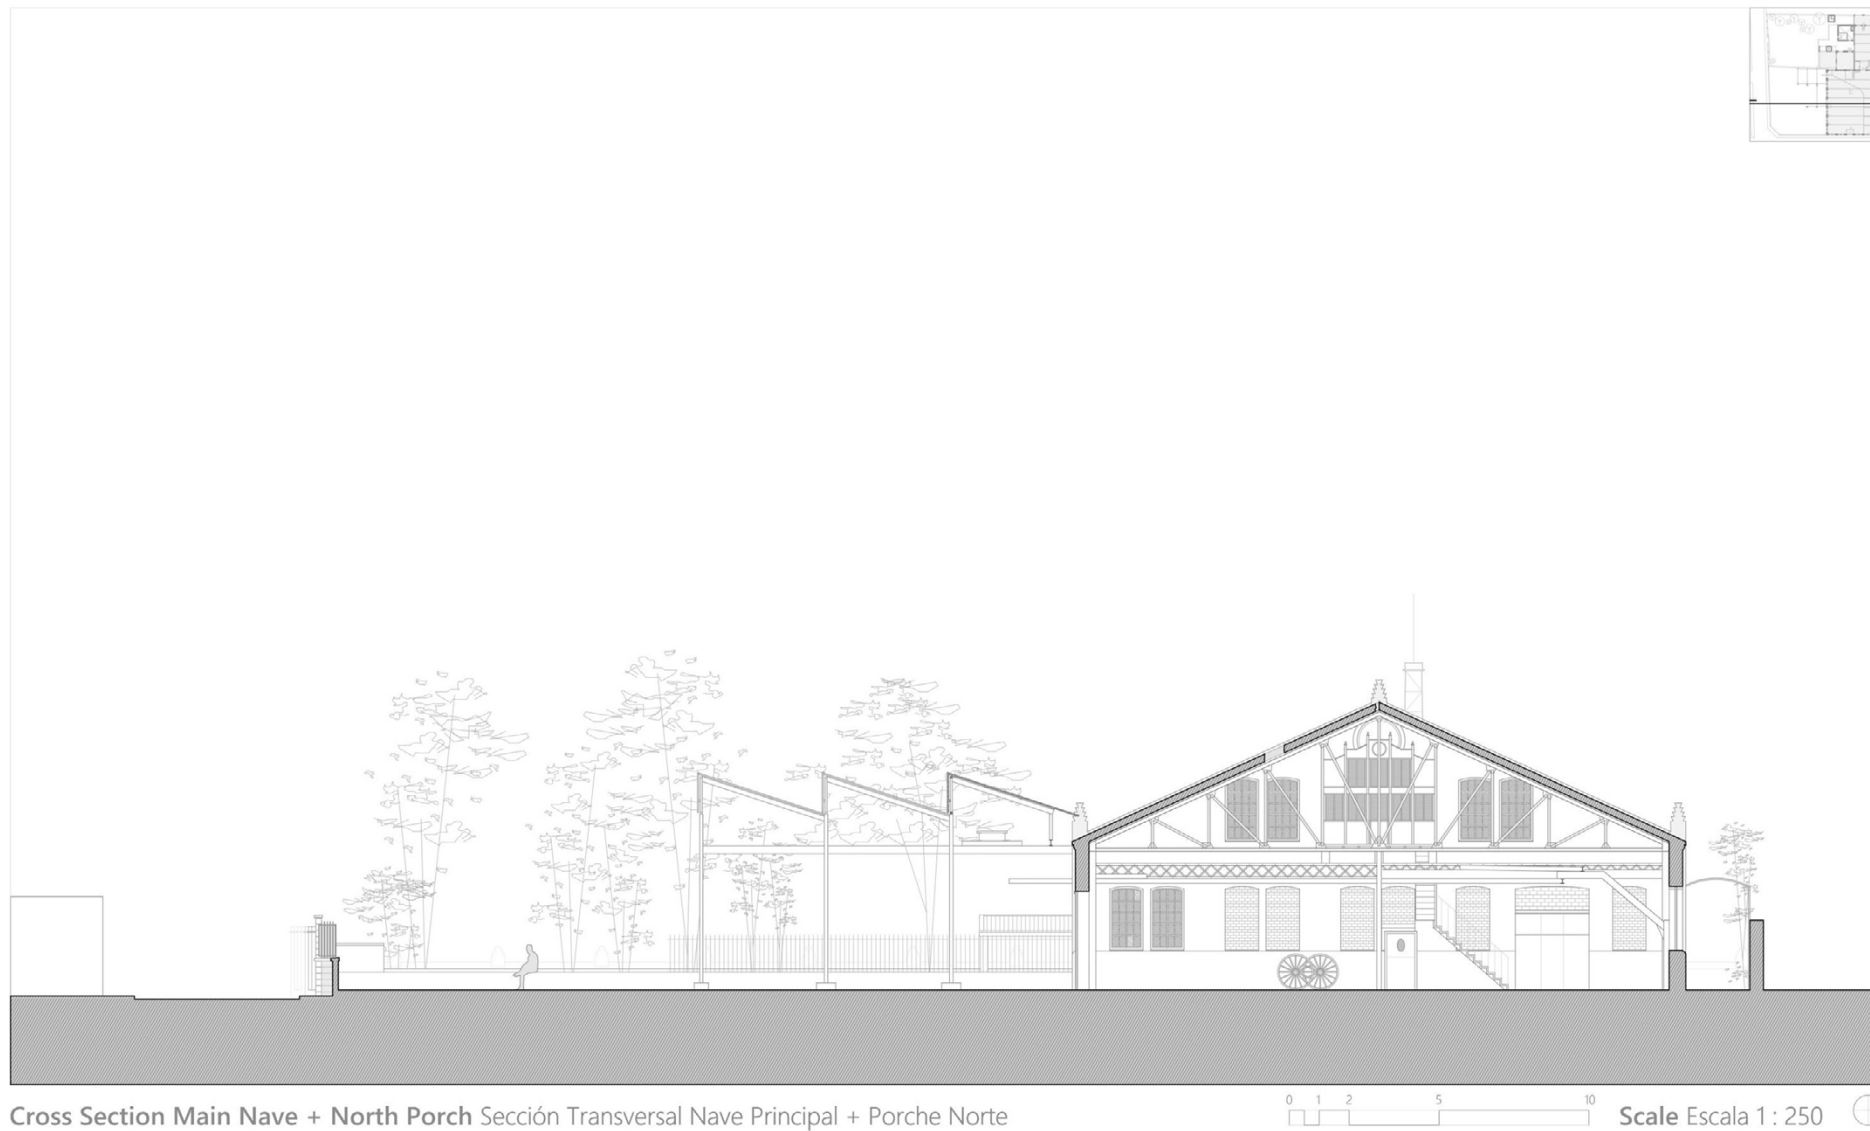
Cross Section Main Nave + North Porch Sección Transversal Nave Principal + Porche Norte

Fig 11. Taller dels Canets (former San Antonio wooden carriage factory), Beneixama (Alicante, Spain), April 2021. Current state drawing of cross section made by the middle of the nave. In this span between trusses is the large open crack in the roof. (Ortin Molina, S.; Ortin Molina, M. A., measurements by hand and drawing in AutoCad).

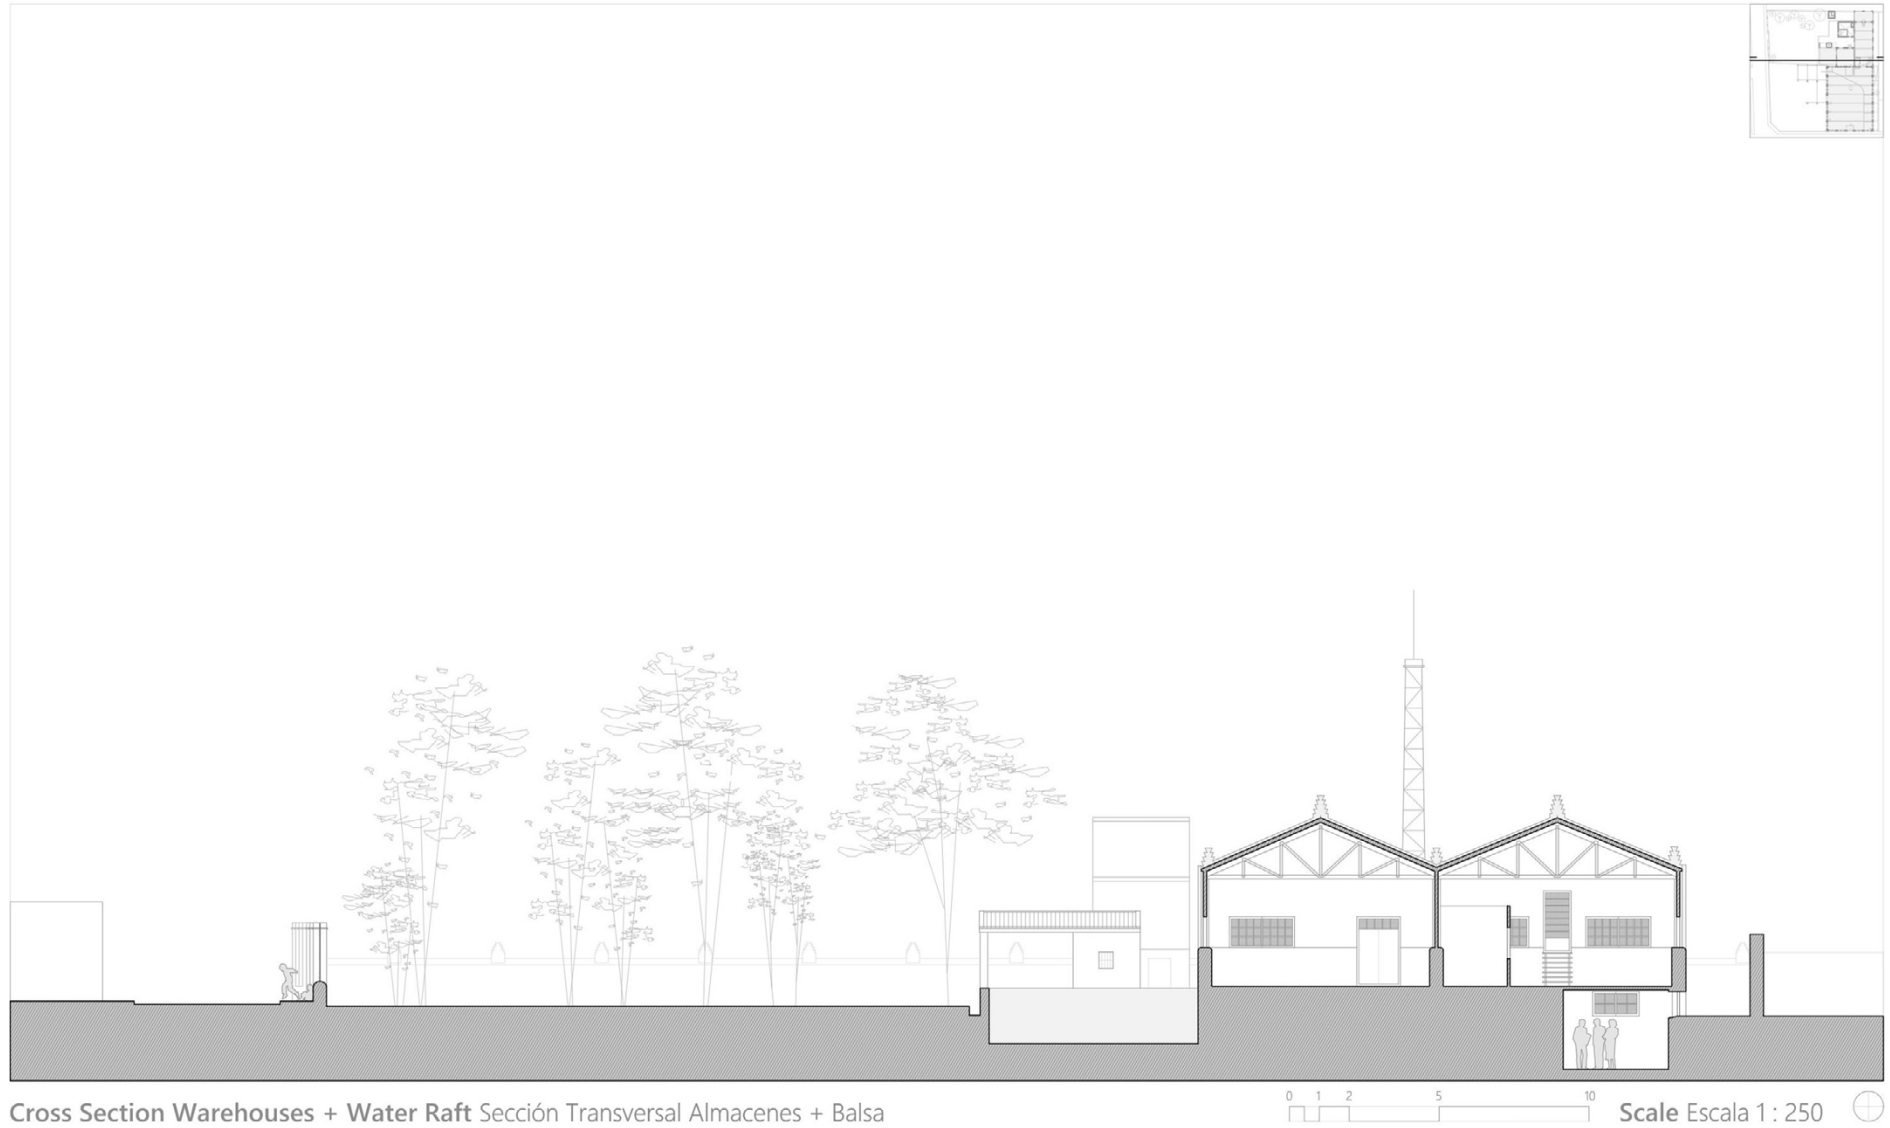
Cross Section Warehouses + Water Raft Sección Transversal Almacenes + Balsa

Fig 12. Taller dels Canets (former San Antonio wooden carriage factory), Beneixama (Alicante, Spain), April 2021. Current state drawing of cross section made by the attached warehouses and the wáter raft. The semi-buried spaces can also be seen. (Ortin Molina, S.; Ortin Molina, M. A., measurements by hand and drawing in AutoCad).
