SURVEY OF THE TALLER DELS CANETS, XIX-XX CENTURIES: THE OLD SAN ANTONIO WOODEN CARRIAGE FACTORY, BENEIXAMA (ALICANTE, SPAIN)

The centennial workshop 'San Antonio' hosted the industrial rise of a family business dedicated to the craft of construction of wooden carriages, now disappeared. A business activity that began in 1860 and almost saw the dawn of the 21st century. The complex has not received appropriate maintenance and its roofs threaten ruin, compromising the survival of the manufacturing building, abandoned since its closure. Almost 2,000 square meters of industrial history languish awaiting an urgent intervention. This publication, therefore, is inserted in a trend of revalue enhancement and recovery of the heritage site. This graphic survey has been carried out with the essential purpose of capturing its current state, in order to serve as a basis for a future and necessary restoration. In the absence of the original plans, prior to 1909, this work constitutes the only existing planimetric document of the building. And it is being shown in this article for the first time.

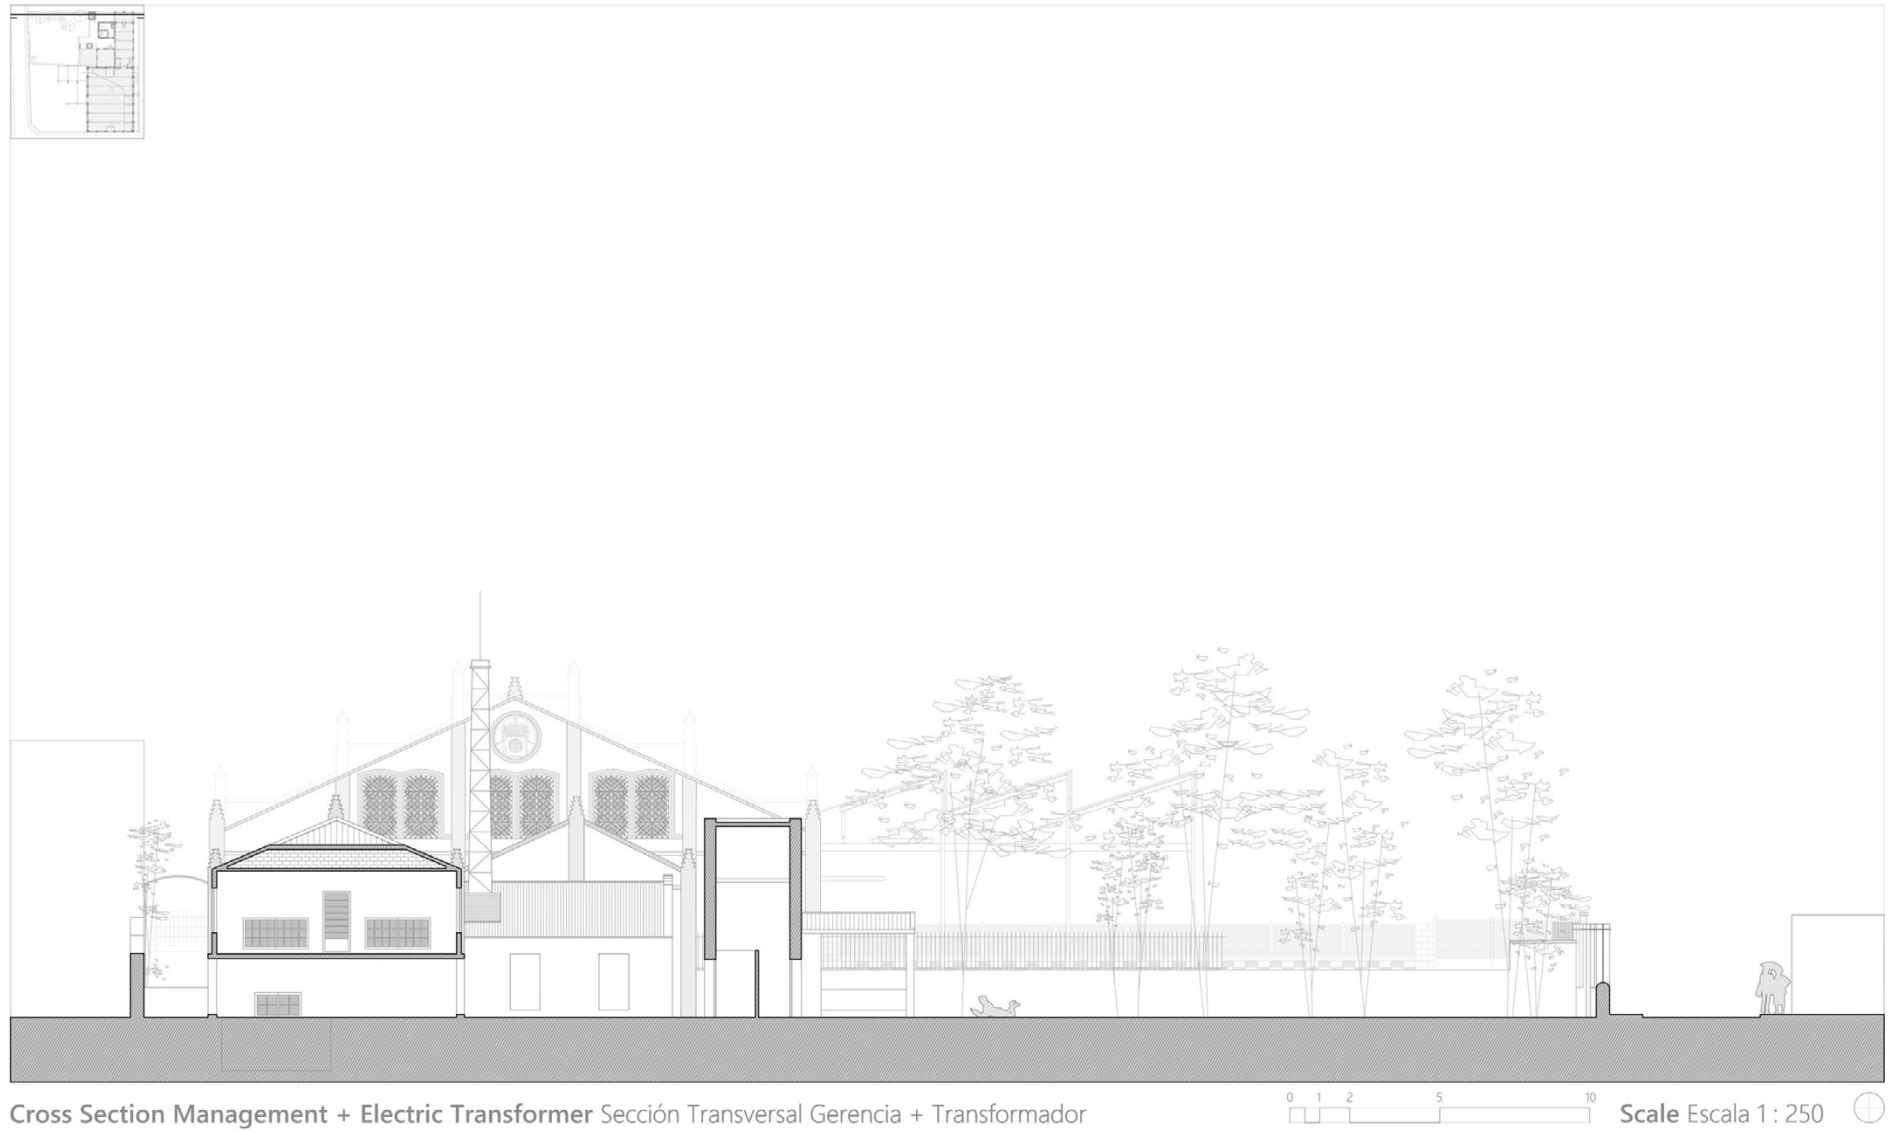
Fig 14. Taller dels Canets (former San Antonio wooden carriage factory), Beneixama (Alicante, Spain), April 2021. Current state drawing of cross section made by the two furthest volumes, the management and the electric transformer, raised on the wall. (Ortín Molina, S.; Ortín Molina, M. A., measurements by hand and drawing in AutoCad).

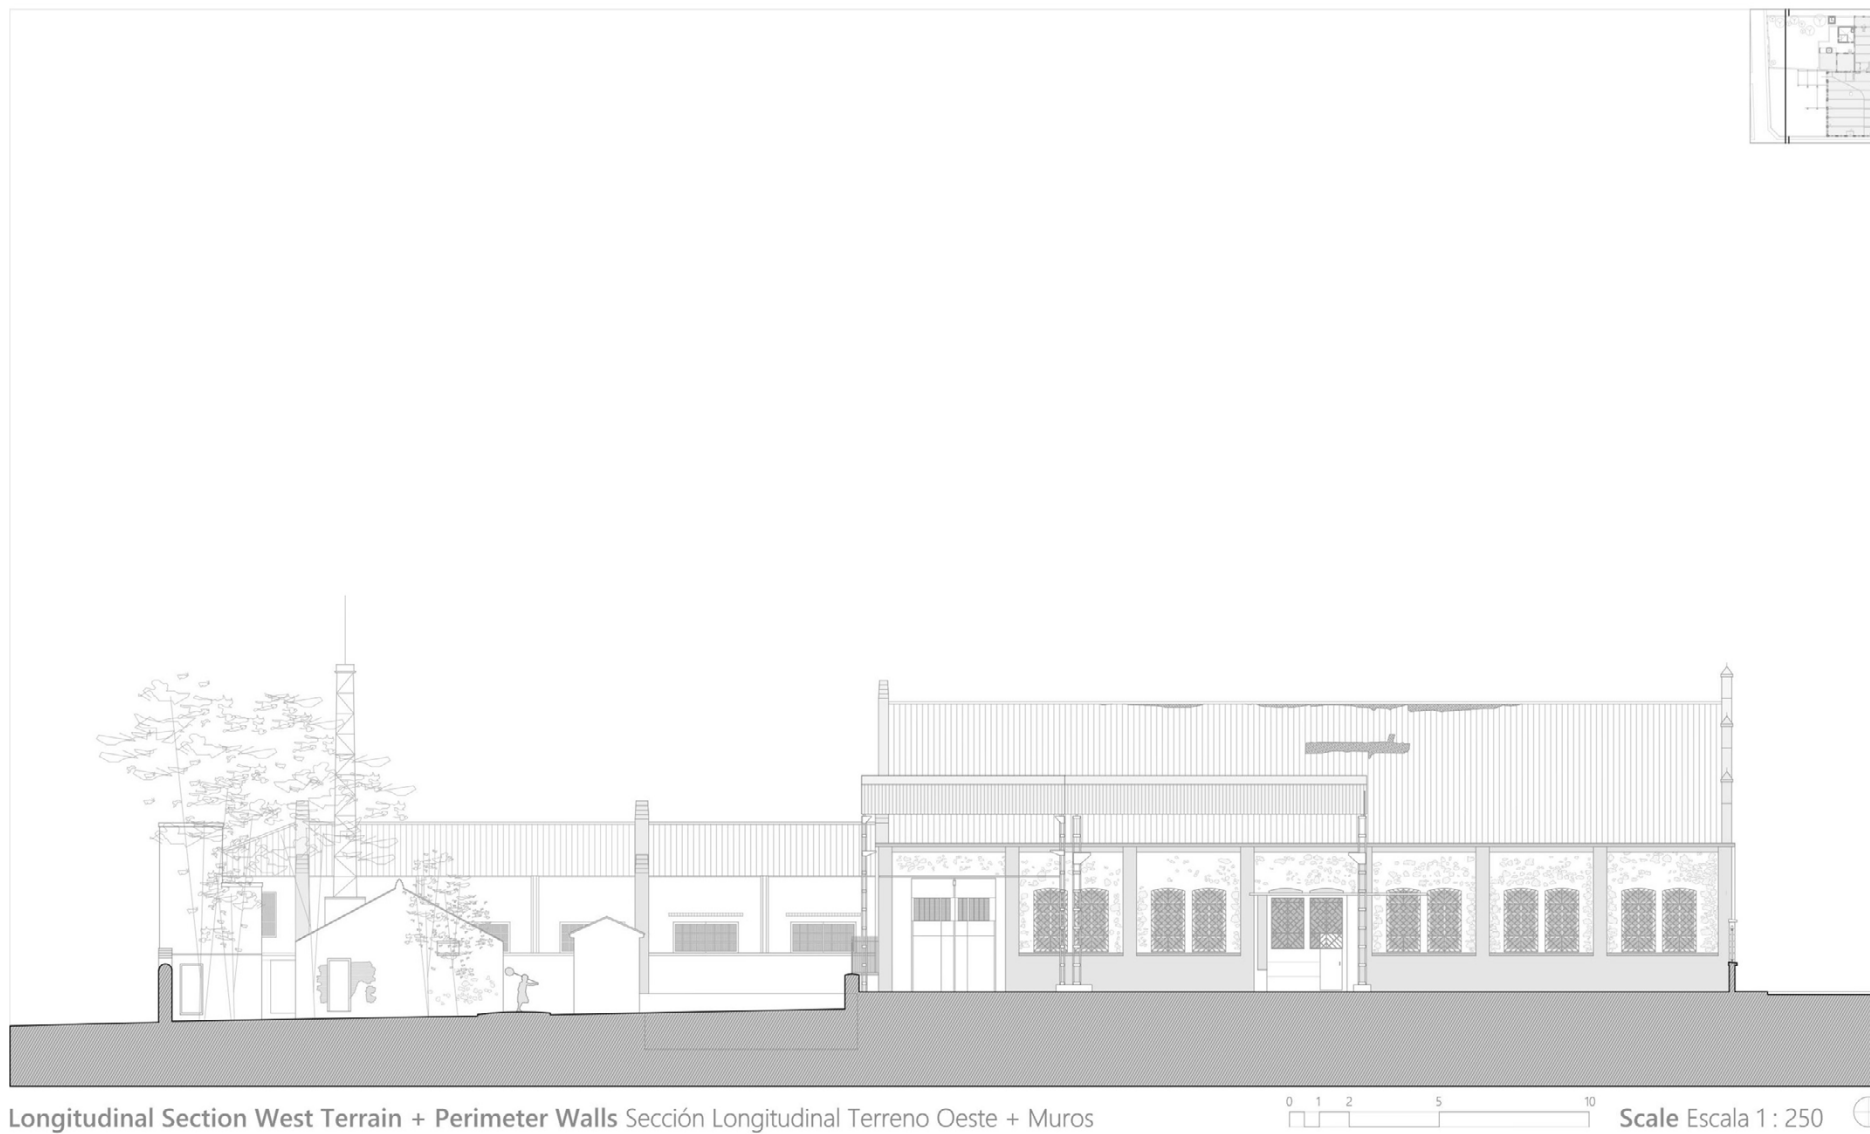
Fig 15. Taller dels Canets (former San Antonio wooden carriage factory), Beneixama (Alicante, Spain), April 2021. Current state drawing of longitudinal section made by the east terrain. The break in the modulation caused by the two doors can be seen. (Ortin Molina, S.; Ortin Molina, M. A., measurements by hand and drawing in AutoCad).

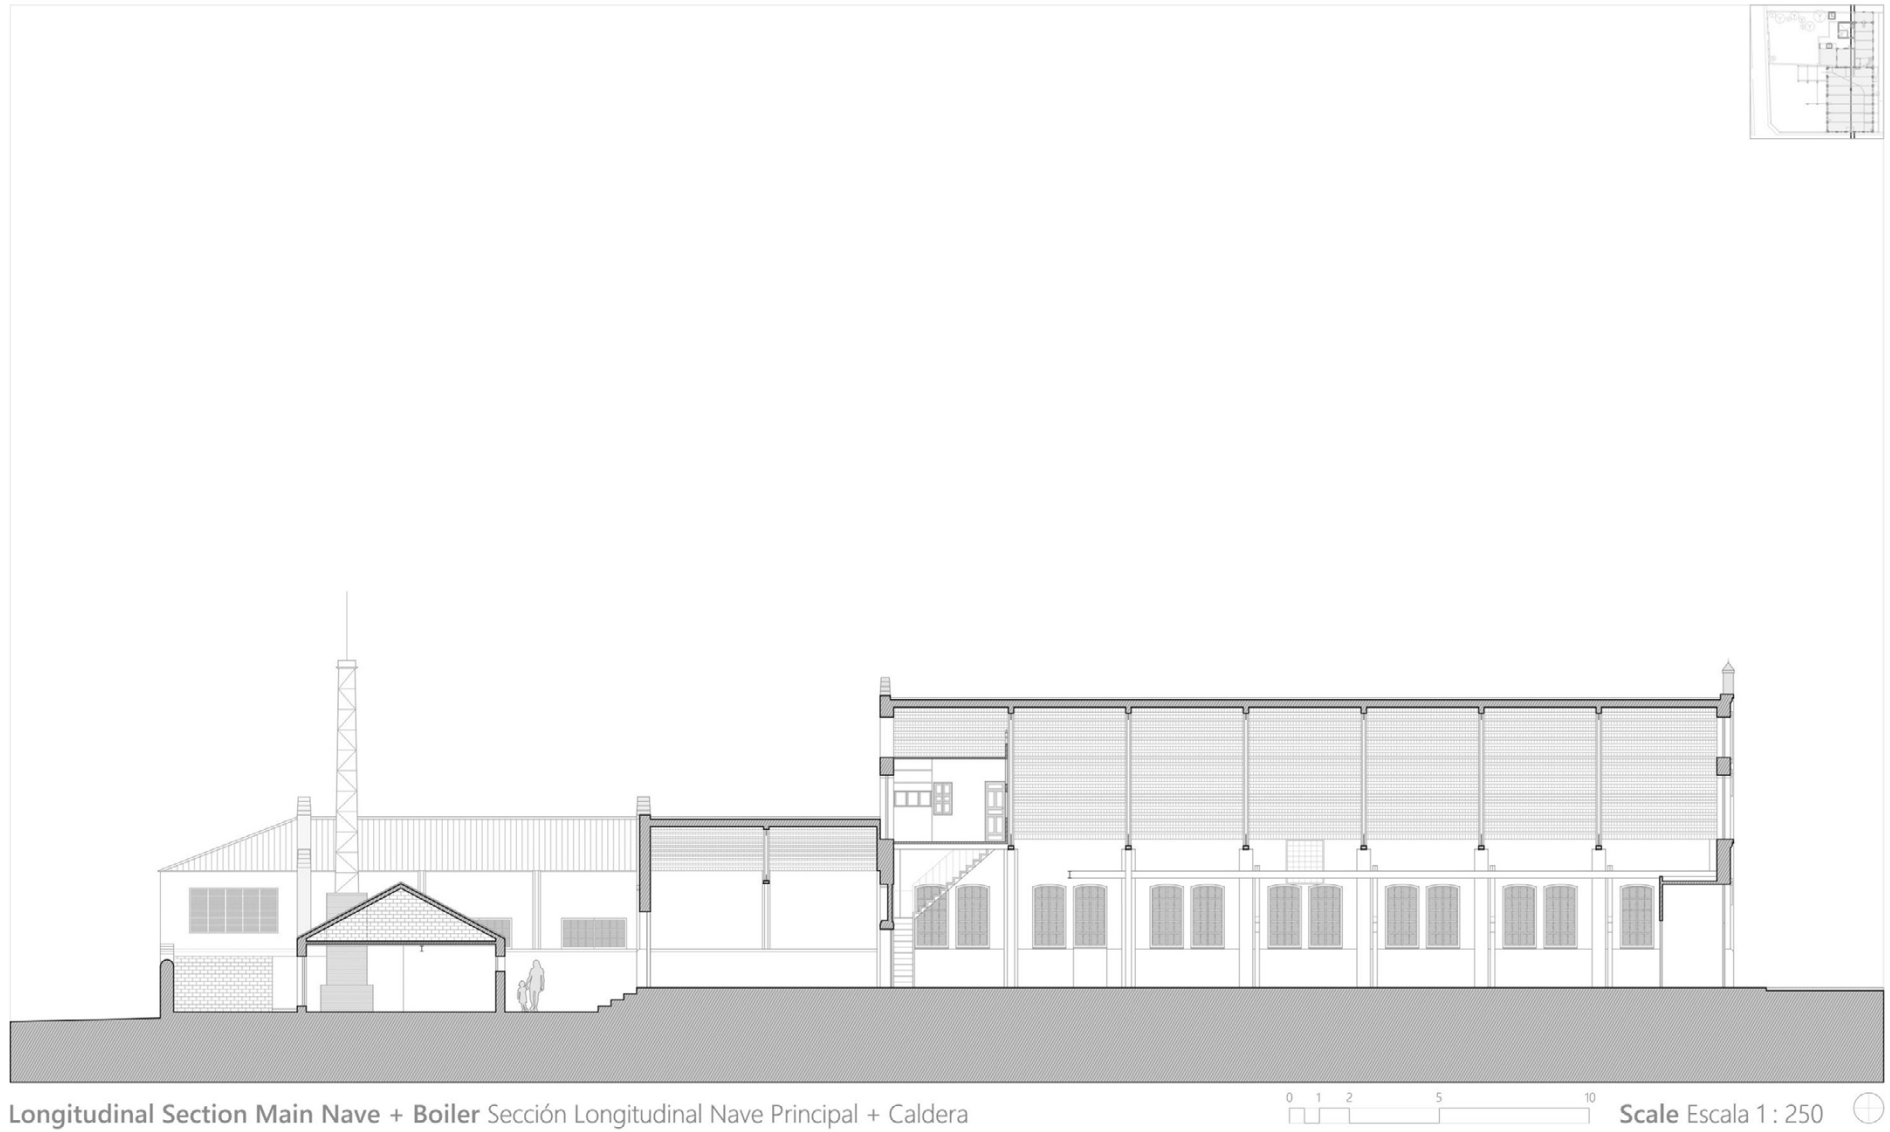
Fig 16. Taller dels Canets (former San Antonio wooden carriage factory), Beneixama (Alicante, Spain), April 2021. Current state drawing of longitudinal section made through the middle of the nave. The difference in height existing in the plot appear. (Ortín Molina, S.; Ortín Molina, M. A., measurements by hand and drawing in AutoCad).

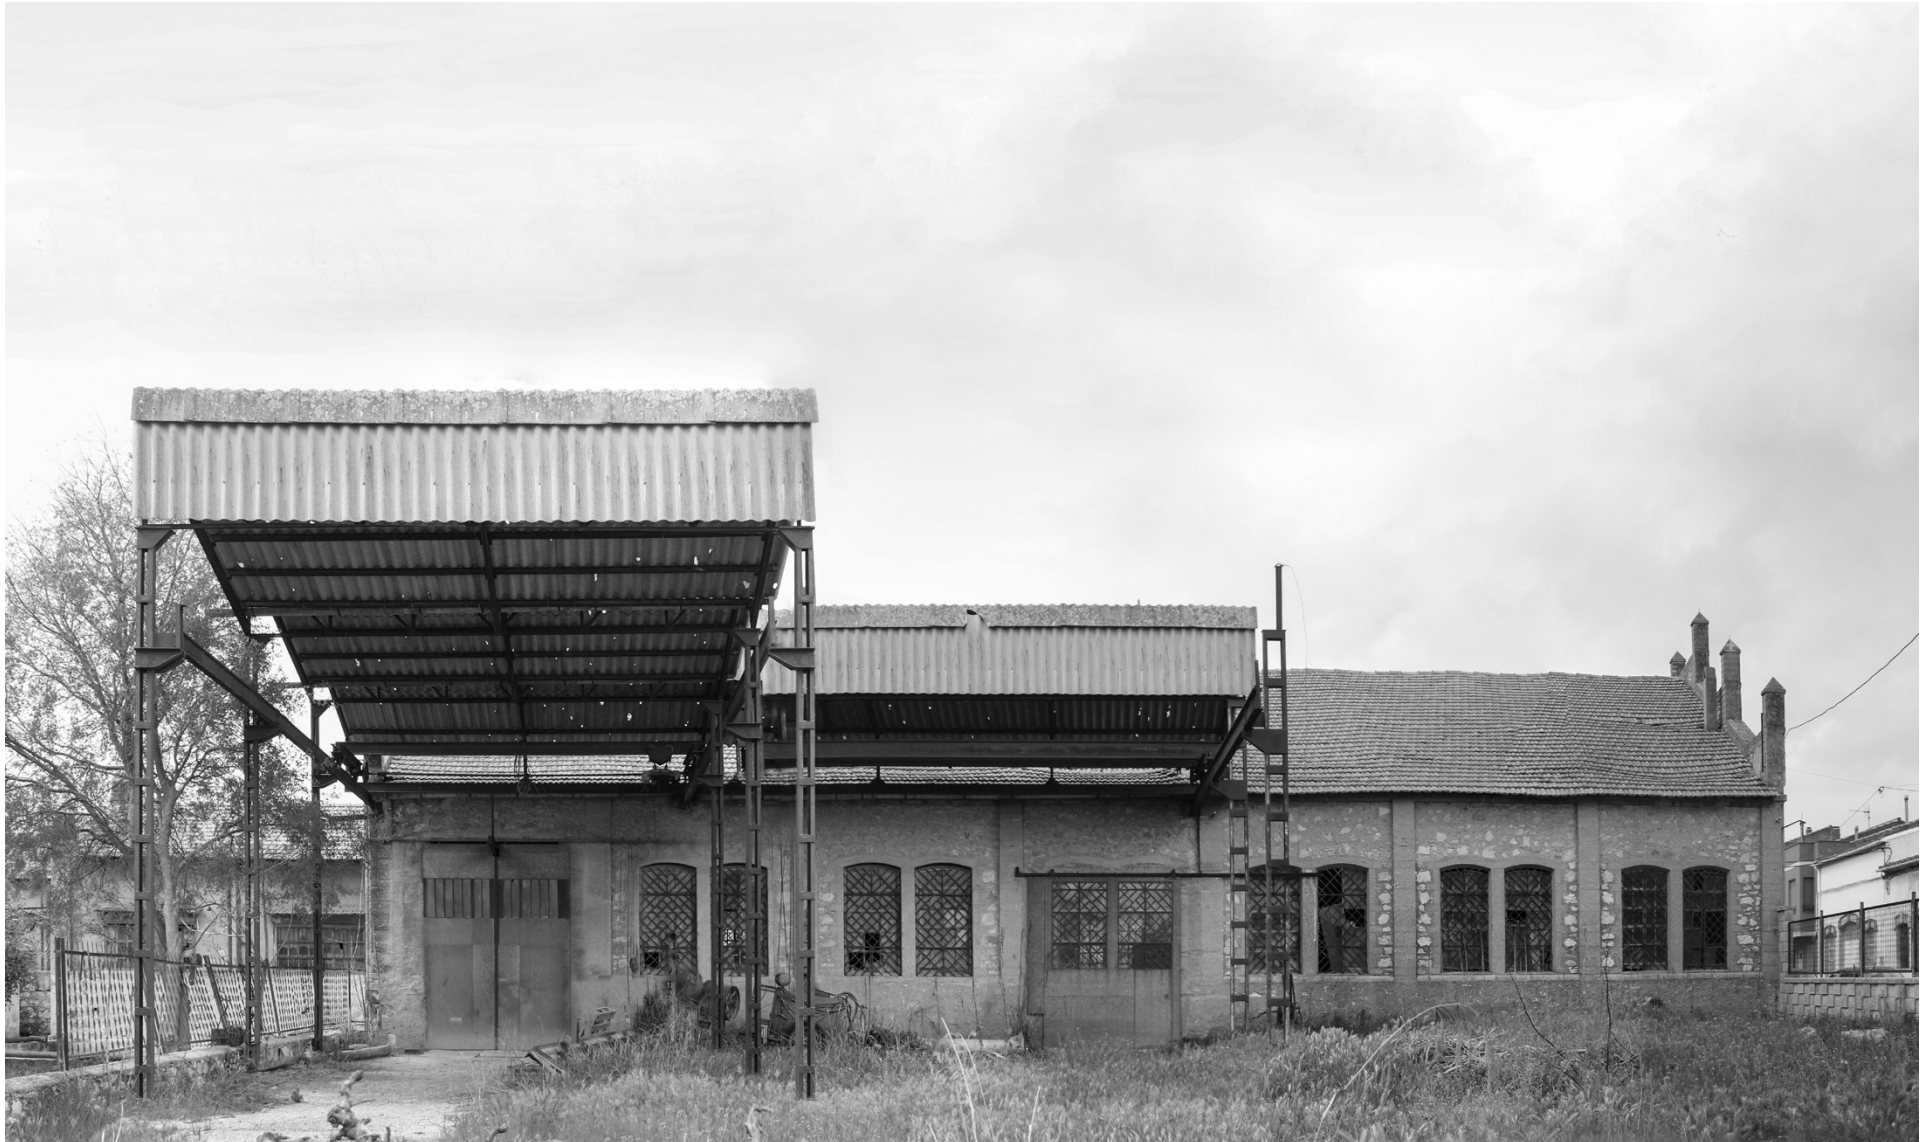
Fig 19. Taller dels Canets (former San Antonio wooden carriage factory), Beneixama (Alicante, Spain), April 2021. Exterior photograph of the workshop main nave east elevation. The decay of the annexed outer space, completely abandoned to nature. (Ortin Molina, S.; Ortin Molina, M. A., photography and digital image post-editing work).

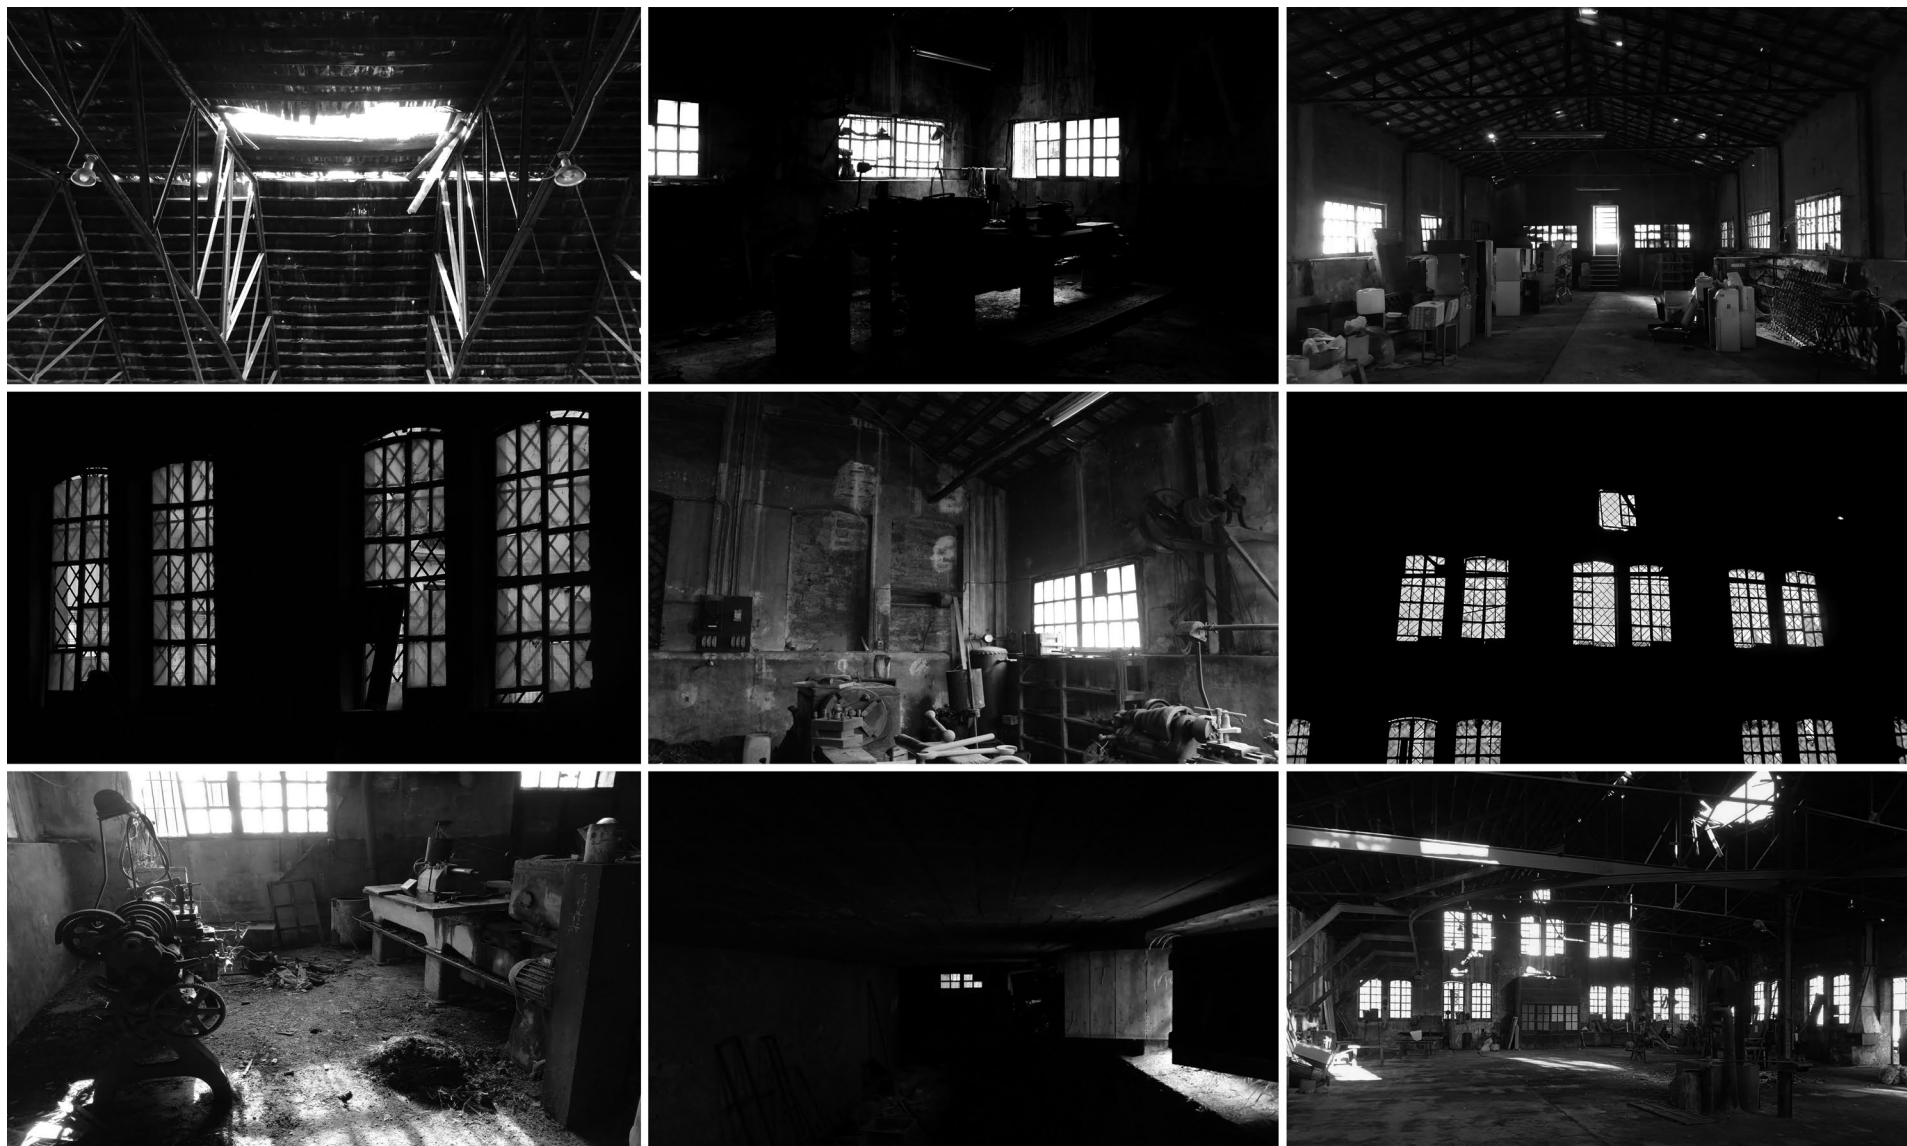
Fig 21. Taller dels Canets (former San Antonio wooden carriage factory), Beneixama (Alicante, Spain), January 2021. Interior photographs of the initial state of the factory before measurements and drawings were made. Workshop spaces: risks and hope. (Ortin Molina, S.; Ortin Molina, M. A., photographs and digital image post-editing work).

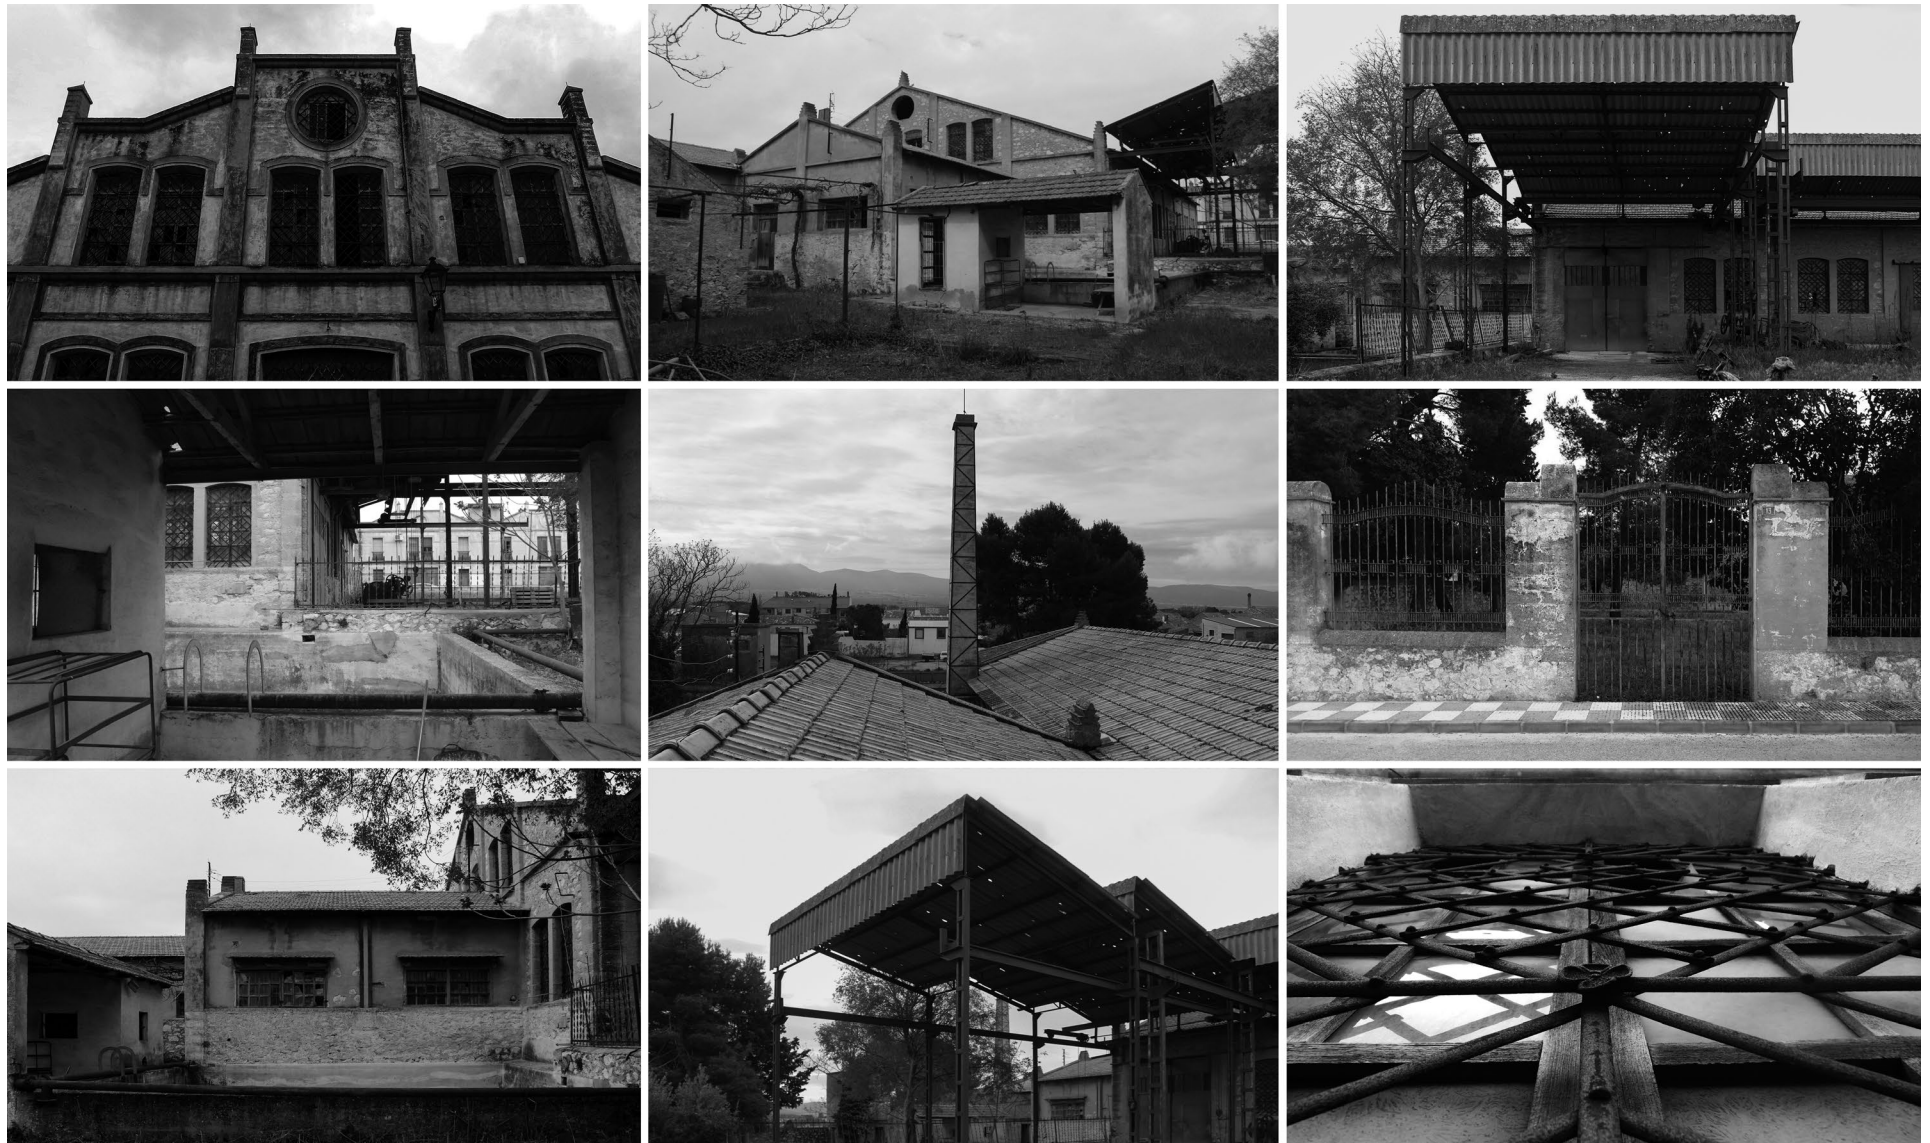
Fig 22. Taller dels Canets (former San Antonio wooden carriage factory), Beneixama (Alicante, Spain), January 2021. Exterior photographs of the initial state of the factory before measurements and drawings were made. Façades, porchs, raft and terrace. (Ortin Molina, S.; Ortin Molina, M. A., photographs and digital image post-editing work).

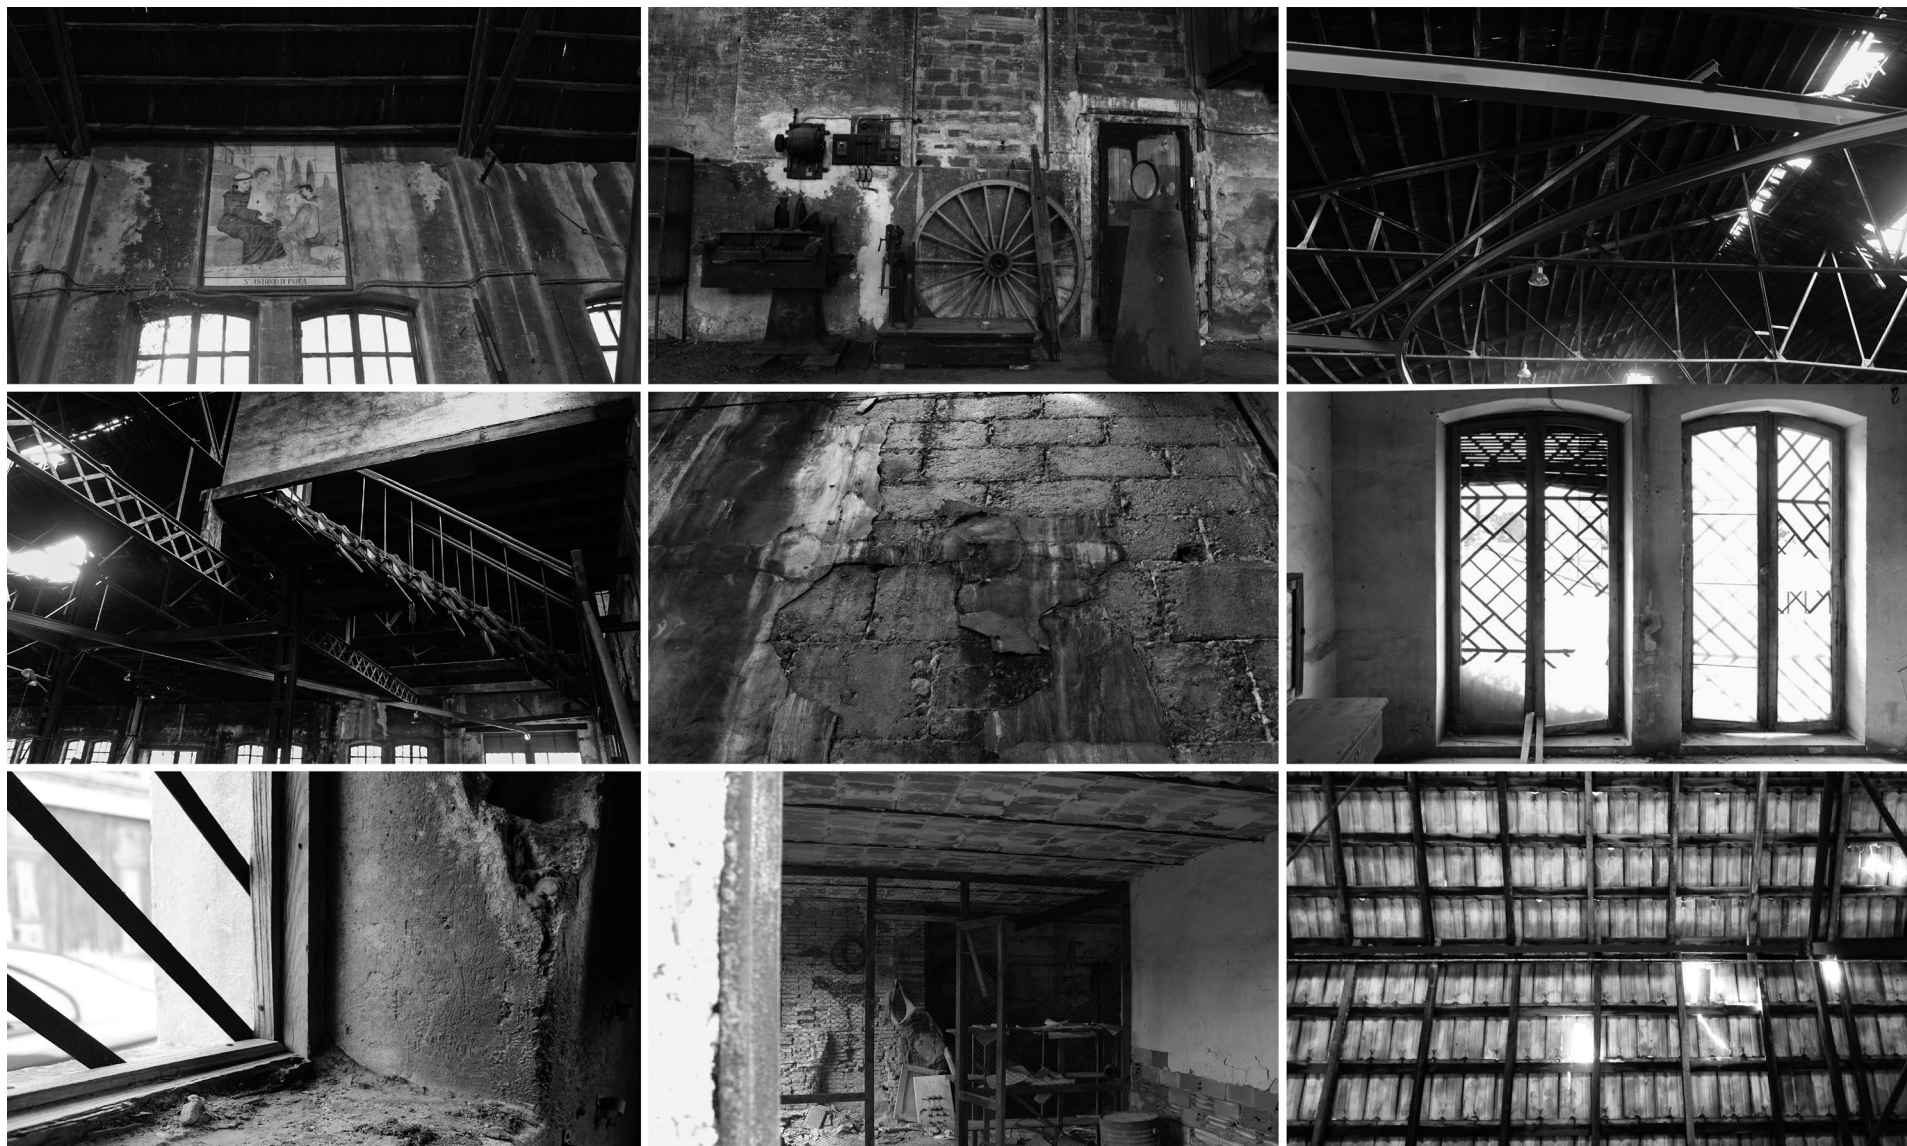
Fig 23. Taller dels Canets (former San Antonio wooden carriage factory), Beneixama (Alicante, Spain), January 2021. Interior photographs in detail of the workshop initial state before measurements and drawings were made. Materials, texture, surfaces. (Ortin Molina, S.; Ortin Molina, M. A., photographs and digital image post-editing work).

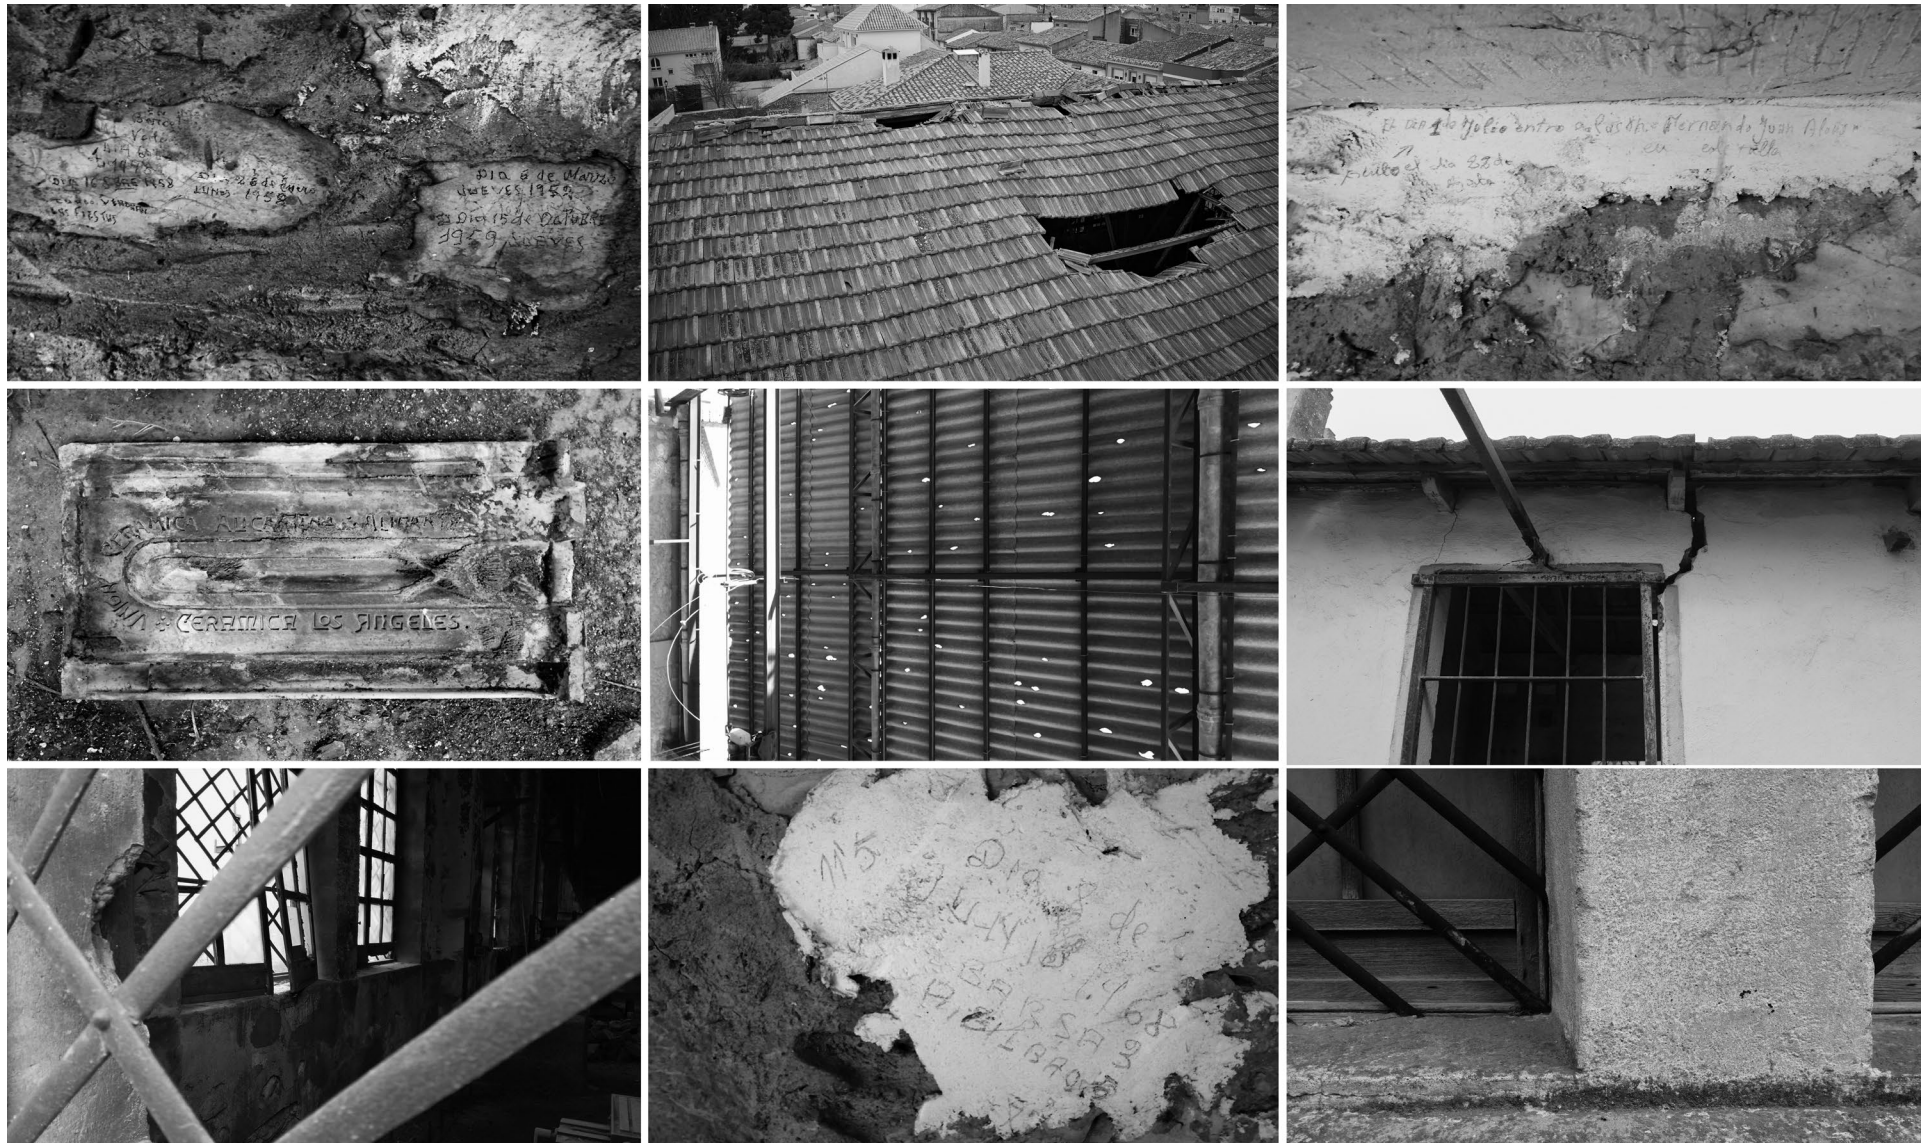
Fig 24. Taller dels Canets (former San Antonio wooden carriage factory), Beneixama (Alicante, Spain), January 2021. Exterior photographs in detail of the workshop initial state before measurements and drawings were made. Materials, texture, surfaces. (Ortin Molina, S.; Ortin Molina, M. A., photographs and digital image post-editing work).

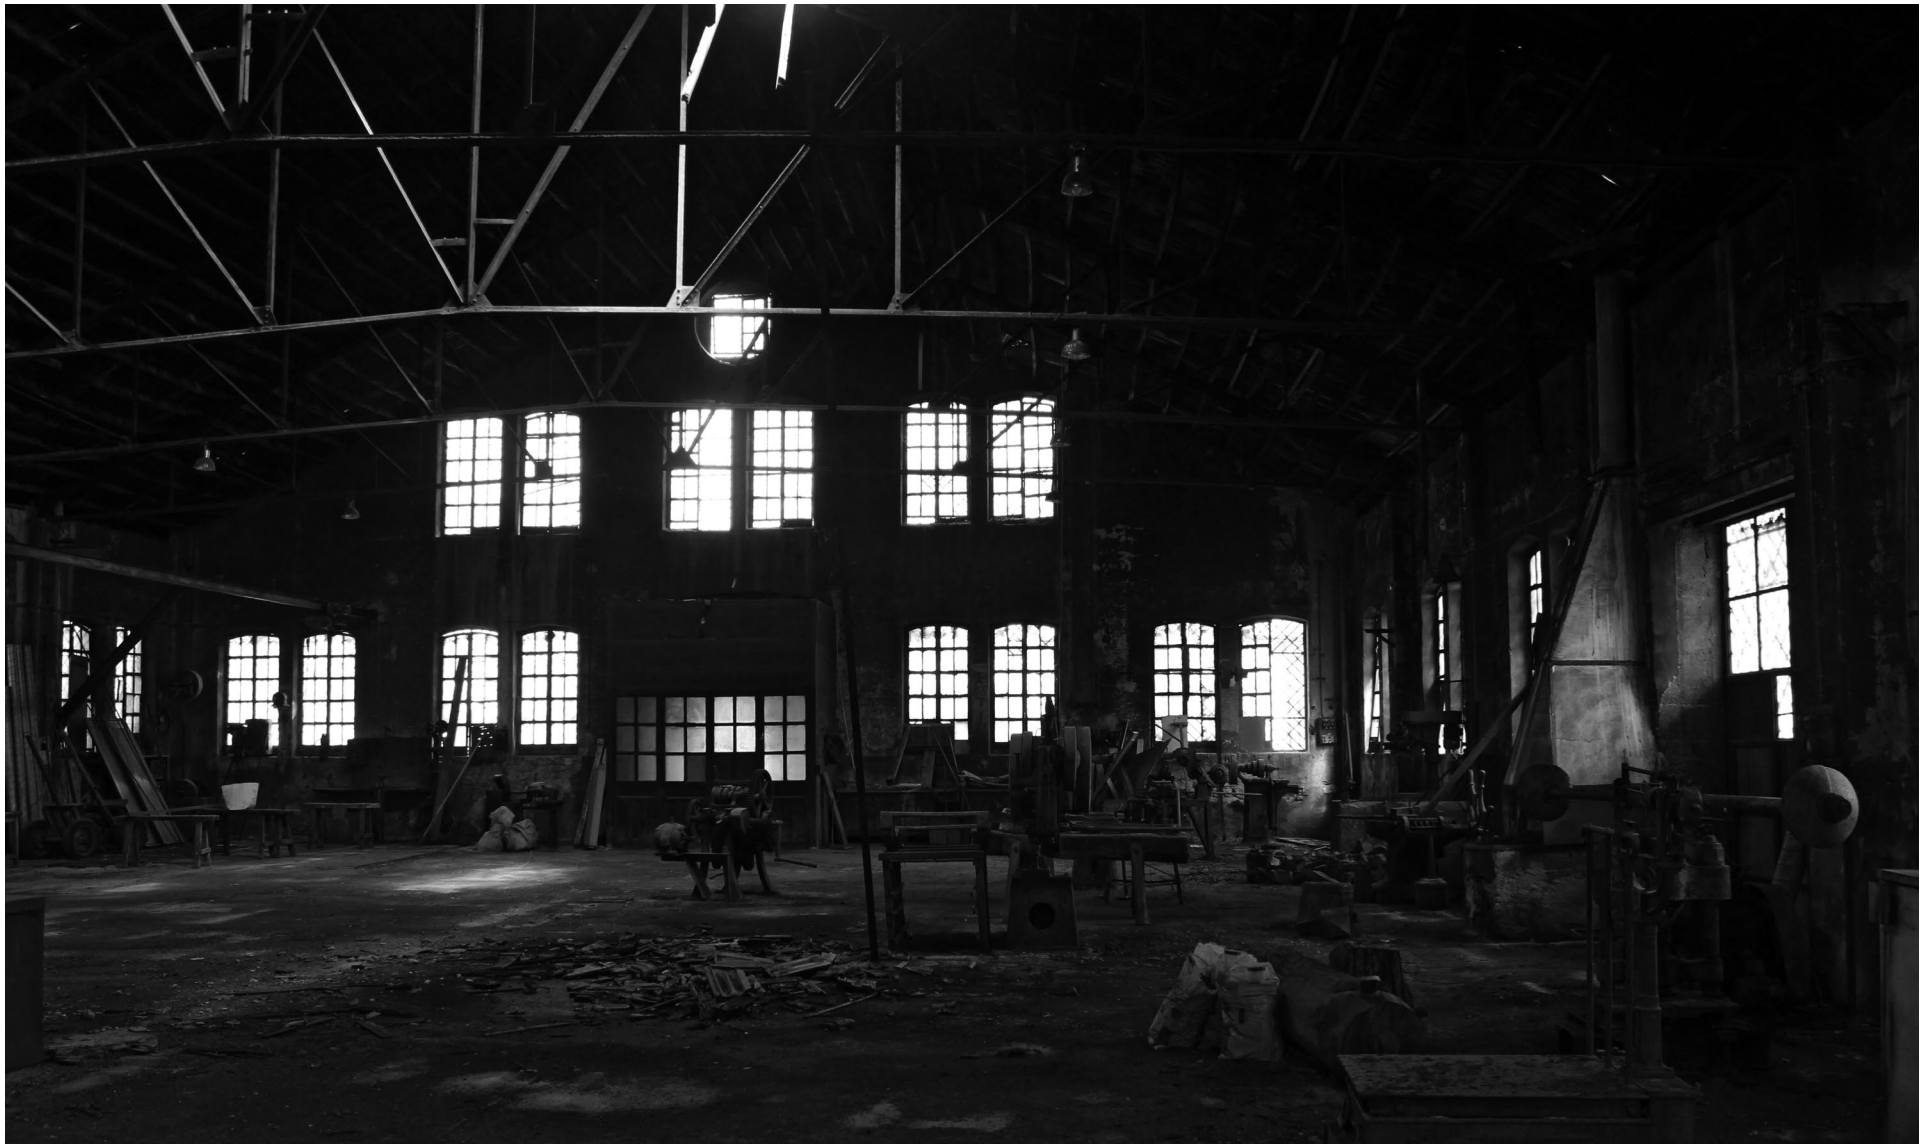
Fig 25. Taller dels Canets (former San Antonio wooden carriage factory), Beneixama (Alicante, Spain), January 2021. Interior photograph of the main nave of the workshop. The decadence and total abandonment state of an iconic centennial industrial site. (Ortin Molina, S.; Ortin Molina, M. A., photography and digital image post-editing work).
