Evaluation of the Structural Stability of an Octagonal Dome with Meridional Cracks. Case Study: Temple of Santa Lucia, Ambalema, Colombia

Jorge Olmedo Montoya¹, Olimpia Niglio², Karol Brigith Romero¹

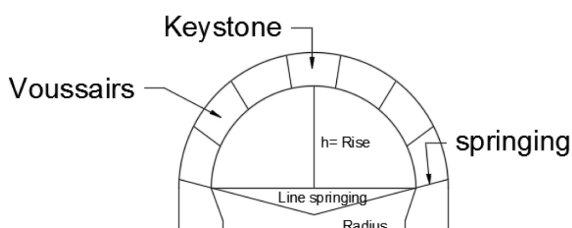
Figure 1.

Parts of an arch
Source: by the authors

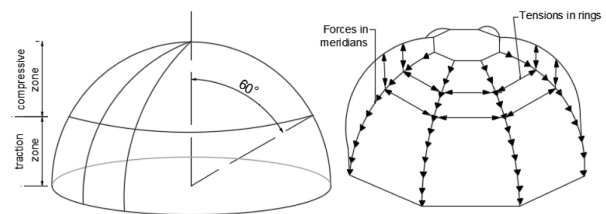
Figure 2.

permit membrane behavior (Ignacio Requena Ruiz, n.d.). The forces on rings that restrict movement of the wedges out of the plane are compressive in the upper zone and tension in the lower zone. The transition from the compression zone to the tension zone occurs between 45 and 60 degrees with respect to the dome's vertical axis (Pavlovic, Reccia, & Cecchi, n.d.) (Figure 2). Tensions in the lower part are not present in atypical cases of domes with flat crown and heavy lantern tower and the effect of the ring forces is more pronounced in a dome's upper region, where the circular compression rings tend to maintain equilibrium (Hall, Lindsay, & Krayenhoff, 2012).

Forces and stress upon the domes.
Source: by the authors

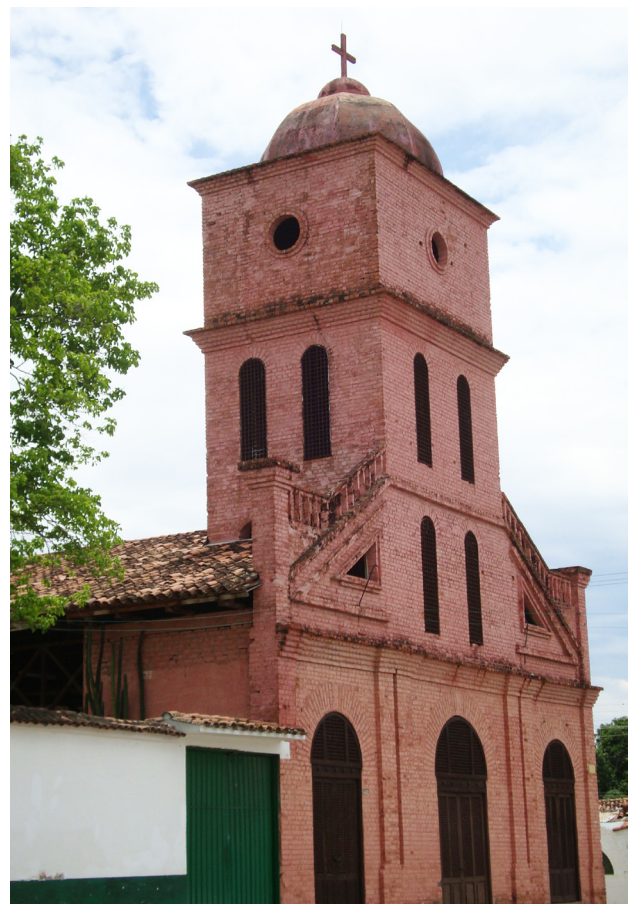
Figure 3.
The ancient Temple of Santa Lucía in Ambalema (Colombia)
Source: by the authors

This last method evaluated the dome's stability of the ancient temple of Santa Lucía in Ambalema (Figure 3). The ancient temple of Santa Lucía located in Ambalema - a municipality in the department of Tolima, Colombia, is a relatively new structure, given that anamnesis concluded that the current structure dates from early to middle 20th century: this structure is part of the historical center of Ambalema (site declared historical heritage of humanity), the temple is mostly constructed in masonry; however, wooden and reinforced concrete elements are found. This structure has an octagonal dome in masonry that presents meridional cracks; due to this, a study was conducted on stability against service loads and seismic loads through a spectral modal analysis.

The dome of the temple of Santa Lucía is hemispherical single leaf with eight caskets constructed in solid brick and mortar. The caskets show cracks of great consideration between them (some reaching 3 cm), indicating the independent work each one undertakes and the tension stress present. However, the dome is stable against service loads due to the union provided by the lantern tower topping it off.

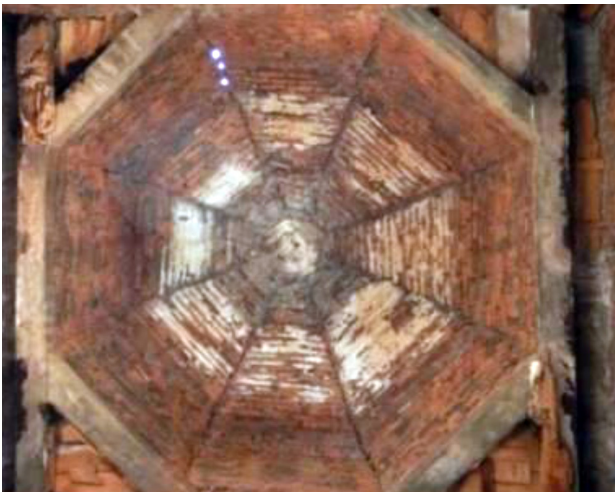
Figure 4.
Inner view of the dome of the temple of Santa Lucía
Source: by the authors

To conduct this study, the geometric characterization of the temple was performed; to determine the dome's geometry, photogrammetric estimates were made. The photographs were taken from the inside and outside (Figures 4 and 5).

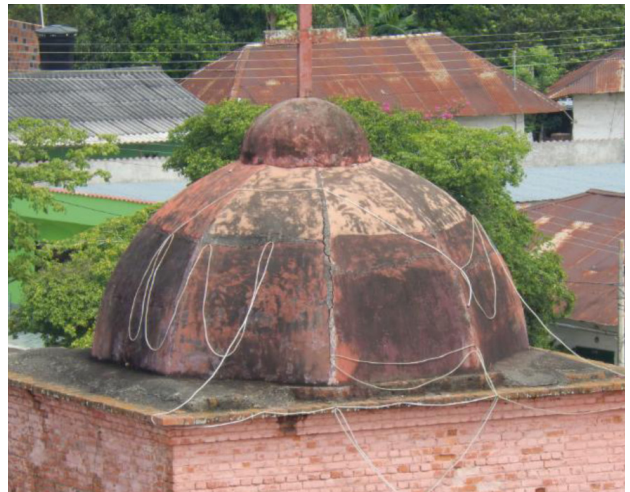
Figure 5.
Exterior view of the dome of the temple of Santa Lucía
Source: by the authors

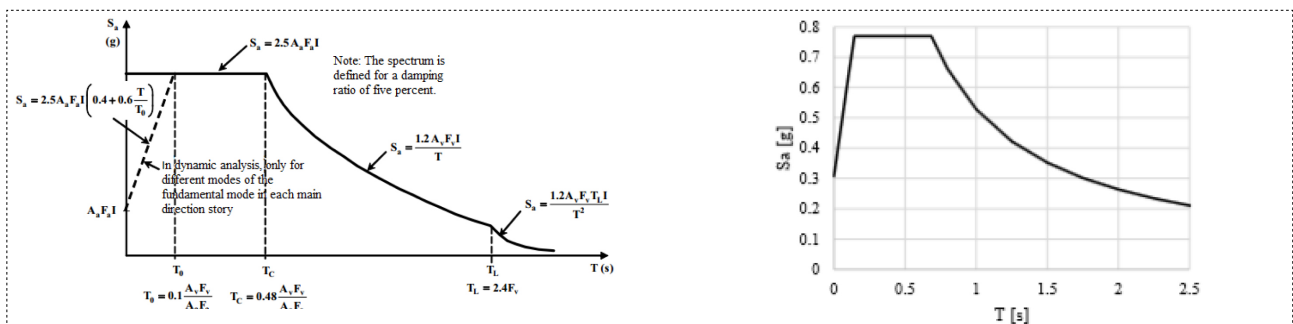
On site data, an acceleration coefficient (A_a) of 0.25 and an effective peak acceleration (A_v) of 0.2 were taken. Regarding soil data, a short-period amplification coefficient, $F_a = 1.4$, was used, along with an intermediate-period amplification coefficient, $F_v = 2.0$

Figure 6.
Elastic spectra of analysis: a). Elastic acceleration spectrum design (NSR-10); b). Elastic acceleration spectrum of determined design.
Source: By the authors

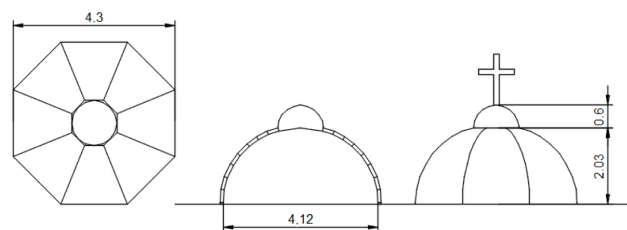
The height from the base to the dome's crown was measured at 18.9 m. It is an octagonal dome of internal diameter and external diameter equal to 4.12 and 4.3 m, respectively. The thickness of the whole dome is constant at 0.09 m. Its total height is 2.03 m and it is hemispherical flattened at the crown, where a concrete lantern tower rests with a diameter of 0.6 m (Figure 7).

Figure 7.
Dome dimensions in meters
Source: By the authors

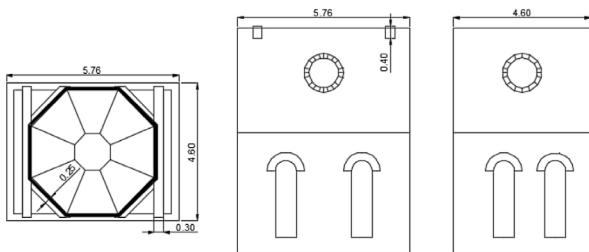
For the case study, the dome is supported on six reinforced concrete beams: two are parallel to the tower walls and the rest form a 45-degree angle with respect to the lateral walls; all the beams are of rectangular transversal section with 0.4 m in height and 0.3 m width and the tower walls have equal thickness at 0.24 m (Figure 8). The two other supports correspond to brick walls, which go to the foundation.

Figure 8.
Dimensions in meters of the dome's supports.
Source: by the authors

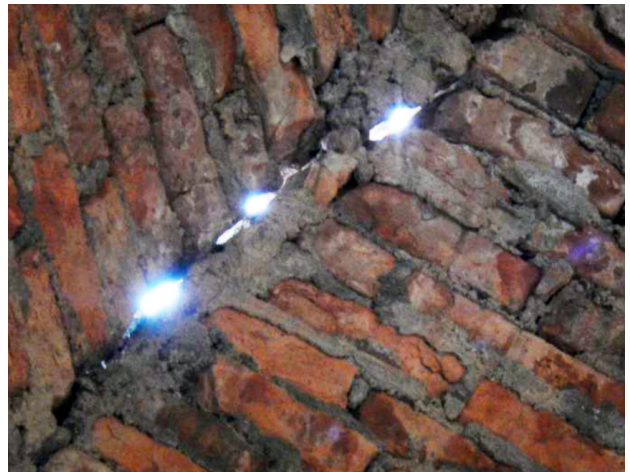
Analysis of the dome's constructive system permits determining its behavior upon loads and its current state. The meridional cracking between caskets presented by the temple's dome is a phenomenon that does not directly compromise the dome's structural behavior. In typical cases, the cracks commonly start in the springer and expand toward the crown without reaching it and descend through the drum; however, the lack of a drum present in the dome of the temple made it easier for total cracking from the springers to the crown.

Figure 9.
Fissures on caskets of the dome of the temple of Santa Lucía.
Source: by the authors

The results obtained from comparing among the different buildings and the dome of the ancient Temple of Santa Lucía permits attributing the fissures among the caskets to the lack of uniformity in supports and to the absence of a drum. The fissures stem from the dome itself, that is, no records exist that the elements that support it present structural problems, and hence, fissures are attributed to the absence of a drum. The presence of a drum is not indispensable in the construction of domes, but it provides stability by counteracting the thrusts produced by its own weight and the service loads, avoiding the presence of tension stress. Lastly, the absence of interlocking between contiguous caskets did not permit guaranteeing transmission of monolithic forces, which facilitated the fissures being present in the brick-mortar union.

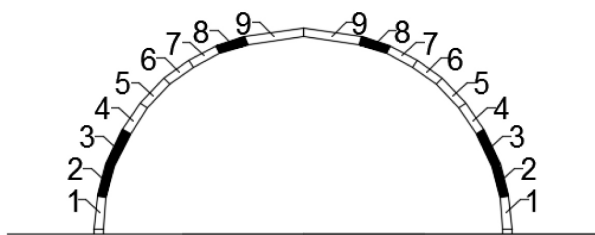
The stability analysis for the service loads shows that the four arches present similar stress distribution. The presence of tensile stress is evident in all the arches. These stress values are noted in keystones 2, 3, and 8 (Figure 10), the maximum values of tension stress the arches are subjected to are 150 and 340 kPa for diagonal and normal arches, respectively. The zones subjected to compression presented maximum stress of 270 and 320 kPa.

Figure 10.
Numbering of the keystones
Source: by the authors

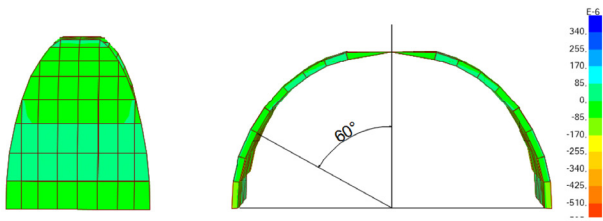
The tensile stress on the four arches occurs as of 60 degrees with respect to the vertical axis from the center of the dome, thus, complying with that proposed by (Pavlovic, Reccia, & Cecchi, n.d.) (Figure 11), reiterating the dome's stability against service loads.

Figure 11.
Stress, in kPa, on arch 1.
Source: by the authors
