Torres Górriz, B.; Bertolesi, E.; Moragues, JJ.; Calderón García, PA.; Adam, JM. (10-1).
Experimental investigation of a full-scale timber masonry cross vault subjected to vertical
settlement. *Construction and Building Materials*. 221:421-432.
<https://doi.org/10.1016/j.conbuildmat.2019.06.015>

1 **Experimental investigation of a full-scale masonry cross**
2 **vault subjected to vertical settlement**

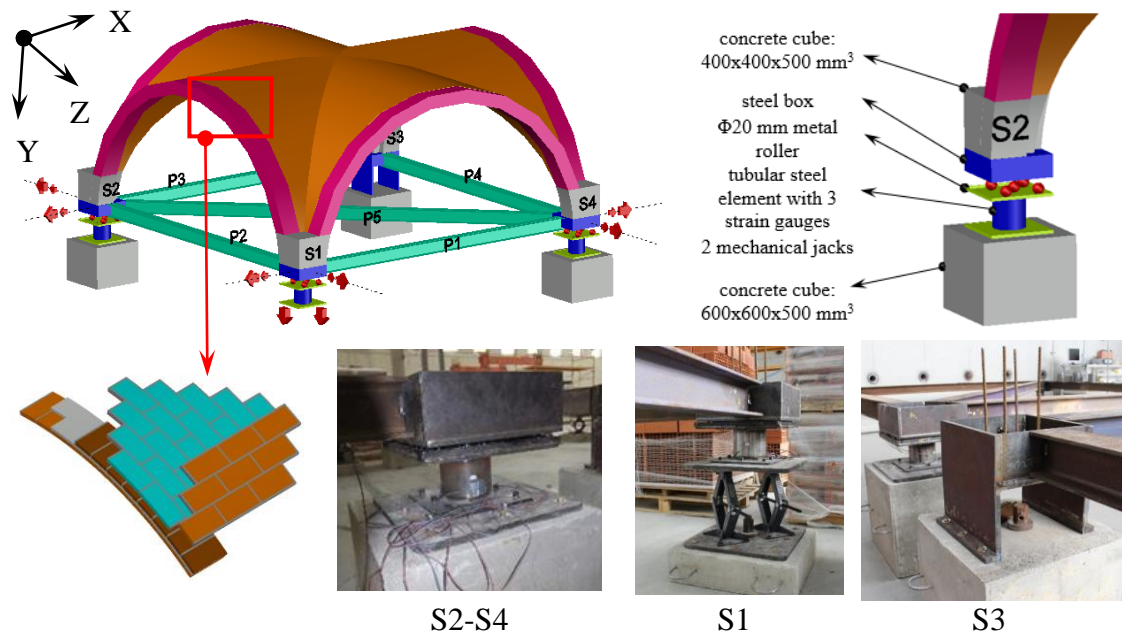
Figure 2. Experimental set-up adopted during the test.

127 The vaults rested on four supports (S1, S2, S3 and S4), formed of steel elements,
 128 designed to allow monitoring of vertical reactions during construction and testing.
 129 Support S1 (Figure 2) was formed by a steel box supported on 20 mm diameter metal
 130 rollers, allowing free movement in both horizontal directions. Below the rollers there
 131 was a 159 mm diameter, 200 mm high and 2 mm thick tubular steel element to allow
 132 monitoring the reactions by means of three strain gauges. In its turn, this element rested
 133 on a 20 mm thick metal plate firmly joined to two mechanical jacks which applied the
 134 vertical displacements. The jacks were anchored to a 600x600x150 mm³ concrete block,
 135 with a 60 mm orifice at its centre, through which the entire support has been fixed to the
 136 laboratory reaction floor slab. Conversely to support S1, supports S2 and S4 have been
 137 restrained with respect to vertical movements, whereas horizontal displacements were

139 directly anchored to a 600x600x520 mm³ concrete block. Finally, S3 has been directly
 140 anchored to a 600x600x500 mm³ concrete block (Figure 2). A detailed sketch of the
 141 parts forming support S2 has been depicted in Figure 2. A solid concrete structure rested
 142 on each of the supports forming a square 4 m long base for the four arches (Figure 2). In
 143 order to prevent the activation of a failure mechanism produced by the free horizontal
 144 movements of supports S2 and S4, and simulated the presence of contiguous vaulting
 145 systems, a lattice frame of steel girders (Figure 2) has been used. To this scope, five
 146 steel beams (with height equal to 140 mm) have been hinged to the steel boxes
 147 supporting the masonry vault. A detail of the connection used is showed in Figure 2,
 148 where it can be noted that the welded surface has been reduced to the central portion of
 149 the beam to prevent the transmission of bending moments and allow axial movements

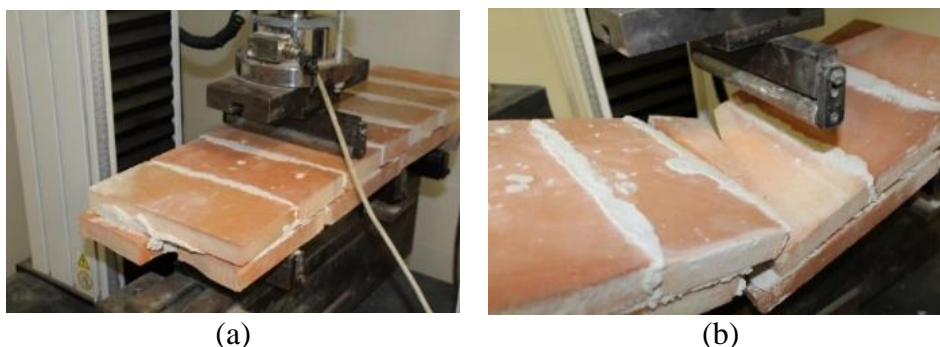
Figure 3. Three points bending test (-a) and failure mechanism (-b).

170 Further experimental tests have been conducted to characterize the mechanical
 171 properties of the masonry constituting the vault web. A total of 10 specimens (four for
 172 compression and six for bending tests) have been employed to characterise the masonry
 173 assemblage. It is worth mentioning that, the brick distribution adopted is similar to that
 174 used in the webbing of the actual vault under study as visible in Figure 3, which shows
 175 the three points bending test carried out.

176 The compressive strength of the specimens was between 8-10 MPa. The bending
 177 strength was more varied; four of the six specimens reached a value of 1.5 MPa while
 178 the other two reached 2,0 and 2.5 MPa.
 179

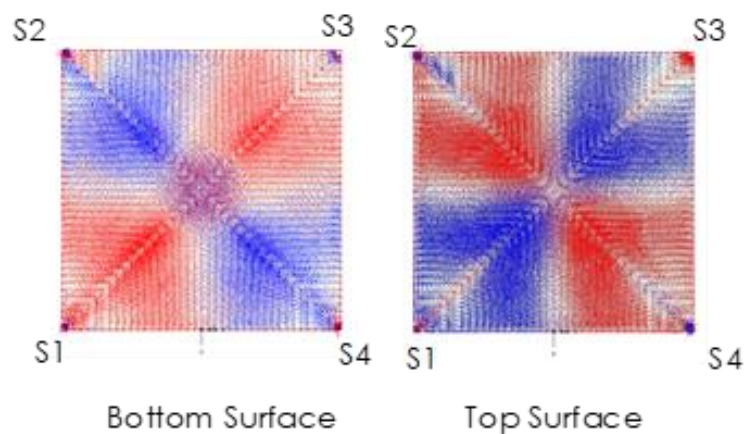
Figure 4. Principal stress maps obtained with an imposed displacement equal to 30 mm.

205
206 As clearly visible in Figure 4, the model has been able to identify the points in the vault
207 that suffered the greatest stresses and thus where cracks could be expected to appear. In
208 details, the critical points on the inner surface of the vault are concentrated along the
209 elliptical arch that joins supports S1 and S3 and close to the support, while on the outer
210 surface the stresses reached the maximum value in correspondence of the keystone of
211 the elliptical arch joining supports S2 and S4. In both cases the tensile forces extend

212 towards the circular arches joining the supports. On the basis of the results obtained, it
213 has been also possible to define the position of the sensors employed. In addition, the
214 tensile forces acting in the truss FEs used to model the bracing frame has been used to
215 design the steel profiles to be used during the experimental test.

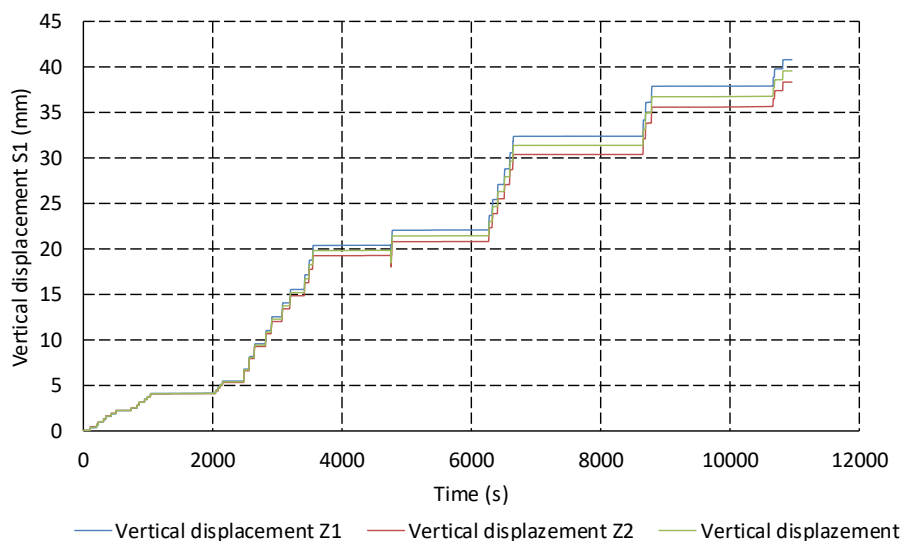
Figure 5. History of displacements applied to support S1.

217 As discussed previously, the proposed masonry vault has been tested applying a vertical
218 downward displacement in support S1. In detail, the vertical settlement has been
219 imposed by means of two mechanical jacks placed parallel to each other under the steel
220 box visible in Figure 2. The downward displacement has been imposed manually in a
221 quasi-static fashion synchronising the mechanical jacks to prevent any rotation of the
222 support. The history of displacements applied is depicted in Figure 5. In addition, a total
223 of 23 sensors have been placed along both the inner and outer surfaces of the structure
224 to allow the monitoring of the vault behaviour. In detail, from the network of sensors
225 employed during the test, it has been possible to extract information about: i) the
226 reactions forces in correspondence of the supports, ii) the collapse mechanism with the
227 widening of tensile and flexural cracks, iii) the horizontal displacements in the supports,

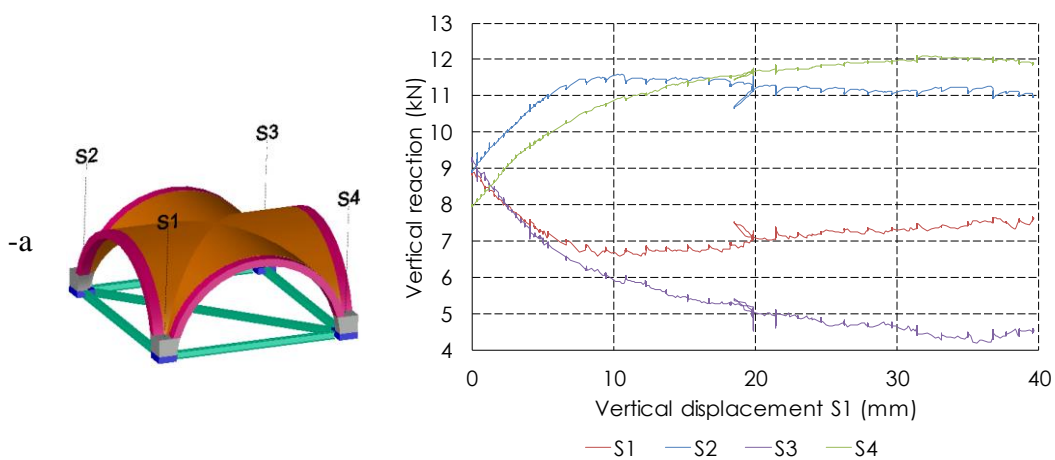
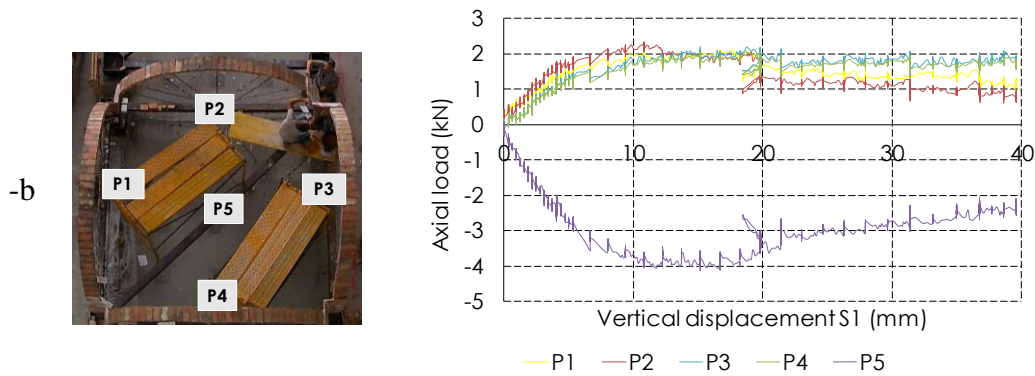
Figure 8. Evolution of reactions according to settlement of S1 (-a) and on the base bracing girders (-b).

264 Figure 8-a shows the evolution of the reactions in the supports according to the
 265 settlement applied in S1. The maximum settlement value applied to S1 was 40 mm. In

266 S2 and S4 the reactions rose while in S1 and S3 they diminished as settlement
 267 increased. In detail, S1 and S3 reactions fell in the order of 28% and 55% of their initial
 268 values, respectively, while those of S2 and S4 rose by 27% and 50%, respectively.
 269 The reaction pairs S1-S2 and S3-S4 had similar evolutions; in the initial phase the
 270 evolution of the reactions is practically linear but becomes increasingly non-linear as
 271 settlement of S1 advances. As a matter of fact, the reactions were found to be linearly in
 272 proportion to the settlement value until this reached 5 mm. Between 5 and 10 mm they
 273 became non-linear and after 10 mm settlement the reactions remained practically
 274 constant or were even found to fall until the end of the test, in spite of the fact that S1
 275 continued to settle. This behaviour was due to the appearance of the first cracks close to

276 the supports, which re-distributed the loads over the rest of the webbing. Similarly, the
 277 loads on the girders that join the supports experienced the same evolutions (Figure 8-a
 278 and-b). In detail, P1, P2, P3 and P4 have been loaded with compressive forces, as
 279 clearly visible comparing Figure 8–b, whereas tensile forces higher than the
 280 compressive forces have been detected in P5. The loads on the girders increased with
 281 settlement up to 15 mm, after that point they remained relatively constant or even
 282 decreased slightly.

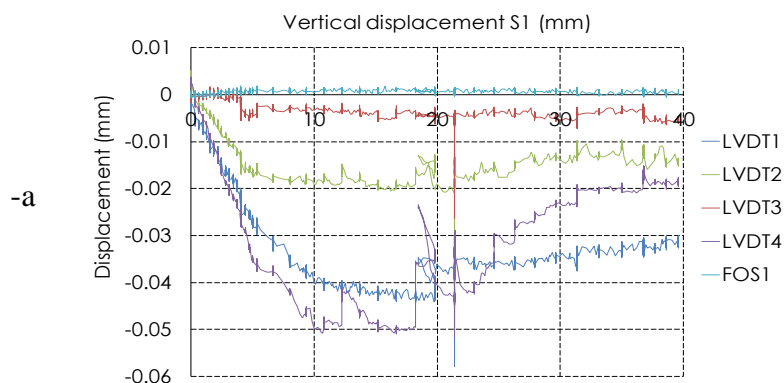
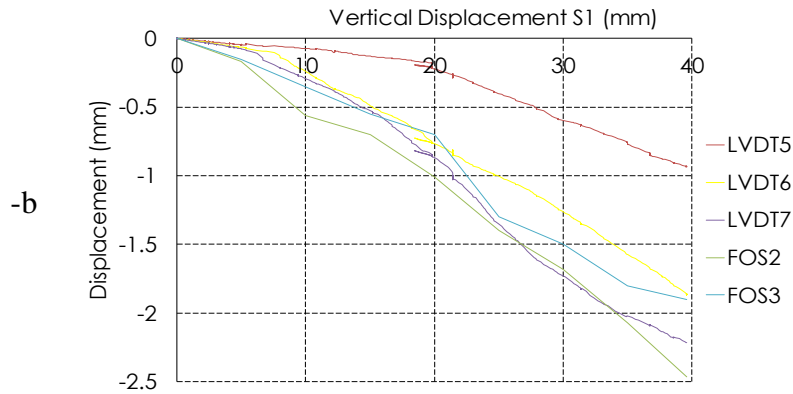
Figure 9. Displacements recorded by long gauge sensors.

284 Figure 9 depicts the displacements recorded by means of the long gauge sensors,
 285 LVDTs and FOS, placed along the vault. It is worth mentioning that, all the sensors
 286 depicted in Figure 9 show displacements related to tensile stresses. Those installed on
 287 S1 along the S1-S3 elliptical arch (LVDT1, FOS1, LVDT2, LVDT3, LVDT4) show
 288 maximum displacements of 0.05 mm, while those attached to the cornerstone on the
 289 upper surface of the vault (LVDT6, LVDT7, FOS2 and FOS3), give considerably
 290 higher displacements of between 2 and 2.5 mm, indicating the presence of cracks. The
 291 value registered by LVDT5 on the lower vault face over arch S1-S3 reached 1 mm at
 292 the end of the test, indicating cracks in this area also.

310 The variation in the S4 reaction became stable after 20 mm settlement and no cracks or
 311 breaks were observed close to this support. The long gauge sensors fitted to the lower
 312 face of the vault close to the elliptical arch S1-S3 (LVDT1, FOS1, LVDT2, LVDT3,
 313 LVDT4) recorded maximum displacements of around 0.05 mm (Figure 9-a), but these
 314 did not cause any cracks in the area covered by these sensors. However, sensor LVDT5
 315 recorded maximum displacements of around 0.9 mm. Figure 10-a shows the crack
 316 recorded by this sensor, which started in the arch and propagated horizontally until
 317 reaching the S1-S3 arch, where it joined up with a smaller crack. Its evolution was seen
 318 to vary at 20 mm settlement, which appears to indicate the beginning of the opening of
 319 the crack. The displacements recorded by the sensors fitted to the vault's upper face
 320 were somewhat larger, with a bigger opening of the crack on elliptical arch S2-S4.

321 Sensors LVDT6 and LVDT7 placed symmetrically on arch S1-S3 showed very similar
 322 behaviour. After a settlement of between 5 and 10 mm (Figure 9-b) the slope of the
 323 displacement curves was seen to vary, indicating the appearance of cracks. Sensor FOS3

324 recorded the opening of a crack at around 15 mm settlement. Cracks also appeared close
325 to sensors FOS2 and LVDT6 and propagated towards support S4 as settlement
326 progressed.

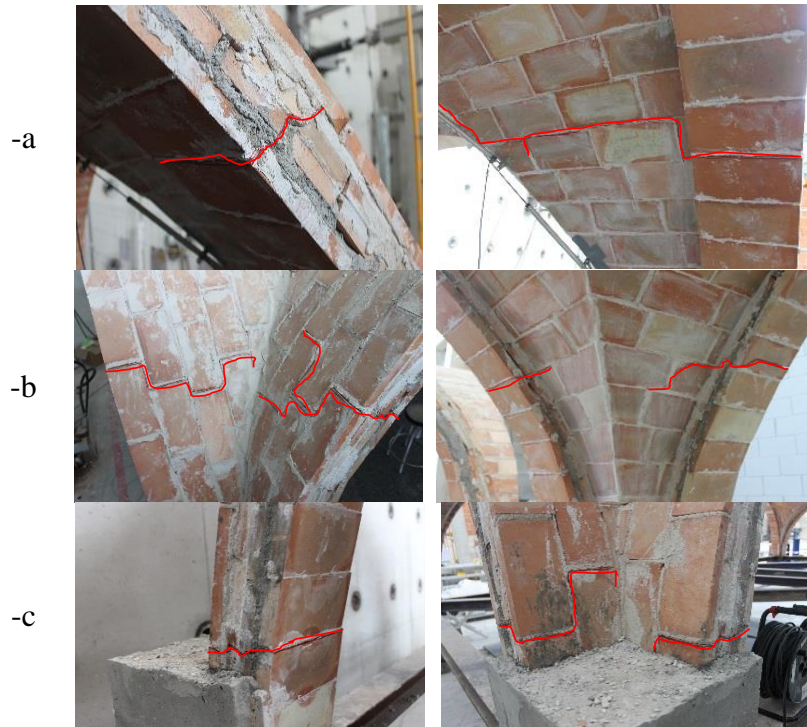
Figure 10. Cracks close to supports S1 (-a), S2 (-b) and S3 (-c).

297 The cracks close to S1 were tensile cracks caused by the settling of the support. These
 298 started in the base of S1 towards S2 and propagated horizontally towards the S1-S3
 299 elliptical arch following the inter-brick joints (Figure 10-a). However, those that
 300 appeared in S2 have been caused by the bending of arch S2-S4 and also started in the
 301 outer faces of the arches rising from S2. They have been propagated not only along the
 302 joints but also through breaks in the bricks themselves. Since these were bending
 303 cracks, their openings were wider on the outer face of the vault, where they reached a
 304 maximum of 3 mm. Those on the inner face were narrower and shorter (Figure 10-b).

305 During the visual inspection carried out when the settlement had reached 20 mm, a
 306 small horizontal crack approximately 1 mm wide was seen on the S3 support along a
 307 line of brick joints. At 35 mm settlement this same crack was 3 mm wide and had gone
 308 from one side of the vault to the other (Figure 10-c).
