APPROXIMATION TO THE USE OF HALF-TIMBERED WALLS WITH EARTH INFILL IN SPANISH TRADITIONAL ARCHITECTURE

A. Hueto Escobar^{1,3,*}, M. Diodato^{1,3}, F. Vegas^{1,3}, S. Manzano Fernández^{2,3}

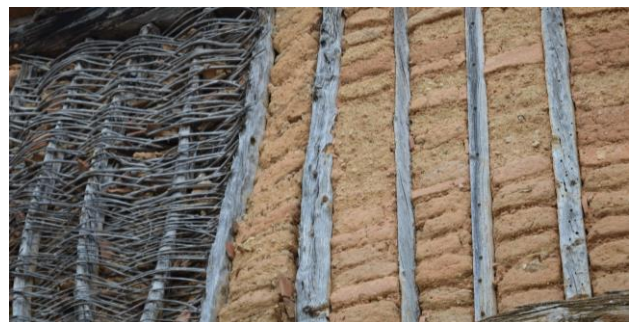
Figure 1. Half-timbered wall with wattle-and-daub (light interwoven fibres) and adobe filling (heavy masonry pieces).

On the one hand, *muros entramados* where the wood assumes almost all the structural function and the spaces between the framework can be filled using monolithic or masonry techniques.

On the other hand, *muros tejidos* where the spaces are completed with screens or light enclosures of interwoven vegetable fibres, such as wattle-and-daub or lath and plaster techniques.

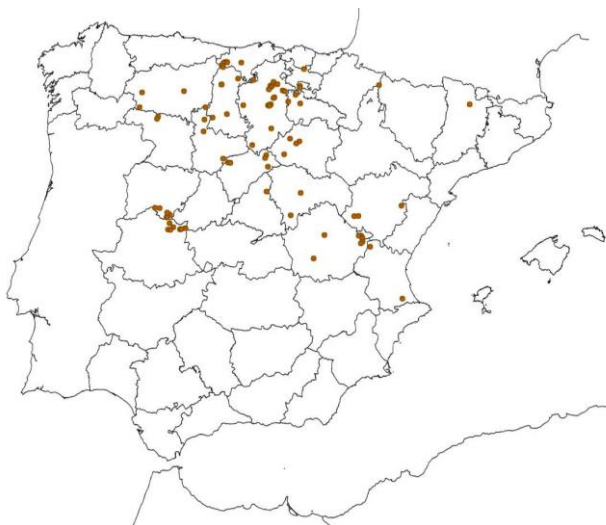
Figure 2. Geographical distribution of the 83 sites where earth and wood mixed walls have been located.

The buildings in the database were then filtered in order to identify only those with half-timbered walls and enough information to constitute valid case studies. The final analysed sample consisted of 217 buildings with the presence of these techniques, distributed throughout 83 different locations (Figure 2).

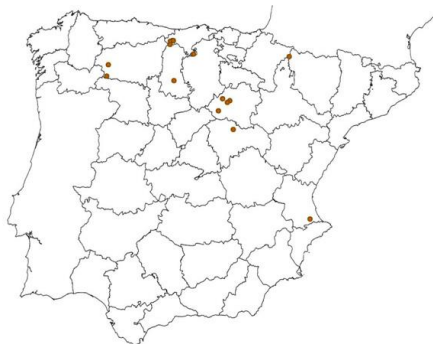
Figure 6. Geographical distribution of analysed half-timbered walls with light enclosures.

In the case of rigid screens or interwoven vegetable fibres enclosures, these walls are mainly concentrated in the north of Castilla y León and the Cantabrian coast (Figure 6).

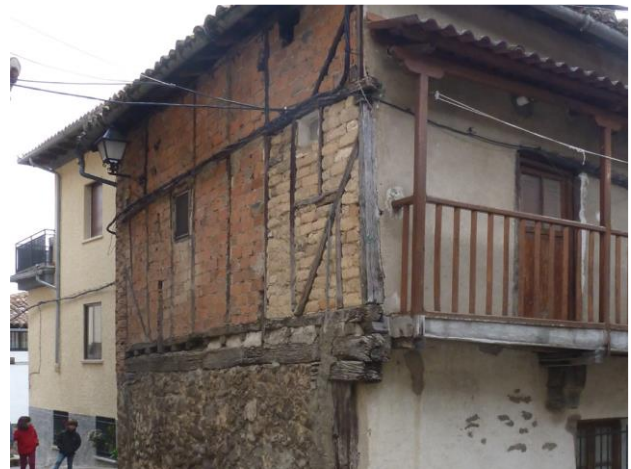
Figure 8. Building in Garganta la Olla (Cáceres), in which adobe infill has been substituted with industrial bricks.

Repairs mostly involve the use of industrial materials, probably for economic reasons or near availability. One example worth mentioning is the partial or total replacement of the original adobe infill with an industrial brick infill (Figure 8). Also, the widespread use of cement mortar to patch some areas of the masonry or to coat entire facades has favoured the appearance of humidity and associated degradation processes.

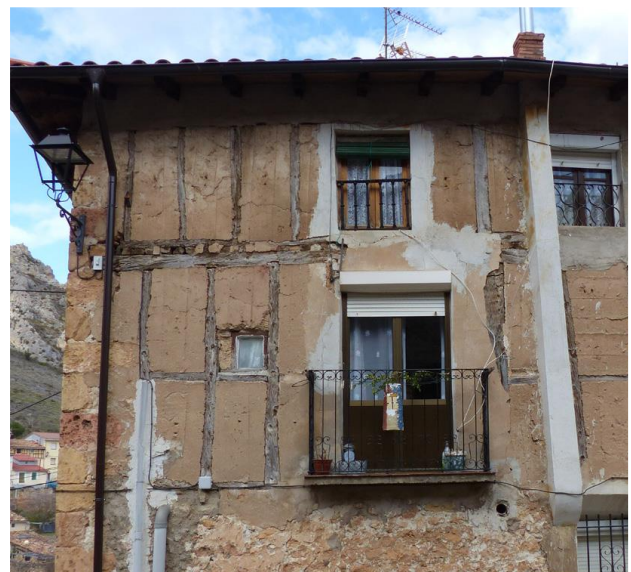
Figure 9. Building in Poza de la Sal (Burgos), partially rehabilitated with new windows.

The most common partial rehabilitation is the replacement of window frames and the installation of blinds (Figure 9). The installation of electrical wiring nailed to the wooden elements is also common. But the most important one involves the modification of the framework to allow access for large vehicles, related to a change of their original use to new use as a garage (Figure 10).

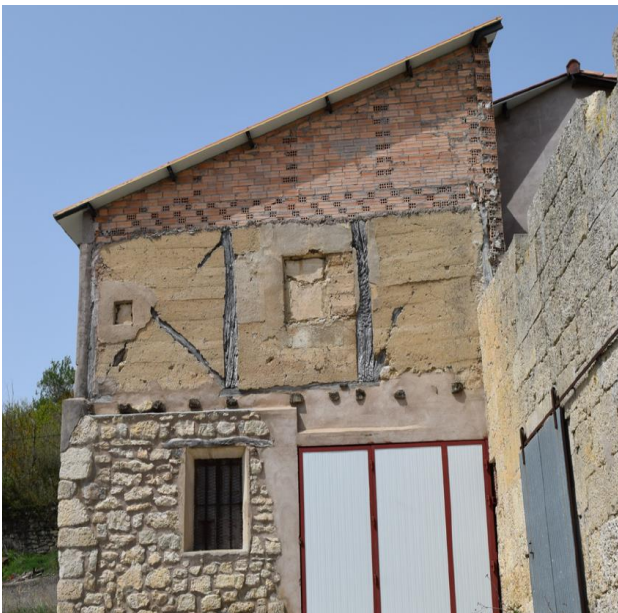
Figure 10. Building in Reinoso (Burgos), extended with brick walls and rehabilitated as a garage.

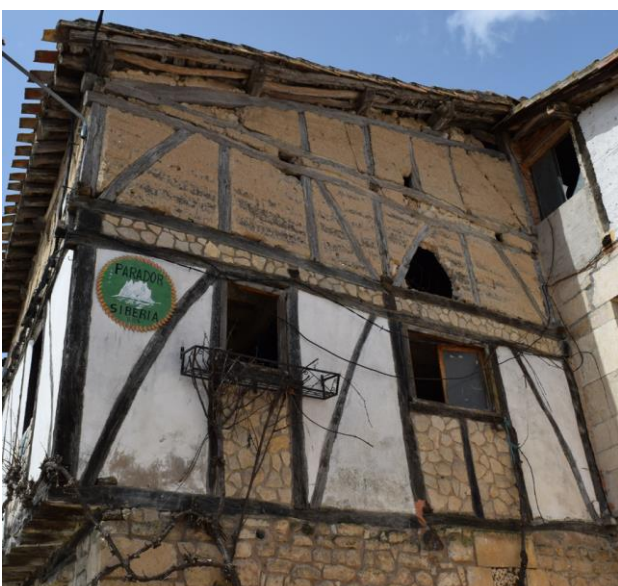
Figure 11. Building in Valdazo (Burgos), aesthetically updated with mortar rendering.

In contrast, larger interventions are less common. Complete rehabilitations are present in 20 of the 180 cases of transformed buildings and expansion in 8 cases. The few expansions detected correspond to increases in height, usually with raised industrial brick walls (Figure 10). The aesthetic updates, found in 65 of the 180 cases studied, correspond mainly to transformations of the main facade and new cement mortar coatings (Figure 11).
